DAMAGE TO EIGHT-STORY RC BUILDING RETROFITTED TO HAVE BASE SHEAR COEFFICIENT OF 0.65

ABSTRACT: An eight-story reinforced concrete building retrofitted according to the 1990 Japanese Standard was severely damaged during the 2011 Tohoku earthquake. The building was constructed in 1966 at Tohoku University. In 1996 the building was retrofitted using structural walls and carbon fiber. The base shear coefficients of the building in the longitudinal and transverse directions after the retrofit were estimated to be 0.67 and 0.65, respectively. This paper discusses the reasons for the severe damage that took place despite the retrofit.

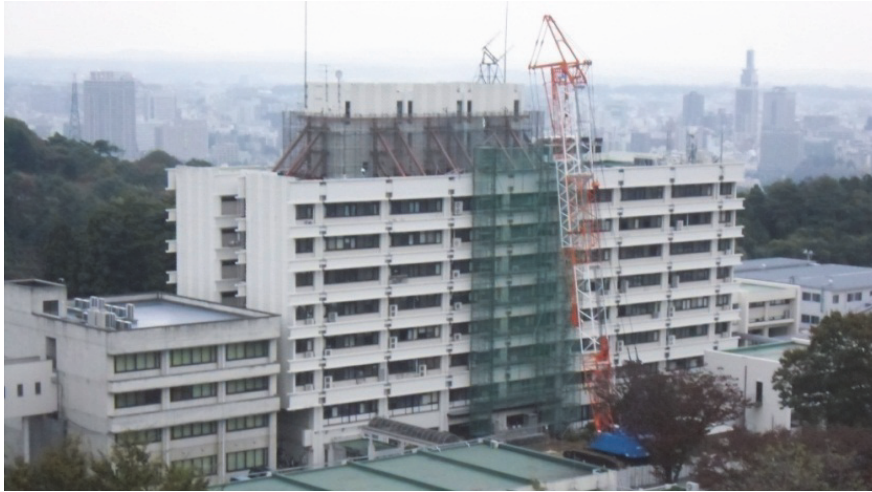
The observed failure modes in this building were different from the predicted ones. Structural walls, which were expected to fail in shear, seemed to have yielded in flexure. Compressive failure associated with bending was also observed in a wall without boundary column. In addition, the carbon fiber used to prevent shear failure of coupling beams did not work properly because of anchorage failures. The penthouse, was also greatly damaged, though the areas of the walls in X and Y directions were 2.8% and 1.3%, respectively, of the total floor area. The penthouse was tentatively strengthened after the earthquake as shown in Photo 1.

Photo 1 General view of the building after tentative strengthening of the damaged penthouse

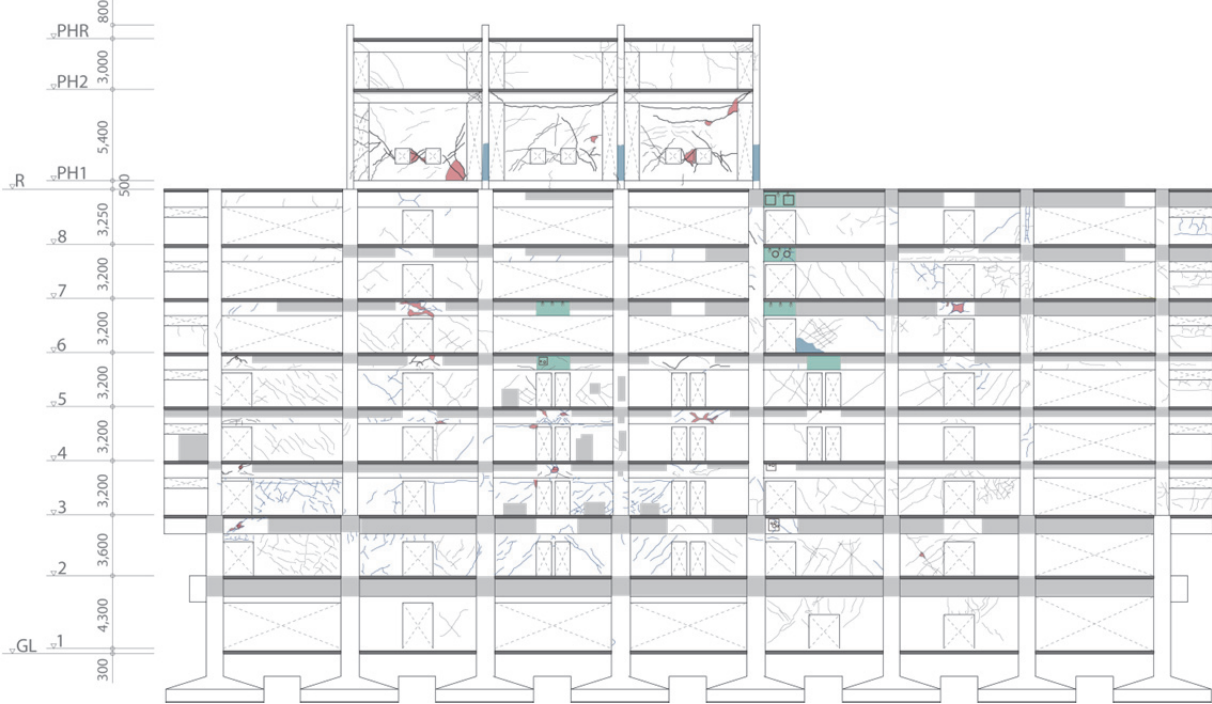
Fig. 3 Frame I cracks schedule

The heaviest damages in the building are located mainly in beams and in the penthouse. Damages in the first story were minor. Figures 3-6 shows the observed cracks in selected frames. The grey shade shows the parts that were not visible, the green one represents carbon fiber reinforcement, the brown one is tape-shaped reinforcement, the red one is detached concrete and the blue one is completely destroyed concrete. Also the thickness of cracks represents cracks between 0.2-1.00 mm, 1.10-2.00 mm and above 2.00 mm. The blue cracks were not measured. The most damaged stories in decreasing order were third, fourth and fifth stories. Regarding to the frames in X direction, damages were more prominent in frames I and J with walls (Fig. 3) than open frames H and K. In Y direction, damages in the penthouse were large as shown in Figs. 4 and 5. Damages in the beams with openings were also prominent as shown in Figs. 5 and 6.

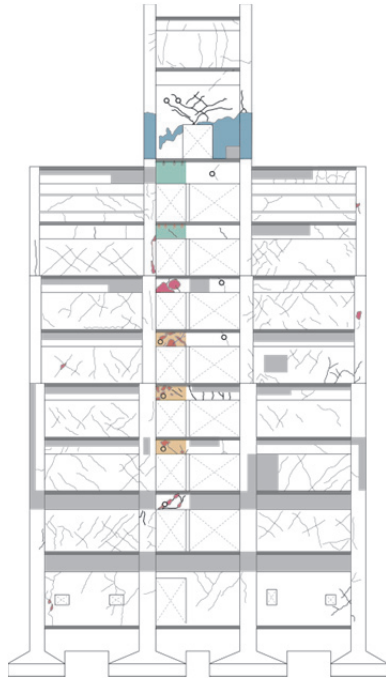
Fig. 5 Frame 11 cracks schedule

Due to the damages seen in frame 11 (Fig. 5) the short beams between frames I-J failed in shear. Therefore, the failure mode as shown in Fig. 18 is assumed to estimate the lateral capacity of this frame. In this model the walls of frames H-I and J-K are strong enough while the coupling beams fail. For the analysis the first story is considered as rigid, because it does not have significant damages. These walls rotate as shown in Fig. 18 and vertical reinforcement bars are assumed to be yielded at the bottom of the second story, where a_t is the cross section area of the longitudinal reinforcement on boundary column and σ_y is the yield strength of the steel. The values N_1 and N_2 are the long term loading axial forces through the boundary columns of the walls. The double circle in this figure represents the plastic hinge of the joint and its plastic moment is computed as sum of the plastic moment of the column and that of the beam.

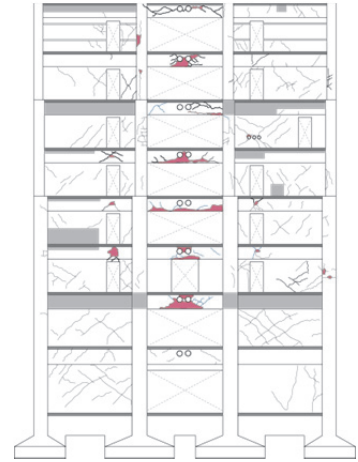
Fig. 6 Frame 14 cracks schedule

Severe damages were also detected in the coupling beams of the frame number 14. They have two 300 \varnothing openings at their midspans and were highly damaged around this area (Photo 12). These openings have been detected also in all the coupling beams of the frame 11 and in some of the frame 9.

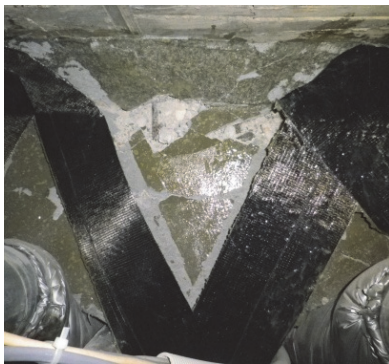
Carbon fiber reinforcement has been used in short and normal beams. The short beams took a lot of damage and failed in shear, while the other beams, even the not reinforced ones, had less damage. Different failures in the carbon fiber of the short beams can be identified such as unstuck tapes (Photo 5), peeled-off tapes (Photo 6), broken fibers (Photo 7), torn fibers (Photo 8) and failure of anchorages (Photos 9 and 10).

Photo 5 Unstuck tapes
Floor 5 Frame 12 Beam I-J

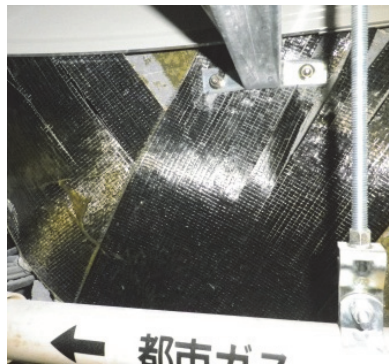
Photo 6 Peeled-off tapes
Floor 5 Frame 11 Beam I-J

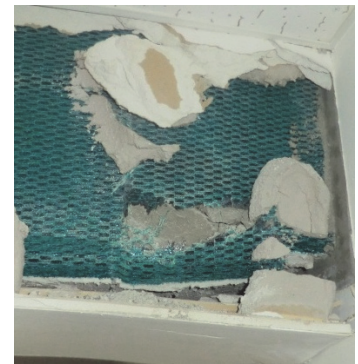
Photo 7 Broken fibers
Floor 7 Frame 11 Beam I-J

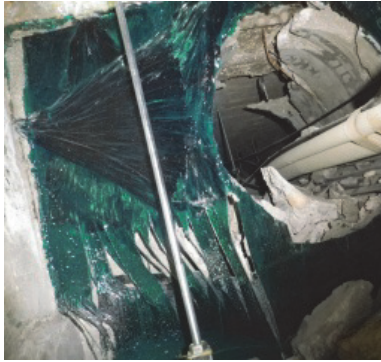
Photo 8 Torn with anchors
Floor 7 Frame 11 Beam I-J

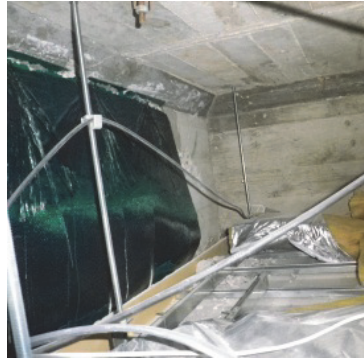
Photo 9 Anchorage failed
Floor 6 Frame 12 Beam I-J

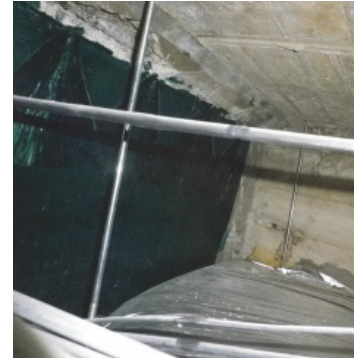
Photo 10 Anchorage failed
Floor 7 Frame 11 Beam I-J

The most severe damage in this group is the failure of the anchorage of two of the carbon fiber reinforcements that were visible. In the last photo the damage was so great that a rebar was visible. For clarifying the photo of the failure a zoom and a drawing are provided in Photo 11 and Fig. 7:

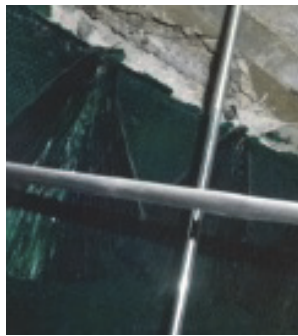
Photo 11 Zoom in failed anchorage
Floor 7 Frame 11 Beam I-J

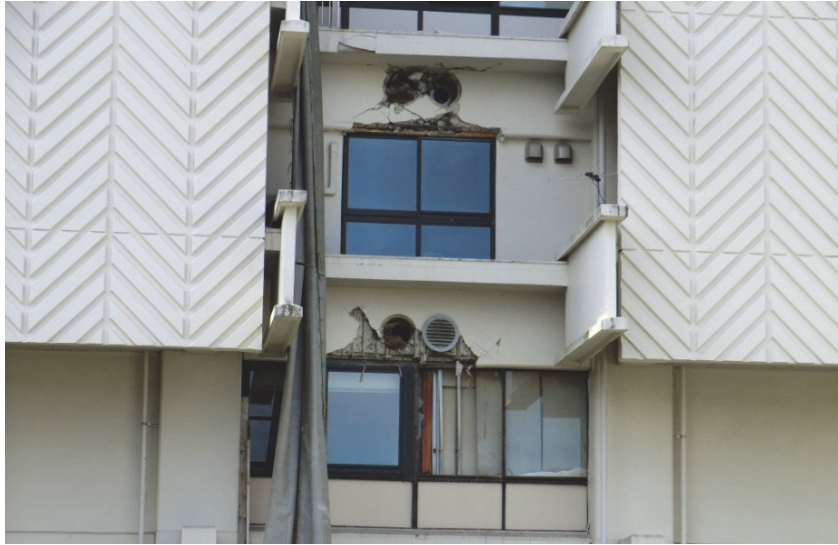
Photo 12 Coupling beams damaged around openings

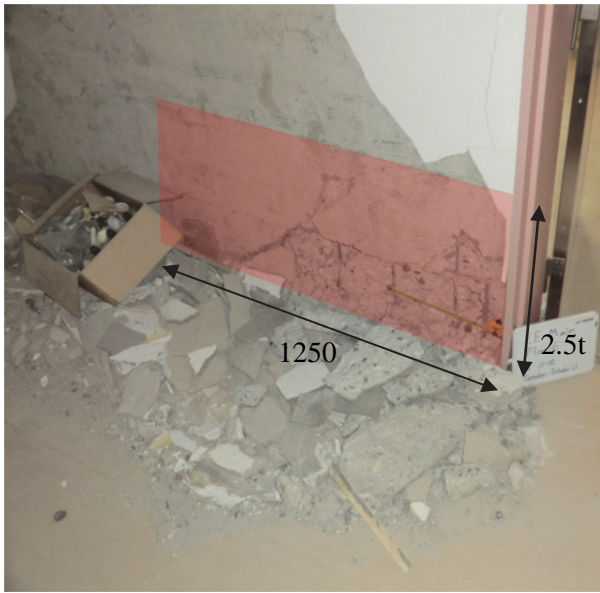
Compressive failure associated with flexural failure was observed in walls without boundary column as shown in Photo 13. The detail of the wall is provided in Fig. 11. The wall has double 9 \varnothing 150@ reinforcement. Some bars were not found in the plans but were visible at the place (Photo 14), the one on the left side may be a reinforcement at the end of the wall. According to the recent study (Takahashi et al, in press), the flexural drift capacity of RC wall can be computed as sum of elastic and plastic drifts and plastic, where the plastic drift is estimated by using the neutral axis depth, plastic hinge length and ultimate compressive strain of concrete. The calculated neutral axis depth is 1250 mm from the border of the wall and is shown in Fig. 11. The height of the observed compressive failure zone was almost 2.5 times of the wall thickness (Photo 13) as predicted by Takahashi et al (in press). From Photo 13, it is supposed that the compressive strain of concrete was very large. If we assume that the compressive strain was from 1% to 2%, the flexural drift is estimated from 0.6% to 1% by the methodology proposed by Takahashi et al. Therefore, actual lateral drift of this building is assumed to be comparable to these values.

Photo 13 Compressive failure
Floor 6 Frame I between frames 11-12

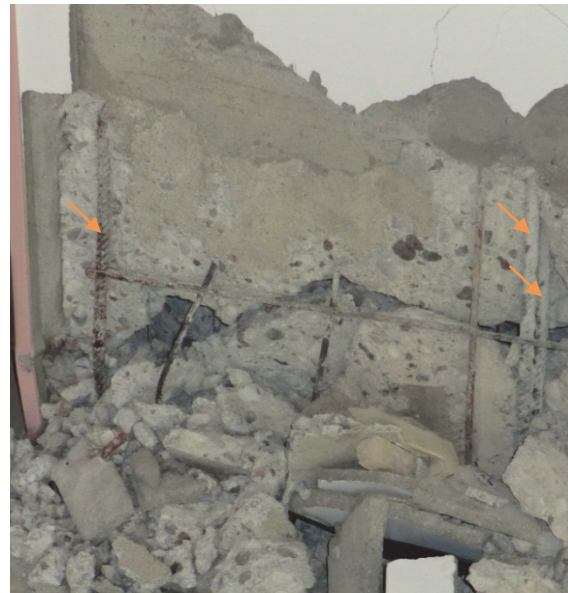
Photo 14 Detail of bars from the other side of
photo 13

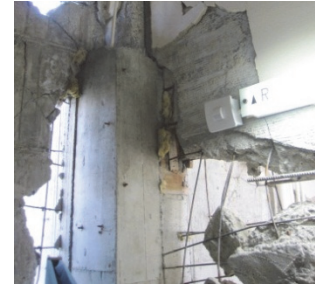
The penthouse of the building was so severely damaged that required reinforcement just after the earthquake in order to prevent collapse (Photos 15, 16 and 17). Both columns and walls were completely destroyed at the first story of the penthouse, while the second story was in a similar condition to the rest of the building.

Photo 17 Later reinforced column of the penthouse
