DAMAGE ON HAZARDOUS MATERIALS FACILITIES

Haruki NISHI¹

¹ Director, Investigation Office, National Research Institute of Fire and Disaster, Tokyo, Japan

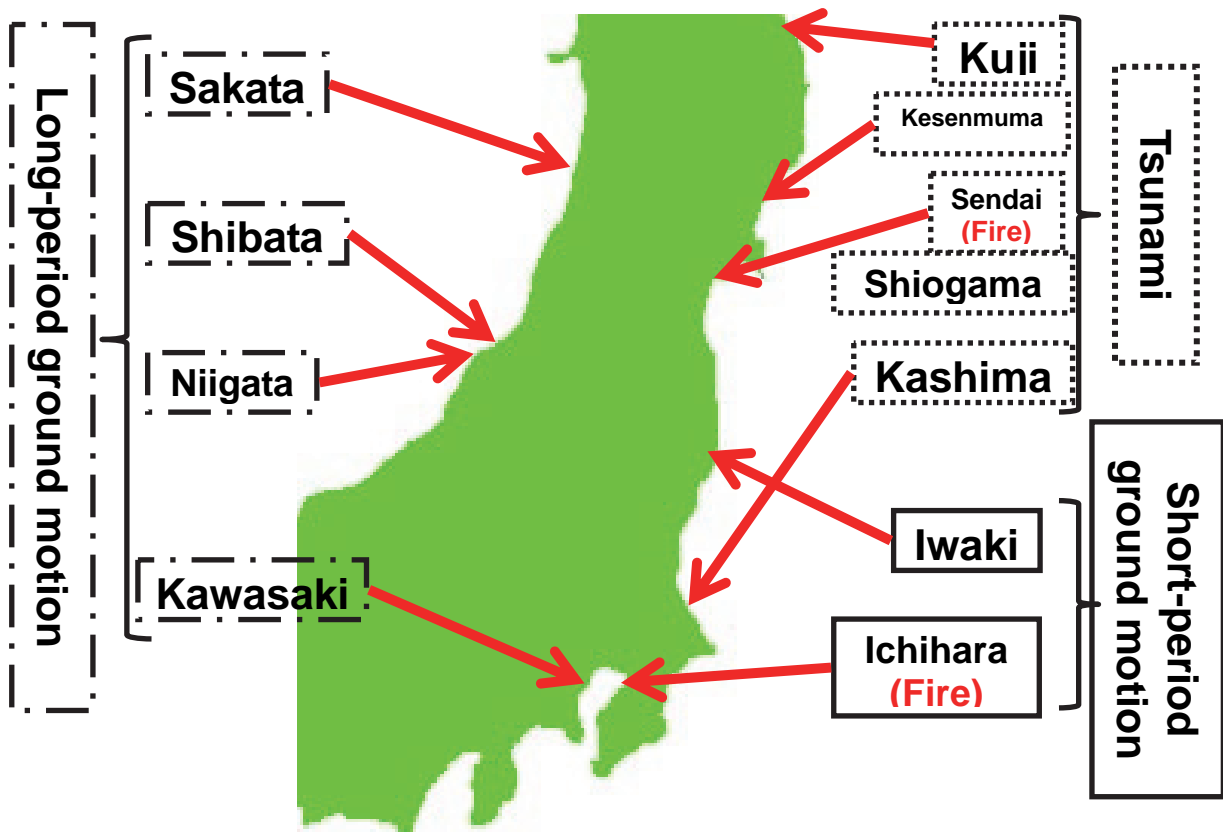
Fig. 1 Type of damage observed mainly in Petrochemical Complex

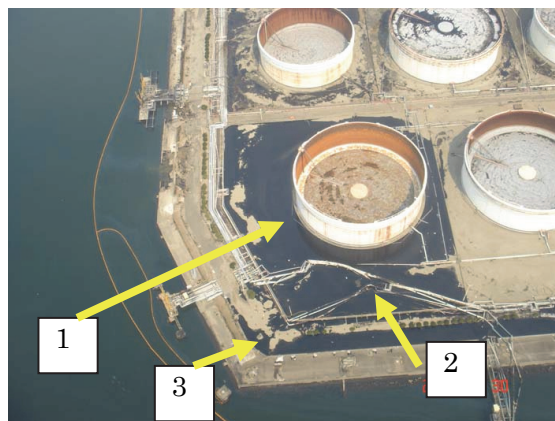
Photo 1 shows the heavy oil spill in the dyke. The tank indicated as #1 in photo 1 is empty when the tsunami struck and submerged into the sea water up to 3.5m high from the bottom plate. The tank did not uplift nor displace even though it was empty. Many pipelines have been bent at the #2 in photo 1 and the large amount of oil leaked from the pipelines spilled all over the dyke and the road beside. These pipelines presumably washed away by the tsunami. The largest fracture was found at an elbow in one of the heavy oil pipeline. Its length is approximately 10cm and its width is approximately 3cm.

Photo 1 Heavy oil spilled in the dyke

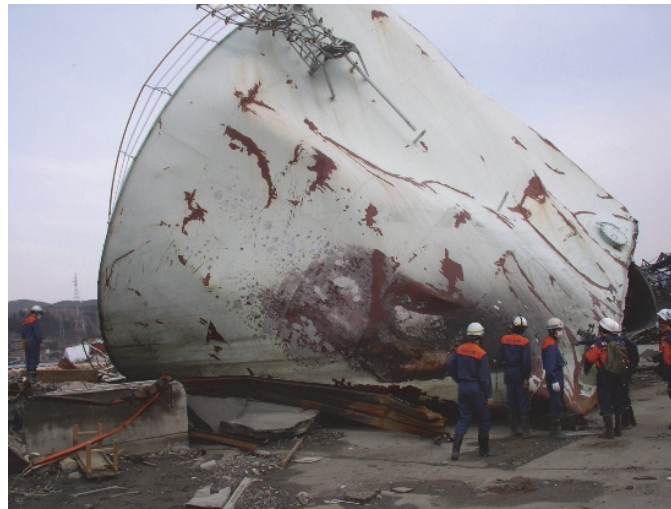
In Kesennuma city, 22 out of 23 above ground oil storage tanks were washed away by the Tsunami. The local fire authority announced that the total amount of oil flowed out of the oil storage tanks were assumed to be 11,721 kL and type of oil is heavy oil, kerosene, diesel fuel and gasoline. Photo 2 shows an oil storage tank which was drifted and collapsed by the Tsunami. It is reported that the large fires

Photo 2 Oil storage tank drifted and collapsed by the Tsunami

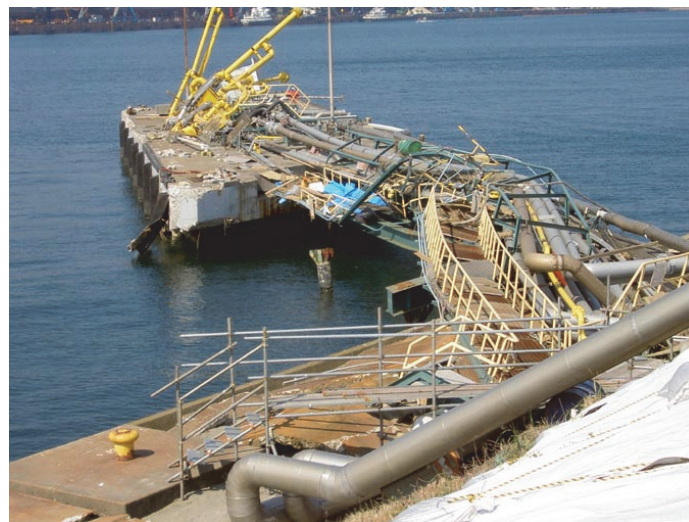
In Kashima area, a sea bank and a berth were damaged by the Tsunami. The berth shown in photo 3 was struck by a drifted oil tanker and collapsed.

Photo 3 Berth collapsed by an oil tanker strike

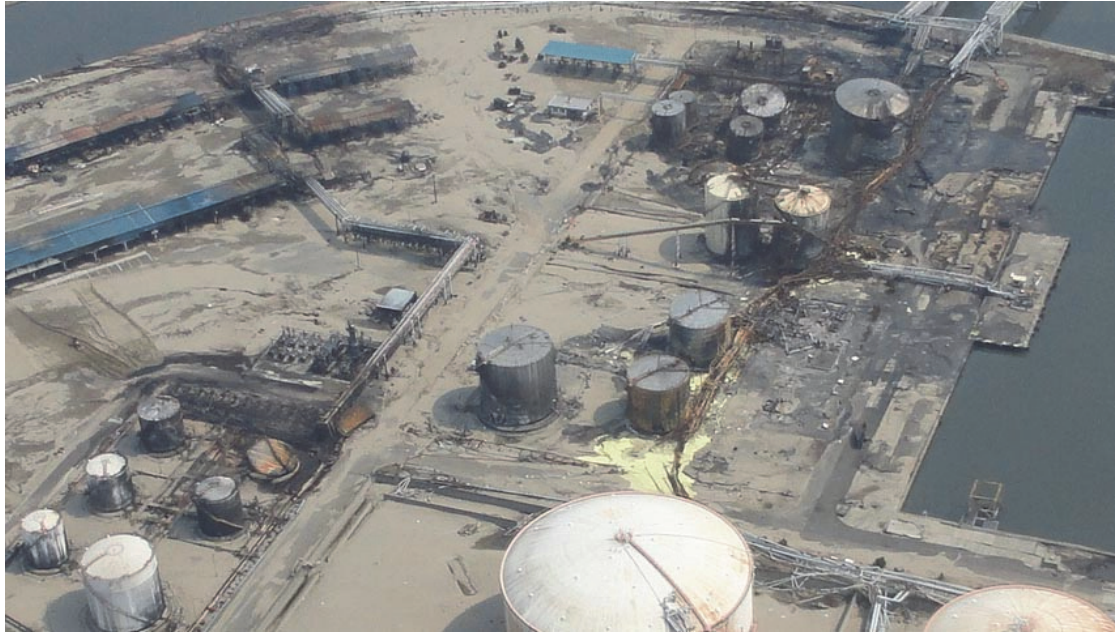
Fires occurred at a refinery in a petrochemical complex in Sendai area. Photo 4 shows a section of the refinery that was burnt out completely by the fires. There were gasoline tank, asphalt tanks, molten sulfur tanks and shipping yard in the burned-out section. Photo 5 shows a burned-out gasoline tank. It seems that the tank inclined to the Pacific Ocean after the Tsunami strike and it collapsed due to the fire. The soil of the dyke and the foundation were washed away by the Tsunami. The welded part of the gasoline tank between the shell plate and the bottom plate fractured along approximately 2.4m.

Photo 4 Burned-out section in a refinery

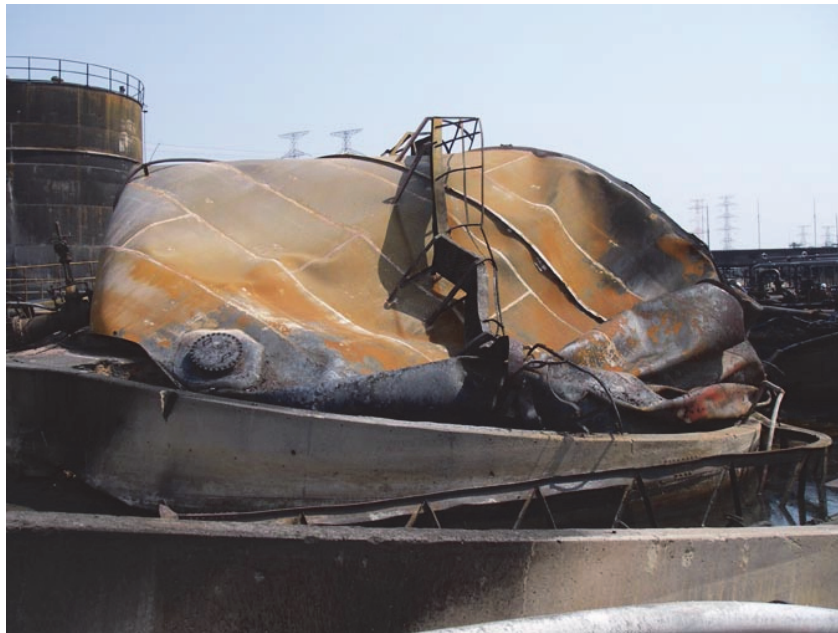
Photo 5 Burned-out gasoline tank

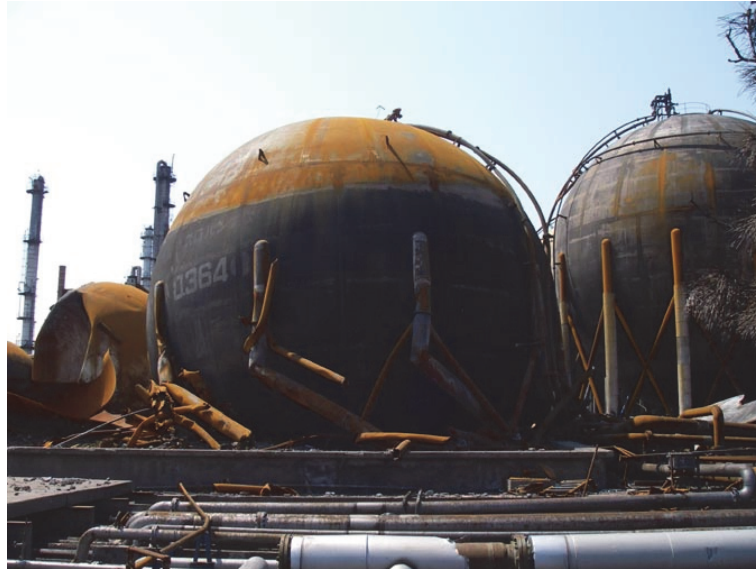
In Ichihara city which locate on the eastern shore along the Tokyo bay, there were fires in which many LPG tanks exploded. It took ten days after ignition to extinguish fires. The largest fire ball in the fire is shown in photo 7. Its diameter is about 600m judging from the height of the plant extractor stack pipe. Many fragments of the LPG tanks scattered in the explosions, therefore the fire spread to the asphalt tanks, the control room and the neighboring factory.

Photo 6 All legs of the LPG tank collapsed and buckled by the earthquake

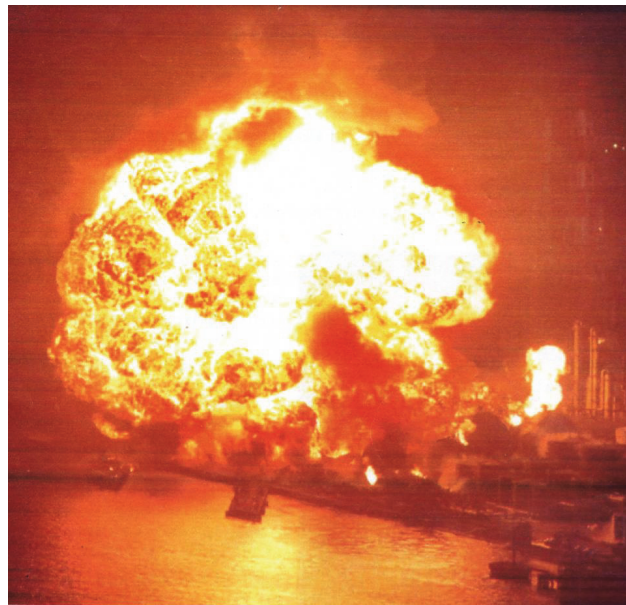
Photo 7 Largest fire ball in the fire with approximate 600m diameter

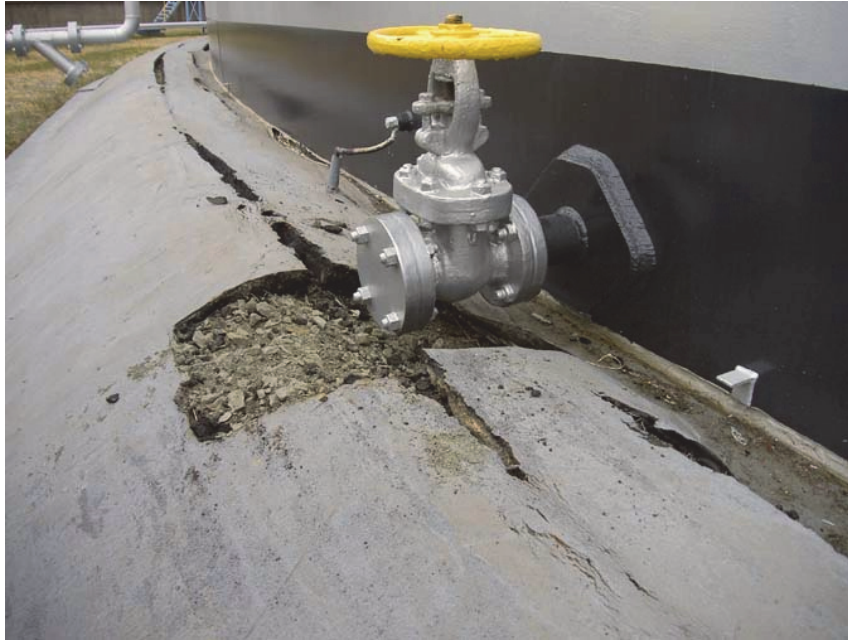
In Iwaki city along the Pacific coast, there was damage due to liquefaction caused by short period strong ground motion. Photo 8 shows an example of a settlement of oil storage tank. The valve of the tank slightly contact to the ground, therefore the asphalt of the berm was removed in order to avoid the failure of the neck of the nozzle in the future settlement.

Photo 8 Tank settled because of liquefaction around the foundation

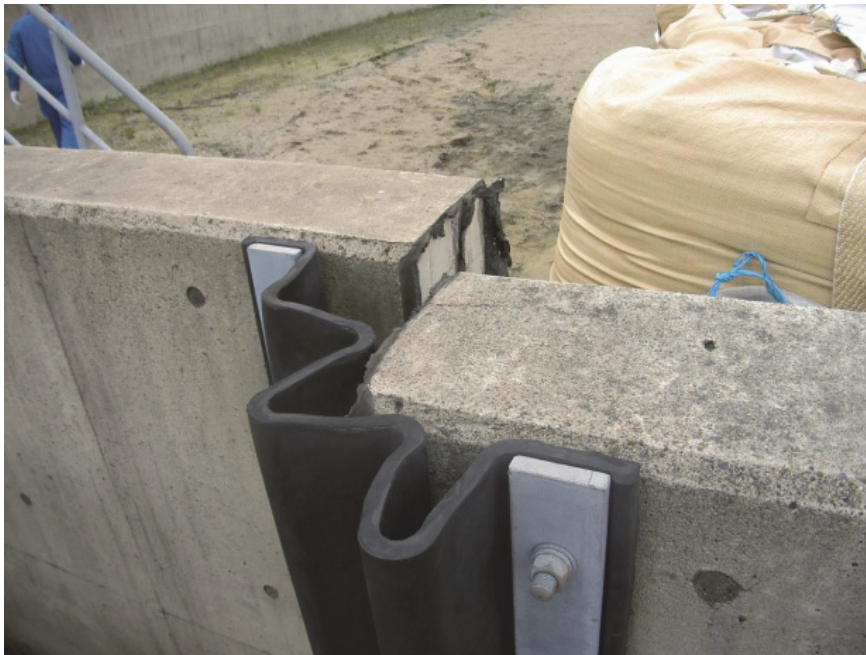
In Kashima area, the wall of the dyke settled and inclined because of liquefaction. As shown in photo 9, fractures of joints of the dykes were found in some walls. Some of them have rubber sheets protection in order to maintain its function in case of joint fracture. Some rubber sheets tore and lost its function of retaining oil inside the dyke.

Photo 9 Fracture of wall joint of the dyke with rubber sheet protection

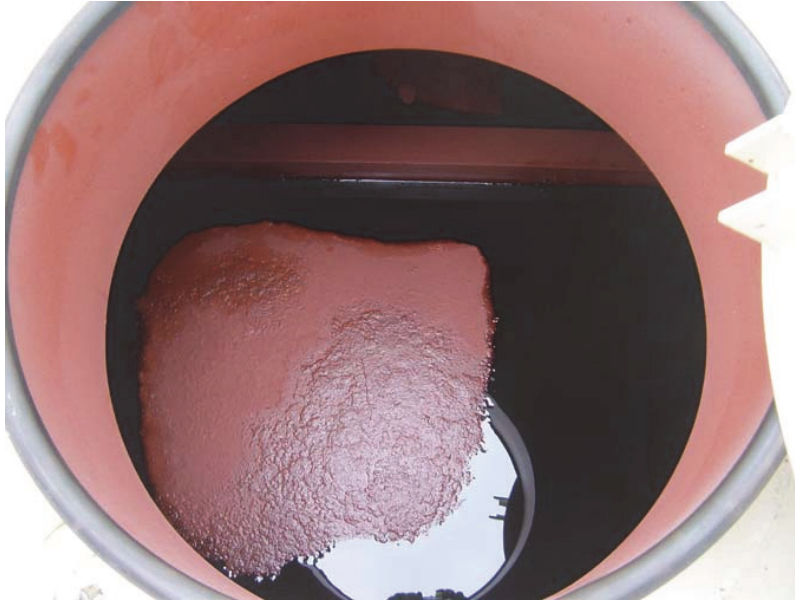
Typical damage of oil storage tank caused by liquid sloshing was found mainly along the Sea of Japan and the Tokyo bay. Oil spilled onto the deck of the floating roof in Niigata city, Shibata city and Kawasaki city. Oil marks on the surface of the shell plates were found in many oil storage tanks. Photo 10 shows crude oil leaked from the fracture part of pontoon of floating roof. In Kawasaki city, floating roof of heavy oil tank completely sank three days after the earthquake as shown in photo 11.

Photo 10 Crude oil leaked from the fracture part of pontoon of floating roof

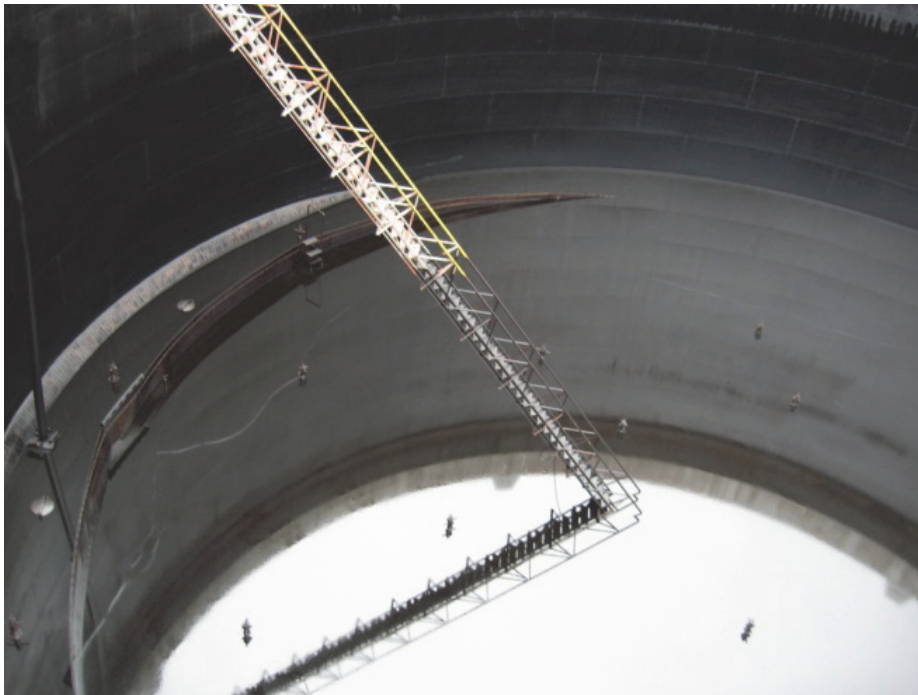
Photo 11 Sinking of floating roof

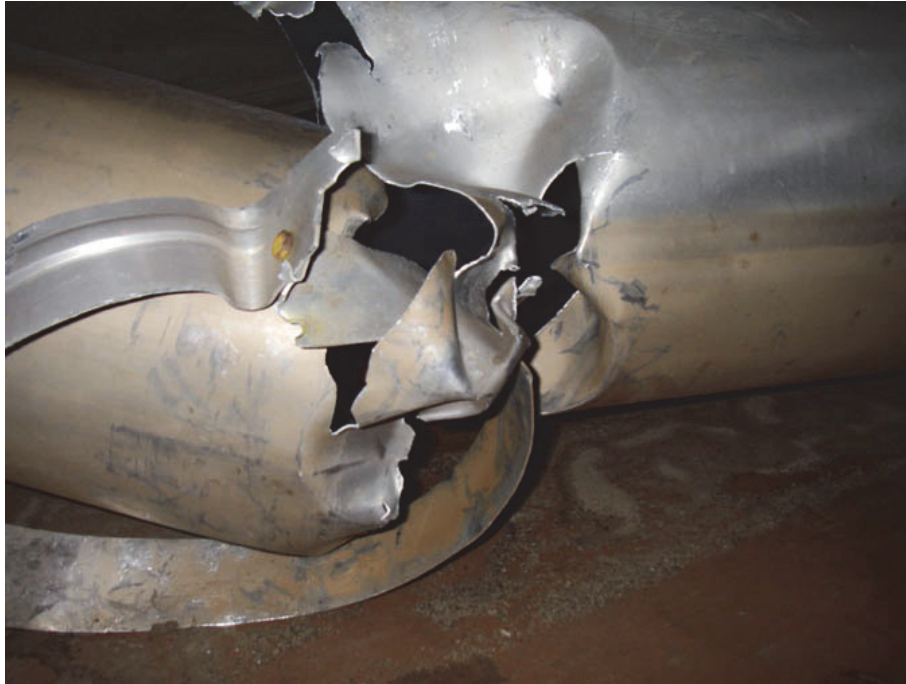
In Sakata city which locate along the Sea of Japan, the aluminum inner floating roof of gasoline tank was broken completely. Photo 12 shows one of broken float tubes of the inner floating roof. Its length is about 6.7m and its diameter is 25.4cm. The natural period of the first-order mode of the sloshing is 4.19s for the tank and velocity response is about 200cm/s at the period. The maximum sloshing height is calculated as 202cm by applying the two dimensional response analysis method (Zama, 1985) and the inclination angle of the inner floating roof is calculated as 15 degree simultaneously. Deck skin and clump beams were also broken up, though the photos are not presented here.

Photo 12 Broken float tube

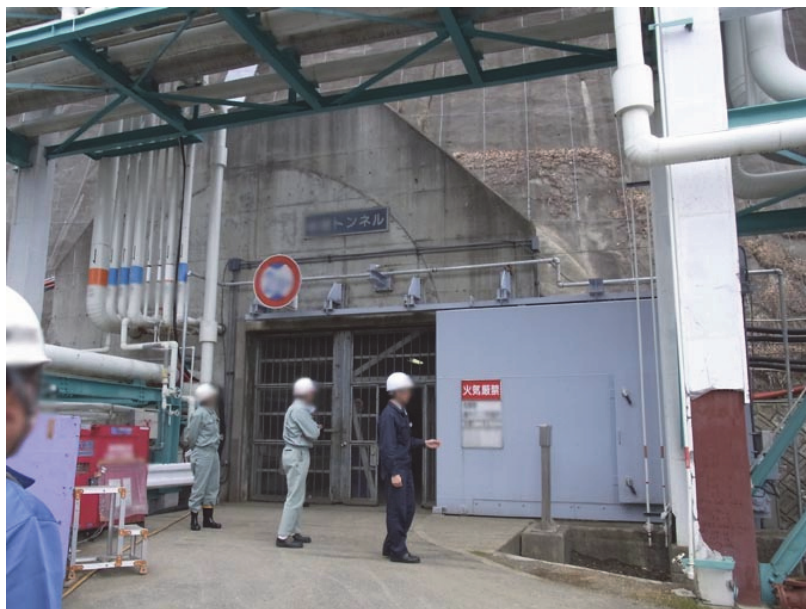
In Kuji city, there are underground rock cavern oil tanks. The tanks suffered no damage by the Tsunami, because the door of the tunnel shown in photo 13 was properly closed by the employee. However, the aboveground facilities were completely destroyed by the Tsunami as shown in photo 14.

Photo 13 Door of the underground rock cavern oil tanks

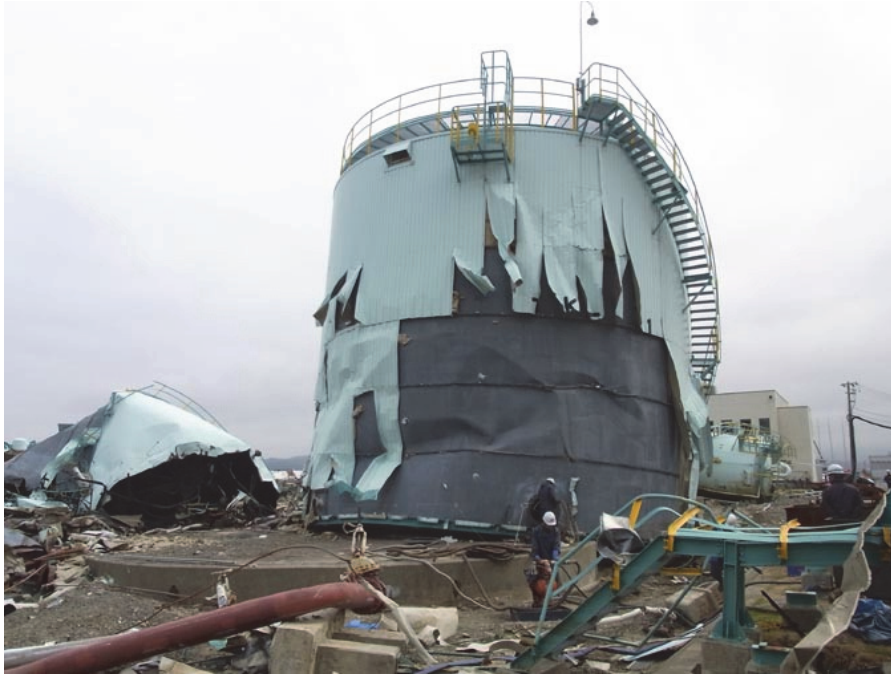
Photo 14 The tank of which the shell plate buckled and the heat reserving materials tore off
