SEISMIC PERFORMANCE OF REINFORCED CONCRETE SCHOOL BUILDING IN FUKUSHIMA UNDER THE GREAT EAST JAPAN EARTHQUAKE

Kazuya KAMATAKI¹, Akira TASAI², and Koichi KUSUNOKI³

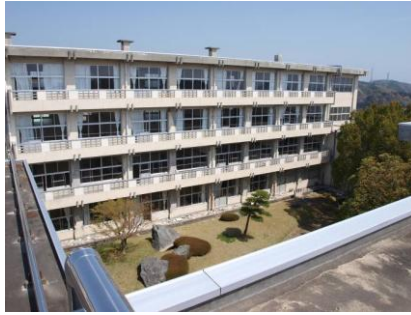
Fig. 2 Overview of Building “A”

Overview of Building “A” is shown on Fig.1, and 1st floor plan with damage indexes of columns and walls is shown in Fig.2.

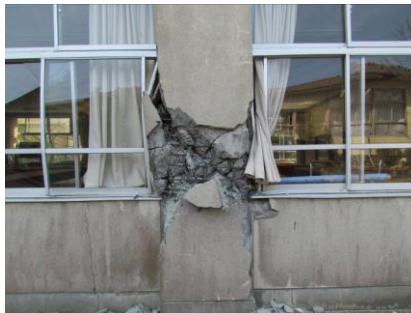
The north frame of the building was severely damaged, and the columns of the special classroom at the west end of the building on the 1st floor failed in shear with its damage index of V. Window frames by the sides of the column deformed due to its vertical shortening as shown in Fig.2

Fig. 3 Shear failure of the first story column at north frame of Building “A”

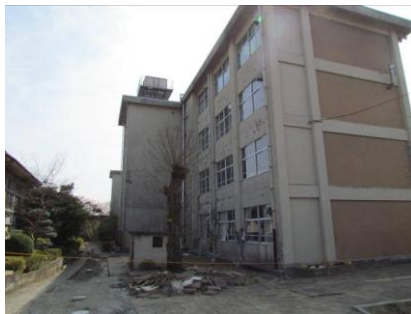
On the other hand, the shear wall at the west end of the building suffered no serious damage as shown in Photo 3. Some girders with standing wall in the north frame failed in shear. Floor level of Building “A” was 15cm lower than building “C”.

Fig. 4 West side view of Building “A”

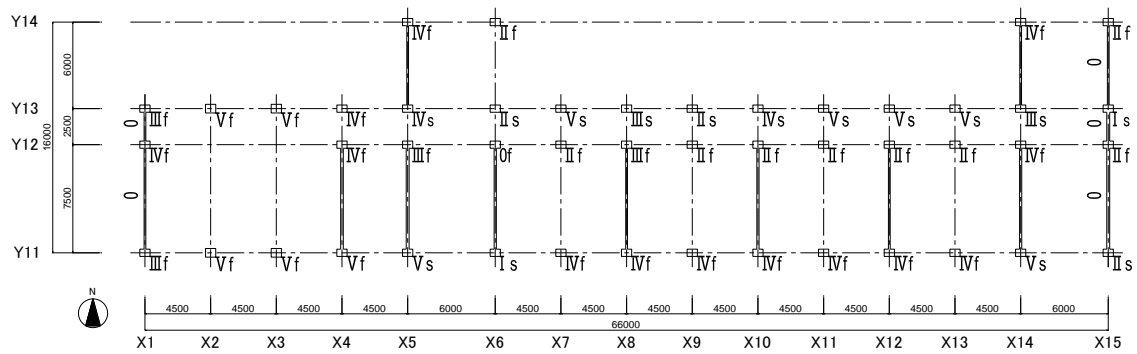
The minimum residual seismic capacity index “R” according to Japanese Guidelines for Damage Classification was 33.3% for the longitudinal direction of the 1st floor. The building was evaluated as “severely damaged” according to the index.

Fig. 5 Plan and damage grade of structural members of Building “A”

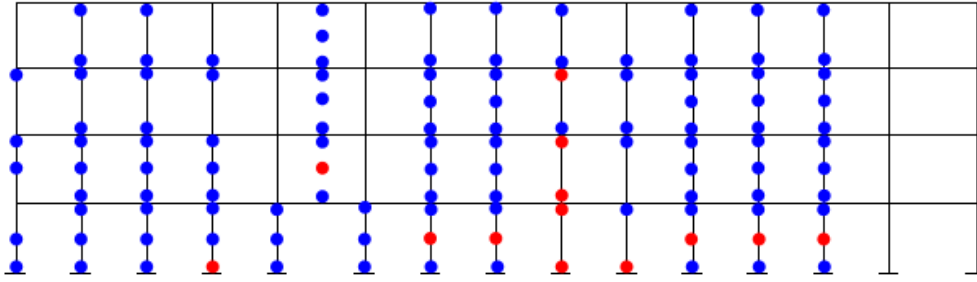
Furthermore, damage state of the drift angle 1/50 is show in the Fig.14, the damage pattern in the Building A by mean of observation is shown in the figure.15, collapse mechanism of the Building A by the shear force is shown in Fig. 16.

Fig. 14 Hinges pattern in the Building A by analysis (Y13-Frame; $R_1=1/50$)

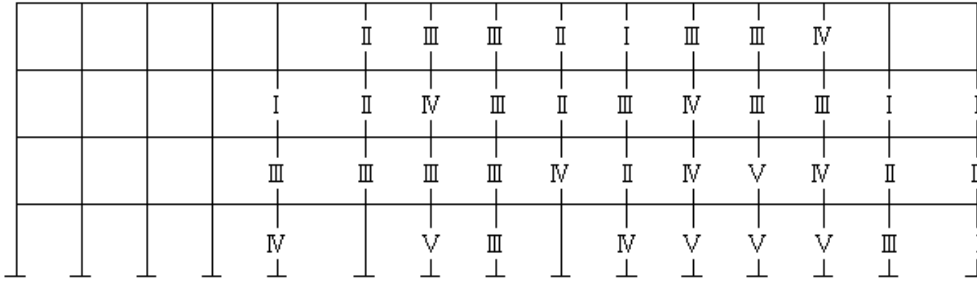
Fig. 15 shows the shear damage pattern in the Building A by observation after the Great East Japan Earthquake, which is described in Fig. 11.

Fig. 15 Shear damage pattern in the building A by observation

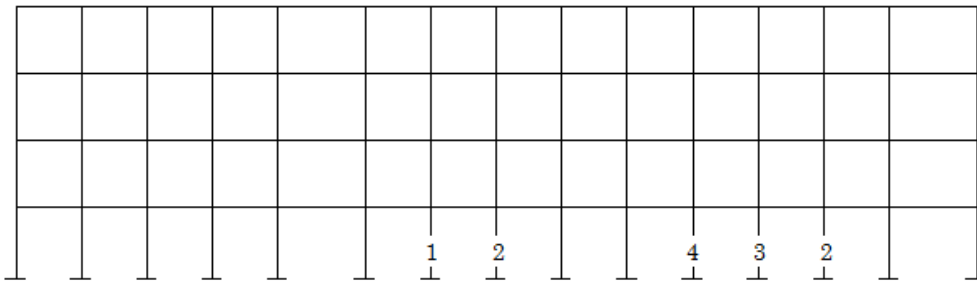
Fig. 16 Collapse mechanism in the Building A by shear force

This study conducted a nonlinear static analysis in an existing RC school building in Fukushima, which was damaged by the Great East Japan Earthquake. Results show a slightly difference between collapse stage of structure ($R=1/50$) and the actual damages pattern obtain by observation. Time-history analysis is needed in order to acutely study the dynamic behavior of this type of structures under strong ground motions.
