BUILDING DAMAGE IN NARITA, SAKURA AND THE TONE RIVER BASIN IN CHIBA PREFECTURE

ABSTRACT: The 2011 Tohoku-chiho Taiheiyo-oki Earthquake that occurred on March 11 caused severe damage to buildings. In Chiba Prefecture, a Japanese Meteorological Agency (JMA) seismic intensity scale (I_{JMA}) of six-minor was recorded at Narita, Inzai-sasagami and Inzai-ohmori. Tsunami damage on the Pacific side and liquefaction damage on the Tokyo Bay side and along the Tone River of Chiba were severe. In addition to this damage, there was building damage by liquefaction. We report here on the building damage in Chiba Prefecture.

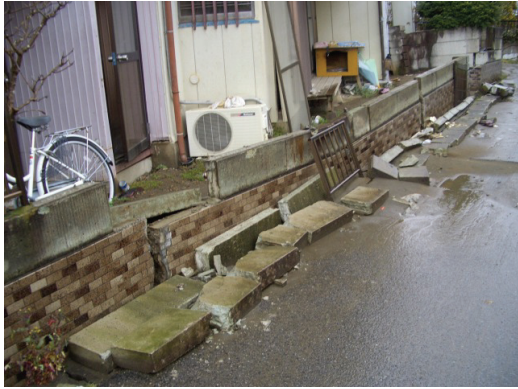
Liquefaction damage was severe on the west side of Katori city hall. Timber houses and power poles were leaning, concrete block walls had collapsed and road surfaces were deformed (Figures 2 and 3). Attached buildings were separated from main buildings by soil failure. A tank was unseated by land subsidence (Figures 4 and 5).

Figure 2 Damage of a masonry garden wall

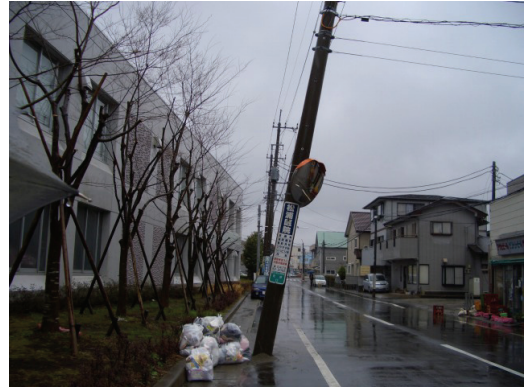
Figure 3 Leaning power pole

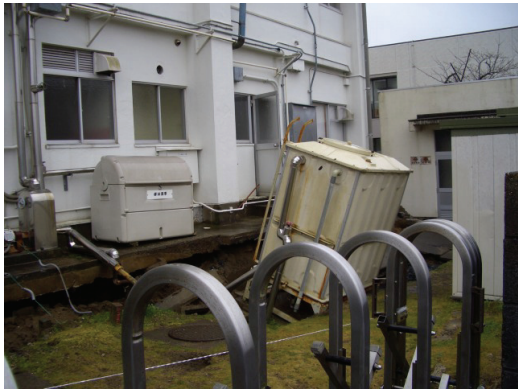
Figure 4 Damage of a tank by land subsidence

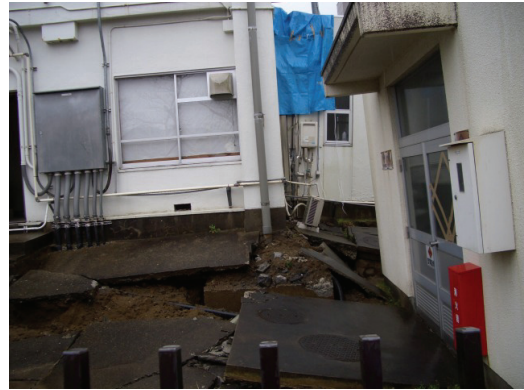
Figure 5 Attached building separated from the main building

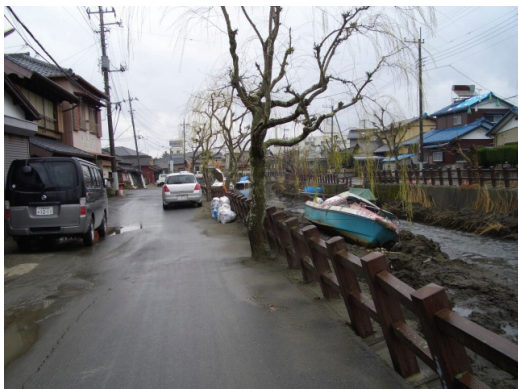
Revetment along the Ono River was damaged (Figure 6). The Ono River dried up by erupting sand leaving boats stranded. Many buildings along the Ono River sank.

Figure 6 Damage to the revetment along Ono River

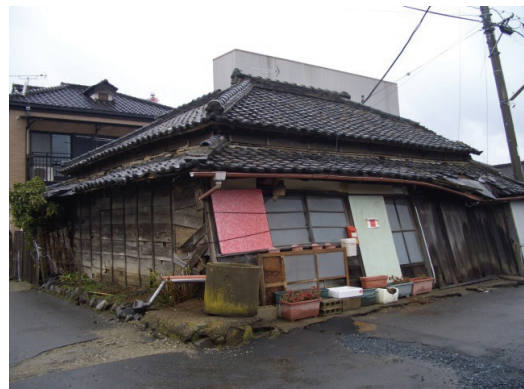
In the important traditional building preservation area of Sawara, the roof tiles and plaster walls of traditional buildings were dislodged and collapsed (Figures 7 and 8). The government-designated excavation of the ruins of the old Ino Tadataka residence was closed and its roof was covered with blue tarpaulins (Figures 9 and 10). Mitsubishi-kan, which is a significant cultural property of Chiba, had no structural damage (Figure 11).

Figure 7 Timber house damage from liquefaction

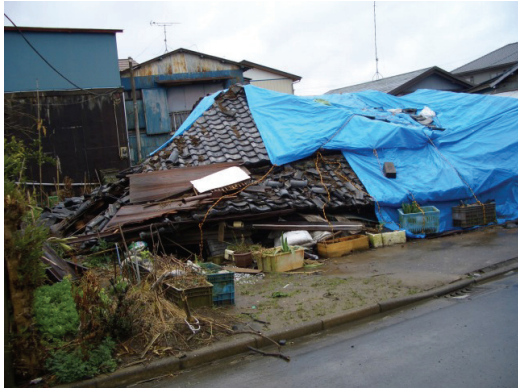
Figure 8 Collapsed timber house near the Ono River Drainage Pump Station

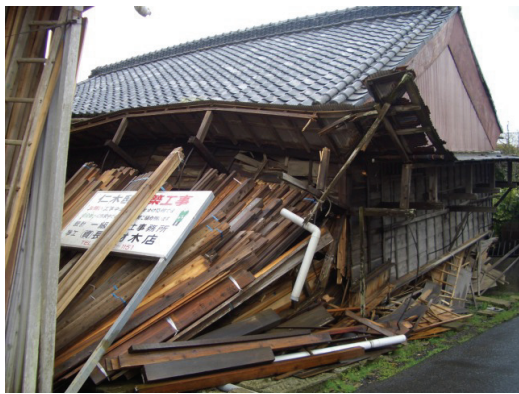
Around Omigawa station there was less liquefaction and soil failure. There were collapsed concrete block walls and fallen exterior walls. Figure 12 shows the collapsed warehouse near the Kurobe River. The warehouse collapsed because of fallen lumber.

Figure 12 Collapsed warehouse

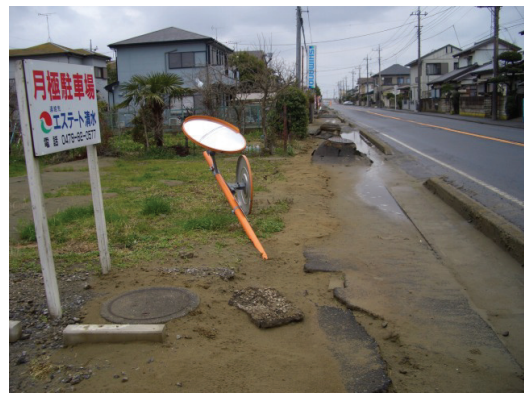
The Shinkai-cho area of Omigawa near the Tone River was severely damaged by soil failure. A manhole and a water storage tank were uplifted by liquefaction as seen in Figure 13. Only one block of land collapsed to the west and a timber house tilted because of soil failure (Figures 14-16). Figure 17 shows a large sand eruption point in the next block. A water tank was uplifted about 30 cm by liquefaction. (Figure 18)

Figure 13 Shinkai-cho area

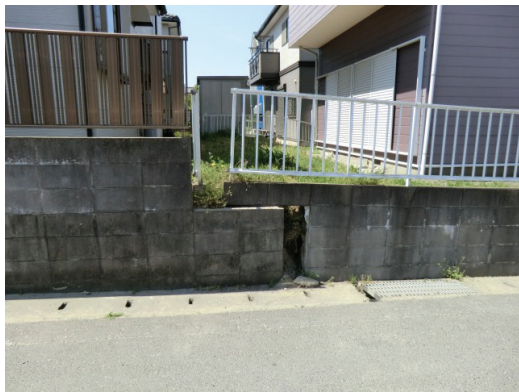
Figure 14 Subsidence damage

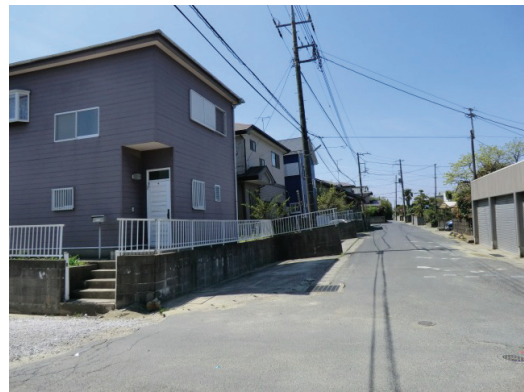
Figure 15 Tilted timber house

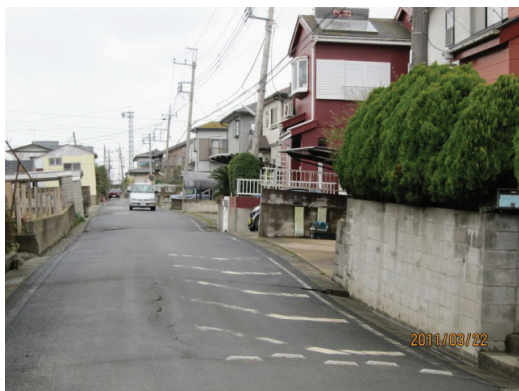
Figure 16 Tilted timber house

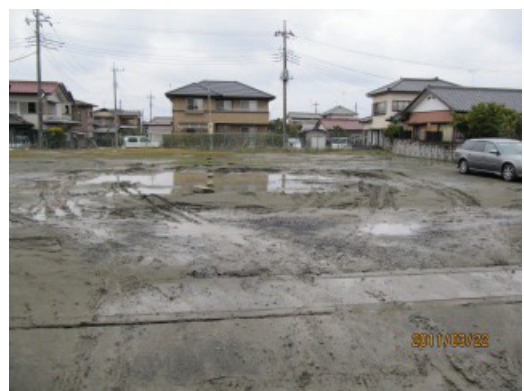
Figure 17 Sand eruption point

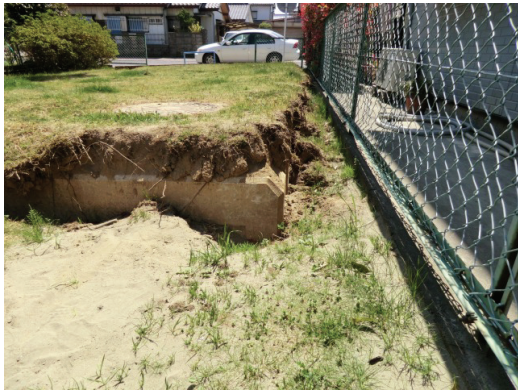
Figure 18 Water tank uplifted by liquefaction

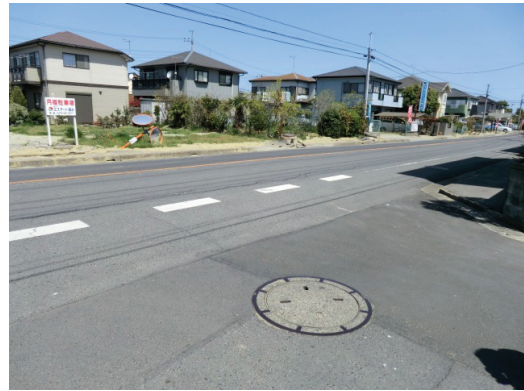
The two adjoining blocks responded differently. One manhole was uplifted, but the others were not damaged as shown in Figure 19.

Figure 19 Shinkai-cho, Omigawa area

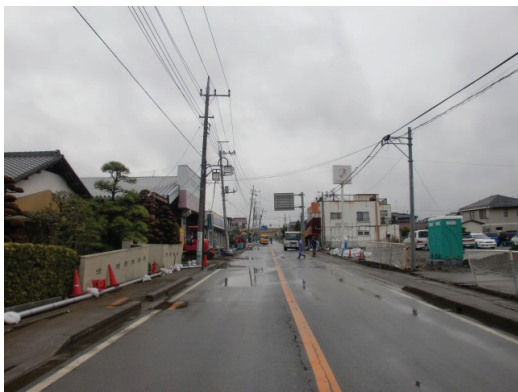
The major damage around Abiko Station was fallen roof tiles. The damage in Abiko was minor excluding the damage caused by liquefaction in the Fusa area. Liquefaction was limited to the Miyako area of Fusa (Figures 20 and 21). This liquefaction area was consistent with its swamp-like origins. There were the leaning power poles and an uplifted manhole (Figures 22 and 23). Many timber buildings in the liquefaction area were tilted and had settled because of subsidence (Figures 24 and 25). The maximum total settlement was about 1 m and the tilt or inclination angle was about 1/100. A reinforced concrete structure apartment in Miyako had no structural damage but did have damage to pipes.

Figure 20 Liquefaction in Miyako

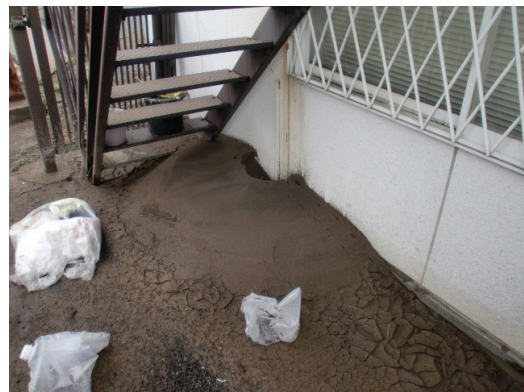
Figure 21 Sand eruption

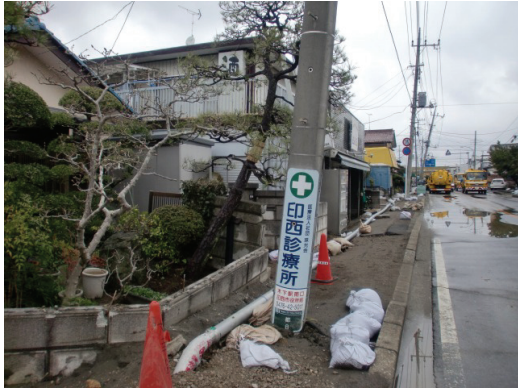
Figure 22 Inclination of power poles

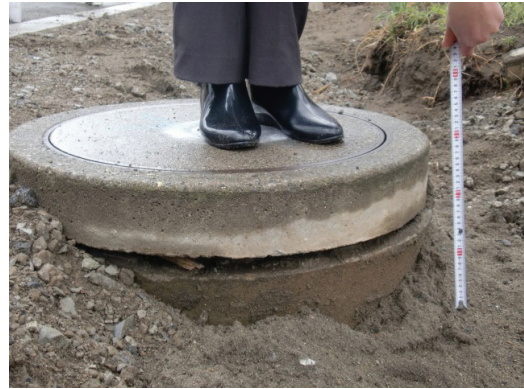
Figure 23 Uplifted manhole

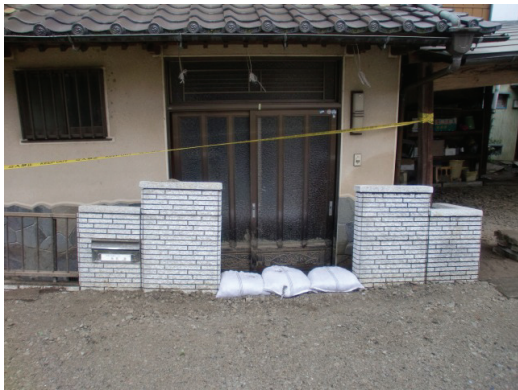
Figure 24 Settling of a timber house due to liquefaction

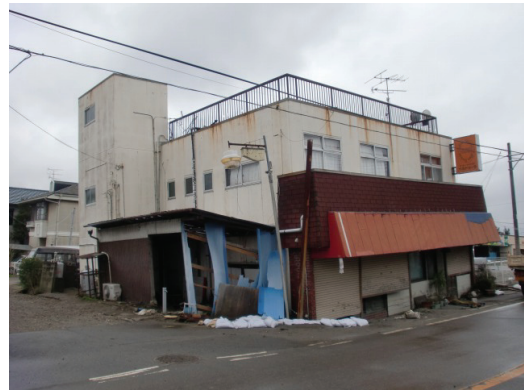
Figure 25 Inclination of a building due to liquefaction

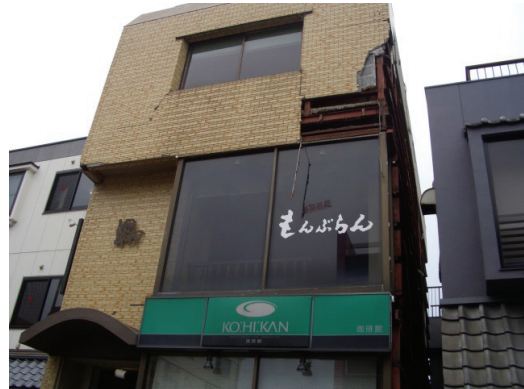
Figure 27 Fallen exterior walls

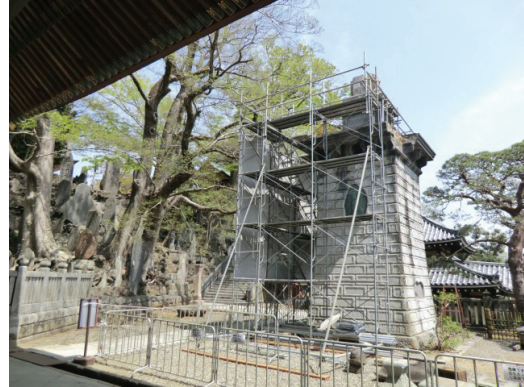
Timber buildings in the Naritasan Shinsho-ji Temple had no structural damage but many stone structures, such as a stone lantern, had fallen.

Figure 29 Damage to a stone structure

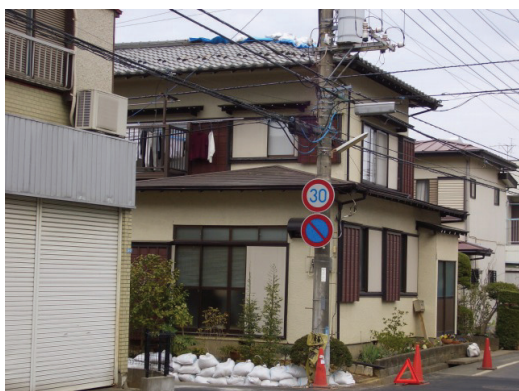
Damage to buildings was reported in the north of the city where the low-lying area and plateau meet. Damage to housing was mainly uneven settling. One of the area concentrated damage was in developed land in the low-lying area. The houses settled about 10 cm.

Figure 32 Settling of a timber house

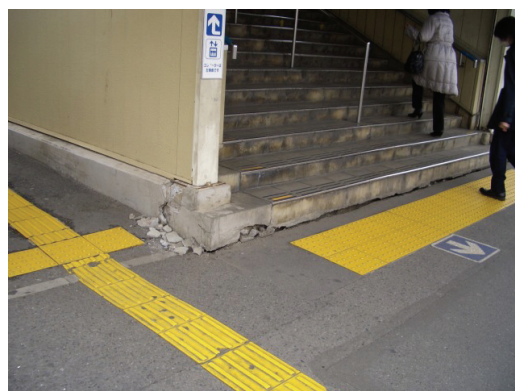
A peak ground acceleration of 1,053 cm/s/s was recorded at the K-NET Sakura station (NIED). The station is set on a slope above the city hall. Figure 30 shows the K-NET Sakura station and city hall. Figure 31 shows the cityscape from Sakura city hall. The damaged roof tiles were covered in blue plastic tarpaulins. There were cracks in the stairs of a building near Keisei-Sakura station located in the low-lying area.

Figure 33 Damage to a column base of the stairs in Keisei-Sakura Station.
