# **BUILDING DAMAGE BY THE 2011 TOHOKU JAPAN EARTHQUAKE AND COPING ACTIVITIES BY NILIM AND BRI COLLABORATED WITH THE ADMINISTRATION**

**ABSTRACT:** This paper presents the outlines of the strong motions recorded in and around the buildings by the BRI Strong Motion Network, the motion induced building and residential land damage and the tsunami induced building damage by the 2011 Tohoku Japan earthquake. On-going coping activities in order to establish necessary technical standards collaborated with the administration are also introduced.

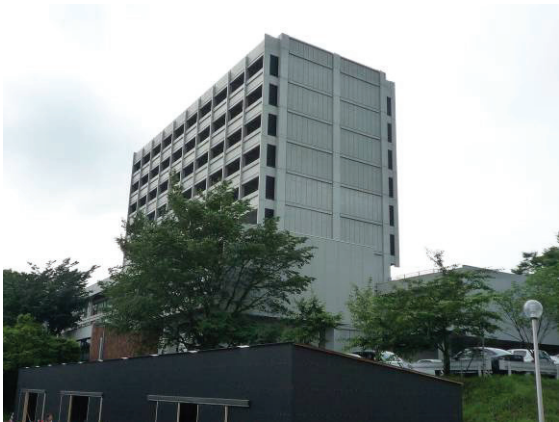
During the earthquake, multi-story shear walls of the building suffered flexural failure with other damage. Photo 1 and Fig. 1 show the appearance of the building and the records of the strong motion. The fundamental natural periods of the building calculated every 10 seconds (Kashima and Kitagawa 2005) increased from 0.6 seconds to 1.5 seconds during the earthquake, which clearly shows and agrees with the building damage.

Photo 1 Building of Tohoku University

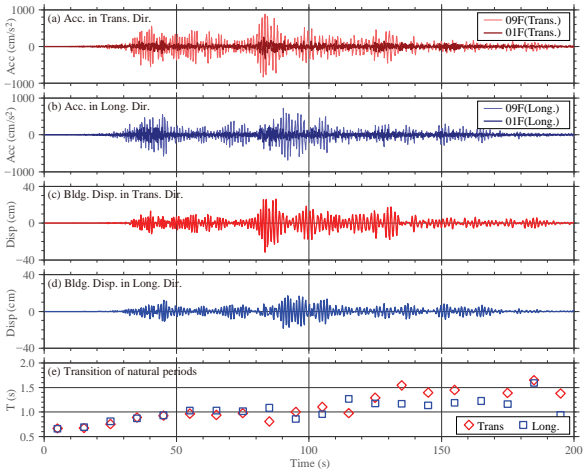
Fig. 1 Records of strong motion

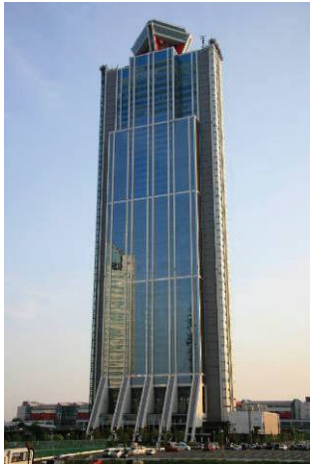
During the earthquake, long-period earthquake ground motions were observed in Tokyo, Osaka and other large cities. One example is the 55-story steel office building on the coast of Osaka Bay that is 770 km away from the hypocenter. Photo 2 and Fig. 2 show the appearance of the building and the records of the absolute displacement waveforms. The absolute displacements in the SW-NE and in the NW-SE directions on the 1<sup>st</sup> floor was less than 10 cm, but the 52<sup>nd</sup> floor in the building suffered a large motion with a zero-to-peak amplitude of more than 130 cm. The pseudo velocity response spectra for the 1<sup>st</sup> floor records (Fig. 3) show clear peak at about 7 second period resulted in large earthquake responses at the top due to a resonance phenomenon.

Photo 2 55-story steel office building (Osaka Bay)

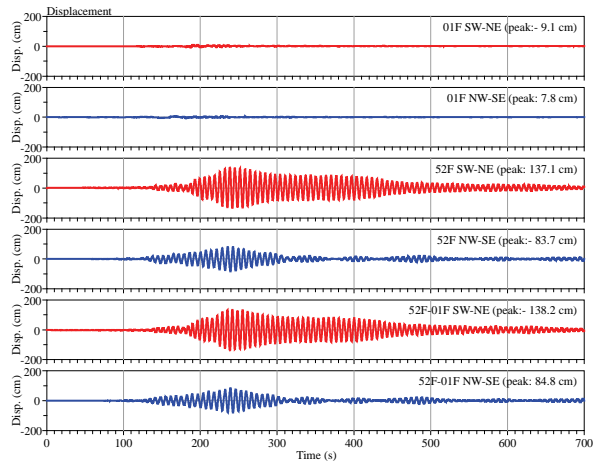
Fig. 2 Records of strong motion

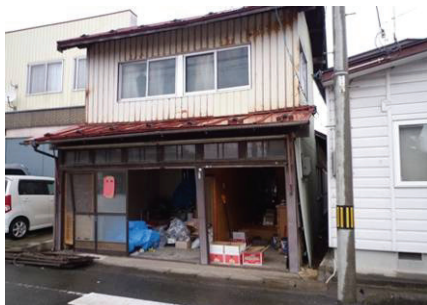
Most of the patterns of the damages to the wood houses by the earthquake were observed in past destructive earthquakes. They are the inclination and/or collapsed of the 1<sup>st</sup> story of wood houses with store as shown in Fig. 5 and Fig. 6 and the fallen down of the finishing due to structural bio-deterioration shown in Fig. 7. Collapse of the 2<sup>nd</sup> story shown in Fig. 8 was quite unusual.

Fig. 5 Inclination of 1<sup>st</sup> story

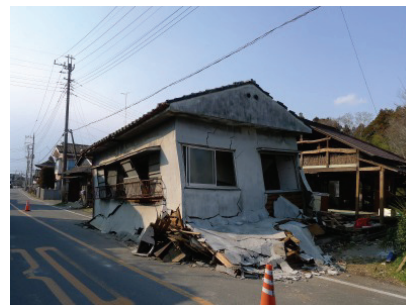
Fig. 6 Collapse of 1<sup>st</sup> story

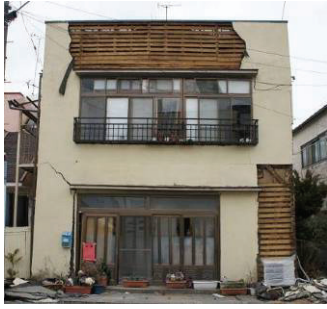
Fig. 7 Fallen down of finishing (bio-deterioration)

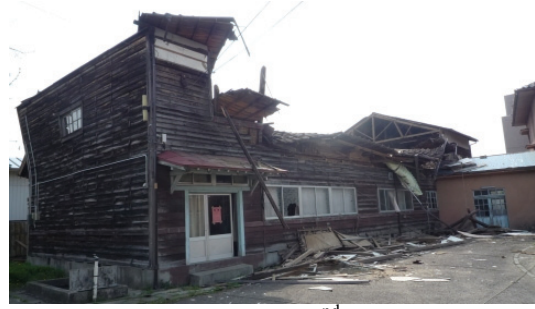
Fig. 8 Collapse of 2<sup>nd</sup> story

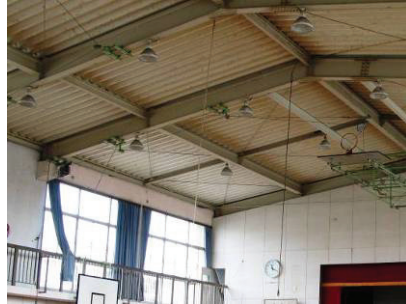
Steel gymnasiums are surveyed extensively in Ibaraki prefecture, as the structural system of them is similar to that of factories and warehouses. Most of the patterns of the damages were observed in past earthquakes, which are the rupture of braces at the joint as shown in Fig. 9 and the rupture of roof braces in Fig. 10. The spalling of concrete at the joint of the steel roof structure and the reinforced concrete column as shown in Fig. 11 and the buckling of latticed column in Fig. 12 were also observed. The dropping of ceiling was observed at many gymnasiums (Fig. 13) which could not be used for emergency evacuation sites.

Fig. 10 Rupture of roof braces

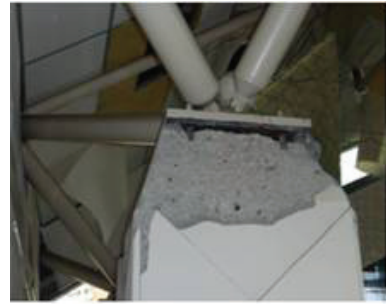
Fig. 11 Spalling of concrete at joint

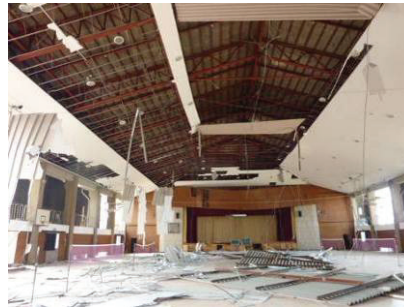
Fig. 13 Dropping of ceiling

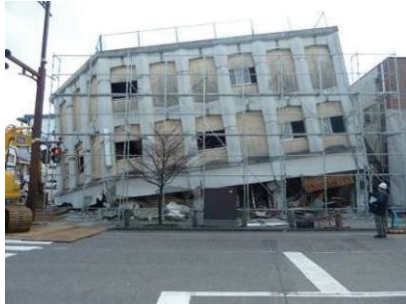
Almost all of the damages of reinforced concrete buildings in the earthquake were observed in past destructive earthquakes. For example, they are the story collapse in the soft 1<sup>st</sup> story (Fig. 14) and/or mid-story (Fig. 15) of buildings due to shear failure of columns (Fig. 16), and so on. The nonstructural walls adjacent to the door of residential buildings suffered damage quite frequently as shown in Fig. 17. The retrofitted buildings behaved well in general with some exception as shown in Fig. 18.

Fig. 14 Collapse of soft 1<sup>st</sup> story

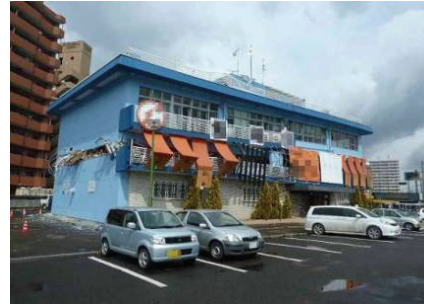
Fig. 15 Collapse of mid-story

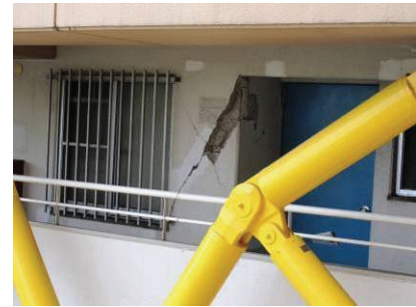
Fig. 18 Damage of retrofitting

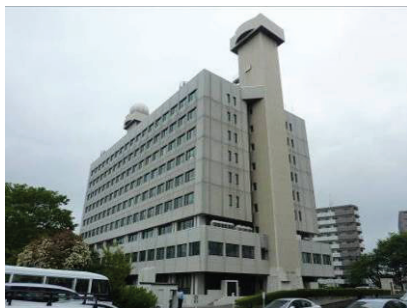
Sixteen seismically isolated buildings in Miyagi prefecture and one in Yamagata prefecture were surveyed in which three buildings were instrumented and recorded strong motions. All of them performed structurally very well (Fig. 19) which was also clarified by the recorded motions. The steel dampers absorbed earthquake energy by the plastic deformation (Fig. 20). However, the lead dampers suffered cracks due to many cycles of small amplitude of reversed deformation as shown in Fig. 21. Damage to the expansion joints (Fig. 22) was seen quite frequently which should be improved very soon.

Fig. 19 Seismically isolated building performed well

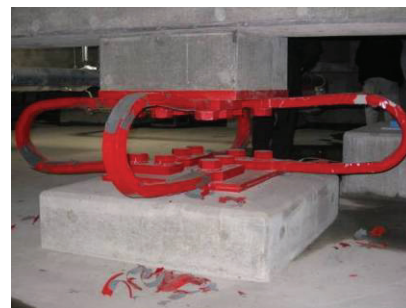
Fig. 20 Yielded steel damper

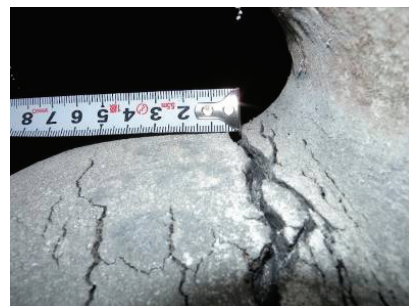
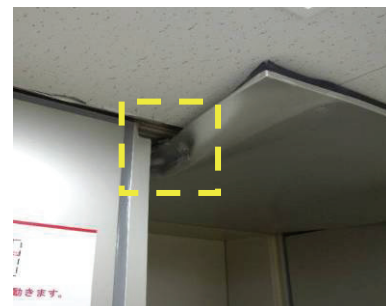
Fig. 22 Expansion joint deformation

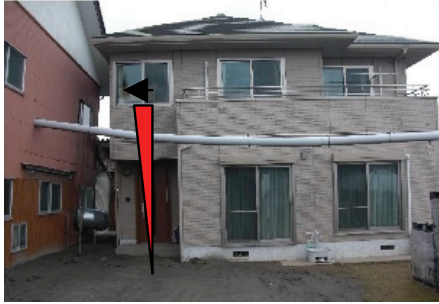
In the catchment area of Tonegawa River and the coastal zone of Tokyo Bay, extensive damage such as sand boiling or ground transformation associated with liquefaction was confirmed. Highly tilted buildings were seen, but visual cracks or fissures on the foundations investigated were not observed as shown in Fig. 23.

Fig. 23 Tilted house by liquefaction

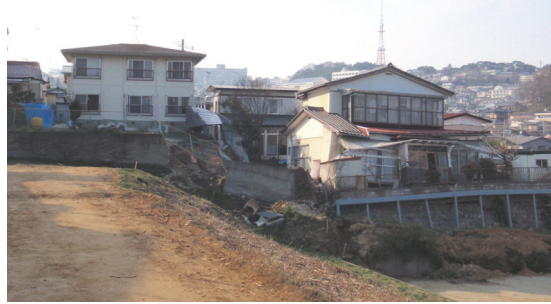
In Sendai city, the ground transformation by sliding of the housing site embankment was observed as shown in Fig. 24, just like the one under the 1978 Miyagi-Ken-Oki earthquake.

Fig. 24 Ground transformation by sliding

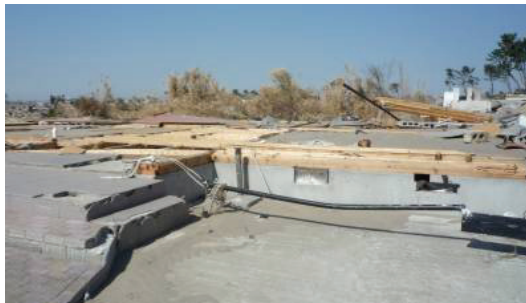
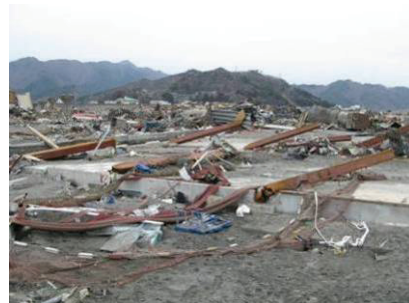
Movement or complete washed away was observed especially in wood houses and steel buildings as shown in Fig. 25. Overturning with the effect of buoyancy was observed mainly in reinforced concrete buildings and exceptionally in steel building as shown in Fig. 26. Tilting by scouring was seen as shown in Fig. 27. Story collapse, out-of-plane deformation of wall and washed out of claddings shown in Fig. 28 are due to horizontal force by tsunami. Figure 29 shows the effect of debris impact, and Fig. 30 shows several survived wood houses by the shading effect of the tsunami front building.

Fig. 25 Movement and complete washed away (left: wood house, right: steel building)

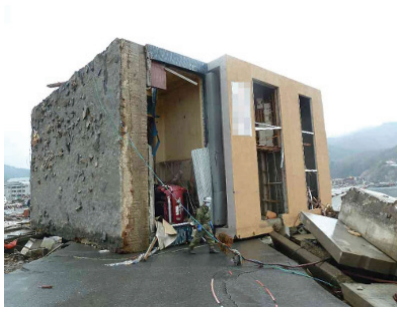
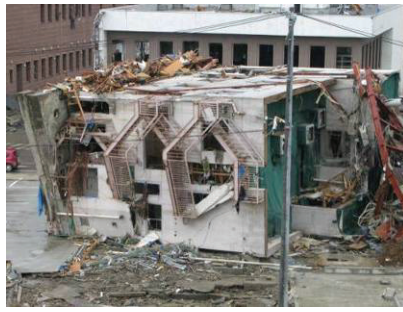
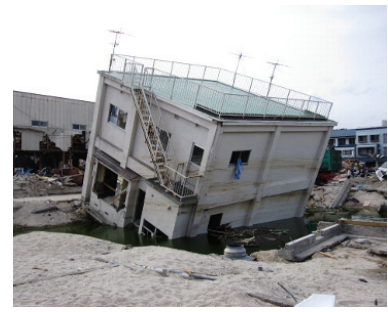
Fig. 26 Overturning  
(left: reinforced concrete building, right: steel building)

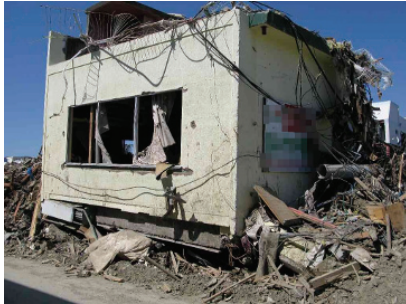
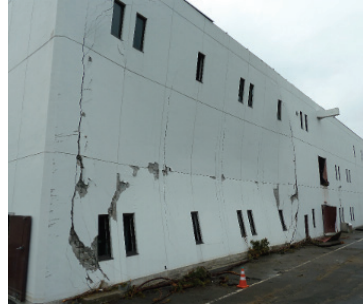
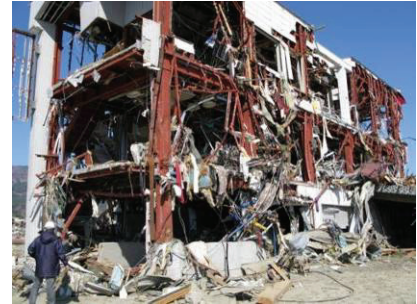
Fig. 28 Story collapse of 1<sup>st</sup> story (left), out-of-plane wall deformation (middle) and washed out of claddings (right)

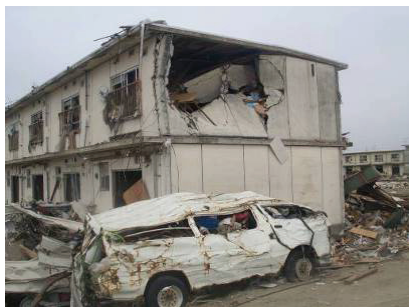
Fig. 29 Debris impact

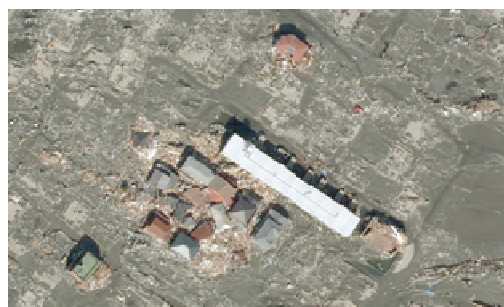
Fig. 30 Shading effect by front building
