FRAGILITY ENHANCEMENT IN SEISMIC-TSUNAMI RISK REDUCTION FOR NUCLEAR POWER PLANTS

Naotaka TAKAMATSU¹、Hiroyuki KAMEDA² and Katsumi EBISAWA³

³ Associate Vice President, JNES, Tokyo, Japan ebisawa-katsumi@jnes.go.jp
(JNES: Japan Nuclear Energy Safety Organization)

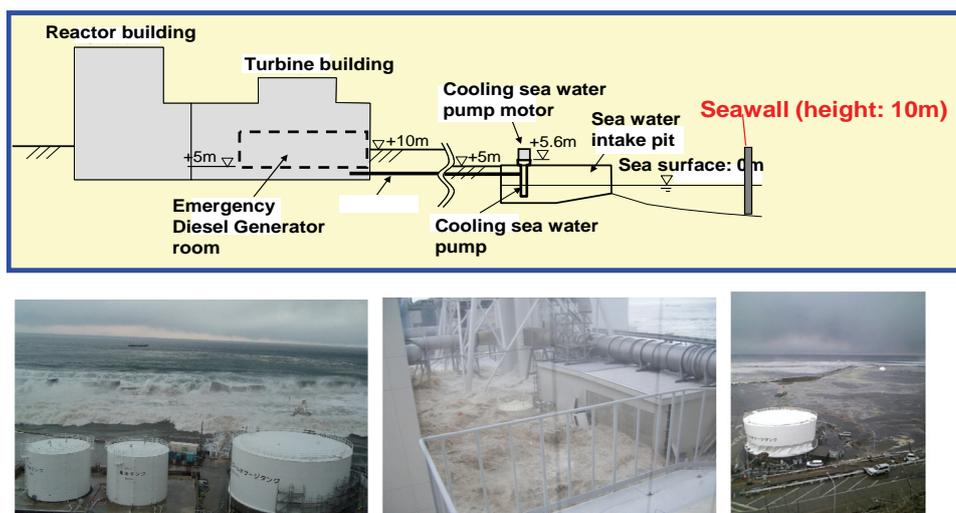
As to the sea water pump facilities for component cooling (height: 5.6 to 6 m), all Units were flooded by tsunami as shown in **Fig.1**. Whether or not they were damaged by wave power is under investigation. The Emergency Diesel Generators (EDGs) and switchboards installed in the basement floor of the reactor and the turbine buildings (height: 0 to 5.8 m) were flooded except for Unit 6, and the emergency power source supply (EPS) was lost. Regarding Unit 6, two out of three EDGs were installed in the first basement of the RB and was flooded, but one DG installed on the first floor of DG building was not flooded and the EPP supply was possible.

F1-NPP was inundated heavily beyond its tsunami protection capabilities, and lost all of them.

Fig.1 Illustration of sea water supply system and situation of tsunami disaster at Fukushima Daiichi nuclear power plant

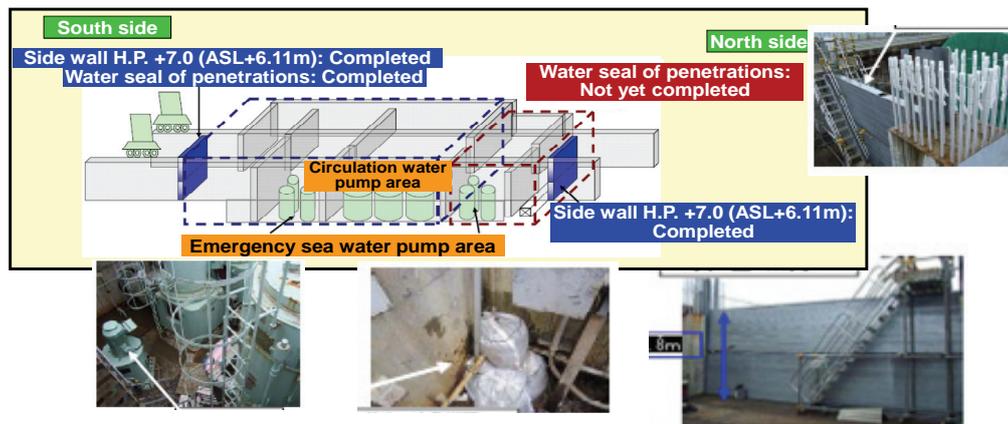
When the earthquake hit the site, the north emergency seawater pump room was under leveling construction of its sidewall as protection against tsunami. The construction work put in place a new sidewall up to H.P. +7.0 m outside the existing sidewall, but the waterproof sealing of the penetration of the wall had not been completed as shown in Fig.2. The tsunami flooded the north emergency seawater pump area in the seawater pump room through the small holes. One of three seawater pumps for EDGs was submerged, and one of three EDGs stopped. The other two EDGs were able to operate, successfully ensuring emergency power supply.

Fig.2 Illustration of sea water supply system and situation of tsunami disaster at Tokai Daini nuclear power plant

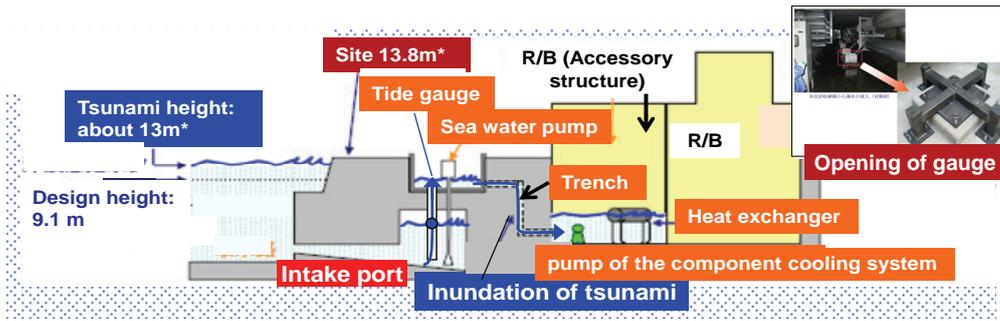
Component cooling system consists of intake channel/seawater pump/ seawater pump room/ heat exchanger room as shown in Fig.3. The seawater pump room was designed as the height of 14.8 m and about 100 m away from the coast to prevent the inundation by run-up tsunami. Inside the room, the tide gauge is installed with an opening. Tide gauge is to allow the automatic stop of the seawater pump in short of seawater due to the backrush of a tsunami. The tsunami did not attack the seawater pump room directly. The seawater overflowed in the room through the opening of gauge. Then the seawater flowed from the pump room, via the trench, into the basement floors of the reactor buildings, causing the heat exchanger room of the component cooling water system in the second basement to be submerged. The component cooling water pump of Unit 2 was also submerged, which thereby caused the cooling function of EDGs to be lost, with two units stopped out of those three generators.

Fig.3 Illustration of sea water supply system and situation of tsunami disaster at Onagawa nuclear power plant

Tohoku Electric Power Comp. Inc. took measures to prevent the piping penetrations and the cable tray penetrations from the seawater pump room to the trench. They would set up a flood barrier around the seawater pump room.

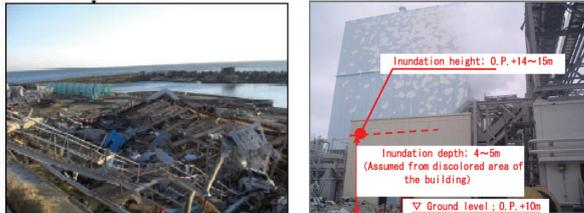
Fig.4 Inundation at Fukushima Daiich NPP

The Fig.4 shows the inundation at F1-NPP. The Fig.5 shows the inundation that the seawater flew in the basement of reactor building through intake tunnel-pump pit-trench due to siphon effects at Onagawa NPP. We must be careful. Seawater flowed into the basement of the reactor building through the intake tunnel, pump, pit and trench due to siphon effects. So we must be aware that water creeps in anywhere if there are accessible paths and head difference.

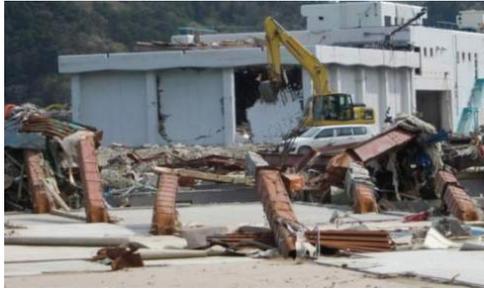
The Fig.6 (a)-(c) shows another very different picture of water-related hazards from ground motion effects. The Fig.6 (a) is the effects of the hydrodynamic forces were bent steel pillars in Onagawa town. The Fig.6 (b) is the seawall gate in Miyako city, this is a very strong one but was destroyed by the impulsive tsunami force. The Fig.6 (c) is the tsunami flew over the tsunami wall of 15.5 m at Fudai River in Fudai village. It broke maintenance girders like the photo, but the main structure remained intact.

(a) Bent steel pillars at Onagawa town

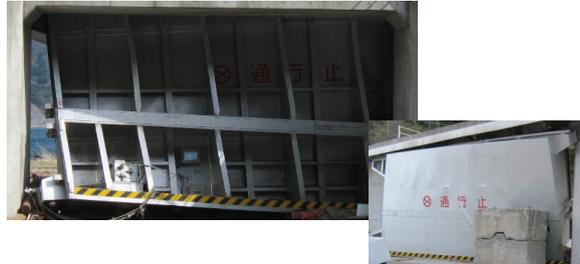
(b) Sea wall gate destroyed by impulsive tsunami force at Miyako city

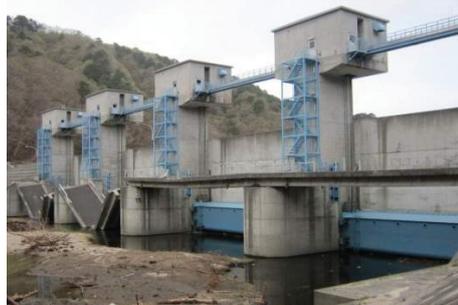
(c) Tsunami flew over the tsunami wall across Fudai River (TP+15.5m), and broke maintenance decks / main structure stayed intact at Fudai village

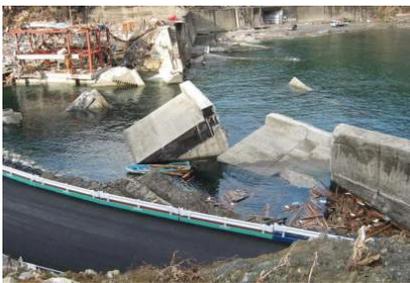
The **Fig.7 (a)-(d)** shows about scouring, buoyancy and uplift. We can observe that this seawall toppled because of scouring as shown in the **Fig.7 (a)-(b)**. The **Fig.7 (c)** is the condition that the fuel tank floated and dislocated at Onagawa NPP. We can say so because this space has not been disturbed at all. The **Fig.7 (d)** is concrete from a bridge. It was not dislocated like the photo, but it was uplifted once and then transported. We can say so because of many evidences of multiple failures, so uplift effects are also these ways.

(a) Seawalls toppled due to scouring at Miyako city

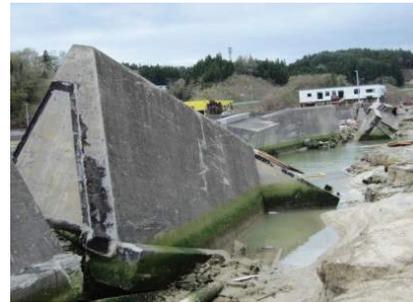
(b) Seawalls toppled due to scouring at Miyako city

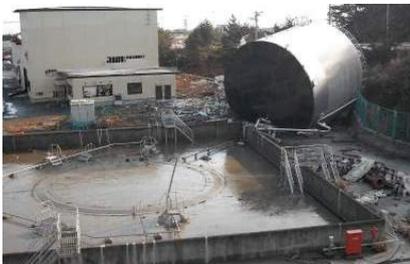
(c) Fuel tank floated and dislocated (Tohoku EPCO) at Onagawa town

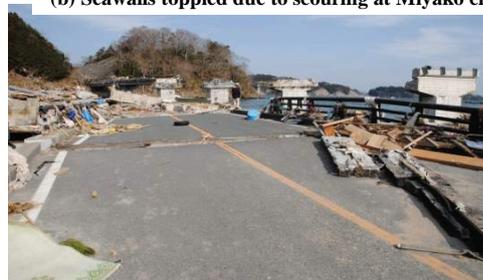
(d) Bridge decks pulled up from the piers and transported (by K.Kawashima) at Rikuzen-Takada city

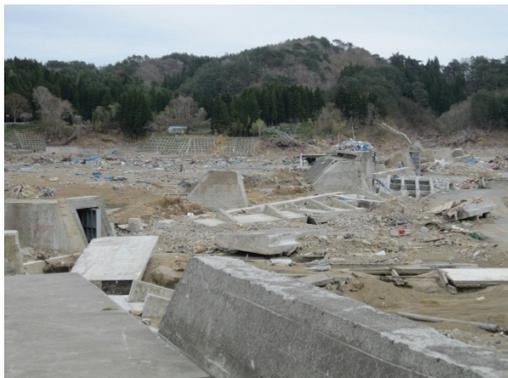
The 10m-high tide embankment in Taro district with a local nickname of “the Great Wall of China”, was destroyed by the 15m-high tsunami as shown in **Fig.8(1)**. However the 15.5m-high tide embankment in Otabe district in Fudai village was constructed according to the village chief’s strong willing as shown in **Fig.8(2)**. This blocked the 15 m-high tsunami and successfully protected the houses in this district. As a lesson learnt from great damages caused by the past tsunamis, local wisdom against a15m high tsunami has been widely disseminated. In contrast to the failure of disaster prevention in the former 10 m-high embankment case, the construction of the latter 15.5 m embankment with the local wisdom led to “a peace consequence” (Japanese government 2011).

(1) Taro district in Miyako city

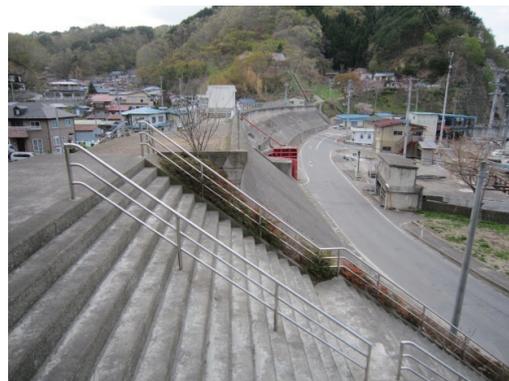
(2) Otabe district in Fudai village

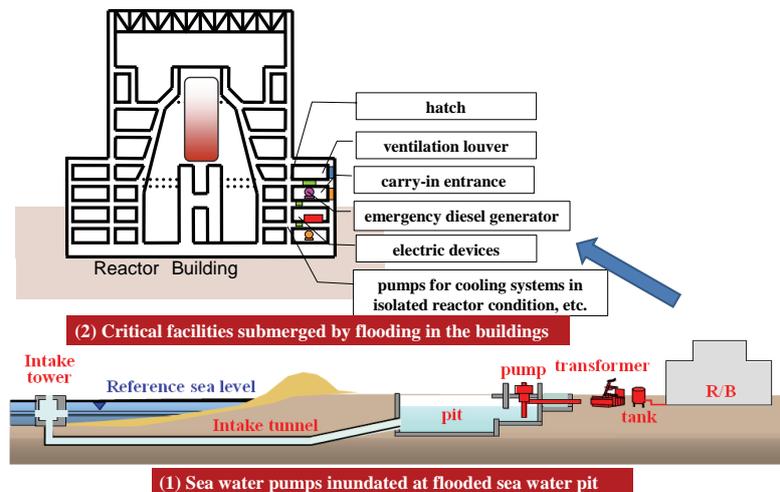
The Fig. 14 (1)-(2) shows how the water came in and crept into NPPs. The paths of tsunami intrusion are as follows.

(1) Sea water pumps inundated at flooded sea water pit

(2) Critical facilities submerged by flooding in the buildings intruding through carry-in entrances, ventilation louvers, etc. Then the seawater is spread in the building through hatches and openings. EDG, electric devices, pumps, etc. are inundated.

Fig. 14 (1)-(2) Water came in and crept into NPPs

Detailed problem identification should be made on tsunami effects on plant safety, on which basis protection works should be enacted using WP, SR and DS technology.

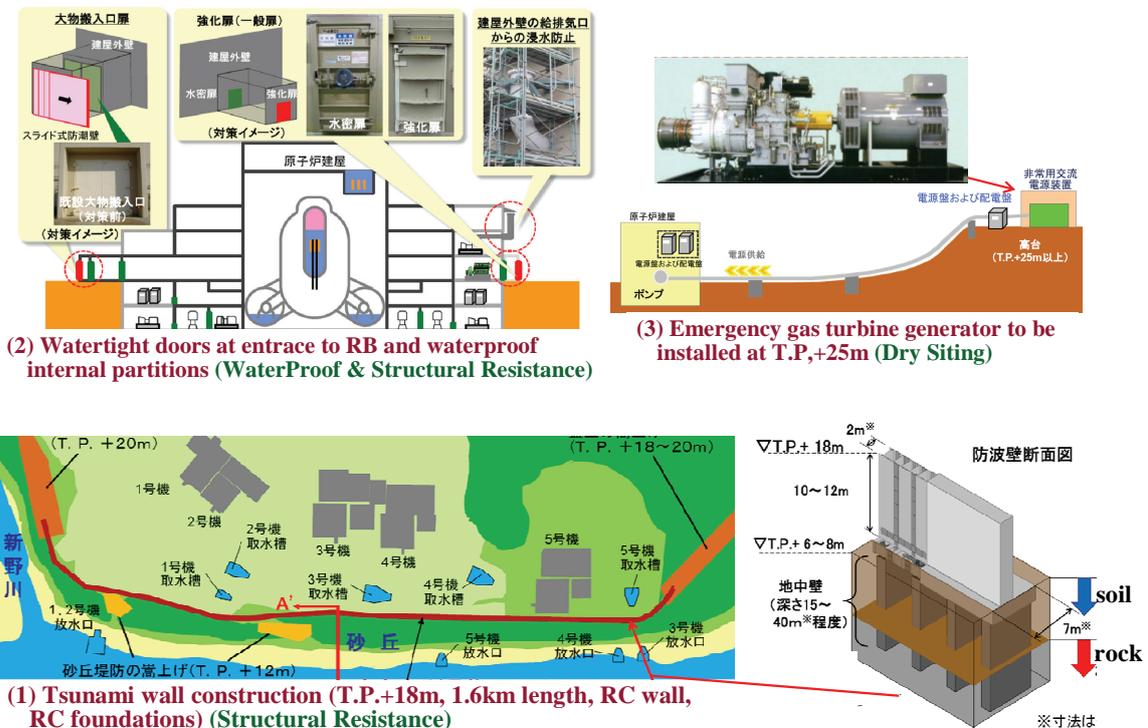
Fig. 15 Action plan at Hamaoka NPP by Chubu Electric Power Co.

Actions are already being taken at Hamaoka NPP by Chubu Electric Power as shown in Fig.15 (1)-(3) because Hamaoka is extreme difficult situation. They anticipate a Tokai earthquake. They are going to complete it by December 2012 as shown in Fig.15.

For example, they are making a tsunami wall with a very strong wall and foundations with a length of 1.6 km like Fig.15(1). The doors and the partitions to enter the building and the internal partitions are to be strengthened and watertight (so waterproof and structural resistance) like Fig. 15(2). Two emergency gas turbine generators are to be installed at an altitude of 25 m like Fig. 15(3), so it's dry siting. This kind of framework should be established.
