DAMAGES TO REINFORCED CONCRETE BUILDINGS OBSERVED IN FUKUSHIMA AFTER THE 2011 EAST JAPAN EARTHQUAKE

Toshimi KABEYASAWA¹, Koichi KUSUNOKI², Daisuke KATO³,
Toshikatsu ICHINOSE⁴, and Akira TASAI⁵

ABSTRACT: This paper reports on structural damages to reinforced concrete buildings observed in Fukushima prefecture after the 2011 East Japan Earthquake. The survey was conducted as part of reconnaissance activity of AIJ, Architectural Institute of Japan. Typical severe damages to reinforced concrete school buildings are outlined, both by the ground motions and the tsunami waves, based on the detailed field observation and with ground motions recorded at K-net stations nearby. The causes of the damages are discussed with problems peculiar to the buildings.

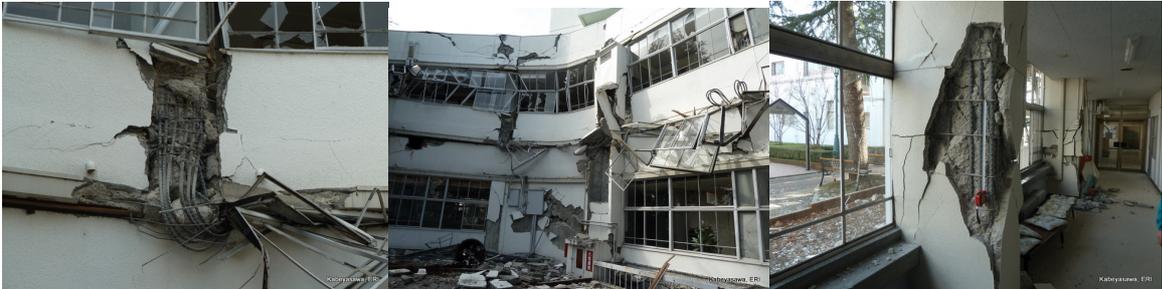
Photo 2 Collapse of the second story

As shown in the Photos 3.2.16 and 3.2.17, most of the slabs around the center stair hall in the third floor had fallen down due to the shear and axial failure of columns in the second story, while the walls at the ends could support the slabs though they inclined towards inside. Also as shown in Photos 3.2.18 and 3.2.19, the spandrel walls in the longitudinal direction could support the floor slabs so that there are spaces enough to survive inside. As shown in Photo 3.2.20, the first-story did not collapse probably owing to a wall in the center hall and amount of main bars increased in the first-story columns. At the time of the earthquake, most of the college staffs working in the building could evacuate before the collapse. It is estimated from the interview that the collapse might have occurred at the end of the main shock, probably around two minutes after they first felt the shaking. Three of them were confined but rescued several hours later so that no casualties were reported. A two-story reinforced concrete building, attached nursery school, in the adjacent area suffered relatively severe damage with axial compression at the column base. The other buildings in the college have been constructed with the current code or retrofitted, which had no damages, slight or minor. The collapsed building was the only one to be retrofitted in the near future.

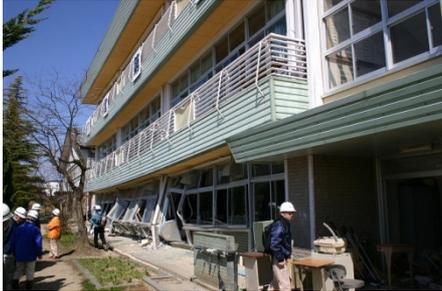
Photo 3 (b) Collapse of south building

Photo 3(b) shows the southern view of the south building. As shown in the photo, the slabs around the center of the building in the second floor had fallen due to the shear and axial failure of columns of the first floor. These columns were isolated columns in the first floor supporting upper shear walls. Therefore, the failure was supposed to be caused by very high axial load generated by walls of upper floors. Photo 4 shows the damage of the isolated column located in the corridor side of the classroom. Although the inner height of the column was long, the column suffered severe damage showing crush of concrete and broken hoop reinforcement around the center of the column with hoop spacing of 250mm. On the other hand, Photo 4 shows the damage of a side column of a barbell type shear wall in the first floor. As shown in the photo the column failed in shear severely in the longitudinal direction but the damage was light comparing to isolated columns due to the presence of the shear wall in the span direction. Photo 3(c) shows the damage of a column with a wing wall of the northern frame in the longitudinal direction. The inner height of the column was short due to the spandrel walls and the column failed in shear severely. The damage grade of the south building may be regarded as near collapse, while the grade of north building was rated as severe from the residual seismic capacity ratio.

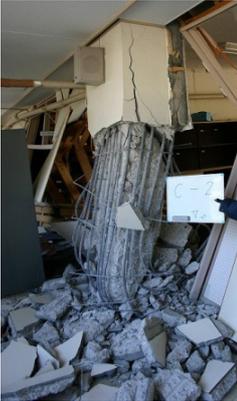
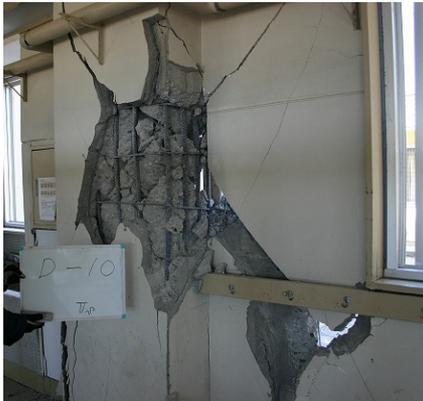
frame without shear walls. On the other hand continuous shear walls from base to top are located as partitions between classrooms in the span direction except for two frames of the first floor. In other words the shear walls of these two frames are not continuous and isolated columns of the first floor support all axial load generated by walls of upper floors, which could become very high during earthquakes.

The columns are located only at the corners of each classroom with 9m in the longitudinal and 7m in the span direction, respectively. The typical columns in the first floor have the sectional size of 750x500mm and 14-φ22 (longitudinal south frame) or 20-φ22 (longitudinal middle frame) main bars (SR235). 9mm round hoop bars (SR235) with 90degree hooks are arranged for shear reinforcement with the spacing of 250mm (column center) or 150mm (column end).

(a) isolated column under walls (b) side column of barbell wall (c) column with sidewalls
 Photo 4 Shear failure of columns in the first story

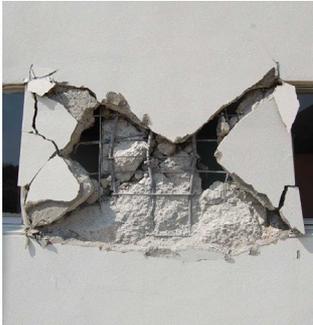
The damage of the building was mainly observed in the longitudinal direction. The I_s -values of the first and second stories in the longitudinal direction had been evaluated as 0.46 and 0.53, respectively. The ultimate base shear coefficient (C_7S_D) was 0.47.

In the first story of the building, the damages of the columns with wing-walls were serious as shown in Photo 6(a). These members failed in shear and vertically deformed, the damage rate of which was Grade 5. The space of hoop reinforcements was approximately 300mm. In addition, about 70 % of columns without wing-wall also failed in shear as shown in Photo 6(b). Damage levels of these columns were between Grade 2 and Grade 4. The residual seismic capacity ratio was estimated to be 39% of the original capacity and the damage was graded as severe.

(a) column with wing-wall (b) column without wing-wall
Photo 6 Damage to columns in the first story

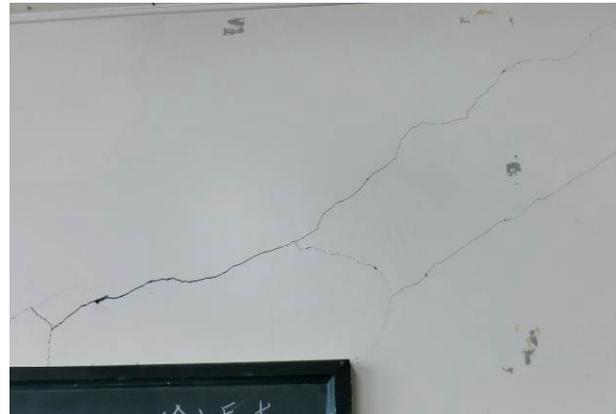
The first floor plan with the damage grade of structural members is shown in Figure 6.2.19. The longitudinal direction of the building is composed of moment resisting frames including secondary walls. In this direction, minor cracks of damage level I or II were observed in many columns and their wing walls. The transversal direction of the building is rigid-frame structure with seismic walls of 100-120 mm in thickness. Diagonal cracks whose maximum damage level was level III were observed in the seismic walls at the first floor.

(b) Shear cracks of a wall in span direction

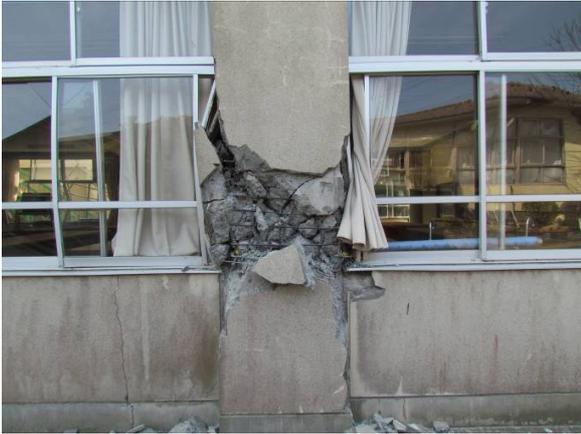
An overview of the Building A is shown in Photo 8. The north frame of the building was severely damaged, and the columns of the special classroom at the west end of the building in the first floor failed in shear up to the damage index of V. The vertical shortening of the columns was estimated obviously from the deformation of the window frames between them as shown in Photo 9. On the other hand, the shear wall at the west end of the building suffered no serious damages as shown in Photo 10. Some girders with standing wall in the north frame failed in shear. The floor level of Building A was 15cm lower than that of Building C. The residual seismic capacity index was calculated as $R=33.3\%$ for the longitudinal direction in the first story, by which the damage was classified into the severe damage.

Photo 9 Shear failure of the first story column at north frame of the building A

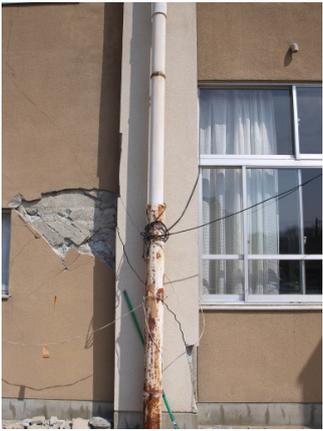
Some of the columns in the Building B failed in shear, which were classified as the damage rate of IV as shown in Photo 11. The joint between Building B and D was damaged due to pounding. The floor level of Building B was lower than that of Building D by 12cm. The residual seismic capacity ratio was calculated as $R=47\%$ for the longitudinal direction of the first story. The damage was classified also into the severe damage.

Photo 11 Shear failure of the column at the south frame of the building B
