## Summary of the Field Survey on the damage of bridges in the 2011 off the Pacific Coast of Tohoku Earthquake

Syuhei TAKEDA<sup>1</sup>, Kenji KOSA<sup>2</sup>, Masakatsu MIYAJIMA<sup>3</sup> and Hideki SHIMIZU<sup>4</sup>

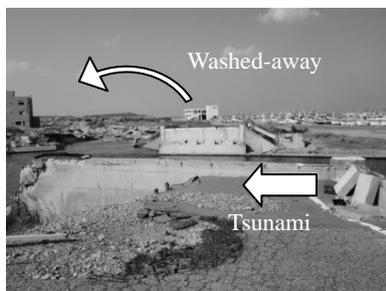
(a)The view of bridge

Tsurishi-Minato Bridge is located in Shinchi town (Fukushima prefecture). Photo 1 shows damage of bridge after tsunami. Superstructure was made with PC, and the type was single beam. We see from the Photo 1 (b) that superstructure washed-away. Aqueduct which was located next to the Tsurishi-Minato bridge, also washed-away.

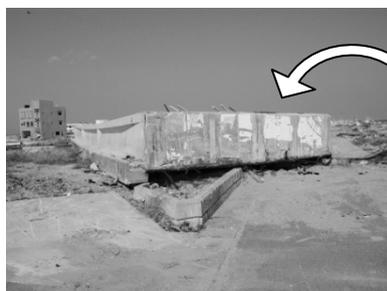
(b) Superstructure

- (1) In the Tsurishi-minato Bridge, superstructure washed-away. But Abutment was not collapse. And superstructure of aqueduct also washed-away.
- (2) In the Ainokama Bridge, superstructure was moved by tsunami.
- (3) In the Yuriage Bridge was damaged superstructure, bearing and joint by strong ground motion. But it was not washed-away.
- (4) Some bridges where are located on saw-toothed coastline, superstructure washed-away by tsunami. In the Koizumi Bridge, pier (P3) was collapse and washed-away.

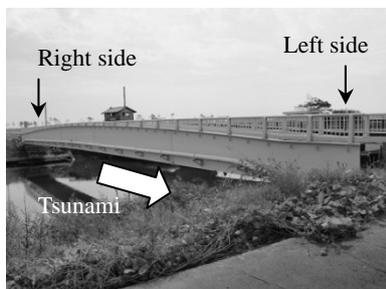
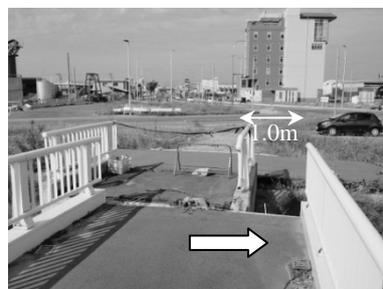
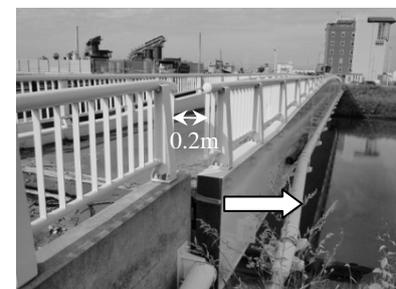
Photo 2 Ainokama Bridge

Ainokama Bridge is located in Iwanuma city (Miyagi prefecture). Photo 2 shows damage of bridge after tsunami. Superstructure was made with steel, and the type was single beam. We see from the Photo 2 that superstructure was moved. Relative displacement of left side was about 1.0m, and other side was about 0.2m.

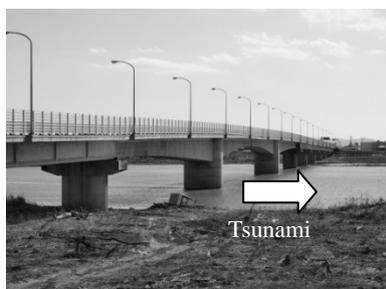
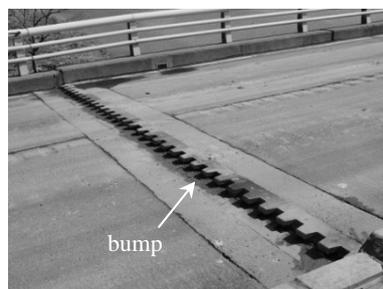
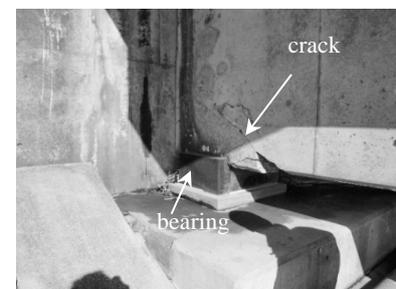
Photo 3 Yuriage Bridge

Yuriage Bridge is located in Natori city (Miyagi prefecture). Photo 3 shows damage of bridge after tsunami. The structure is 541.7m long and consists of three-span continuous PC-Box type girder bridge with PC-T type girder approach bridges of seven spans. And the bridge supported by steel bearings as shown in Photo 3 (c). We see from the Photo 3 (b and c) that joint and girder was damaged by strong ground motion. But the structure did not wash-away by tsunami.

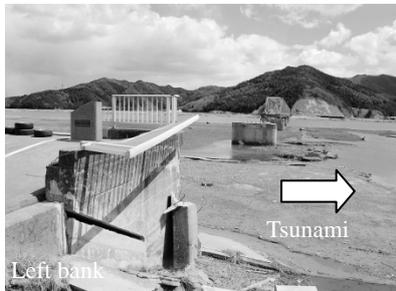
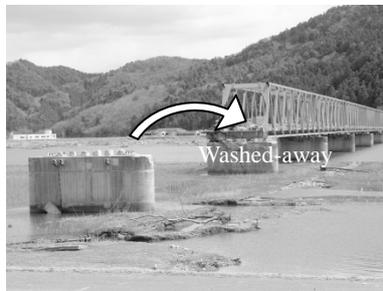
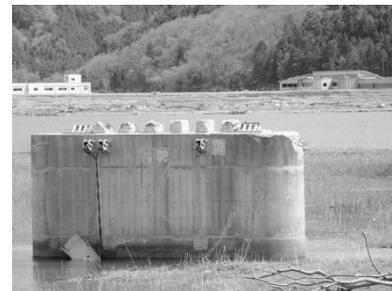
(b) Superstructure  
Photo 4 Shin-kitagami Bridge

Shin-kitagami Bridge is located in Ishinomaki city (Miyagi prefecture). Photo 4 shows damage of bridge after tsunami. Superstructure was made with steel, and the type was truss beam. We see from the Photo 4 (b) that superstructure (two-spans) washed-away.

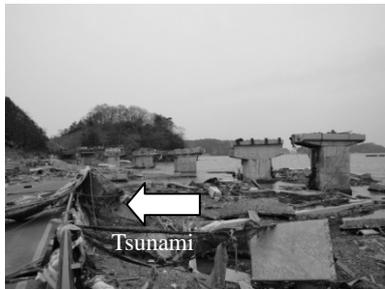
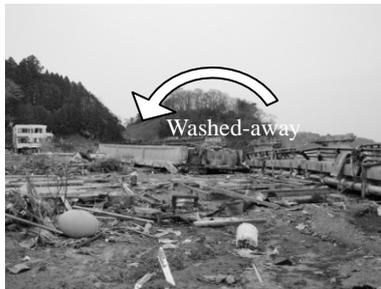
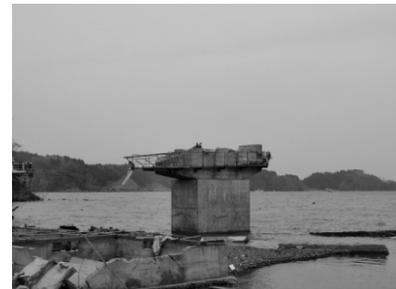
(b) Superstructure  
Photo 5 Utatsu Bridge

Utatsu Bridge is located in Minami-sanriku town (Miyagi prefecture). Photo 5 shows damage of bridge after tsunami. The structure is about 304m long, and the superstructure was made with PC, and the type was PC-T beam. We see from the Photo 5 (b) that superstructure (eight-spans) washed-away.

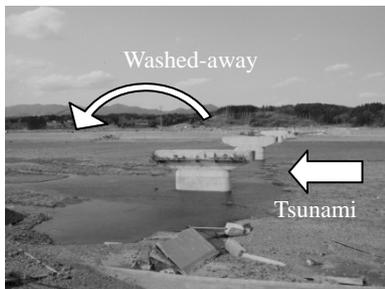
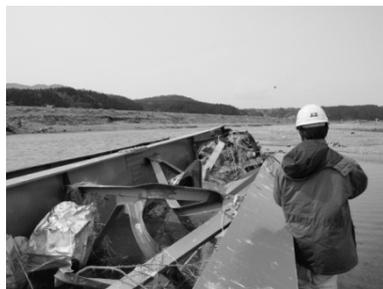
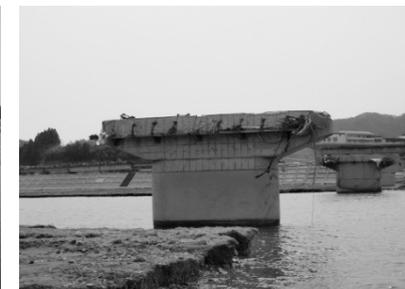
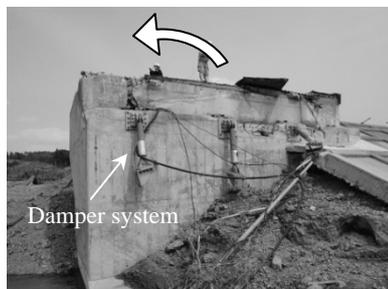
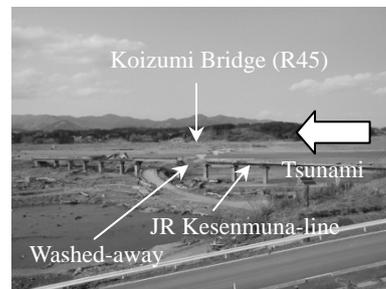
Photo 6 Koizumi Bridge

Kozumi Bridge is located in Kesennuma city (Miyagi prefecture). Photo 6 shows damage of bridge after tsunami. The structure is 182m long, and the superstructure was made with steel, and the type was continuous girder. We see from the Photo 6 (b) that superstructure (six-spans) washed-away. And one pier (P3) was collapsed and washed away. The boundary of bearing was movable. This bridge was retrofitted by damper system as shown in Photo 6 (d). JR-line viaduct that is located next to the Koizumi Bridge, also washed-away by tsunami as shown in Photo 6 (e).

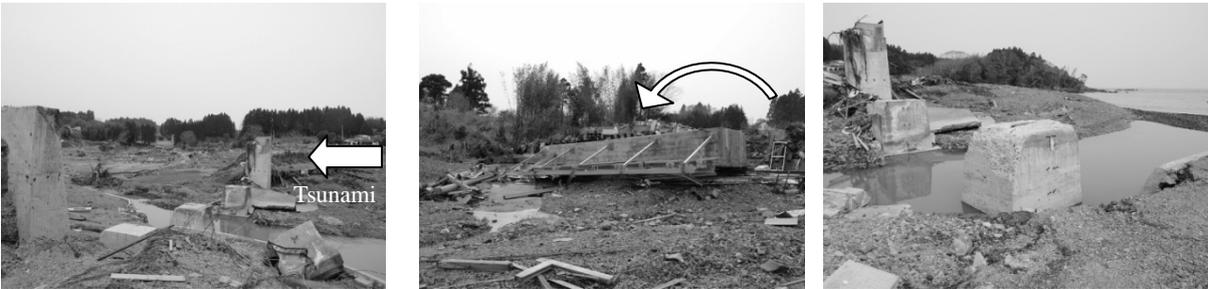
(a)The view of bridge (b) Superstructure (c) Pier  
Photo 7 JR-line Bridge (Kesennuma-line)

JR-line Bridge is located in Kesennuma city (Miyagi prefecture). Photo 7 shows damage of bridge after tsunami. The superstructure was made with PC, and the type was single beam. We see from the Photo 7 (b and c) that superstructure (three-spans) washed-away, and two piers were collapsed.

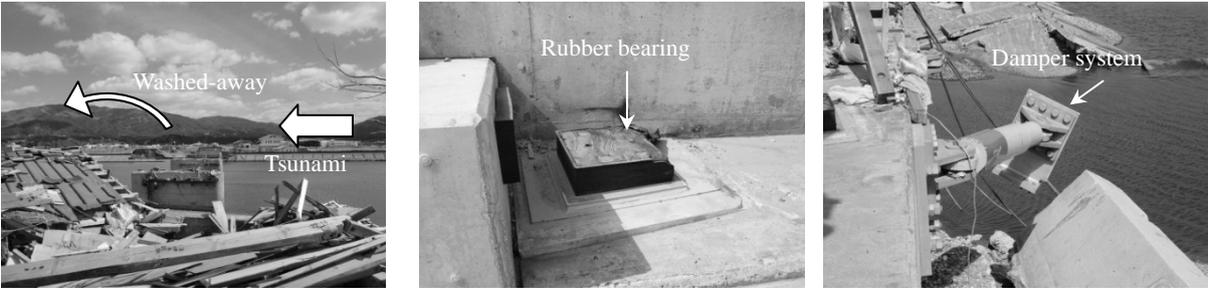
(a)The view of bridge (b) Rubber bearing (c) Damper  
Photo 8 Kesen Bridge

Kesen Bridge is located in Rikuzentakata city (Iwate prefecture). Photo 8 shows damage of bridge after tsunami. The structure is 181.5m long, and the superstructure was made with steel. And the bridge supported by rubber bearings as shown in Photo 8 (b). We see from the Photo 8 that superstructure (all-spans) washed-away. This bridge was retrofitted by damper system as shown in Photo 8 (c).

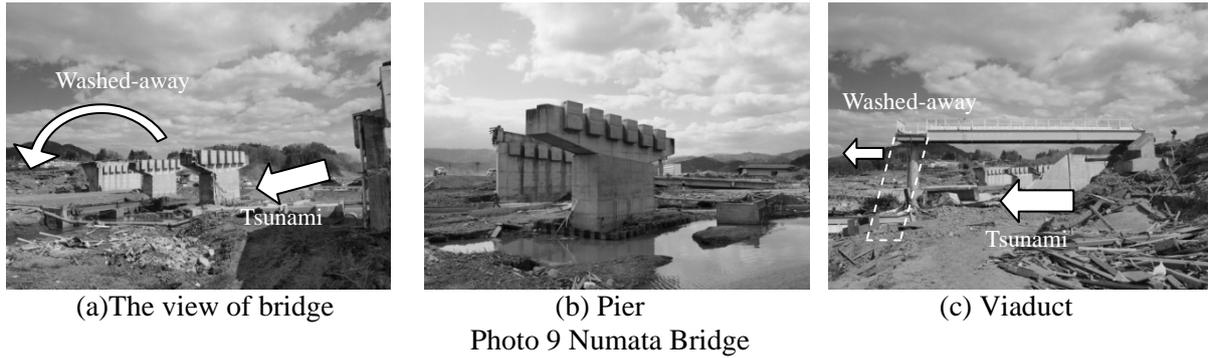
Numata Bridge is located in Rikuzentakata city (Iwate prefecture). Photo 9 shows damage of bridge after tsunami. The structure is about 65m long, and the superstructure was made with PC. We see from the Photo 9 that superstructure (all-spans) washed-away. Viaduct that is located next to the Numata Bridge, also washed-away by tsunami as shown in Photo 9 (c).
