# LESSONS AND VIEWS ON HARDWARE COUNTERMEASURES WITH EARTH BANKS AGAINST TSUNAMI ESTIMATED IN 2011 GREAT EAST JAPAN EARTHQUAKE

Ken-ichi TOKIDA<sup>1</sup> and Ryusuke TANIMOTO<sup>2</sup>

**ABSTRACT:** Through the field survey after the 2011 Great East Japan Earthquake, 13 damaged and/or non-damaged earth banks and 10 eroded dug pools related to the tsunami flood stream are investigated to focus on the effects of earth banks against the tsunami. Based on the investigations, important lessons on the hardware countermeasures against the tsunami with the earth banks are learned, and the performance-based design concepts for the reconstruction in this earthquake and the future tsunami disaster can be proposed.

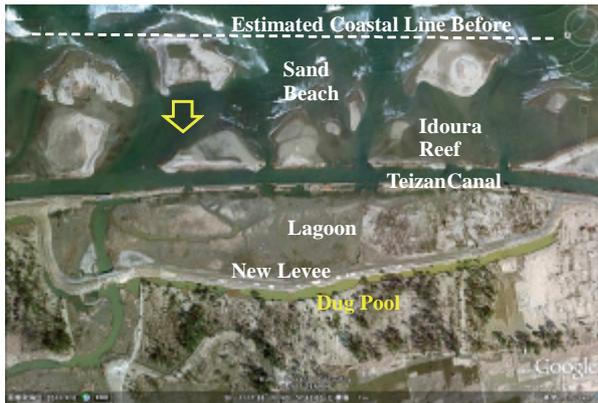
Photograph 1 is the satellite photo (Google 2011) around the levee newly constructed along the existing Teizan Canal at Idoura of Wakabayashi Area in Sendai City. The arrow in Photo 1 shows the direction of the leading wave which is same as follows in this paper. The new levee is about 3.9m high and about 1.5km long and located around the lagoon of 200m width. The purpose of the levee is supposed to reinforce Teizan Canal with the height of 2m along the lagoon. The coastal zone can be seen to be flooded away.

Photo 1 Around new river levee on April 6

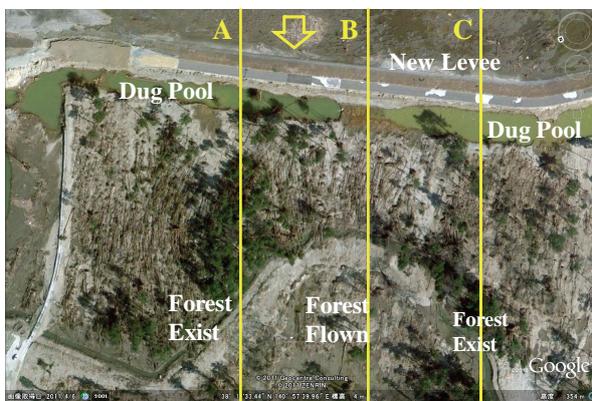
Photo 6 Dug pool and forest on April 6

The dug pool shown in Photo 5 is very interesting from the engineering view point which can be known more clearly in the satellite Photo 6 (Google 2011). It can be indicated that the forests located at the back side of the dug pools through the section A and section C seem not to be flown away severely and existed after the tsunami, and on the other hand, the forest at the back side of the levee without the dug pool through the section B seems to be flown away severely and not to be existed. Considering the difference of the damage level on the forests at these sections, very important lesson that the dug pool is effective to reduce the flow velocity of the tsunami can be obtained.

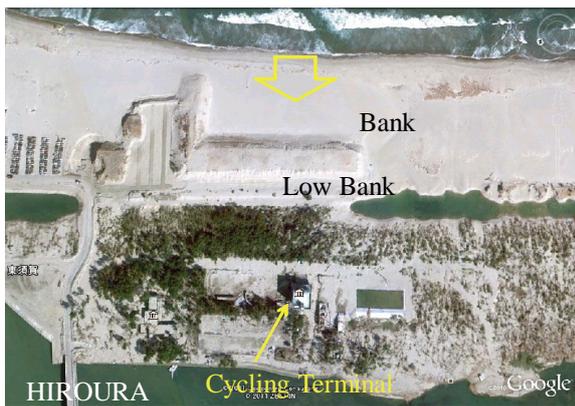
At the sand beach located at the east side of the Yuriage Fishing Port, the sand bank can be found during the field survey on July 9. As shown in Photo 7 (Google 2011), the bank is about 5.6m high and about 150m long and the crest is about 24m wide and the front slope at the sea side is about 1: 2.7. Photo 8 (Japan Coast Guard 2011) shows the tsunami just attacking the bank and the tsunami wave around the bank can be seen to be almost stopped and the forest at the back side of the bank is flooded slightly. However the bank wasn't aimed to be constructed as the countermeasures against the tsunami, the sand bank indicates the effectiveness against the tsunami. However the tsunami attacking the

Photo 7 Bank after tsunami on April 6

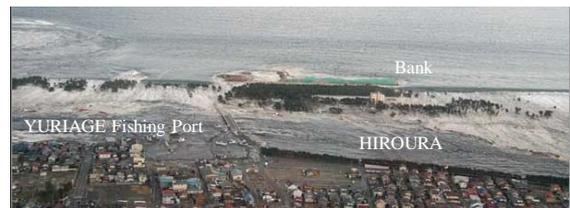
The net covered on the sand bank seen in Photo 8 can be verified also before the earthquake in the satellite photograph on August 14 in 2009 (Google 2009), and then the net seems not to be covered with the surface soils when the tsunami attacked. However the net is almost flown away at the time of July 9, the crest of the bank seems to be flooded slightly and the flooded depth is estimated about 0.5m shown in Table 1 because the net and the small pine tree of 30cm high can be observed at the field survey on July 9.

Photo 8 Just attacking by tsunami

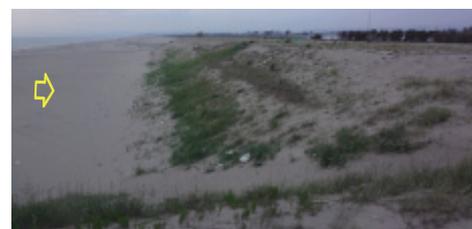
On the other hand, Photos 9 and 10 show the conditions of the front slope and the back slope, respectively which seems to be eroded slightly at the time of on July 9. Additionally, Photo 10 shows the back side of the bank where the low bank whose height is 1.6m and the base width is 12.8m and the surface isn't eroded because of the reduction of the flood by the front sand bank. Photo 11 shows the view at the right edge of the sand bank shown in Photo 7 and can be known that the trees are fallen down in the direction of from the left side to the right side of the photograph which means that the tsunami flood went around the edge of the bank. The flown net can be also seen.

Photo 9 Front slope of bank on July 9

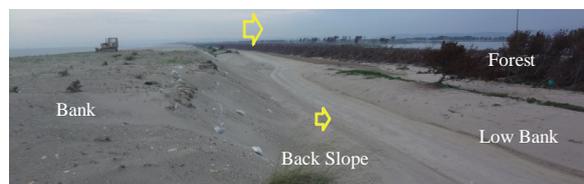
Photo 10 Back slope and background on July 9

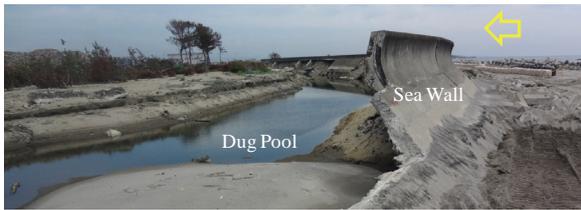
At the back sides of the earth bank shown in Photo 6 and the sea wall shown in Photo 12, many dug pools appeared in this earthquake and as shown in Photo 6, the reducing

Photo 12 Dug pool at sea wall on June 9
