SOME CONSIDERATIONS BASED ON OBSERVATIONS OF DISASTER-STRICKEN AREAS IN MIYAGI, IWATE AND AOMORI PREFECTURES AFTER THE GREAT EARTHQUAKE AND THE ISLAND OF OKUSHIRI

Kiyoshi SHINGU¹

ABSTRACT: The author visited disaster-stricken areas in Miyagi, Iwate, and Aomori prefectures after the 2011 great east Japan earthquake, and after that, visited the disaster-stricken areas in the island of Okushiri in Hokkaido. This paper reports on damage conditions of houses, buildings, breakwaters, tide embankments, and so on in those areas, and presents considerations of what can be learned from observations of Okushiri island, which was damaged about 19 years ago.

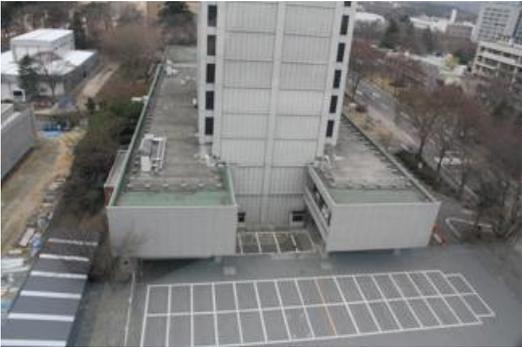
Photo 1: Building damage at Tohoku University (esp. 3rd floor column base)

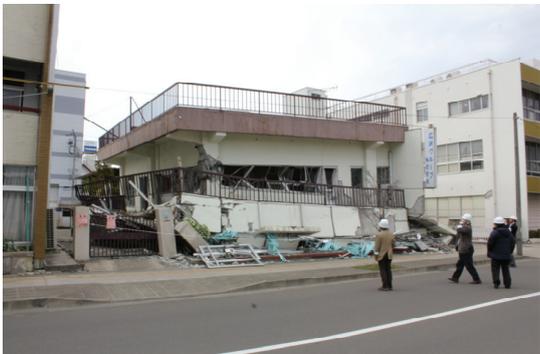
Photo 2: Reinforced concrete building destroyed by the earthquake. (Sendai city)

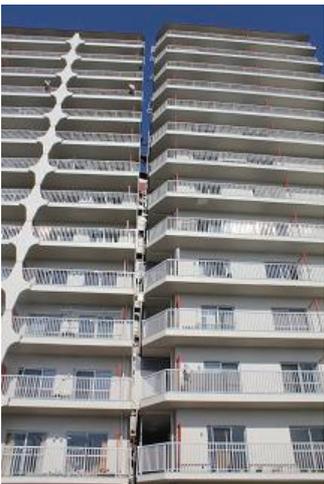
Photo 3: Leaning high-rise residential building. (Sendai city)

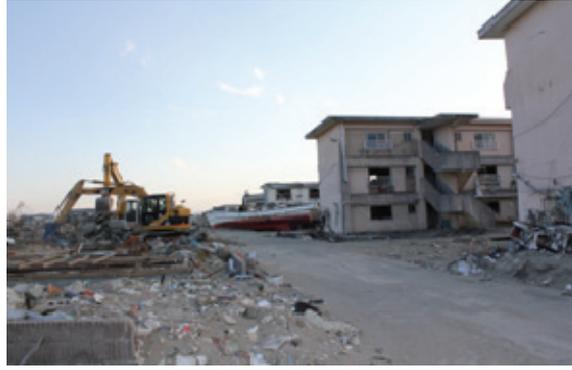
Photo 4: Tsunami-damaged reinforced concrete apartment building. Wooden houses were washed away, and only the foundations remain. (Natori city)

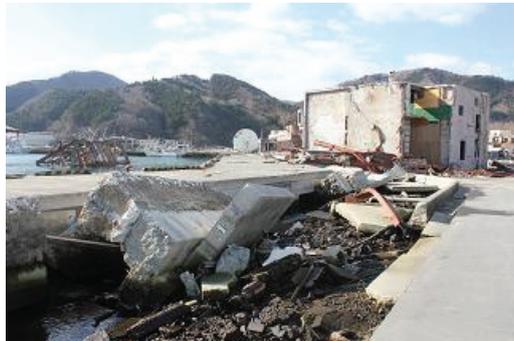
Photo 5: Overturned reinforced concrete structure and damage to coastal structure. A cylindrical tank is visible in the distance. (Onagawa town)

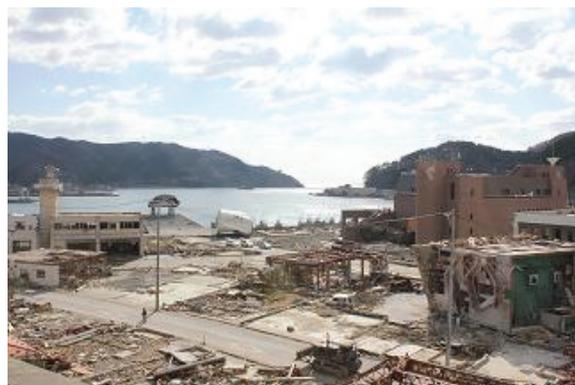
Photo 6: Overturned reinforced concrete structure and damage to coastal structure. The aforementioned cylindrical tank (Photo 5) is seen on its side. (Onagawa town)

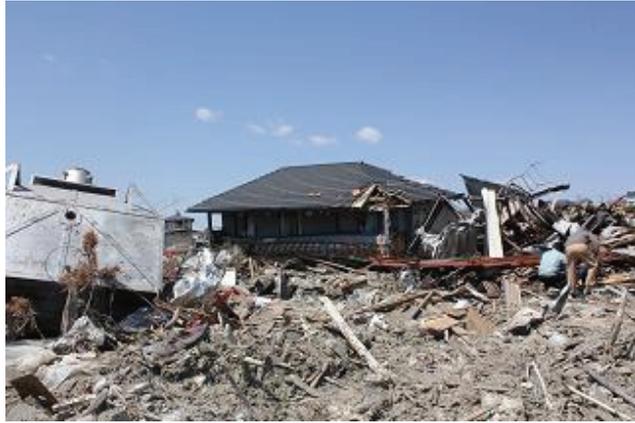
Photo 7: Washed away and destroyed homes.
A mound of rubble has been formed in the foreground. (Ishinomaki city)

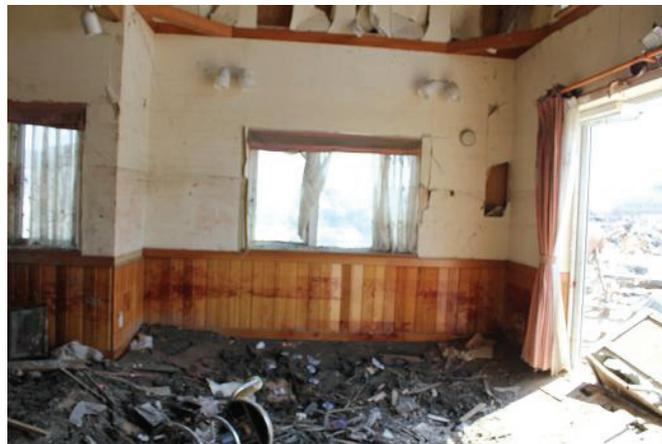
Photo 8: Interior of a house destroyed by the tsunami.
The floor has been swept away by water pressure. Taken with consent. (Ishinomaki city)

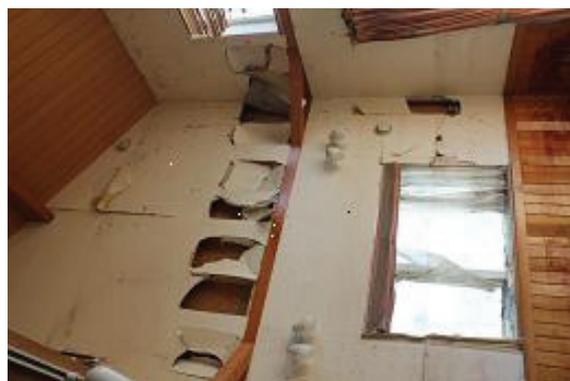
Photo 9: Interior of a house destroyed by the tsunami.
Water pressure has made holes in the wall.
Taken with consent. Same house of the Photo 8. (Ishinomaki city)

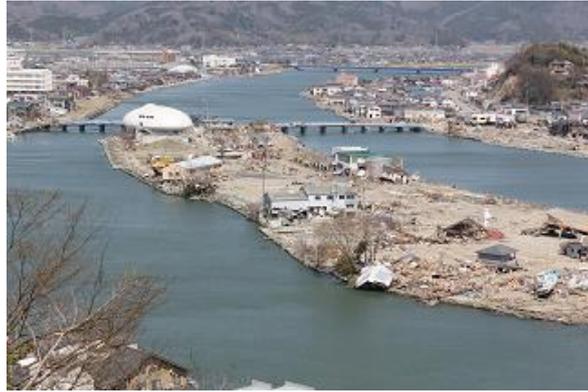
Photo 10: Tsunami damage in river basin. (Ishinomaki city)

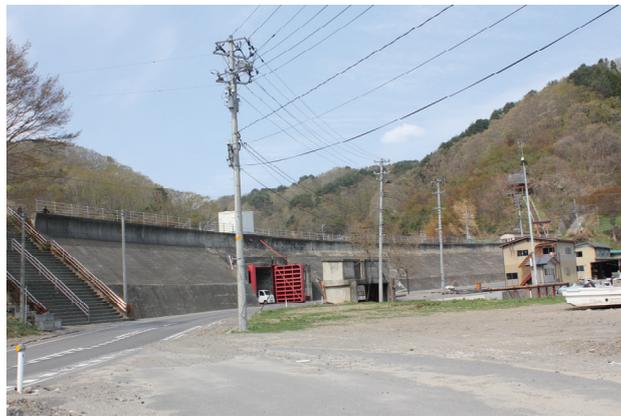
Photo 11: 15.5m high seawall. The houses behind the wall remain undamaged.
Photo taken from the sea side of the wall. (Fudai village)

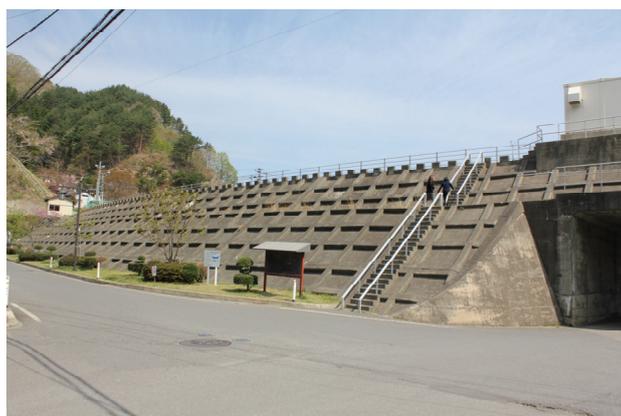
Photo 12: The 15.5m seawall from the previous photo, photographed from the opposite (village) side.
Compare size with the two people on the steps. (Fudai village)

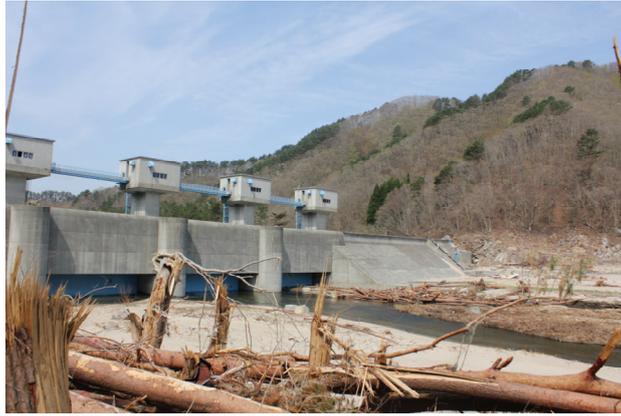
Photo 13: Sluice gates (sea side). Trees have been knocked down in the foreground. (Fudai village)

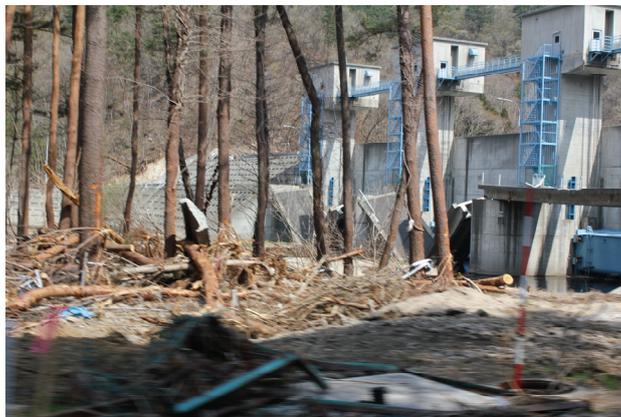
Photo 14: Sluice gates (village side). The tsunami exceeded the height of the gates slightly, so some trees have been knocked down, but the wave did not reach the residential area and so human casualties were avoided. (Fudai village)

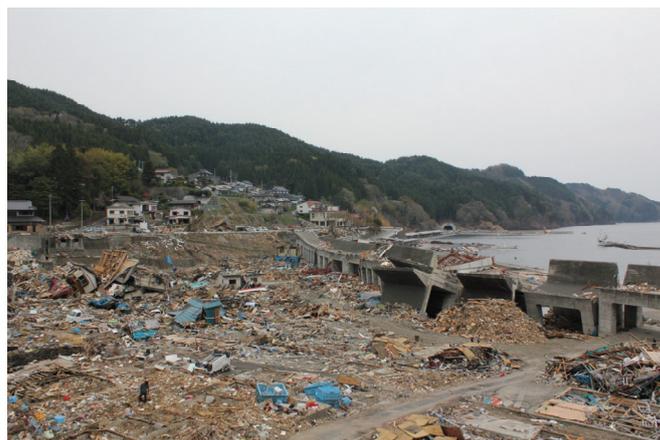
Photo 15: Fallen seawalls by the tsunami and destroyed town. There is a person who is standing in dumb surprise in the lower left. (Kamaishi city, Touni town)

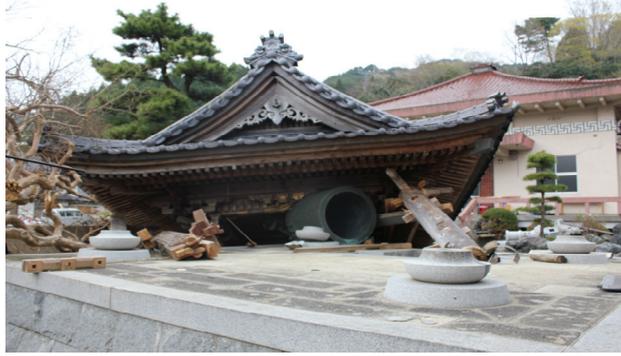
Photo 16: Bell tower at a hilltop temple destroyed by the earthquake
(Kamaishi city, Touni town)

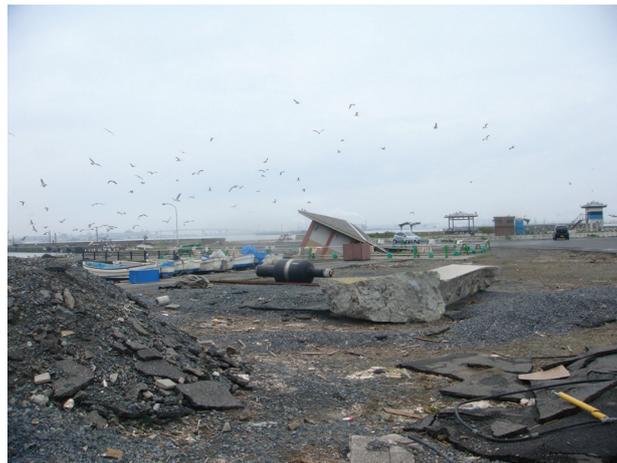
Photo 17: Area around Kabushima, Port of Hachinohe, Aomori prefecture.
The force of the tsunami has tilted the reinforced concrete toilet building in the centre of the image.

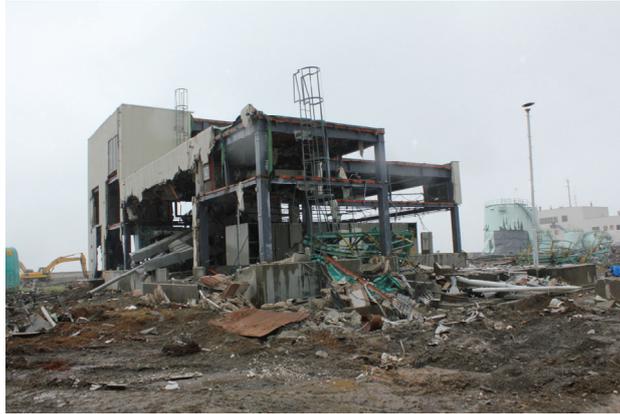
Photo 18: Steel frame structure at national oil reserve facility.
The site, excavated from a mountainside, escaped damage (Kuji city)

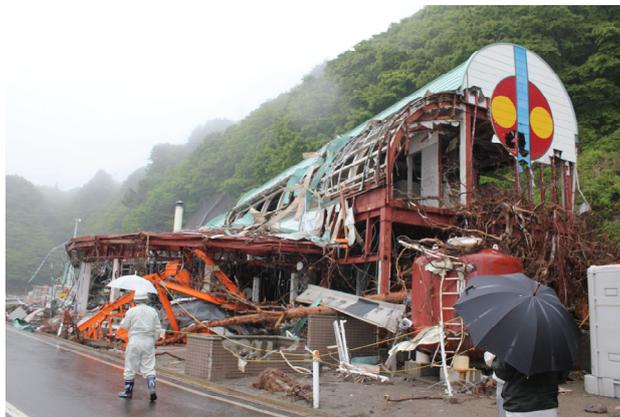
Photo 19: Steel frame structure of aquarium near oil reserve facility.
Only the skeleton remains. On the day of the disaster, all visitors were able to retreat to safety thanks to advance warnings. (Kuji city)

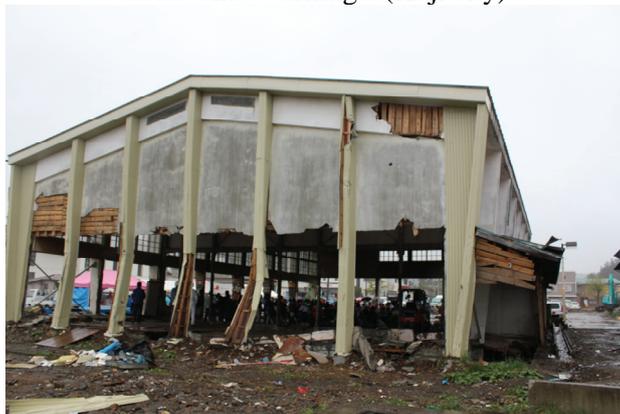
Photo 20: Steel frame structure used as an occasional concert venue.
The floor of the near side of the building has been pulled out by the tsunami. (Noda village)

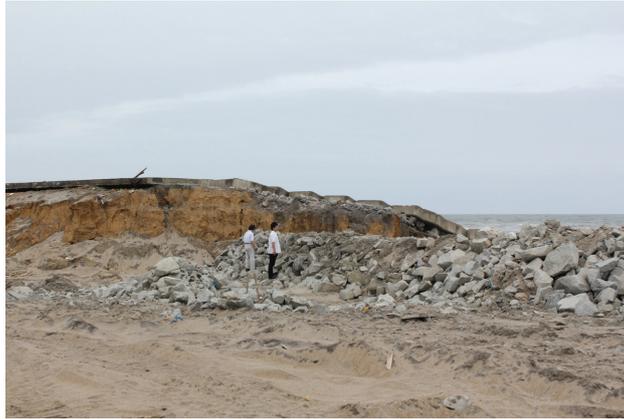
Photo 21: Broken breakwater by the tsunami that is located very close to Fukushima Prefecture (the right). The Pacific Ocean is visible (the right).

- 1) Big trees in an emergency green area, ships and cars hit houses, buildings, schools, gymnasiums, and so on.
- 2) Many reinforced concrete gravity type breakwaters except few ones have been broken by the tsunami, because there had been no piles.

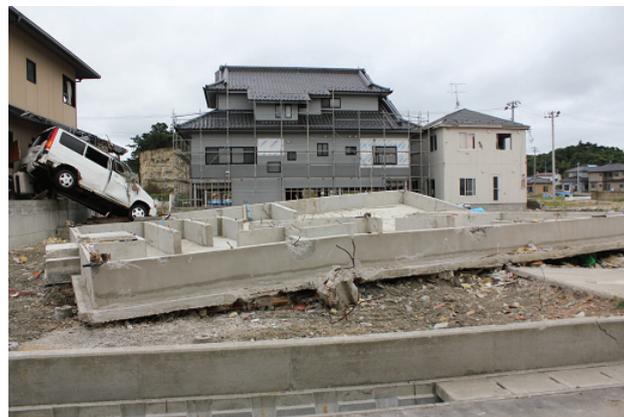
Photo 22: A mat foundation flown by the tsunami from another place to here. A northern part in the prefecture.
