Special Session 24.4 Great East Japan Earthquake
15th World Conference on Earthquake Engineering
Lisbon, Portugal, September 24, 2012

A Great Success and Future Challenges for Mitigating Damage of Bridges

Kazuhiko Kawashima
Tokyo Institute of Technology

2011 Great East Japan earthquake was a good opportunity to learn whether damage of bridges was mitigated as a consequence of code upgrading since 1990

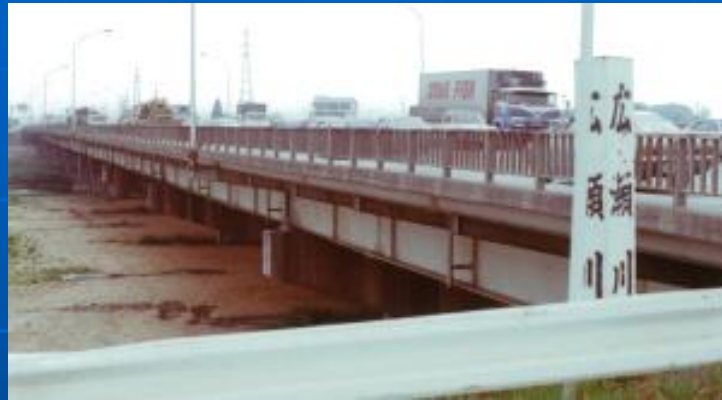
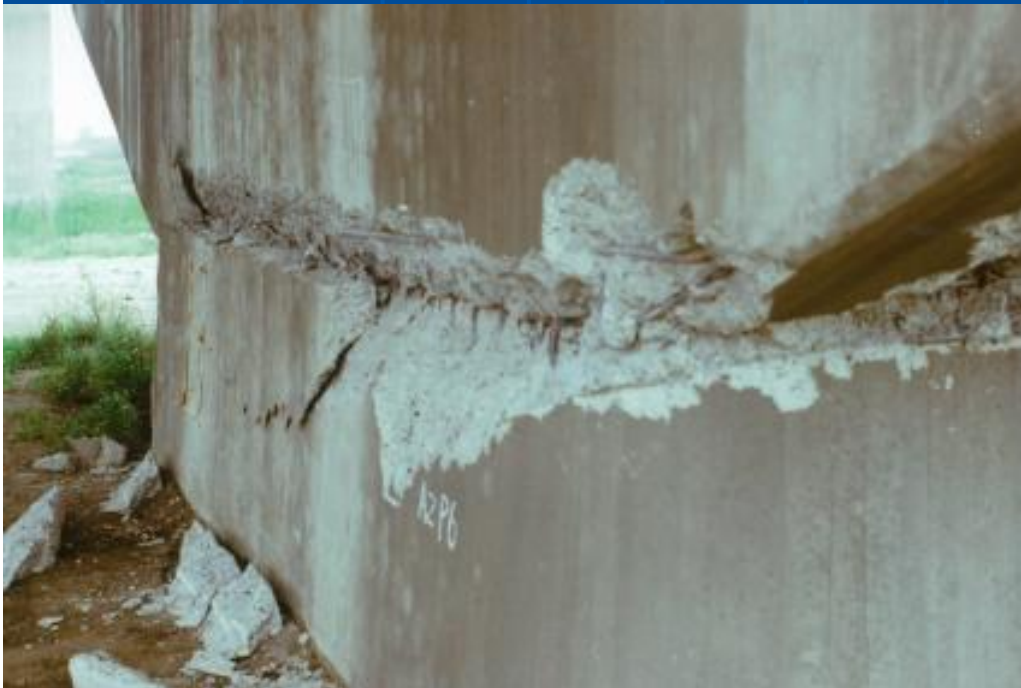
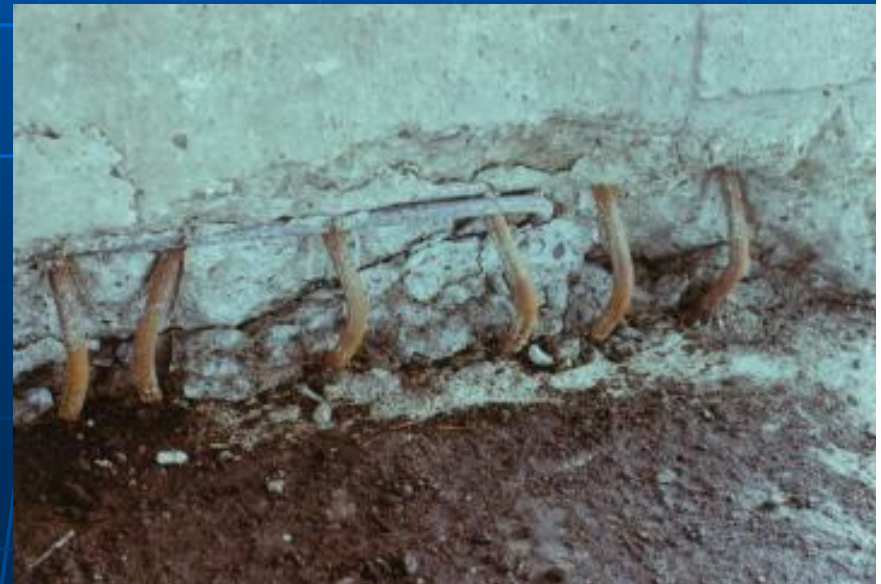
Sendai Bridge
National Road 6

1978 Miyagi-ken-oki Earthquake ($M_{JMA} 7.4$)

Damage concentrated to RC columns at lap splice of longitudinal bars

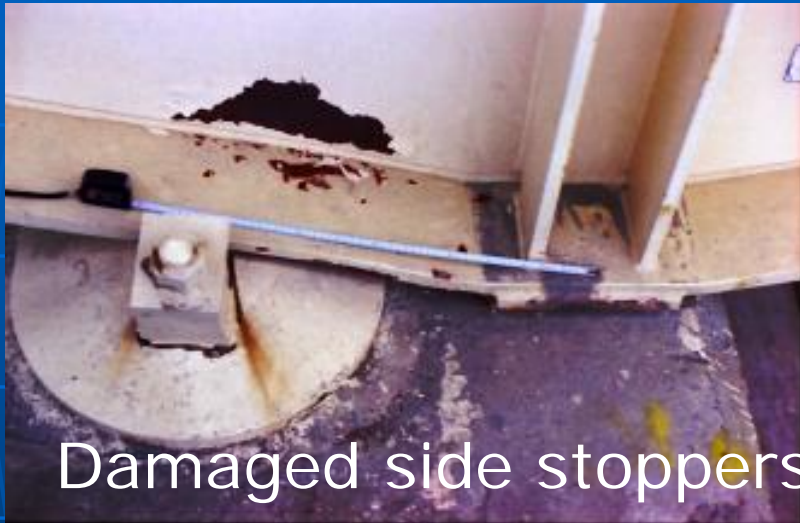
Damaged side stoppers

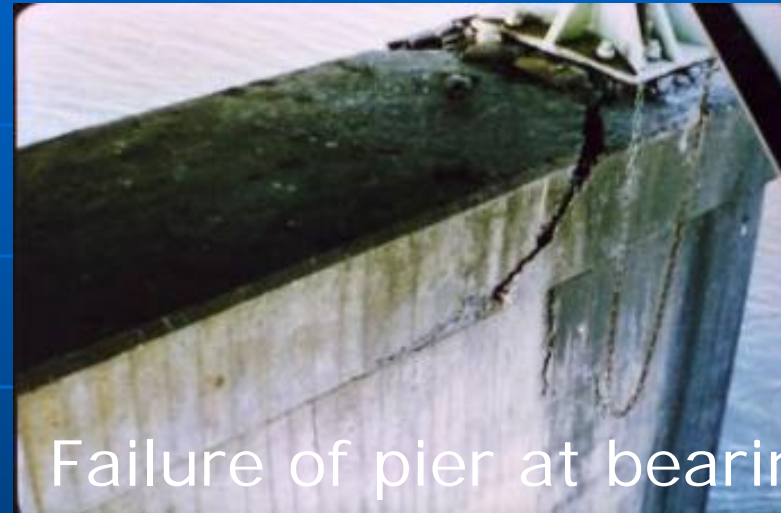
Failure of pier at bearing

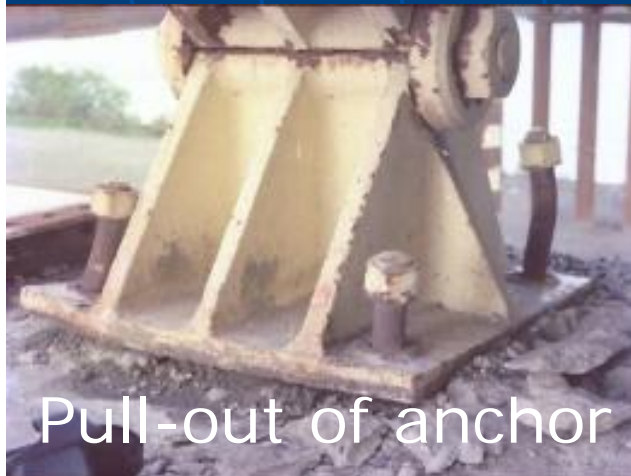
Pull-out of anchor bolts

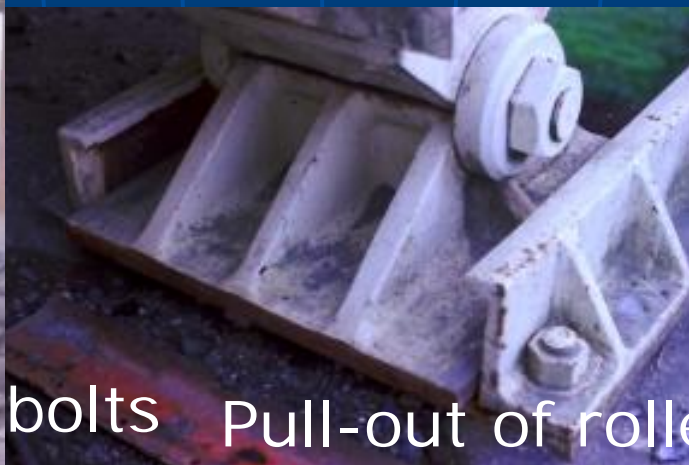
Pull-out of roller

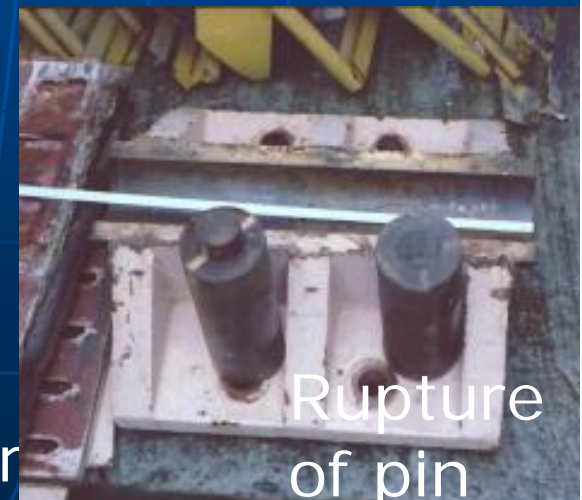
Rupture of pin

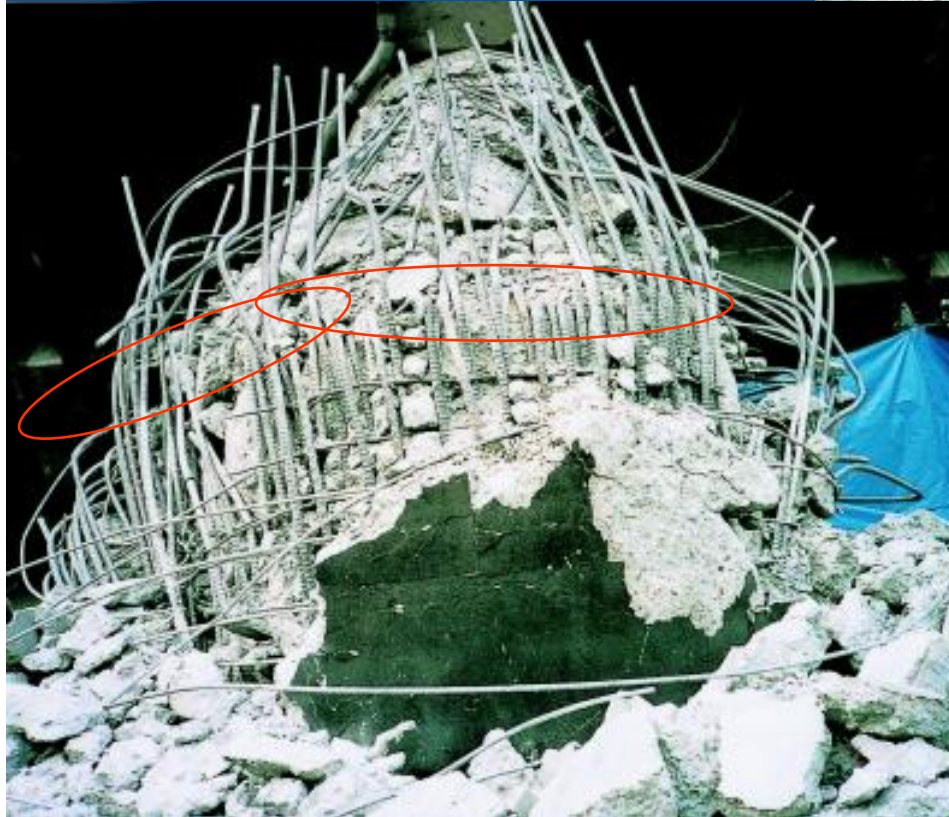
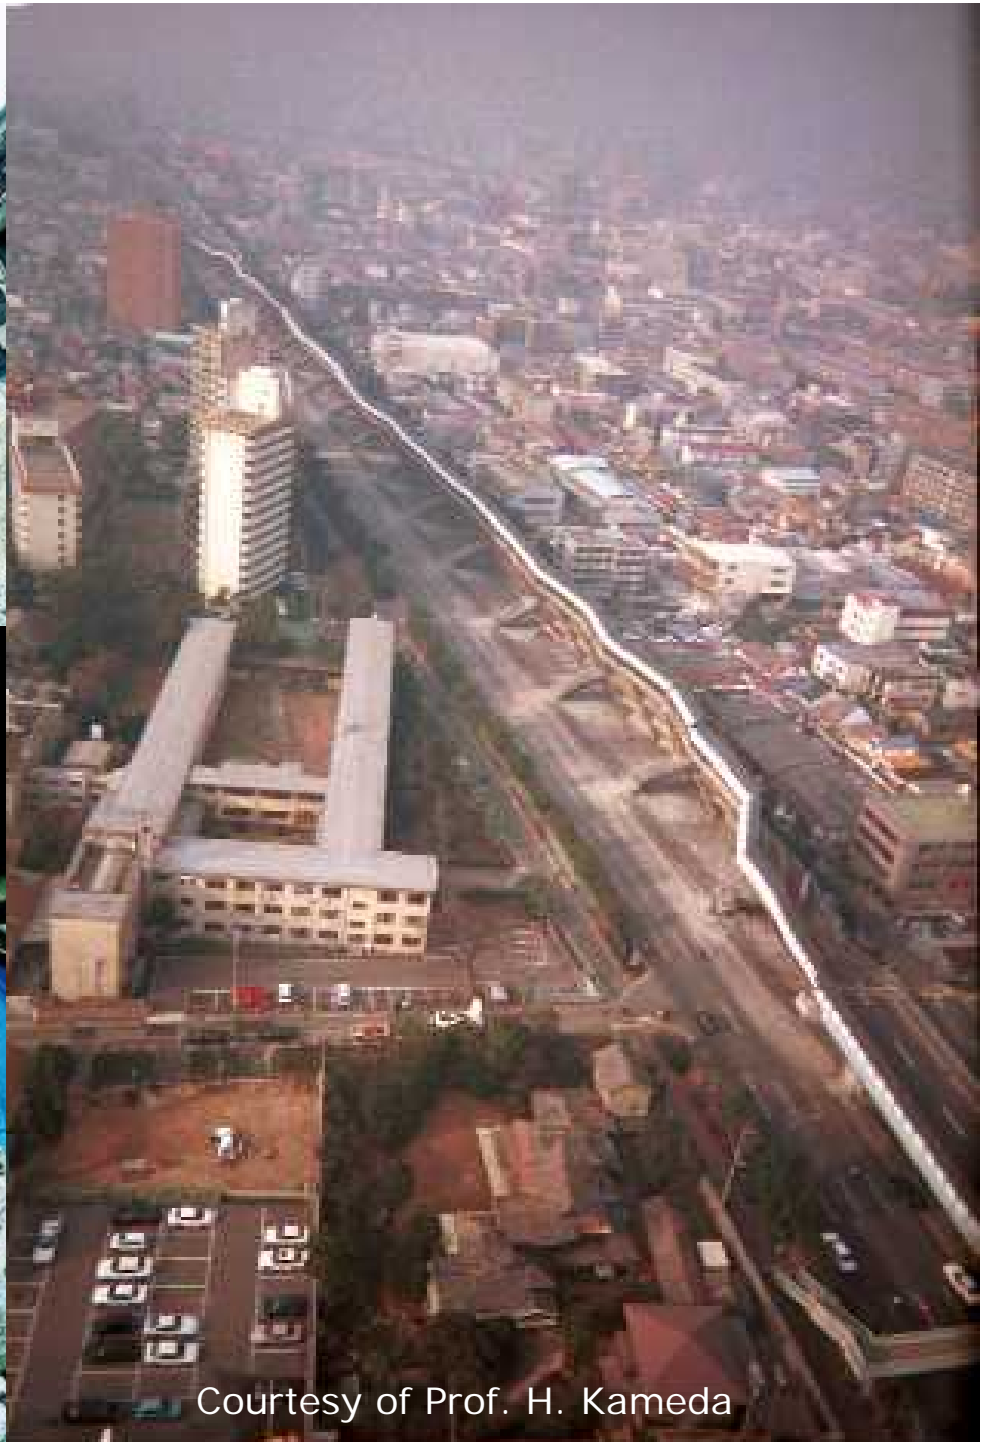
1995 Kobe earthquake

Extensive Shear Failure at Cut-off of Longitudinal Rebars

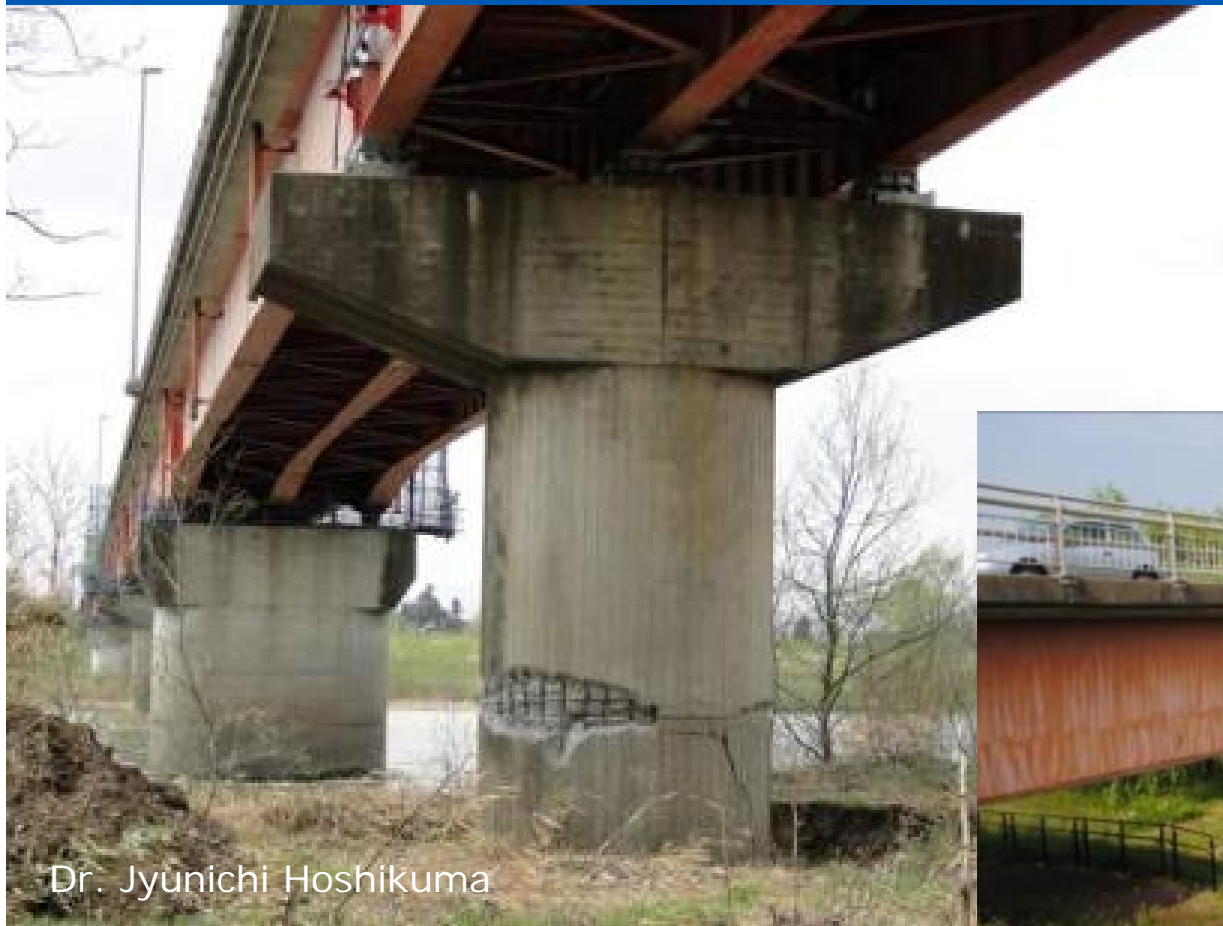
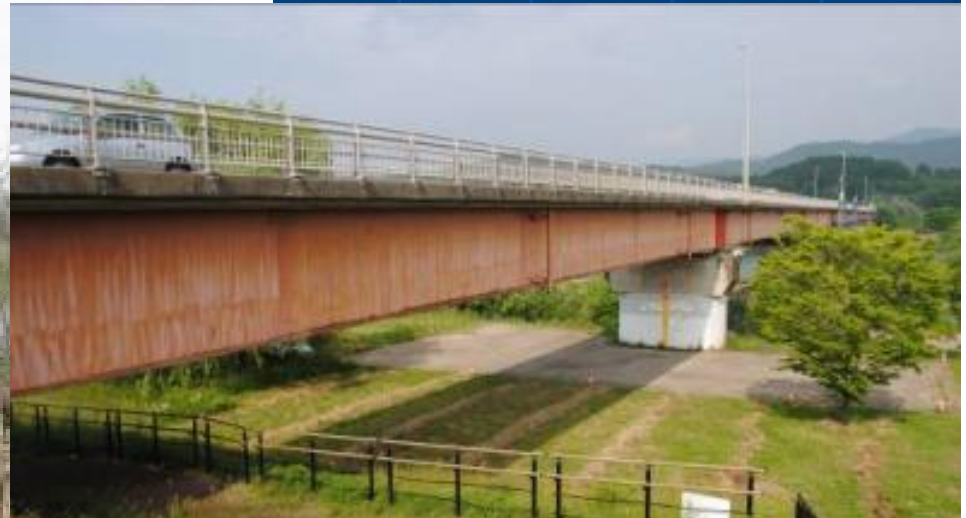
Fuji Bridge, Iwate-ken

During the 2011 Great East Japan earthquake, shear failure at cut-off still occurred at RC columns which have not yet been retrofitted

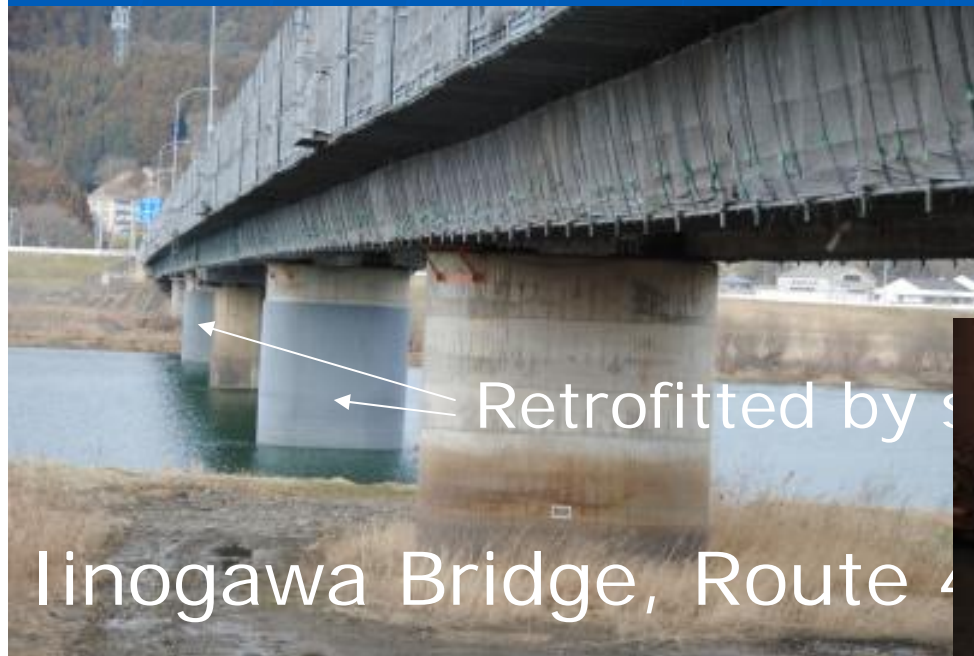
Bridges which were retrofitted in accordance with the post-1990 code suffered virtually no damage

Steel jacking was effective

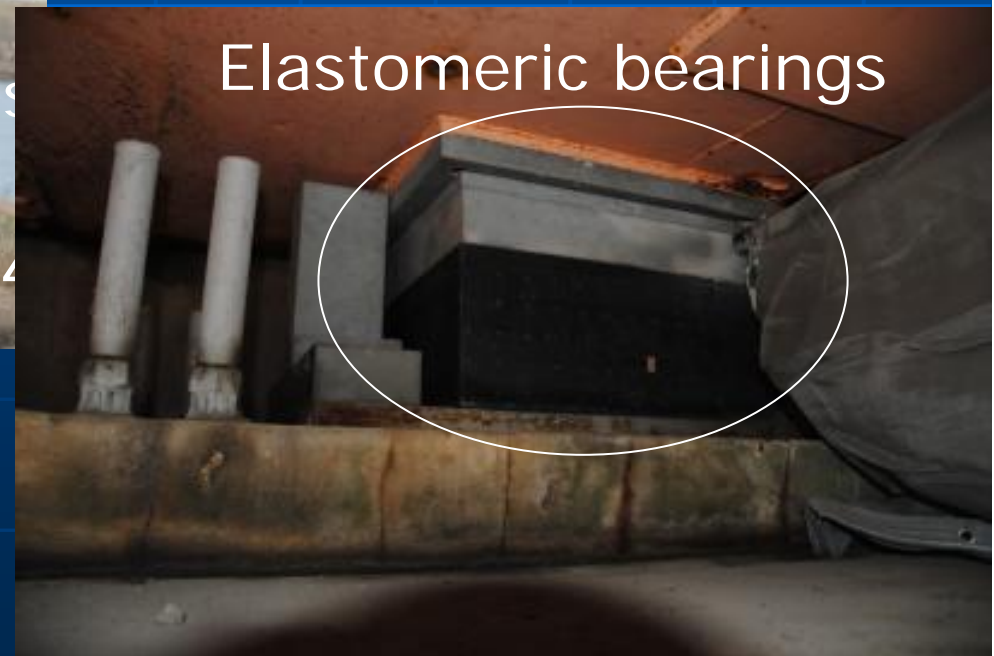
Linogawa Bridge, Route 4

Replacement of vulnerable steel bearings with elastomeric bearings was effective

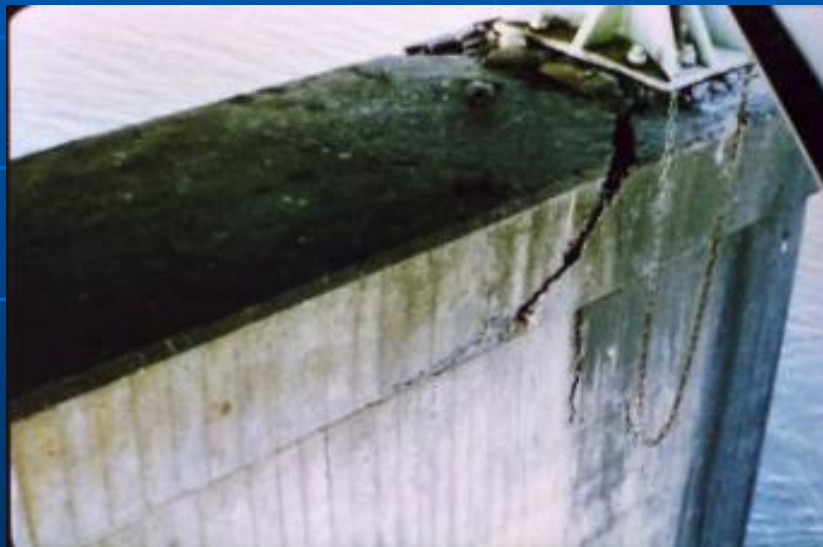
Steel bearings and their support which suffered damage during 1978 Miyagi-ken-oki earthquake suffered damage again

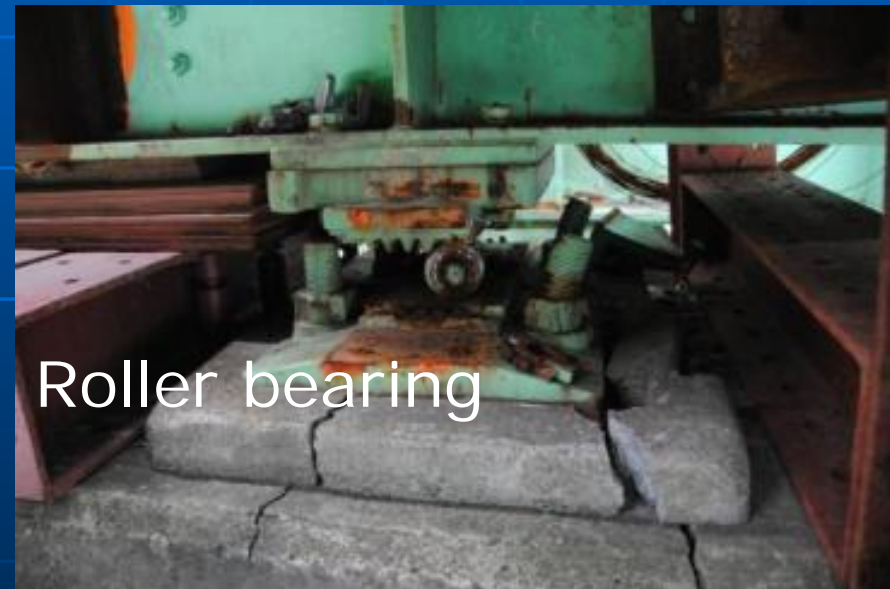
2011 Great East Japan

Bridge was about to collapse if an aftershock was stronger

Roller bearing

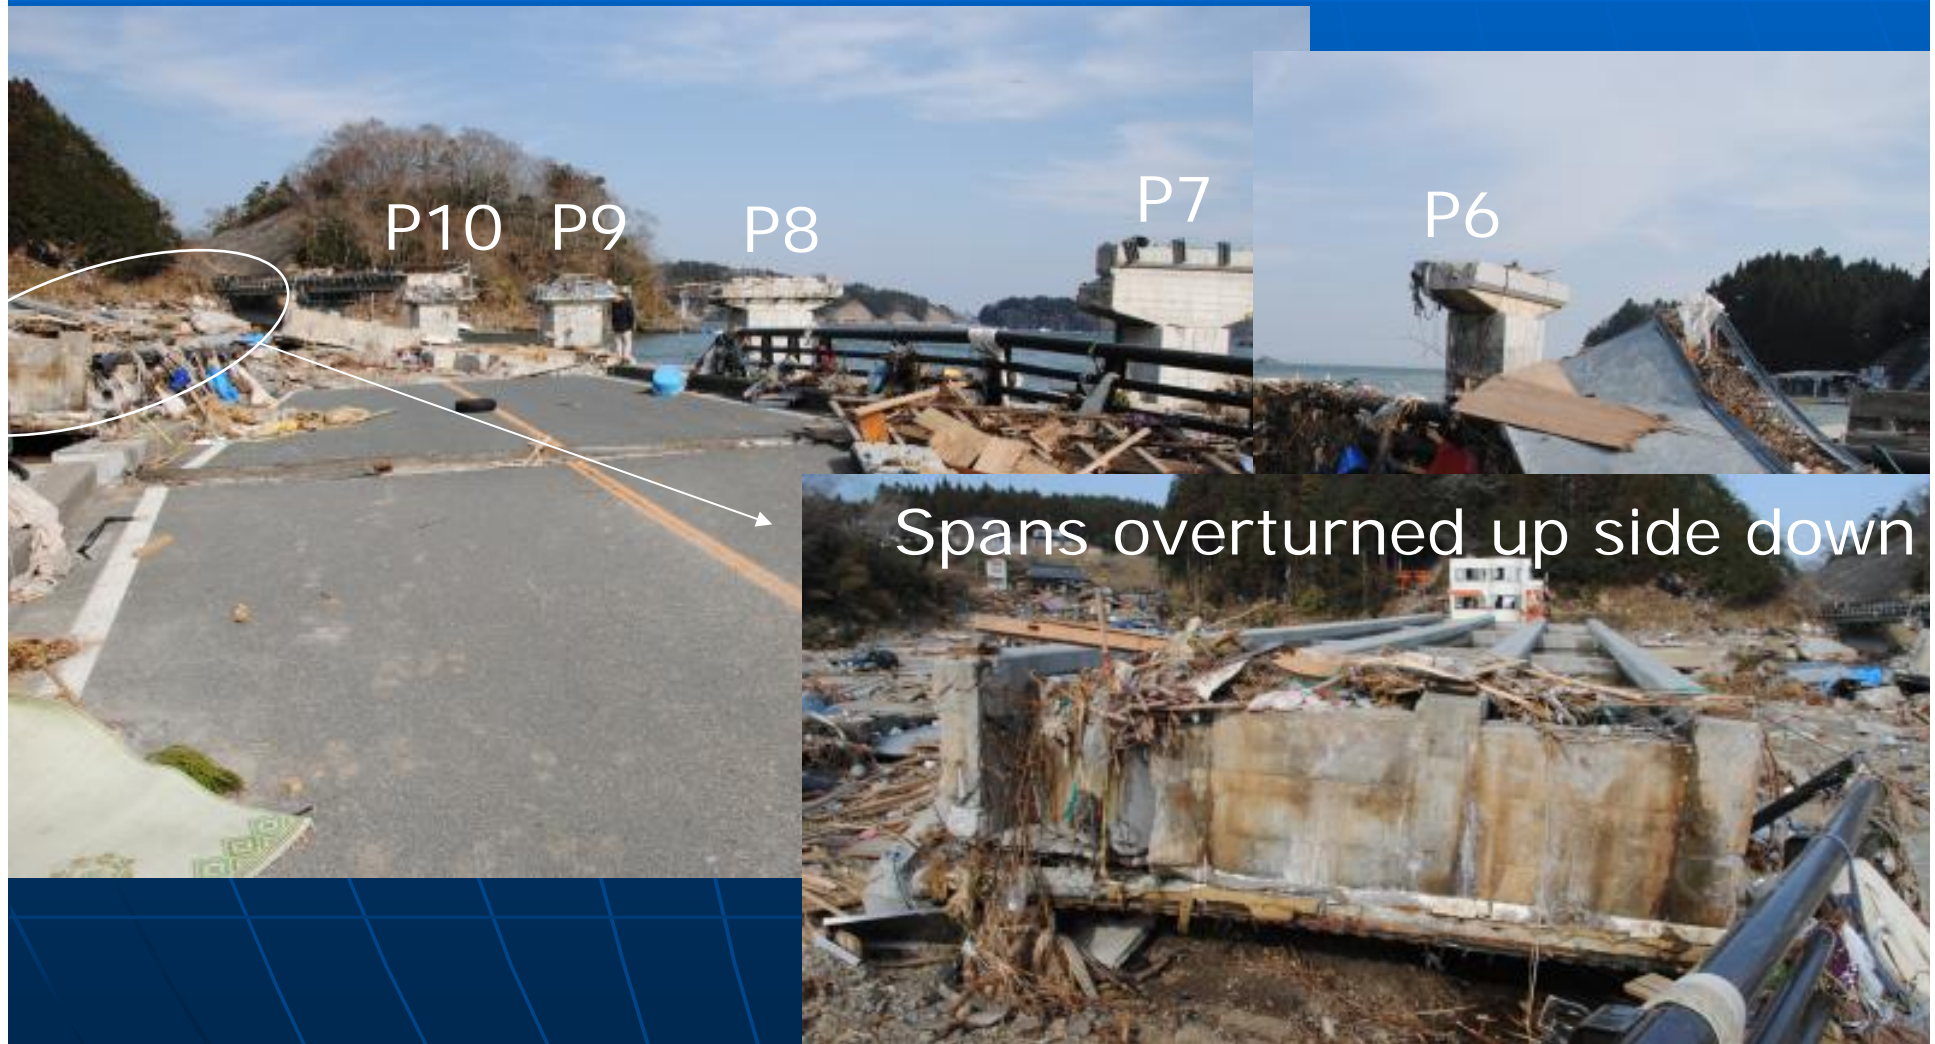
Utazu Bridge, Route 45, Rikuzen-Takada City

PC girder decks floated by tsunami

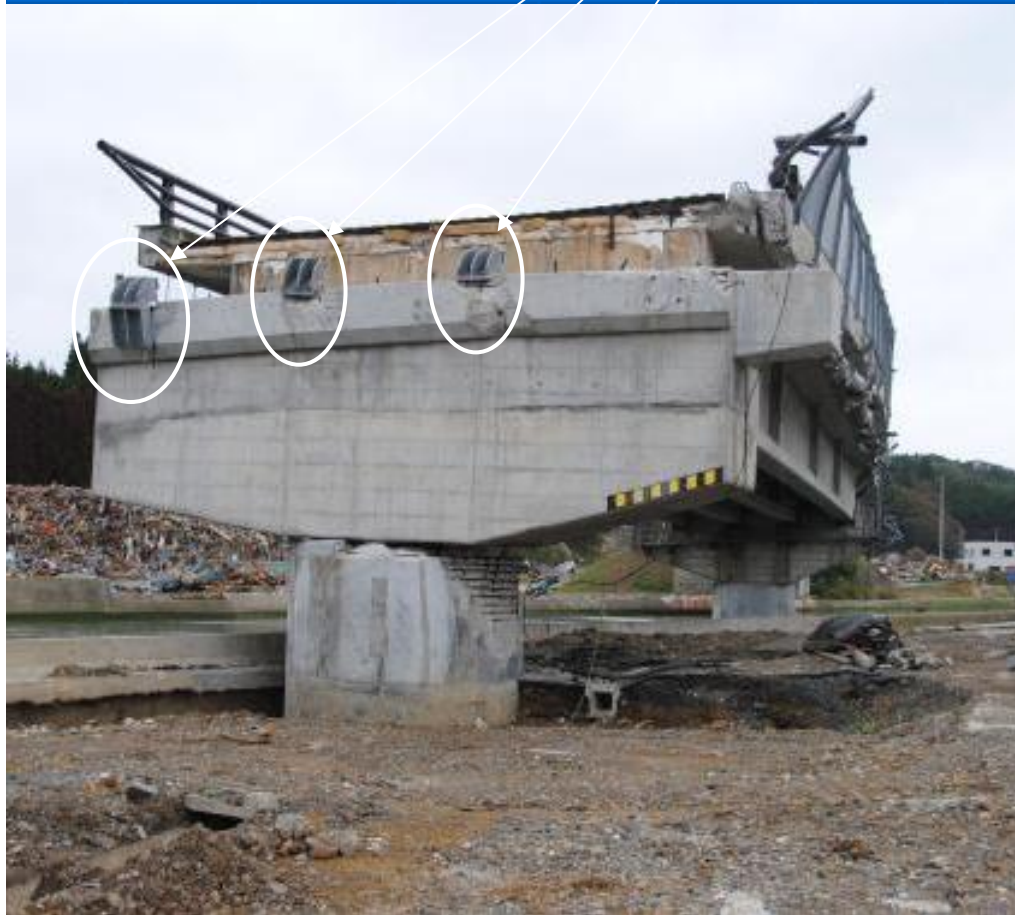
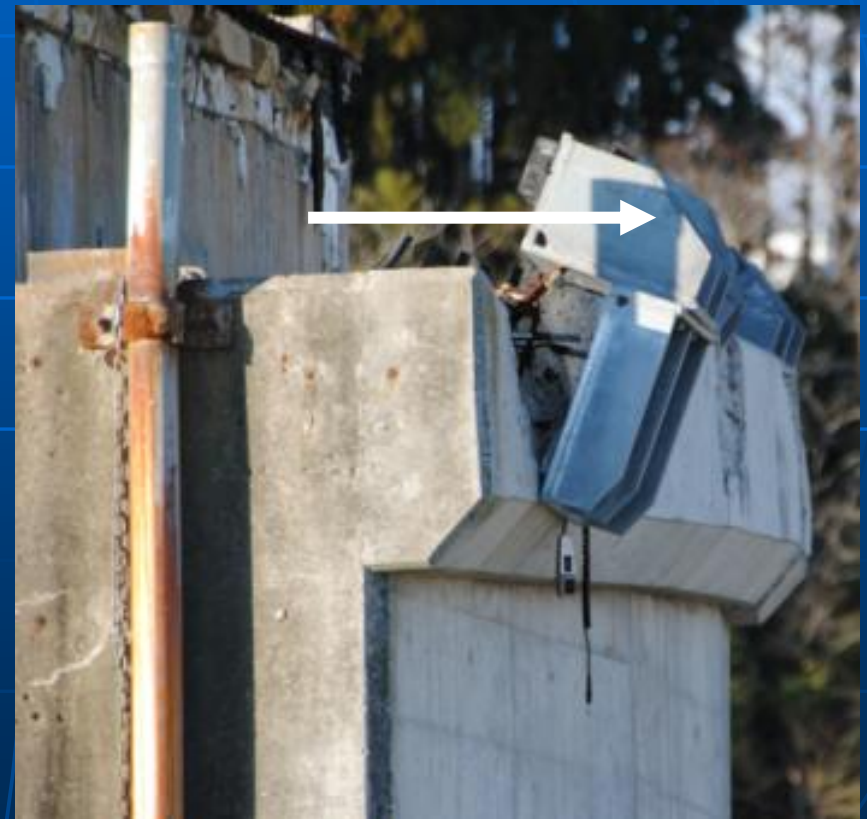
Short span decks were simply dragged by tsunami

Stoppers for preventing excessive deck displacement in the longitudinal direction

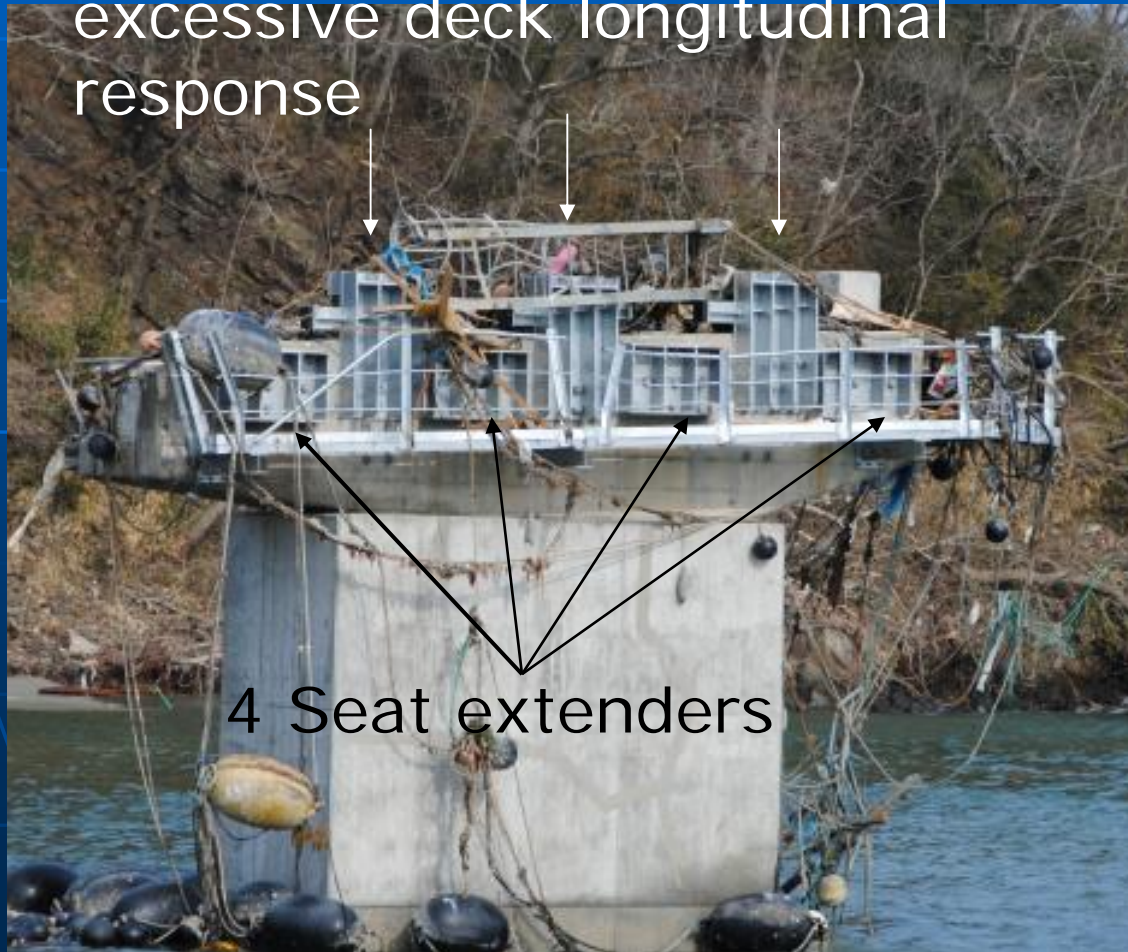
Steel stoppers were provided, but they were ineffective for preventing transverse deck movement & uplift by tsunami

3 stoppers for preventing excessive deck longitudinal response
