**Special Session for the Great East Japan Earthquake** 15 WCEE, Lisboa, September 24, 2012

## Geotechnical Effects of the March 11, 2011, Tohoku, Japan earthquake

#### **Kazue Wakamatsu** Kanto Gakuin University

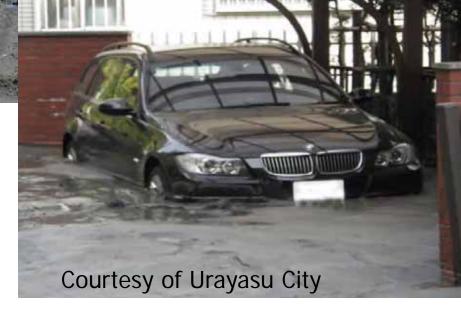
# Huge amount of sand erupted

# Mihama and Mihama,

Urayasu City

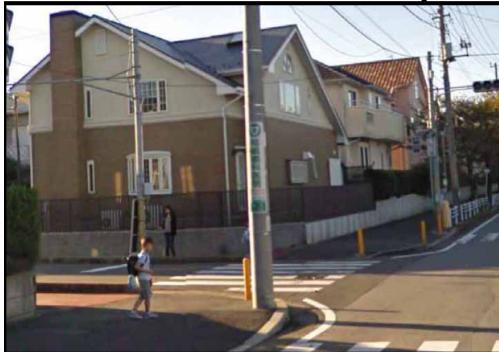
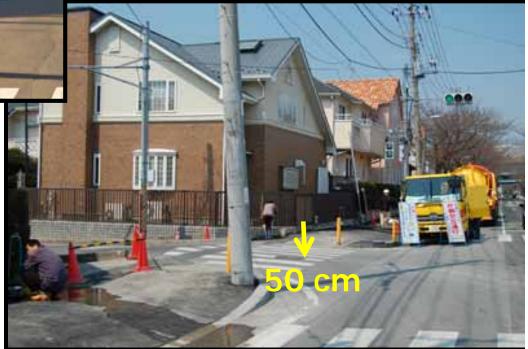
# A house before and after the 2011 Earthquake in Urayasu

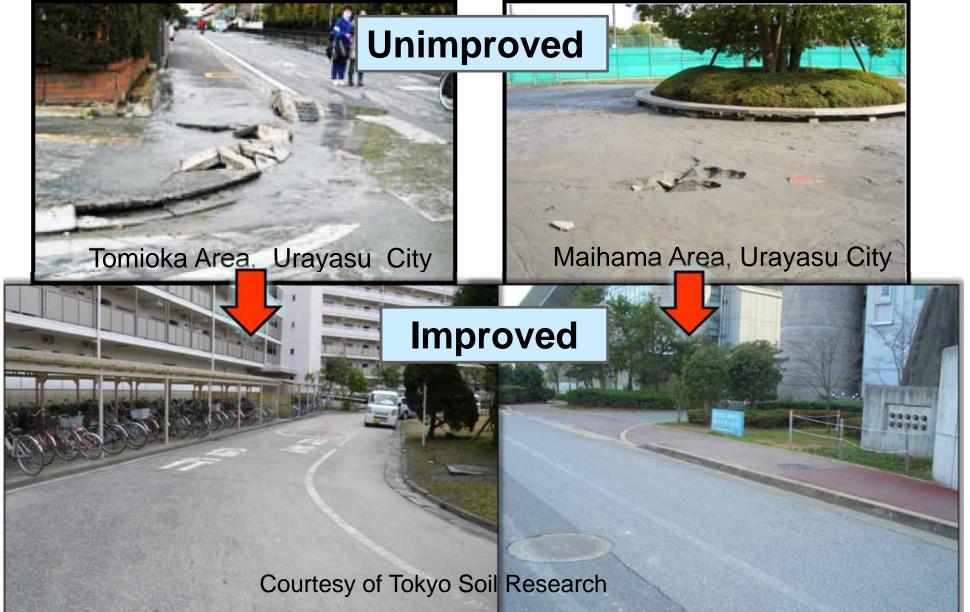
#### Successful examples of soil improvement (Vibroflotation)

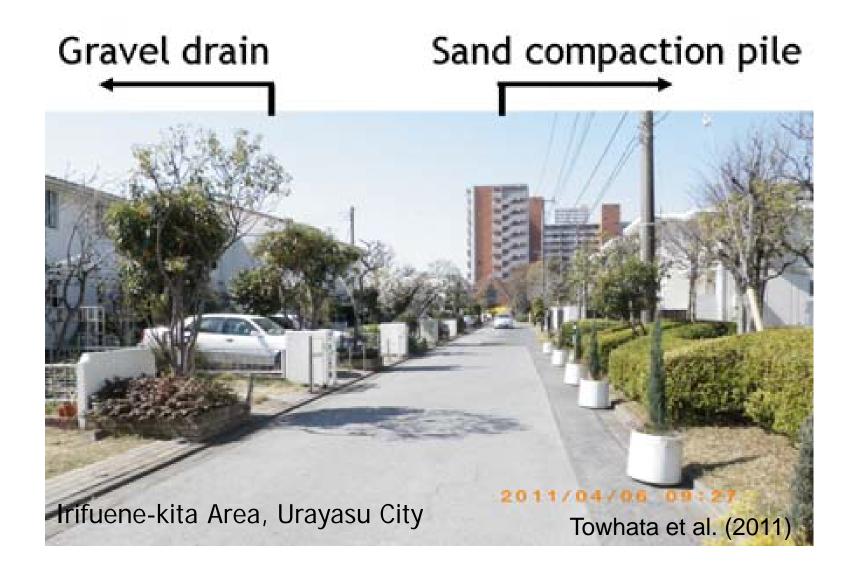
### Successful soil improvement in Urayasu residential area

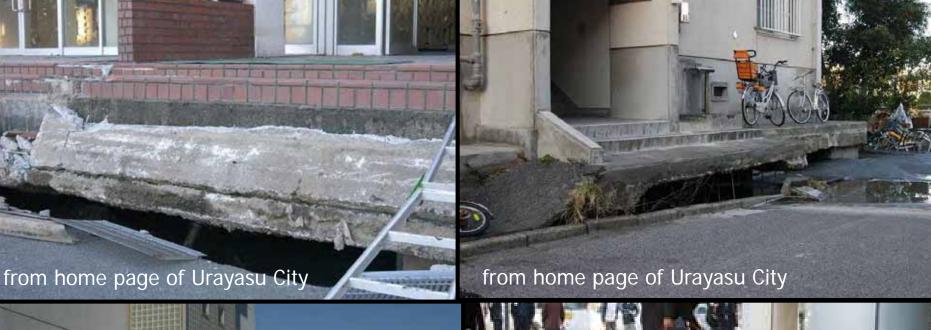
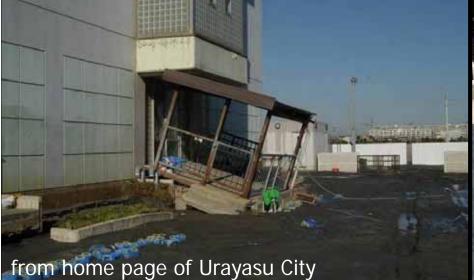
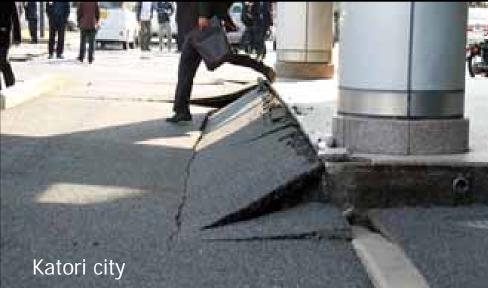
# Relative settlement between building with pile foundation and surrounding ground

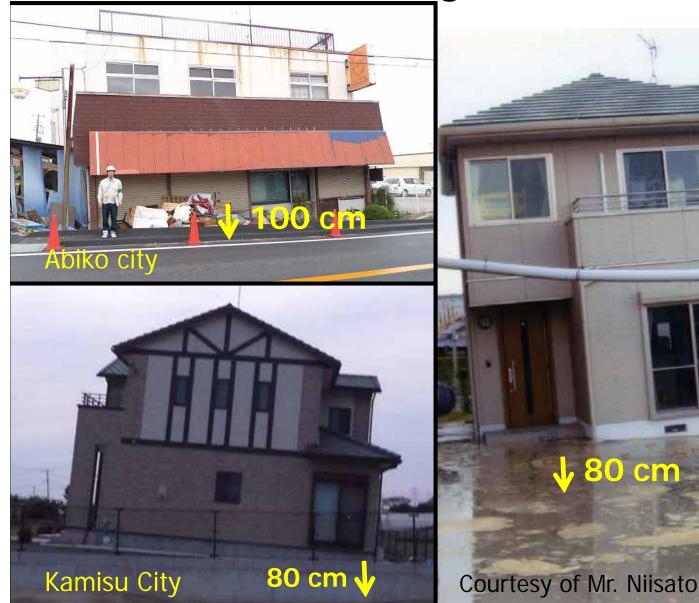
#### Large differential settlement (area along the Tone River)

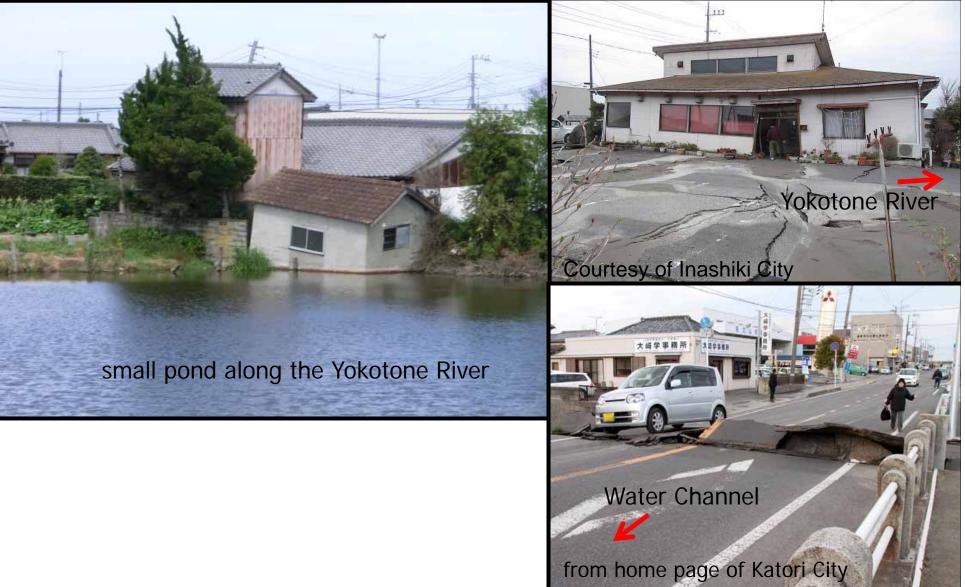
#### Lateral spreading occurred in the area along the Tone River

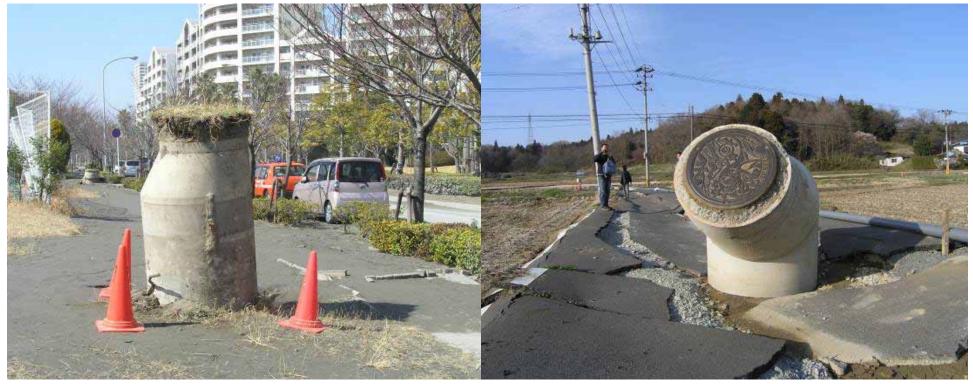
Urayasu, Chiba Prefecture Sukagawa, Fukushima Prefecture

# Uplift of manholes observed wide area

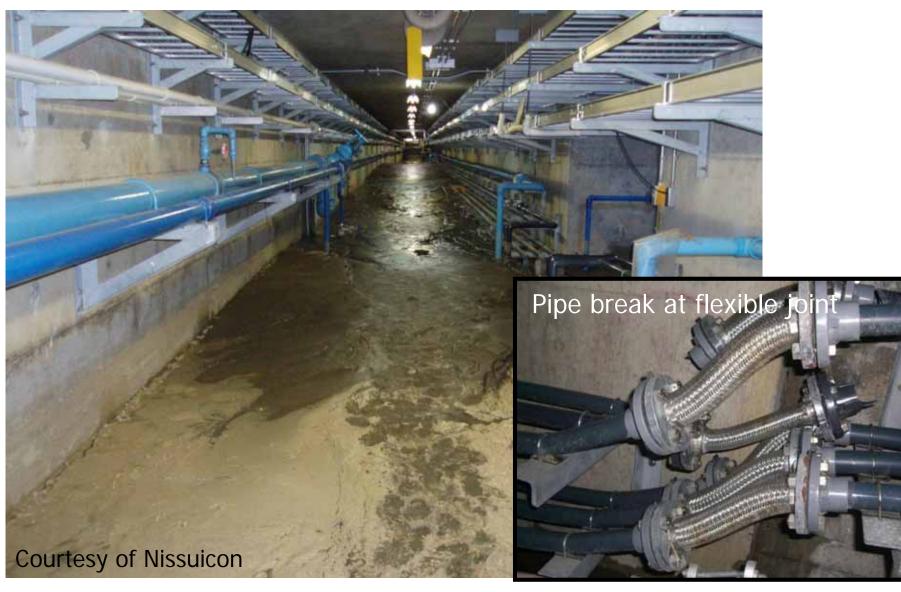
### Inside of uplifted underground conduit

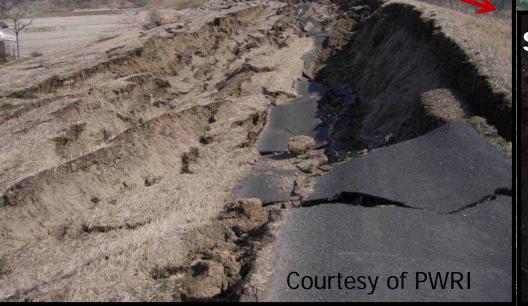
#### Major slumping of landside slope

Sand boils in the levee crack

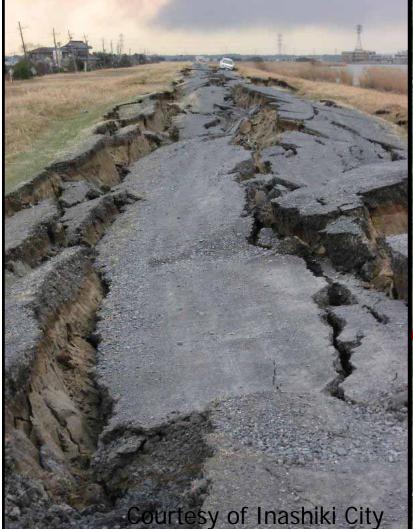
#### Longitudinal Cracking and Slumping of the Kasumigaura Lake levee

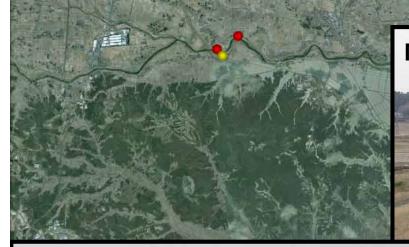
Successful example of soil improvement of Naruse River right levee at river kilometer 14.7k+90~14.9k+70

No observable damage in the improved levee

Repaired with a mix-in-place soil cement foundation ground improvement after the 2003 earthquake.

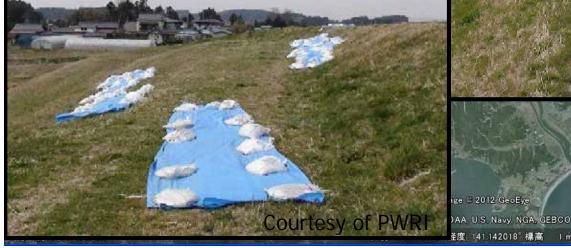
#### Minor damage in unimproved levee

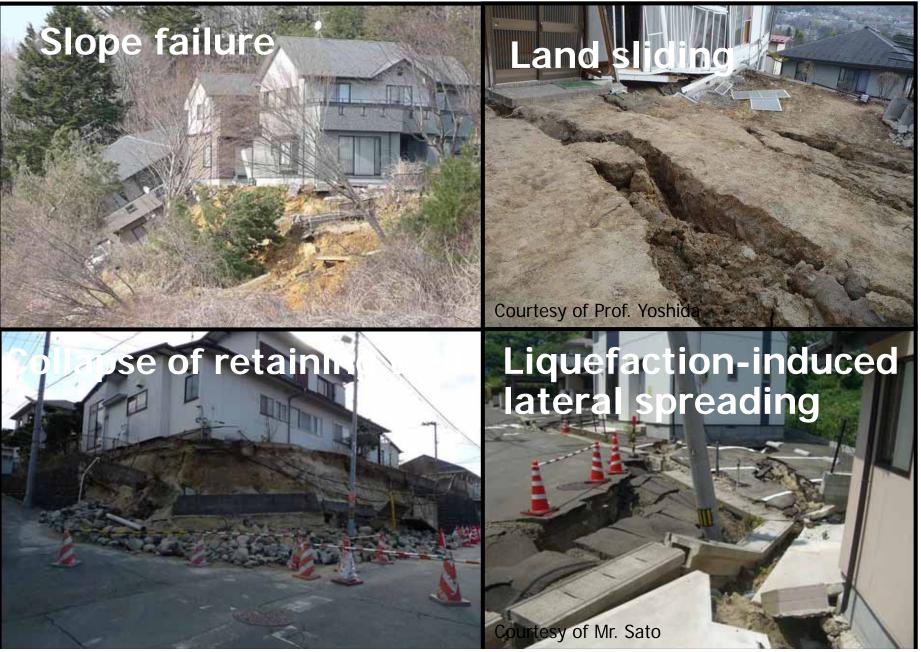
#### Damaged housing lots in Sendai City

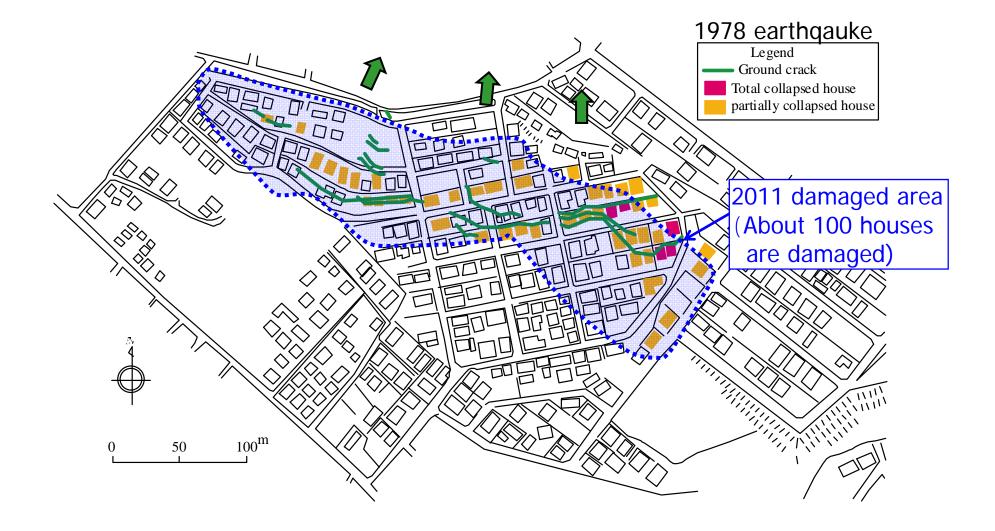
### Repeated damage in Midorigaoka 4-chome, Sendai

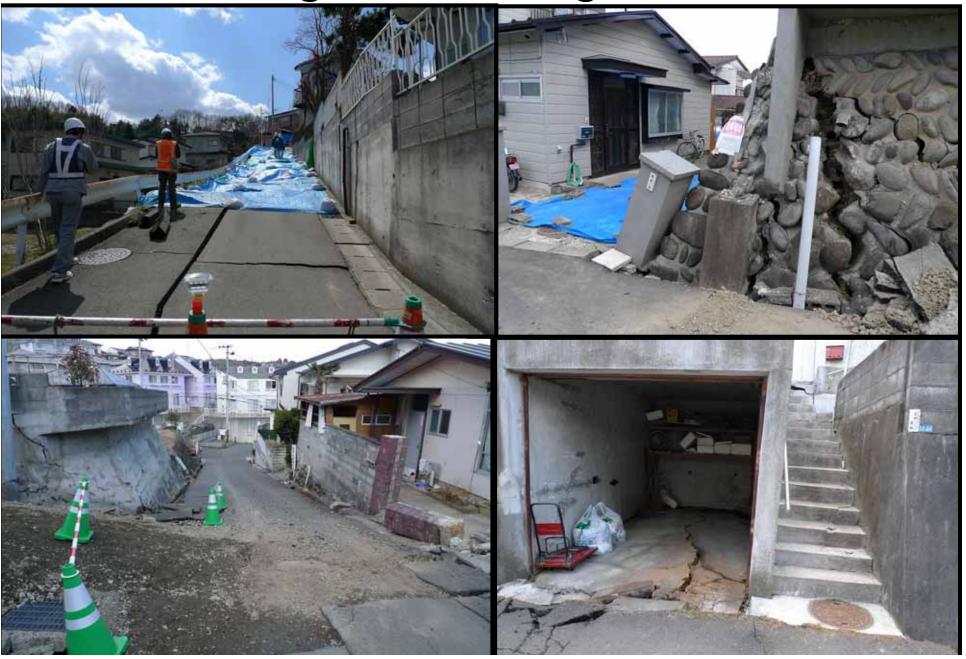
### 2011 damage in Midorigaoka 4-chome

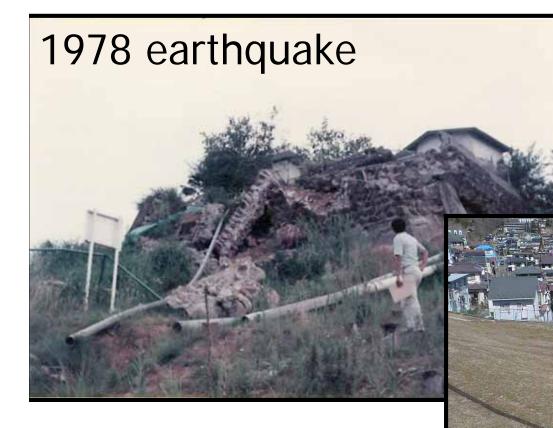
# Midorigaoka 1-chome

No observable damage

- Countermeasures
- $\cdot \mbox{Area}$  has been converted to
- a green park
- ·Steel piles
- ·Retaining wall
- ·Drainage well

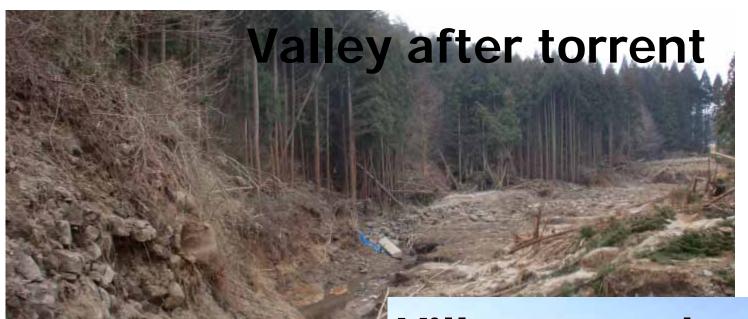
#### **Empty reservoir**

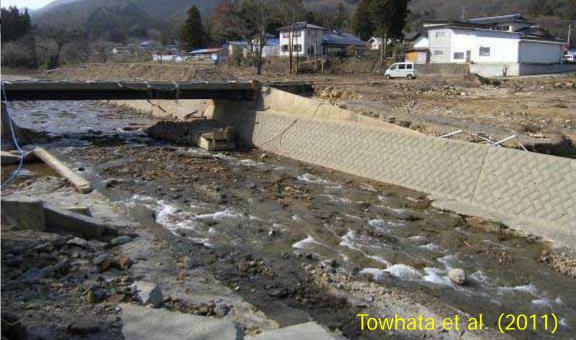
#### Village attacked by flood

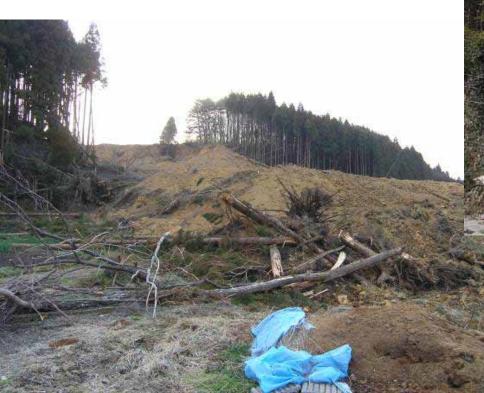
Rock fall at Ohgo, Ibaraki Prefecture

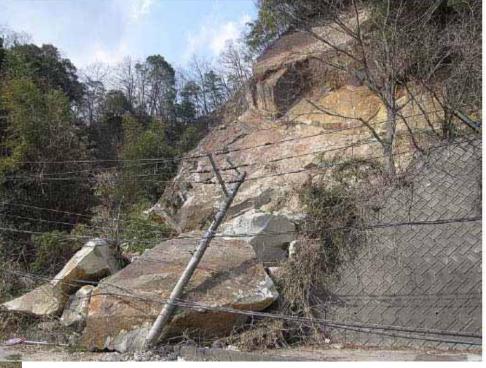
Failure of natural slope at Hanokodaira Shirakawa City, Fukushima Prefecture

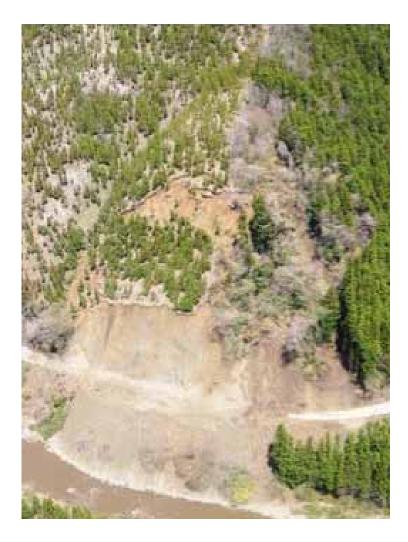
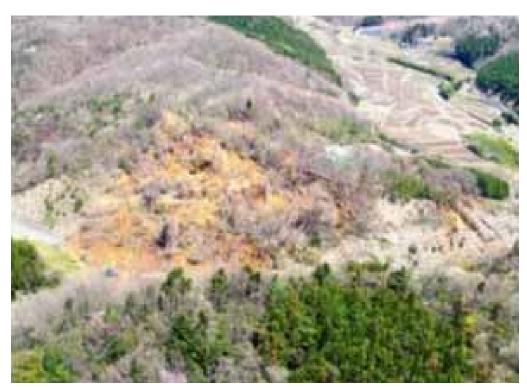
#### Landslides in Iwaki City, Fukushima Pref.
