## THE KUTCH EARTHQUAKE OF JANUARY 26, 2001

Masonori Hamada  
Waseda University, Department of Civil Engineering

Ömer AYDAN  
Tokai University, Dept. of Marine Civil Engineering, Shimizu

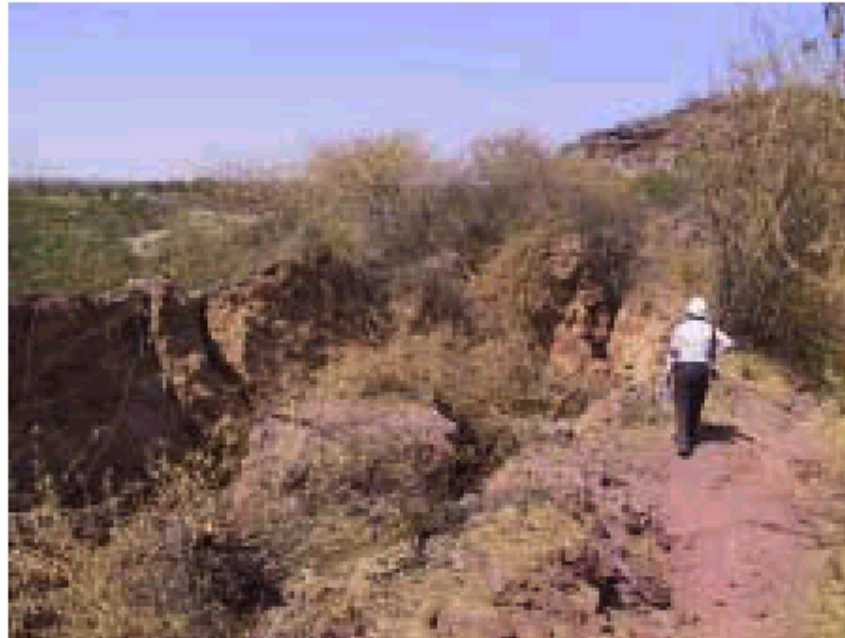
(a) Chang Dam

Most of the dams are earthen dams except a few, which is stone masonry, built. The dams are built for irrigation purposes. There are more than 174 earth dams in the region. Seven medium sized dams and 14 small sized dams in Kutch were damaged. The major dams, which were damaged during the earthquake, were Chang, Tapar, Suvi, Shiviakha, Kaswati and Rudramata dams. Most of the dams failed or damaged at their old river course sections. The reason of the failure or damage was associated with the liquefaction of sub-soil below the embankment of the dam. Figure 13 shows views of damage to Suvi and Chang dams.

Figure 13 Views of Failures of Chang and Suvi dams

Although the base rock of the Chang dam was mudstone with almost horizontal layering, the old river course may be consisted of sandy material. In the upstream side the sand boiling can be clearly observed even more than 50 days passed over the earthquake (Figure 25(a)). It seems that the failure of the dam is due to liquefaction at its base and it resembles to the failure of San Fernandes dam. Furthermore, some lateral spreading could be observed at many locations around the reservoir (Figure 25(b)).

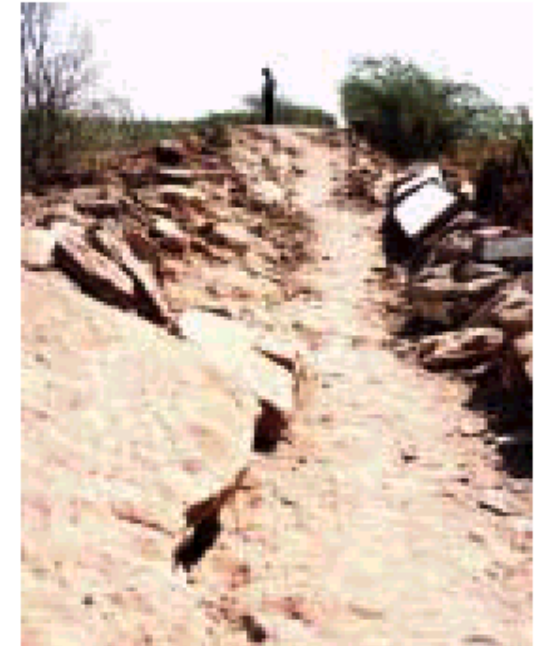
(b) Suvi Dam

Some lateral spreading of ground was observed within the Suvi dam reservoir. This may be due to soil liquefaction as quartzitic sand with a repose angle of 32 degree is observed along the cracks. The slumped section of this dam was also thought to be the result of liquefaction of soil at the base of the dam.

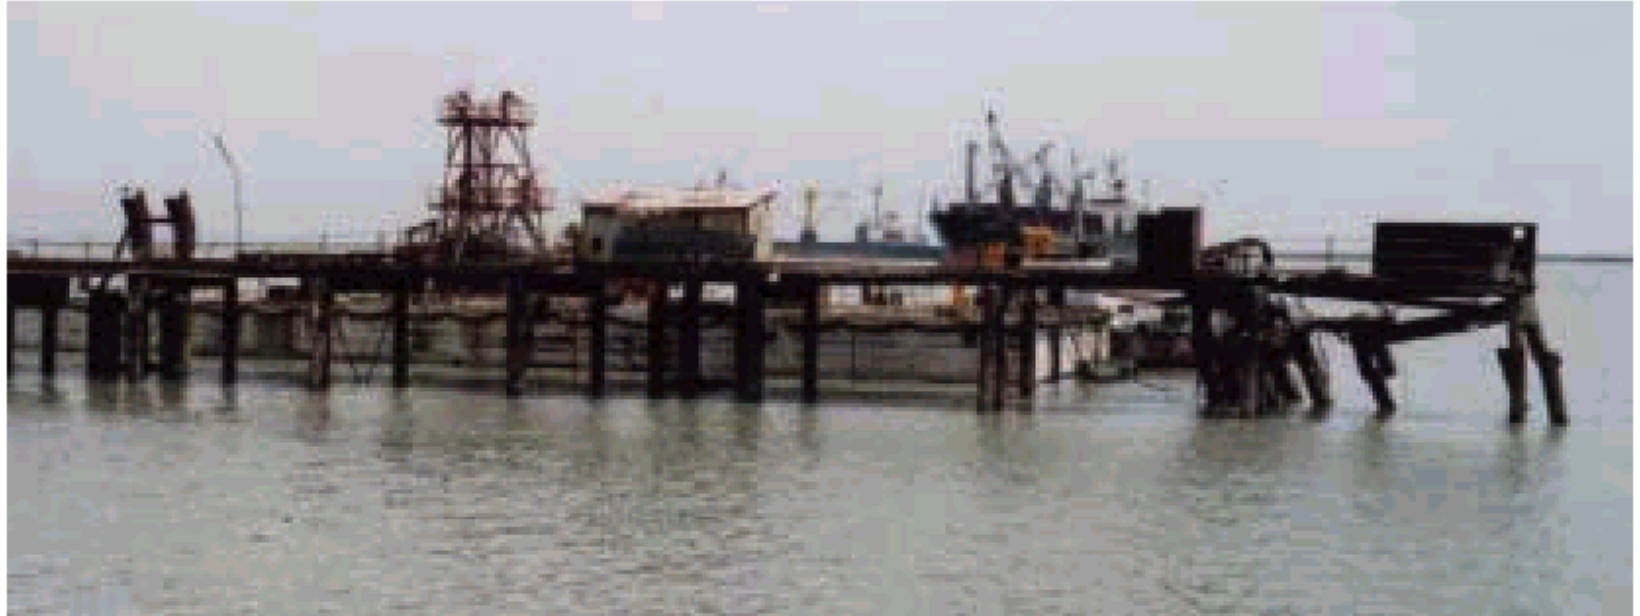
The old jetty of the port on the piles with a length of 15m is shifted towards the sea. The top of piles had small hair cracks. Furthermore, the settlement of filled section of the port was about 7cm. The jetty of the oil-pipelines at Kandla port was heavily damaged due to breakage of the piers (Figure 15). The piers were almost ruptured at their mid.

Figure 15 A view of damaged oil jetty at the Kandla port on March 19, 2001.

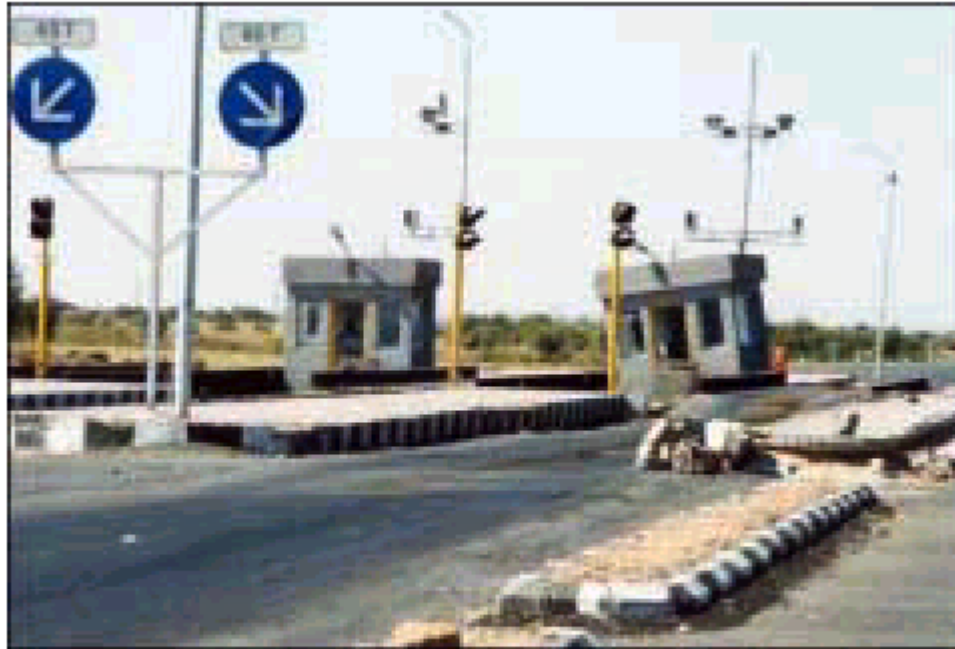
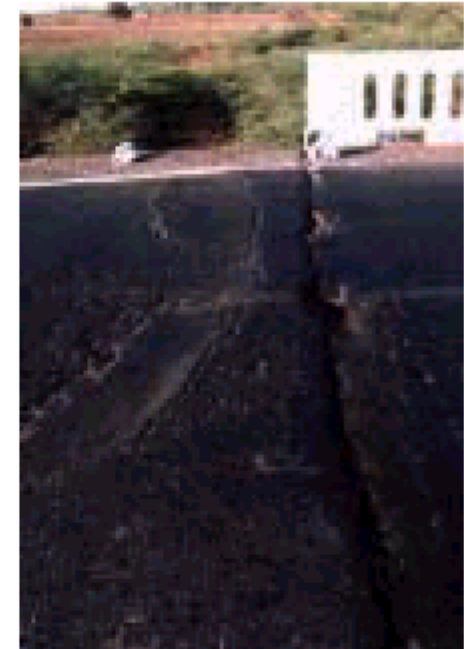
Out of 650 Kms of highways, 100 Kms severely damaged. Most of roadways had to be re-surfaced due to extensional and bulging type cracking (Figure 16). Furthermore, the embankments of bridges settled and caused the slow down of the traffic (Figure 17). In some places, the traffic had to be diverted for the repairment of embankments. The tollgate buildings of the highway 8A were broken at their base columns (Figure 17).

Figure 17 Damage to toll gates and settlement of bridge embankments

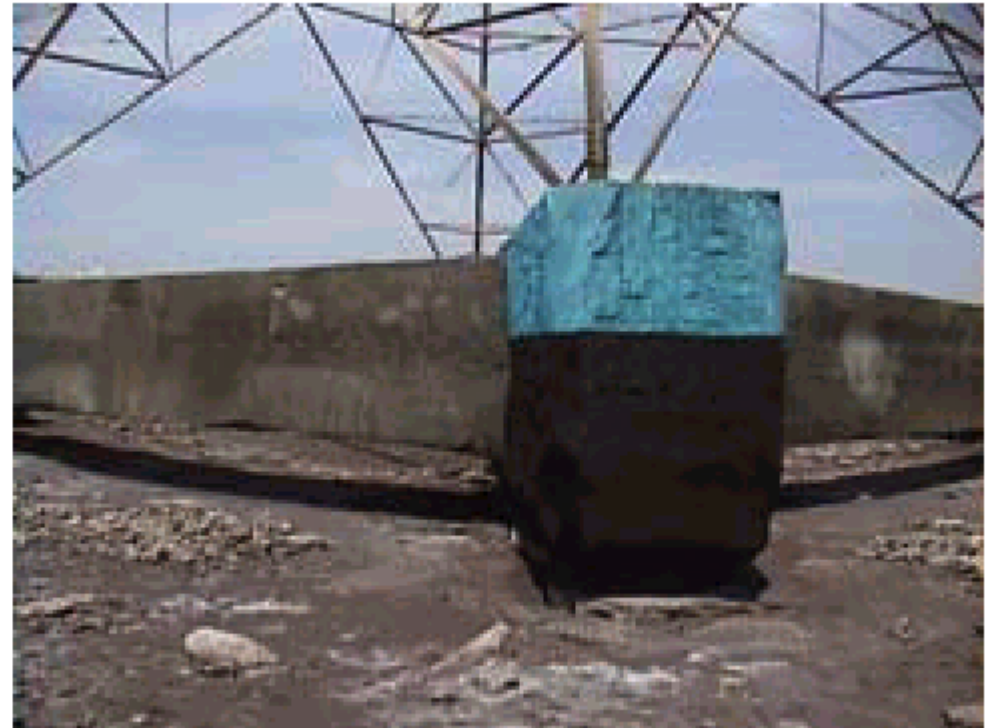
Figure 19 Damaged pylons near Hadakia Bridge

- Pylons were almost non-damaged in the earthquake area even some of them passed through the marsh lands and salt playas. but some of them passes through salt playas experienced damages

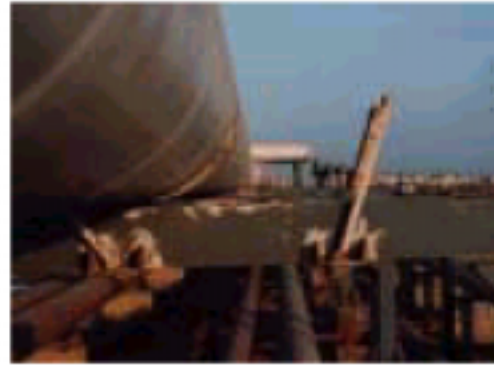
Product pipelines from Vadinar to Kandla & Kandla to Bhatinda were shutdown. The pipe racks made of steel and were bent or buckled in the vicinity of the port. There was no breakage of the pipelines at any location although they were displaced from their original locations. The steel stripe type fixtures were either broken or separated from their welding locations (Figure 23(a)). The pipes were displaced both laterally 30cm and longitudinally 40cm. The direction of movement was NE towards the epicenter. The liquefaction and lateral movement of the ground was observed at the base of pipelines as shown in Figure 23(b). Crude oil pipelines from Salaya, feeding Koyali/Mathura/Panipat refineries resumed operations since 27th Jan after due checking. The oil pipelines from the Kandla Port were severely damaged (Figure 23(c)). The pipelines are supported by the two layer steel frames and each frame supports three pipelines (Figure 23(d)). Two of them were filled with oil during earthquake. The pipelines are running to the NS direction and the south ends are curved to the west direction. Because the ground motion of the NS direction was dominant and the shaking modes were different for the three parallel pipelines, which have different curvatures, the steel frames were buckled and collapsed with the pipelines.

Figure 23 Damage to pipelines

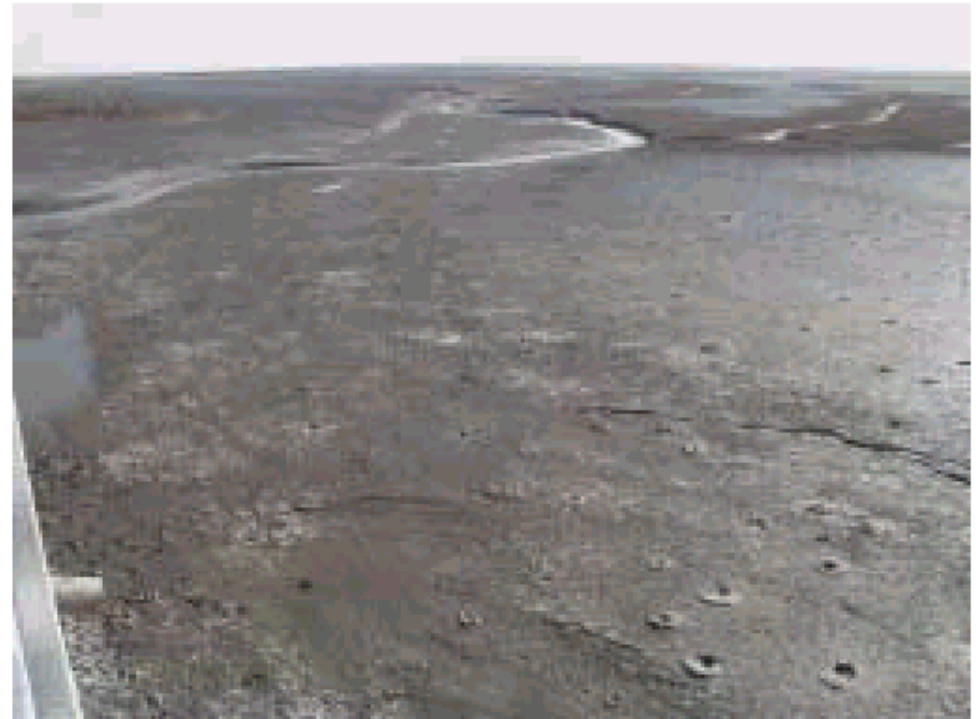
(b) Hadakia Bridge

The bridge was severely damaged due to the liquefaction and its induced ground displacement. Numerous sand vents could be observed on the river bed in the neighborhood of the bridge as shown in Figure 24(b). The evidences of liquefaction-induced ground displacement were found on the riverbed. And the concrete piers with caisson foundations moved toward the river center due to the ground displacement as shown. The bridge also suffered considerable subsidence of foundations caused by liquefaction and the transportation function was lost after the earthquake.

Figure 24 Some examples of liquefaction

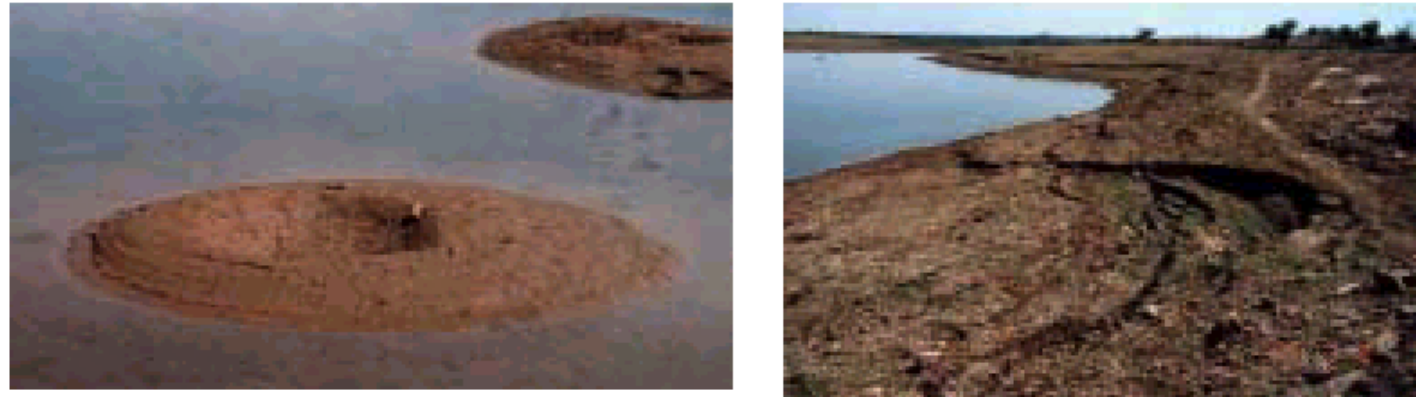
Figure 25 Liquefaction and lateral spreading at Chang dam

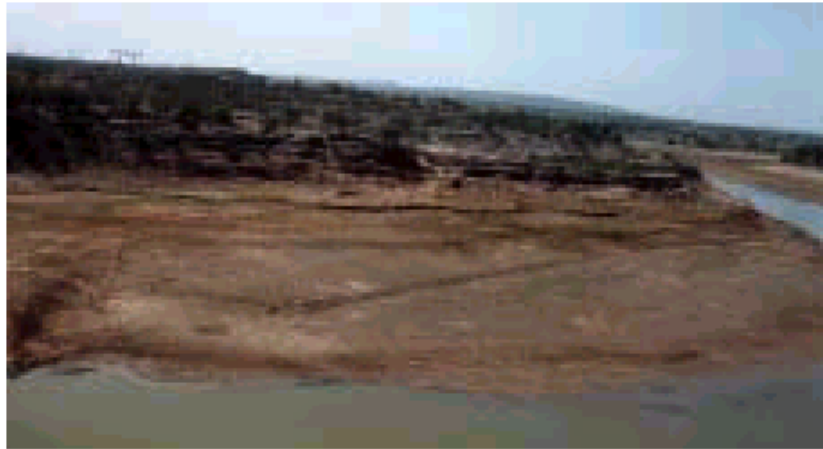
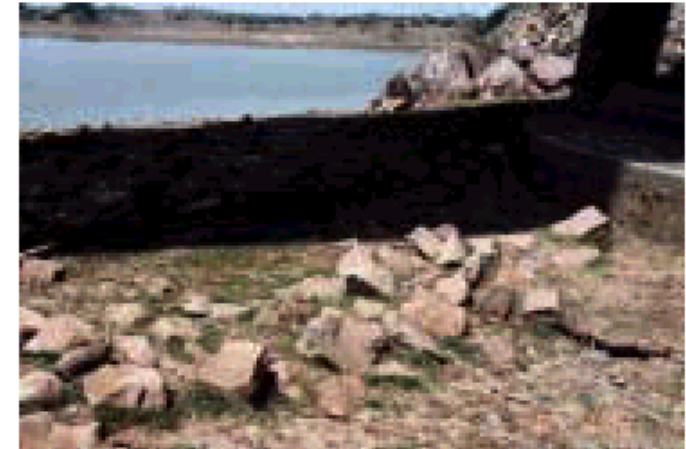
Wide spread lateral spreading of ground was observed at both sides of the valley of the Rudramata Bridge. The soil at both sides of the settled and spread towards the center of the valley. Cracks run along the longitudinal axis of the valley. The crack on the south embankment was mistakenly interpreted as the fault break. The crack is due to the lateral spreading of the ground (Figure 26).

Figure 26 Settlement and lateral spreading in the vicinity of Rudramata Bridge

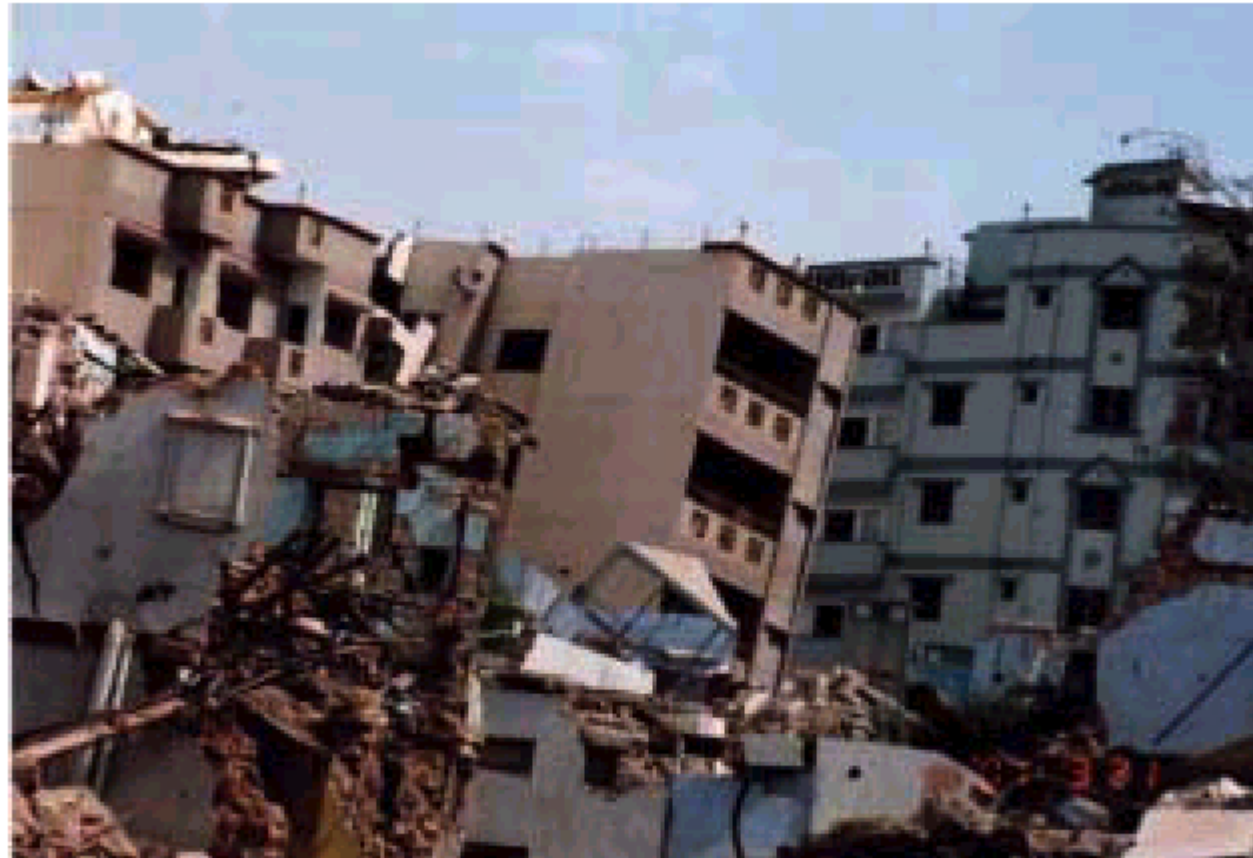
- a) Long duration of shaking (about 90 seconds)
- b) Damage was concentrated to areas that the land was re-claimed and buildings were new
- c) The number of stories of buildings ranged between 4 and 5.
- d) The top soil was sandy clay with sand soil below,
- e) Collapsed buildings had isolated footings and the footings were not connected to each with lateral tie beams.
- f) Constructors did not follow the earthquake design code
- g) Collapsed buildings were mostly pivot type and no shear walls at ground floor
- h) Ground amplification due to geological structures such as in Anjar and Ahmedabad
- i) Poor workmanship
- j) Rusting of steel bars due to the use of saline sand and gravel

Figure 30 Collapsed Apartment blocks are ground floor in Bhuj
