Kutch (Kutch) region in Gujarat State of India was severely shaken by a powerful earthquake at 8:46 am on 26 January 2001 of the India Standard Time, which has been the most damaging earthquake in the last five decades in India. The M7.9 quake caused a large loss of life and property. Over 20,000 persons are reported to be dead and over 167,000 injured. The estimated economic loss due to this quake is placed at around US\$5 billions. The entire Kutch region of Gujarat sustained highest damage with maximum intensity of shaking as high as X on the MSK intensity scale.

The investigation by the earthquake engineering sub-committee of The Japan Society of Civil Engineers (JSCE) has been undertaken between March 16 and 24, 2001. The investigation on the 2001 West India earthquake covered various aspects of the earthquake. This article presents an overview of the investigation results of the JSCE Kutch earthquake investigation team. The article covers the geology, tectonics and seismicity of the earthquake region, seismic intensity and the characteristics of strong motion records and damage to civil engineering structures. The findings and observations of the investigation aforementioned

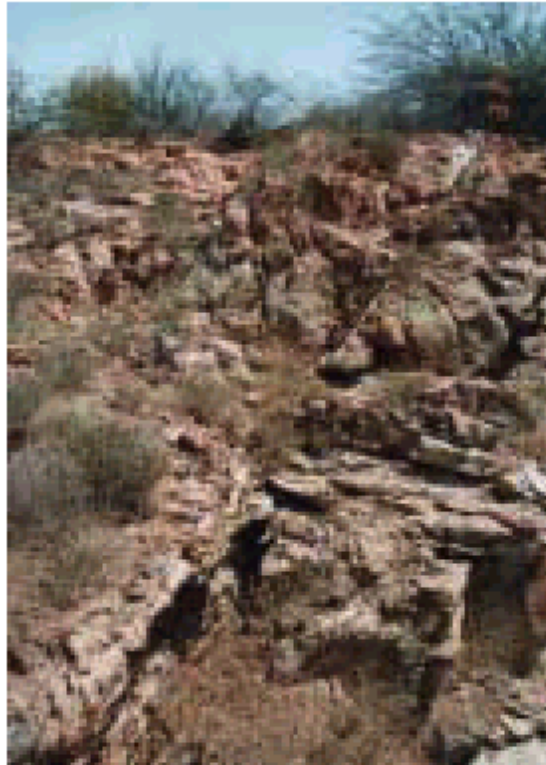
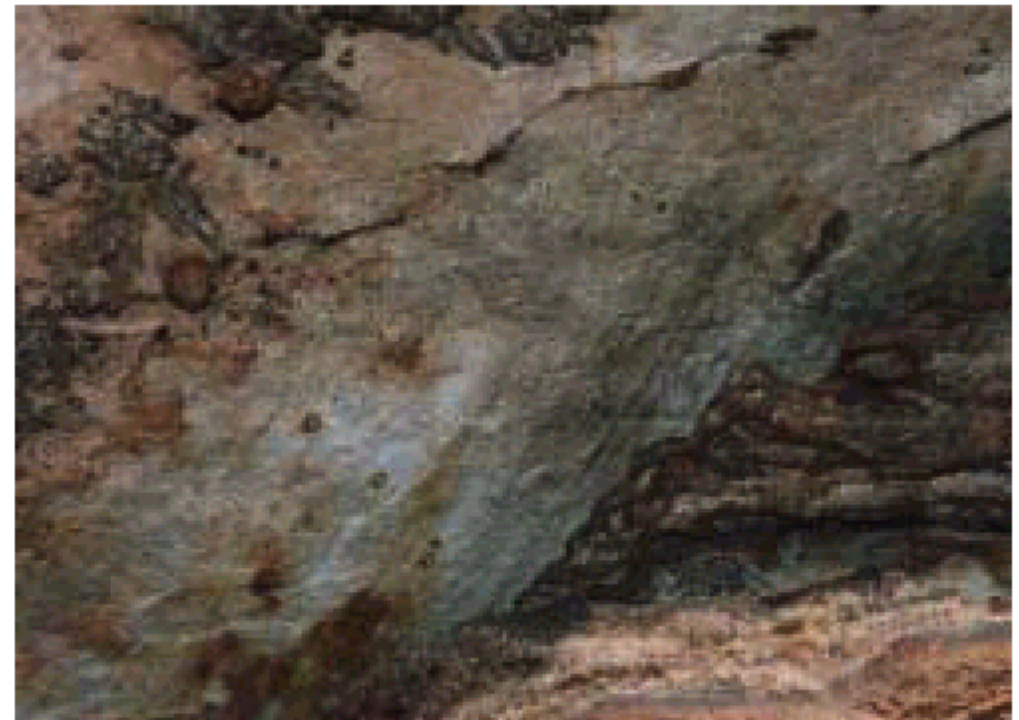
Figure 9 A thrust fault with striations at the northern embankment of Rudramata Bridge

As stated previously, there was not any well-defined fault scarp on the ground surface. It seems that many earthquakes in Indian plate do not result in well-defined fault scarps. This was claimed to be due to the low stiffness of the earth's crust of the Indian plate. Nevertheless, some fault scarps could be observed along the roadcuts during site investigations. Figure 9 shows a fault scarp near the northern

Striations on the thrust fault plane (picture towards north)

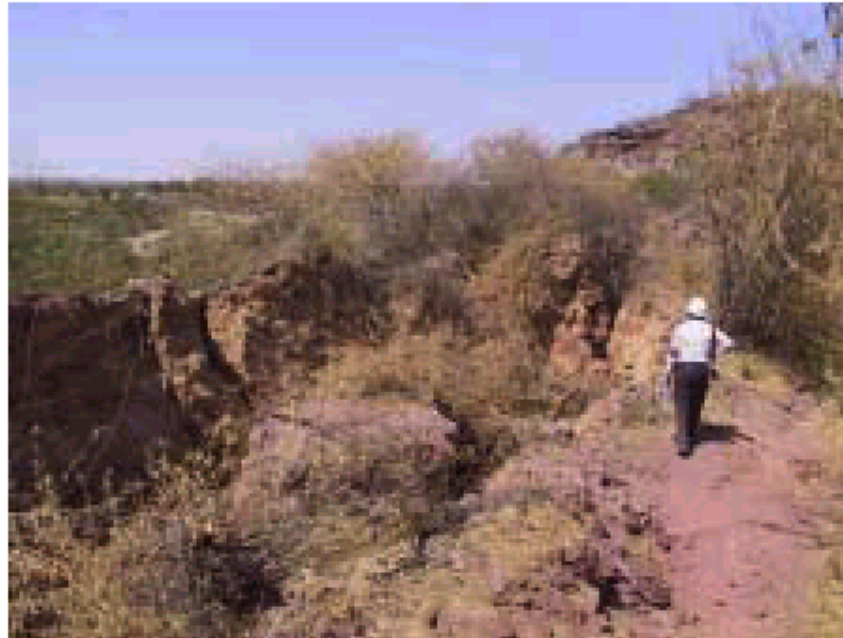
(a) Chang Dam

Most of the dams are earthen dams except a few, which is stone masonry, built. The dams are built for irrigation purposes. There are more than 174 earth dams in the region. Seven medium sized dams and 14 small sized dams in Kutch were damaged. The major dams, which were damaged during the earthquake, were Chang, Tapar, Suvi, Shiviakha, Kaswati and Rudramata dams. Most of the dams failed or damaged at their old river course sections. The reason of the failure or damage was associated with the liquefaction of sub-soil below the embankment of the dam. Figure 13 shows views of damage to Suvi and Chang dams.

Figure 13 Views of Failures of Chang and Suvi dams

Although the base rock of the Chang dam was mudstone with almost horizontal layering, the old river course may be consisted of sandy material. In the upstream side the sand boiling can be clearly observed even more than 50 days passed over the earthquake (Figure 25(a)). It seems that the failure of the dam is due to liquefaction at its base and it resembles to the failure of San Fernandes dam. Furthermore, some lateral spreading could be observed at many locations around the reservoir (Figure 25(b)).

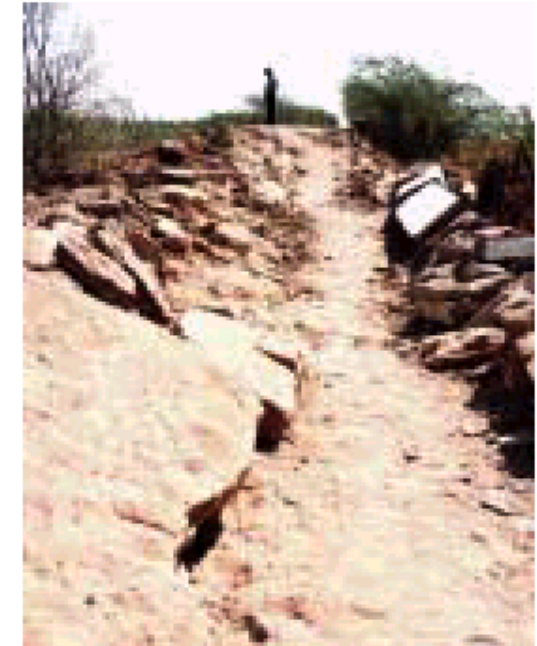
(b) Suvi Dam

Some lateral spreading of ground was observed within the Suvi dam reservoir. This may be due to soil liquefaction as quartzitic sand with a repose angle of 32 degree is observed along the cracks. The slumped section of this dam was also thought to be the result of liquefaction of soil at the base of the dam.

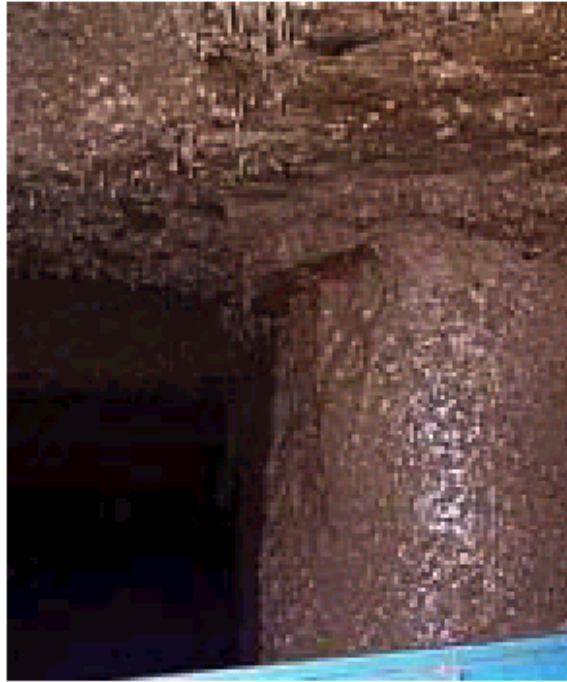
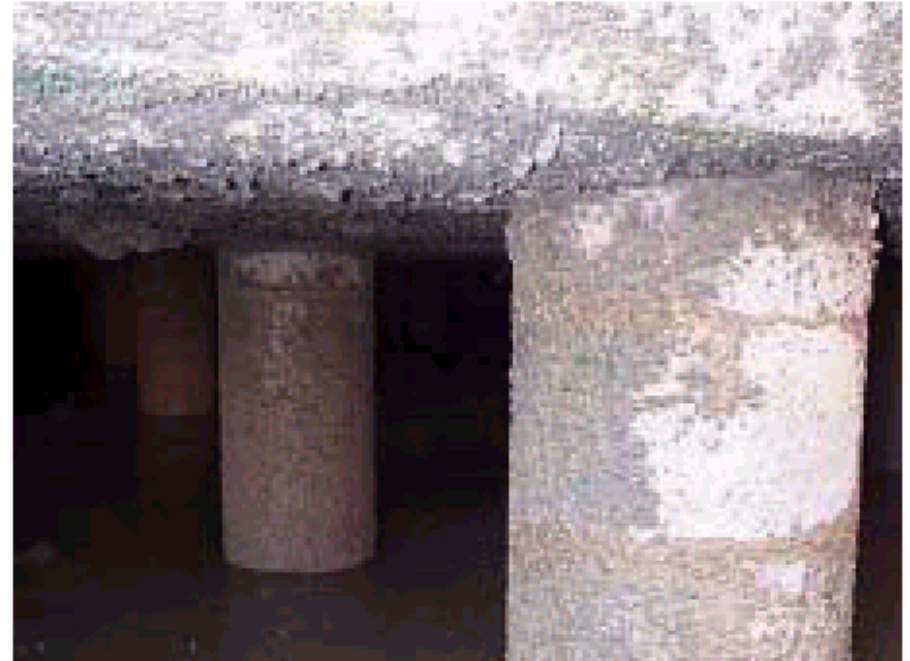
Figure 14 Cracking of piles at Kandla port

The old jetty of the port on the piles with a length of 15m is shifted towards the sea. The top of piles had small hair cracks. Furthermore, the settlement of filled section of the port was about 7cm. The jetty of the oil-pipelines at Kandla port was heavily damaged due to breakage of the piers (Figure 15). The piers were almost ruptured at their mid.

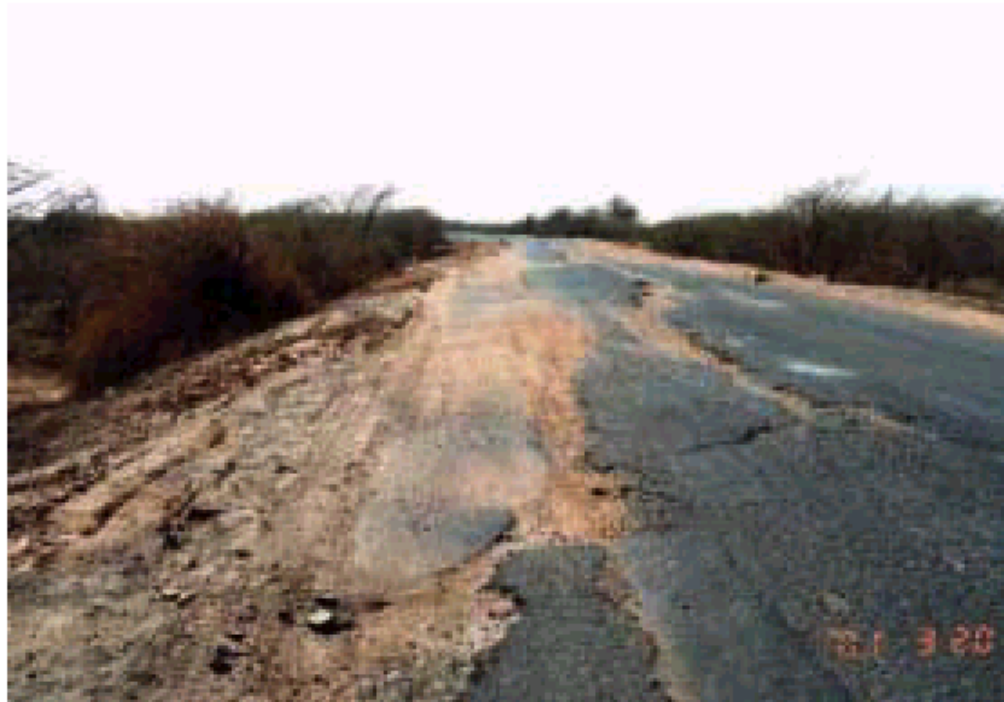
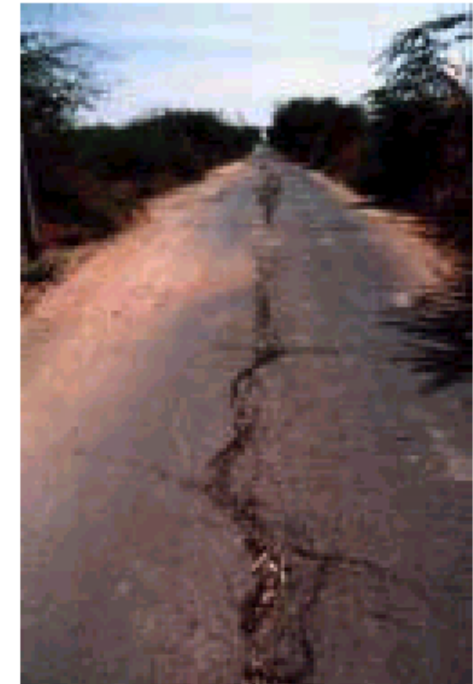
Figure 16 Damaged roadways due to ground deformation

Out of 650 Kms of highways, 100 Kms severely damaged. Most of roadways had to be re-surfaced due to extensional and bulging type cracking (Figure 16). Furthermore, the embankments of bridges settled and caused the slow down of the traffic (Figure 17). In some places, the traffic had to be diverted for the repairment of embankments. The tollgate buildings of the highway 8A were broken at their base columns (Figure 17).

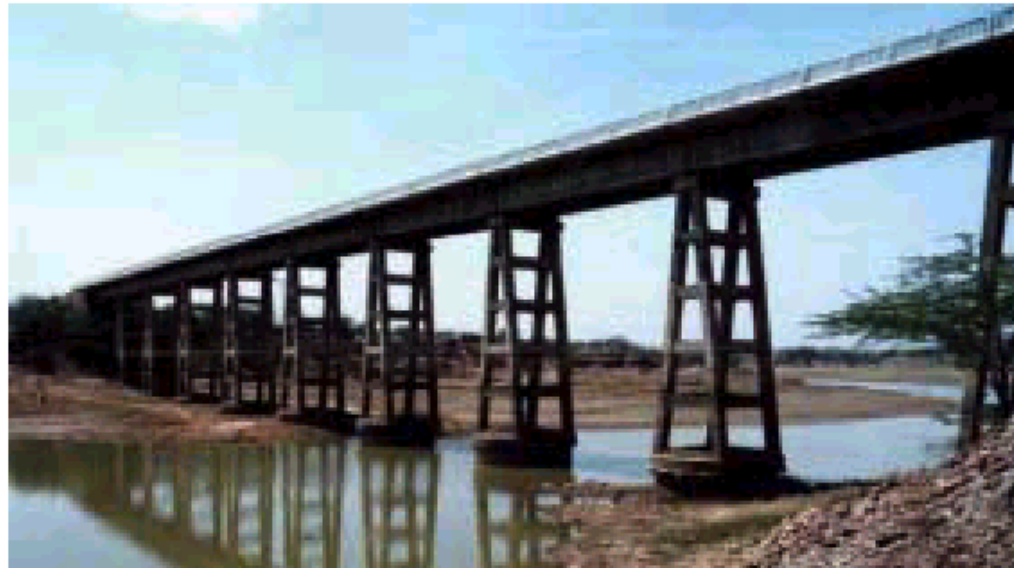
Figure 18 Rudramata bridge

Most of the minor/major roadway and highway bridges in Kutch region were damaged. Parapets of the minor and major bridges were totally or partially toppled or displaced in the entire region affected by the earthquake. The settlement and lateral spreading of ground particularly affected the piers of Hadakia Bridge and Rudramata Bridge. The soil at both sides of the bridge abutments settled and spread towards the center of the valley (Figure 18).

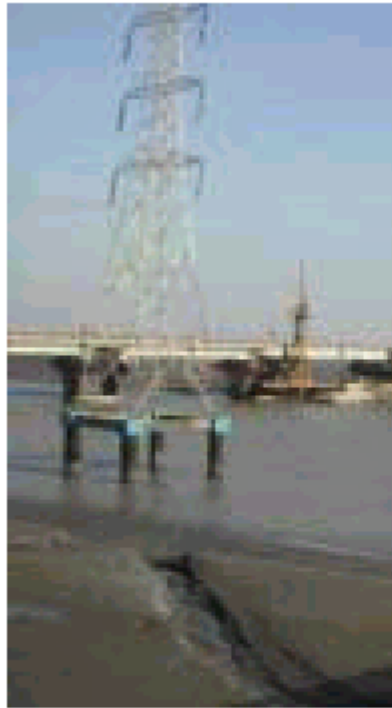
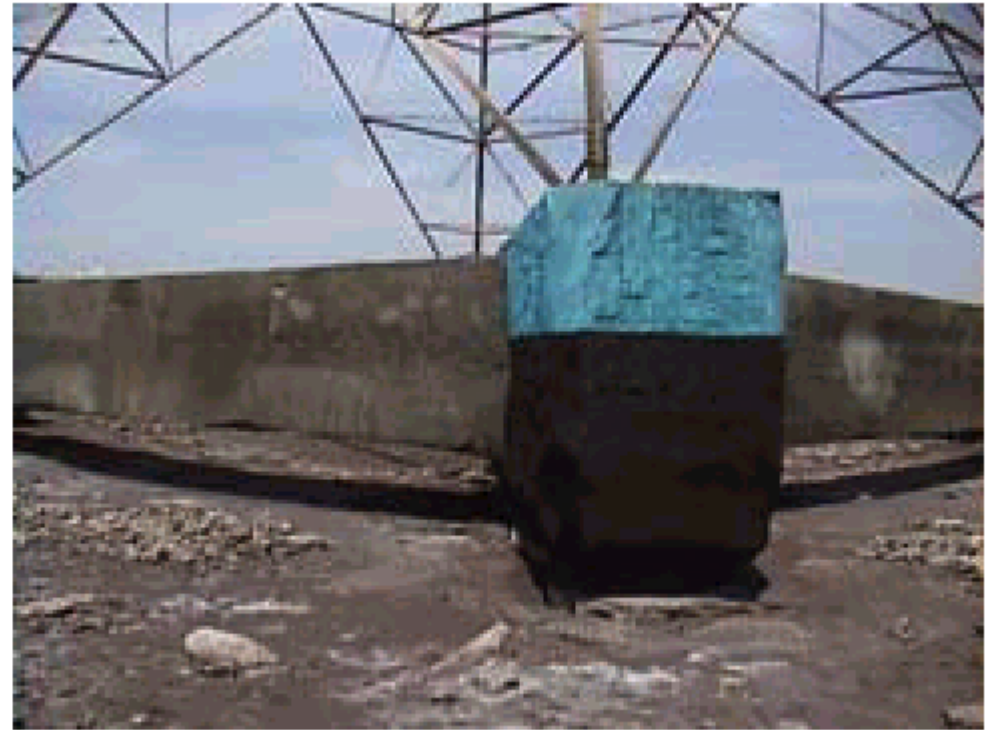
Figure 19 Damaged pylons near Hadakia Bridge

Power is transmitted from Panandhro, through 220 kV and 132 kV systems, southeast through the region. Over a dozen substation control buildings collapsed, and a total of 45 were damaged. The control building damage had the greatest impact on the overall system failure. Pylons were almost non-damaged in the earthquake area even some of them passed through the marsh lands and salt playas. but some of them passes through salt playas experienced some damages. Figure 19 shows the damage of the pylon foundation in salt playas near Hadakia Bridge. The foundation moved and about 11 cm wide gaps occurred between the pile-foundations and the surrounding ground, and the concrete beams which connected the pile foundations experienced some cracks.

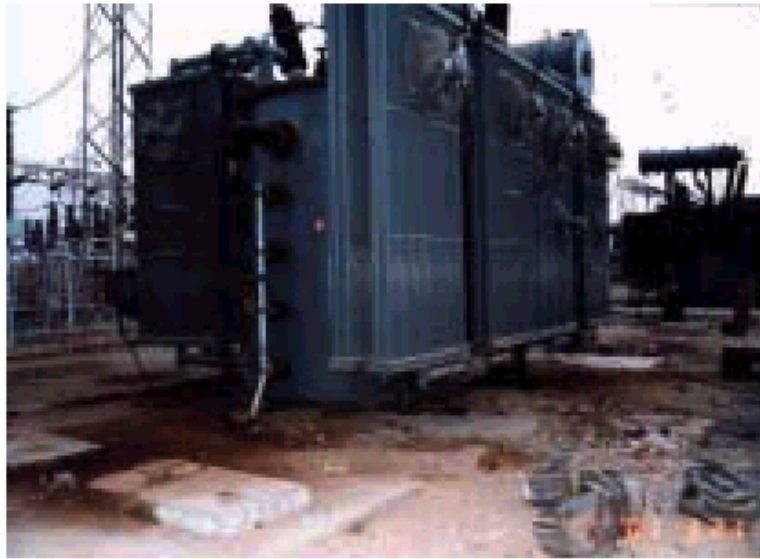
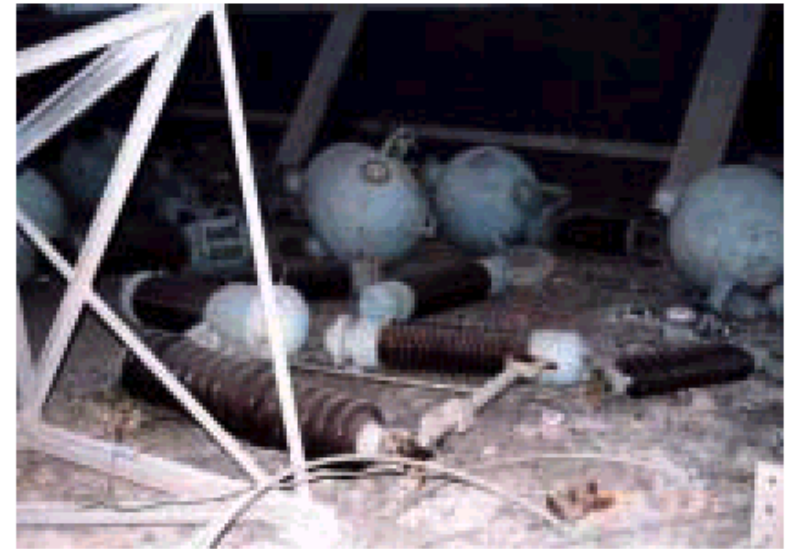
Figure 20 Displaced transformers and damaged breakers at Anjar sub-station

In the Anjar 220 KV substation, the communications system and power protection system had failed when the battery rack collapsed. They could not enter the control building because of concerns about collapse of the roof. The unanchored control panels inside did not topple. In the yard, all transformers derailed, some bushings broke (Figure 20). Four circuit breakers had failed porcelain insulators (Figure 20). The first major substation was brought back online on 1/29 in Bhuj (132 kV), and the first 220 kV substation brought back on line in Anjar on 1/30. As of 2/5, an estimated 80% of the region's power had been restored.

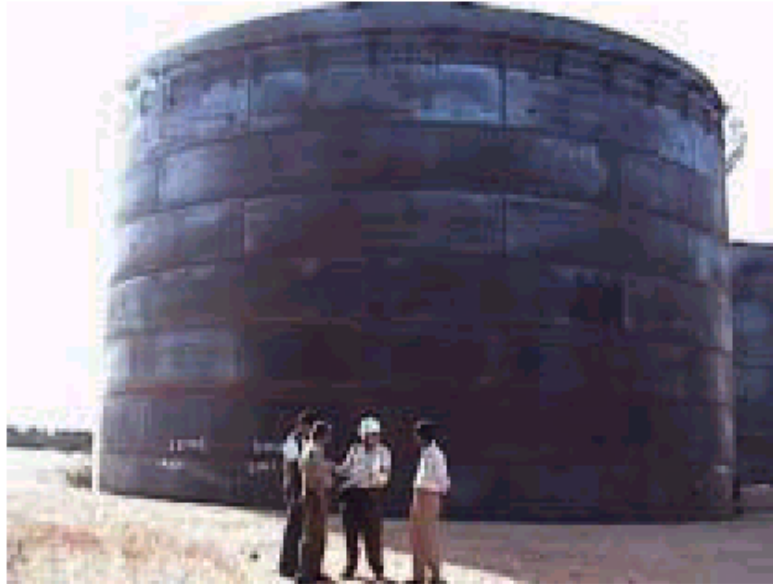
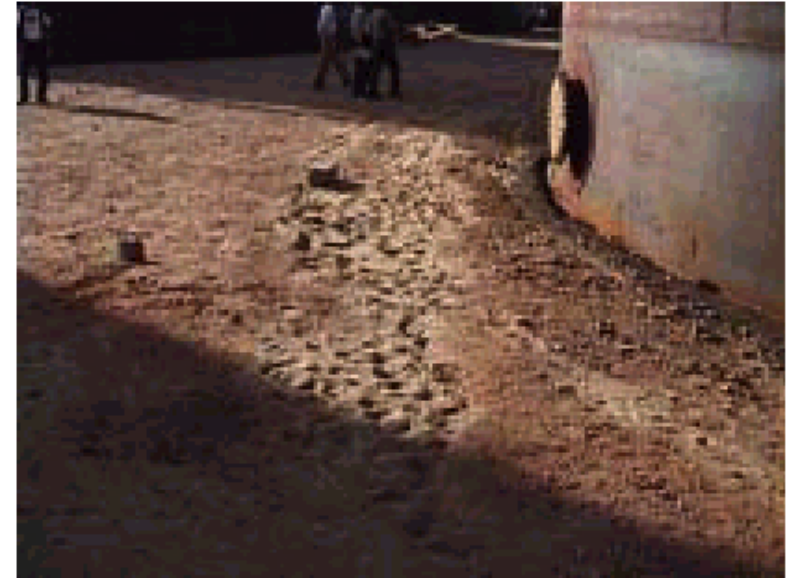
Figure 21 Tilted and damaged tanks at the Friends Tank Farm

Two tanks were heavily tilted and connections of valves to pipelines were damaged due to tilting and sinking of the tanks (Figure 21). It seems that the tilting and sinking were due to foundation failure associated with the base soil. Considering the bulging and motion of the ground, it seems that the ground moved in the direction of S40W-S50W. Besides the two heavily tilted tanks, some differential settlements, tilting and sinking of the tanks were observed in the newly reclaimed tank yard. In oil tank yard, which was built for more than 20 years ago, the settlement of the ground was not observed.

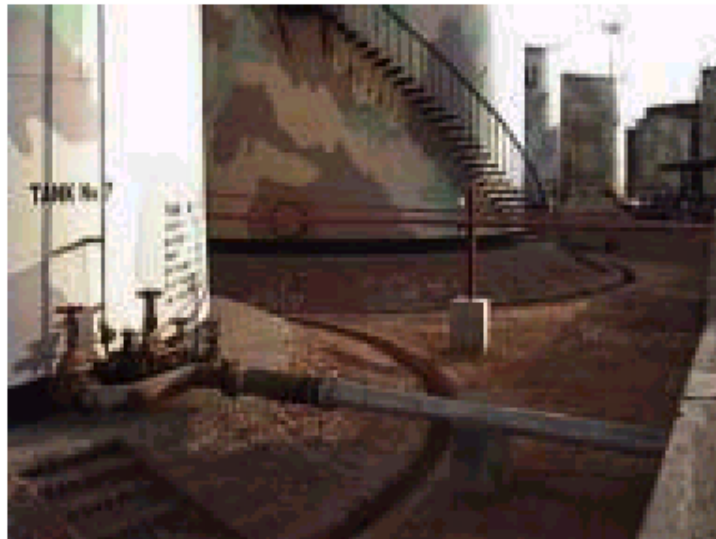
(a) Damaged Tanks at Oil India

Most of tanks were non-damaged in the Tank farm of Oil India (Figure 22(a)). Nevertheless, some oil tanks were buckled or tilted. Some of damage to tanks was due to the liquefaction of the foundation soil. There were 6 steel tanks with a conical fixed roof. No damage to tanks was observed although it was very close to the epicenter of the earthquake (Figure 22(b)). The tanks had 2m thick concrete basement. The buildings in this complex, however, were heavily damaged. One of storehouses was completely collapsed while the roofs of other storehouses were partially collapsed.

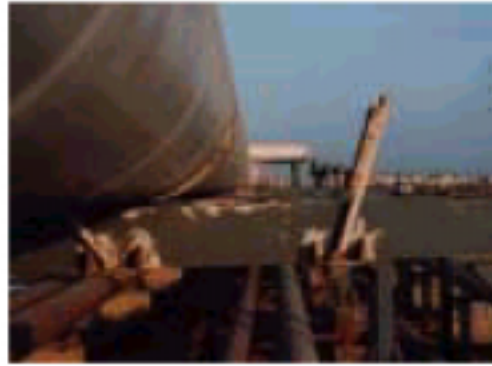
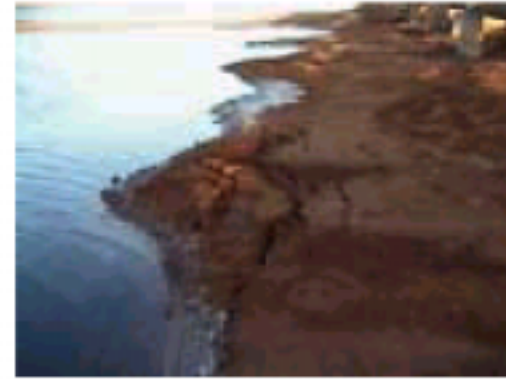
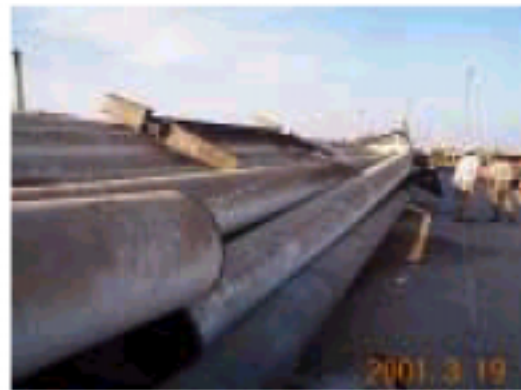
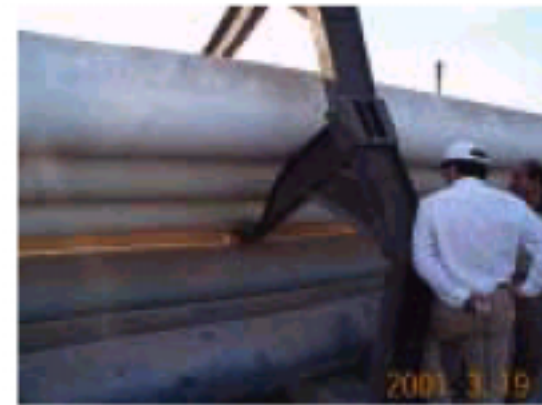
Figure 23 Damage to pipelines

Product pipelines from Vadinar to Kandla & Kandla to Bhatinda were shutdown. The pipe racks made of steel and were bent or buckled in the vicinity of the port. There was no breakage of the pipelines at any location although they were displaced from their original locations. The steel stripe type fixtures were either broken or separated from their welding locations (Figure 23(a)). The pipes were displaced both laterally 30cm and longitudinally 40cm. The direction of movement was NE towards the epicenter. The liquefaction and lateral movement of the ground was observed at the base of pipelines as shown in Figure 23(b). Crude oil pipelines from Salaya, feeding Koyali/Mathura/Panipat refineries resumed operations since 27th Jan after due checking. The oil pipelines from the Kandla Port were severely damaged (Figure 23(c)). The pipelines are supported by the two layer steel frames and each frame supports three pipelines (Figure 23(d)). Two of them were filled with oil during earthquake. The pipelines are running to the NS direction and the south ends are curved to the west direction. Because the ground motion of the NS direction was dominant and the shaking modes were different for the three parallel pipelines, which have different curvatures, the steel frames were buckled and collapsed with the pipelines.

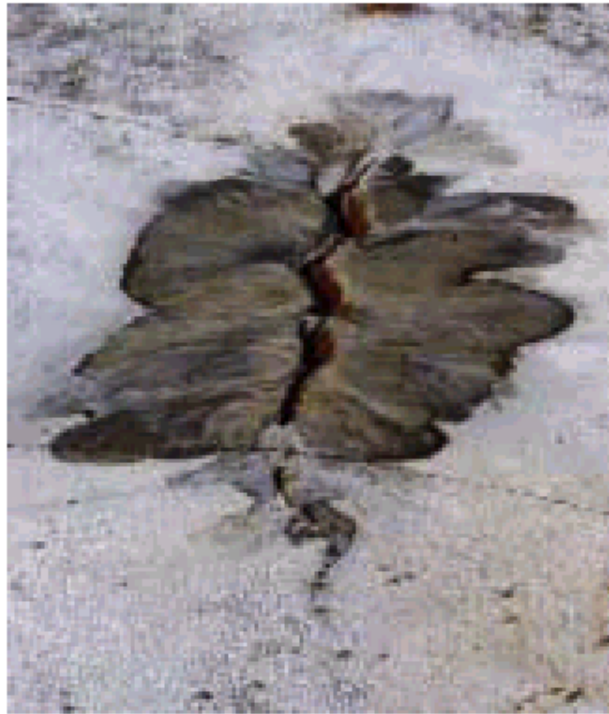
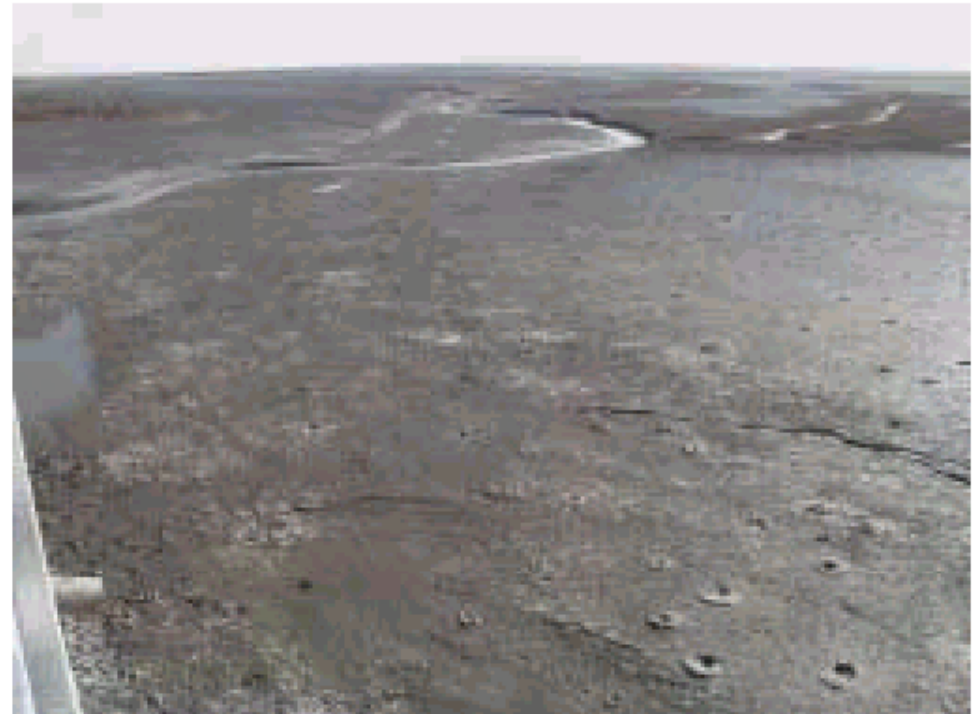
Figure 24 Some examples of liquefaction

Widespread liquefaction was observed in the Rann of Kutch, the Little Rann of Kutch as well as the coastal areas of the Gulf in the vicinity of Ghandidham, Kandla, and between Malya and Samakhiali. Liquefaction was widespread particularly along the seashore, riverbeds, ponds and marshland and salt playas. The liquefaction has manifested along long fissures and at many places it is of vent type (Figure 24(a)). This phenomenon was responsible for failure of some embankments in the mesoseismal area. In the coastal areas and dam reservoirs evidences of lateral spreading were also observed. Some embankment failures and traces of liquefaction and lateral spreading of ground were observed at distances more than 100km from the epicenter such as nearby the Bridge over Malia Creek and Kadhan in Pakistan.

The bridge was severely damaged due to the liquefaction and its induced ground displacement. Numerous sand vents could be observed on the river bed in the neighborhood of the bridge as shown in Figure 24(b). The evidences of liquefaction-induced ground displacement were found on the riverbed. And the concrete piers with caisson foundations moved toward the river center due to the ground displacement as shown. The bridge also suffered considerable subsidence of foundations caused by liquefaction and the transportation function was lost after the earthquake.

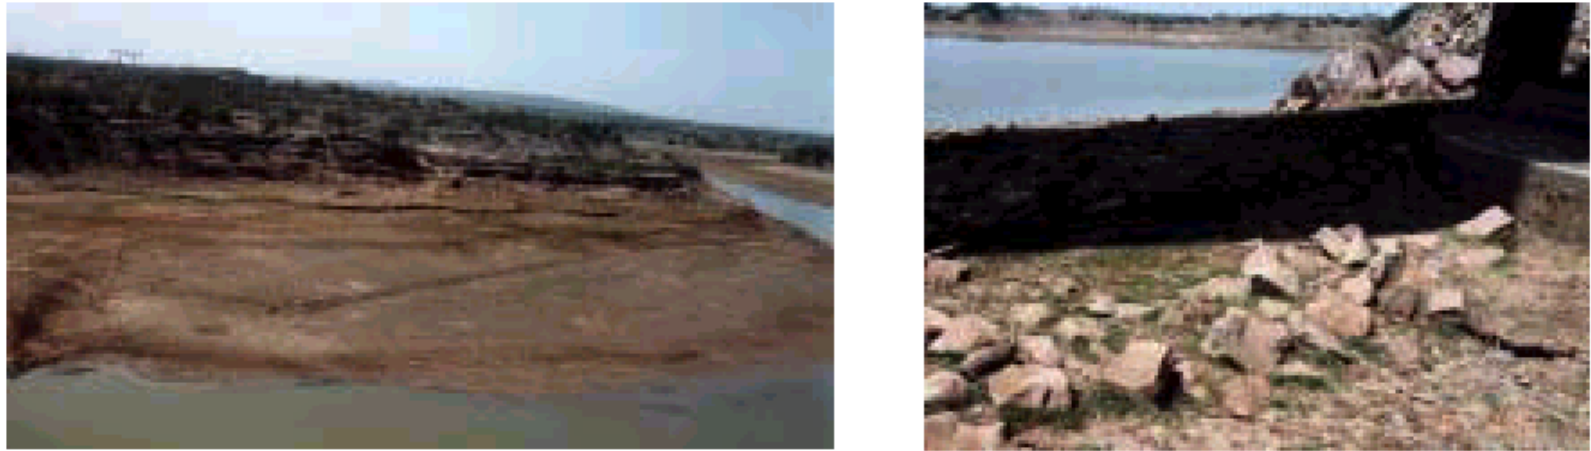
Figure 26 Settlement and lateral spreading in the vicinity of Rudramata Bridge

Wide spread lateral spreading of ground was observed at both sides of the valley of the Rudramata Bridge. The soil at both sides of the settled and spread towards the center of the valley. Cracks run along the longitudinal axis of the valley. The crack on the south embankment was mistakenly interpreted as the fault break. The crack is due to the lateral spreading of the ground (Figure 26).

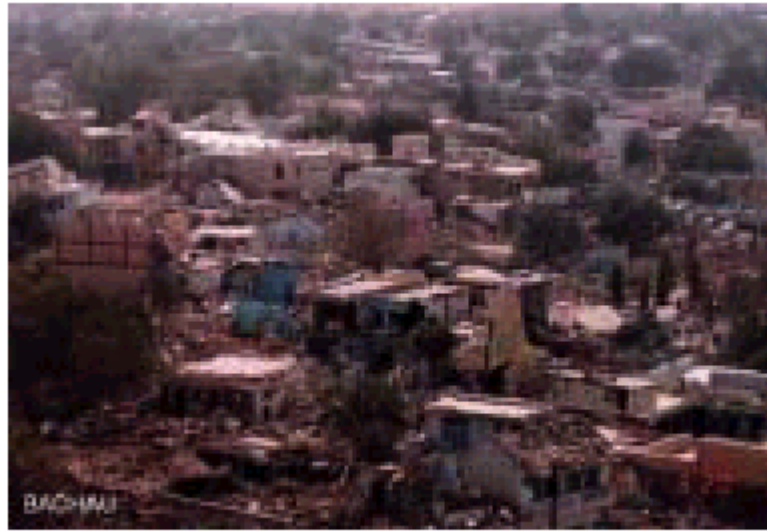
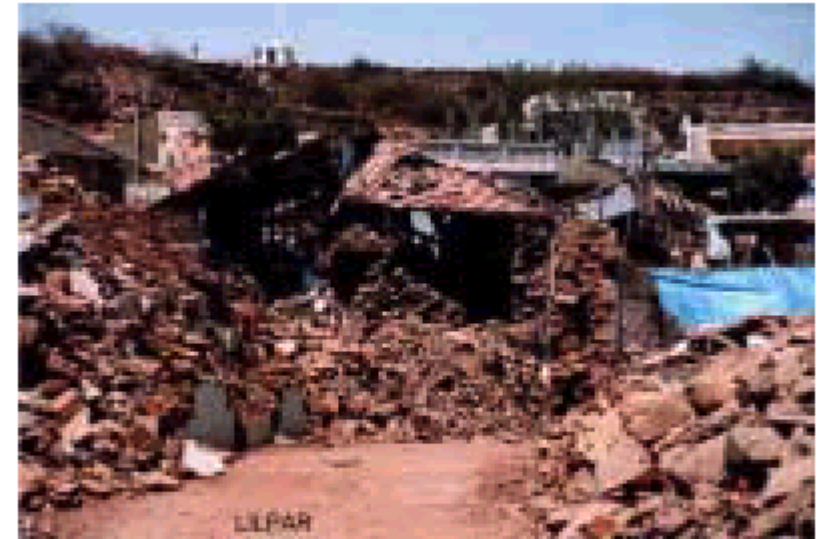
Figure 28 Examples of damage to masonry buildings in Bachau and Lilpar

Most of dwellings made of mud mortar either totally collapsed or heavily damaged. The damage rate was quite high near the epicentral area, particularly, Bachau, Anjar, Lilpar, Chobari, Ratnal and the old city of Bhuj within the fort. Figure 28 show several examples of the heavy damage to masonry structures with mud mortar. On the other hand, if masonry buildings are constructed using mortar is lime or cement mortar, they performed much better and the total collapses were much less as seen in the same figure. Most of the standing masonry buildings in the pictures are such structures. Especially, the use of cement mortar together with well-spaced concrete slabs improved the integrity of the buildings.

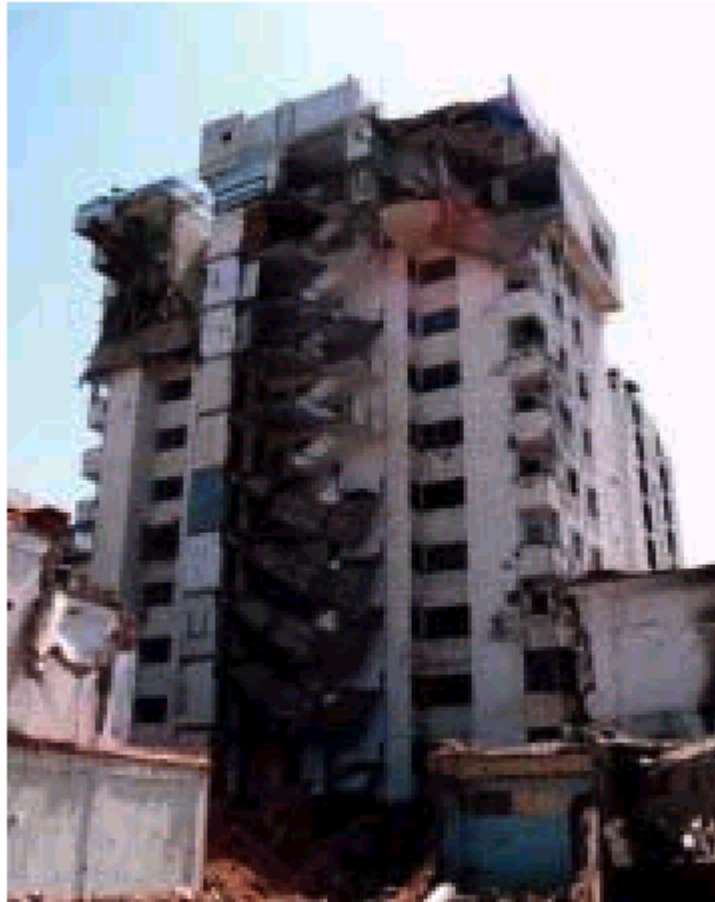
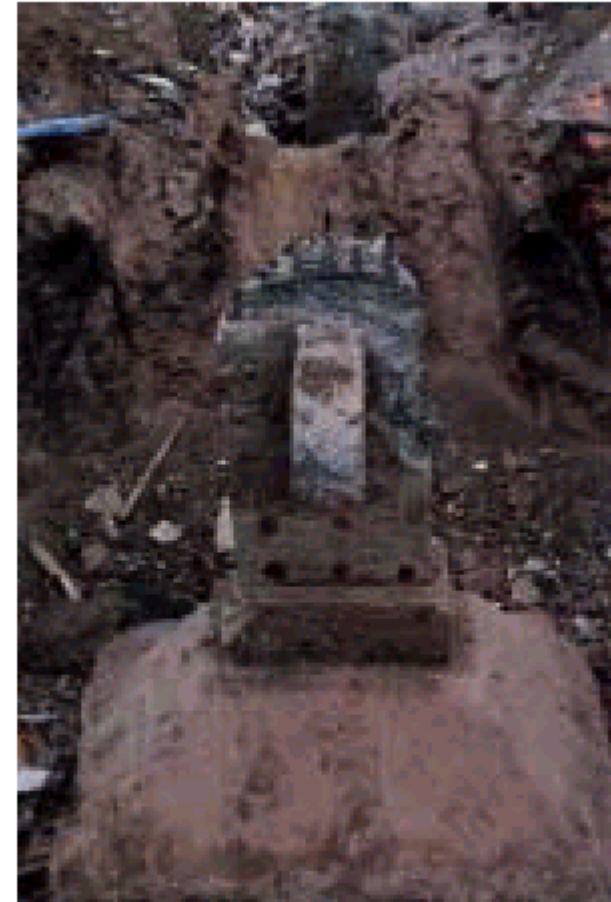
Figure 29 Partially collapsed Mansi Apartment Complex in Ahmedabad and its footing

Among the cities affected in the area are, Many modern reinforced concrete multi-story buildings collapsed in two densely populated metropolitan cities of Ahmedabad and Gandhidham. Among the multi-story buildings that collapsed, most had the ground story left open for parking convenience with few or no filler walls between the columns. Most buildings with complete infills in the ground story have withstood the earthquake without collapse. Some of causes of damage to reinforced concrete buildings in Ahmedabad City (210km away from the USGS epicenter) as well as in other cities and towns are as follows (Figures 29 & 30):

- a) Long duration of shaking (about 90 seconds)
- b) Damage was concentrated to areas that the land was re-claimed and buildings were new
- c) The number of stories of buildings ranged between 4 and 5.
- d) The top soil was sandy clay with sand soil below,
- e) Collapsed buildings had isolated footings and the footings were not connected to each with lateral tie beams.
- f) Constructors did not follow the earthquake design code
- g) Collapsed buildings were mostly pivot type and no shear walls at ground floor
- h) Ground amplification due to geological structures such as in Anjar and Ahmedabad
- i) Poor workmanship
- j) Rusting of steel bars due to the use of saline sand and gravel

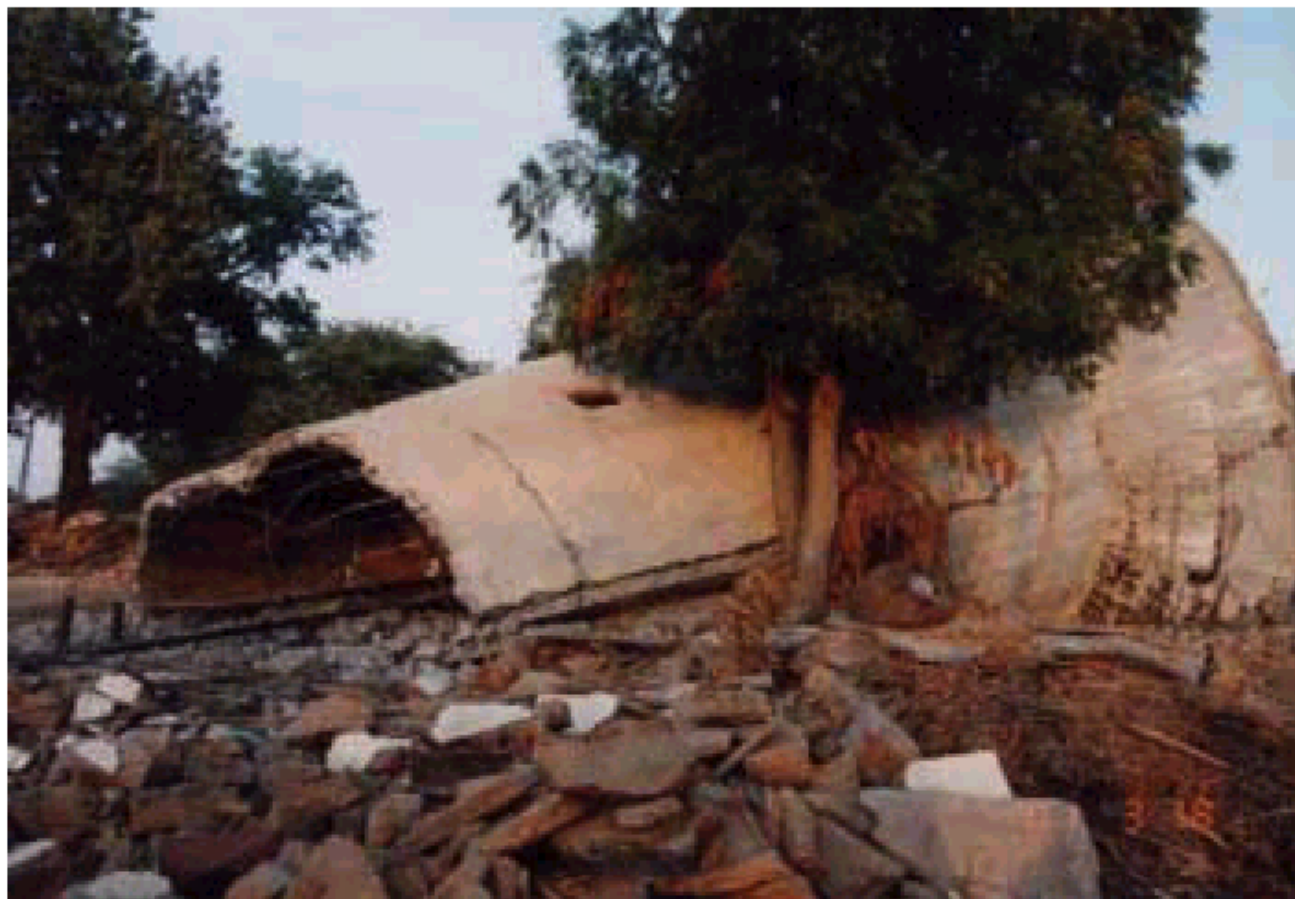
Figure 30 Collapsed water tank in Chobari village

Many of the systems have elevated concrete storage tanks that are on the order of 30m high (Figure 31). Most of the water tanks, which are elevated, did not suffer any substantial damage although severe damage could be observed at nearby buildings and structures. The water tank at Chobari village was toppled (Figure 32). The water tower was fallen in the direction of S30E. The location is $23^{\circ} 31' 22''\text{N}; 70^{\circ} 20' 64''\text{E}$. The water tank in Bachau town also survived the earthquake. The water tank in Anjar was an RC structure with four piers and built in 1955 with a capacity of 20000 gallons. It seems that there is more 250 water tanks in the region. However, 5 elevated tanks failed in the Malya-Morbi region south of the Gulf of Kutch. All the tanks are designed in the same state office. However, it is unclear why the failures in the Malya-Morbi area would have occurred and this deserves further investigation.
