LAS COLINAS LANDSLIDE CAUSED BY THE JANUARY 13, 2001 OFF THE COAST OF EL SALVADOR EARTHQUAKE

ABSTRACT: El Salvador was struck by two devastating earthquakes within a month. The first quake of Jan. 13, 2001, which was centered off El Salvador's southern coast, damaged and/or destroyed nearly 108,000 houses, and killed at least 944 people, including hundreds of residents buried in a huge amount of soil slipped down Las Colinas mountainside in the city of Neuva San Salvador (Santa Tecla). This report outlines the findings obtained through the reconnaissance by the JSCE team and laboratory tests that followed it.

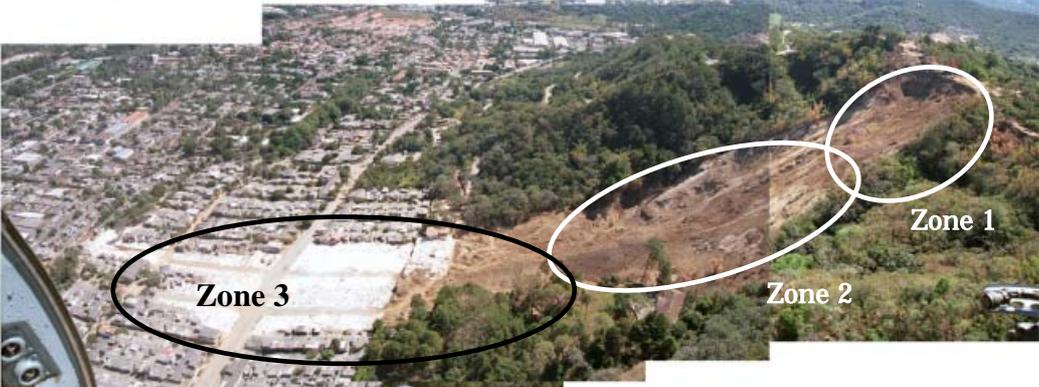
A mountain ridge called El Balsamo rises south behind the city, and the slope failure took place in its northern side (Fig. 1). Other small landslides and cracks are also found along the mountain ridge. Just behind the top scar is a flat area slightly slanting southwards, and there were two unfinished brick houses, which were supposed to become a school. A coffee plantation spreads along the ridge keeping the soil moistened in places.

Fig. 1. Bird's eyes view of the Las Colinas landslide

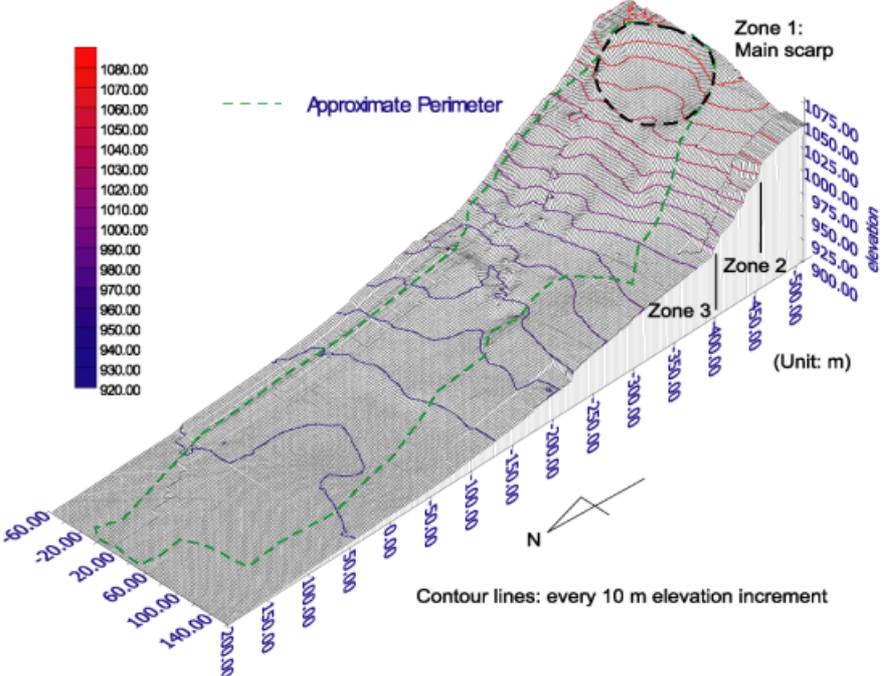
Fig. 2. Surveyed Slope plotted with surfer with green dashed perimeter.

The Las Colinas sliding surface was surveyed with a laser based theodolite (Laser Ace 300), connected to a portable computer. The theodolite has a built-in digital compass, and with its laser beam, it calculates the azimuth, dip angle, and horizontal distance to a point. The exposed failure surface can be roughly divided into three zones (**Fig. 2**). The uppermost zone (**Zone 1**) is a hollow of about 100m in diameter, which was caved in some 20-30 m from the original ground surface. South beyond the hollow, there appears a steepest slope (**Zone 2**), which becomes gradually gentle as it comes close to the toe. In **Zone 3**, the slid soil mass and flushed houses had been removed already, and the cleared area was totally white with disinfectant (see **Fig. 1**).

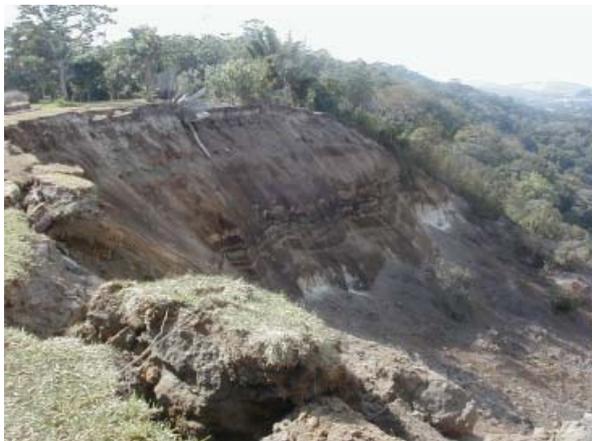
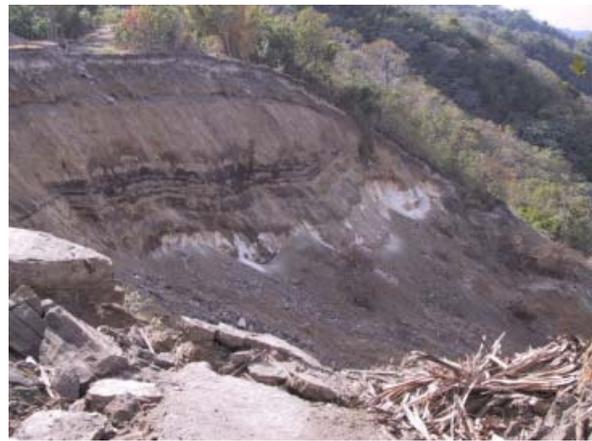
Two photos (**Fig. 3**) of the same soil layers appearing on the west half of the uppermost scarp were taken on January 14 and February 4, respectively. Dark and blight colored stripes appearing on the scarp shows a stratified soil profile with the top lapilli tuff layer of about 2.0 m thickness overlying a pair of two differently colored (ocher and white) pumice layers of about 11.9m thickness. Some bedding planes separate the lapilli tuff into some sub-layers of varying thickness (10cm to 25cm). Dark brown color of soil indicates that the soil is moistened, and this pair of photos shows that the dark colored stripes were steadily thinning, in other words, exposed soils were drying. This fact may evidence that the intact soils along the slip surface were wet before the event. Beneath the dark and wet soils, there appear white and/or ocher colored pumice soils. They were also moistened and weakly cemented. The pumice is easily broken into small pieces or into powder just by rubbing together with fingers. Broken fragments of this pumice have sub-angular or angular shapes. Some pieces were medium-sized (1 mm × 4 mm × 7 mm for example) and some were fairly large reaching 12 mm × 25 mm × 35 mm (**Fig. 4**). As shown in **Fig. 5**, cracks and joints were observed even on an intact part of pumice.

Fig. 3. West slope of main scarp

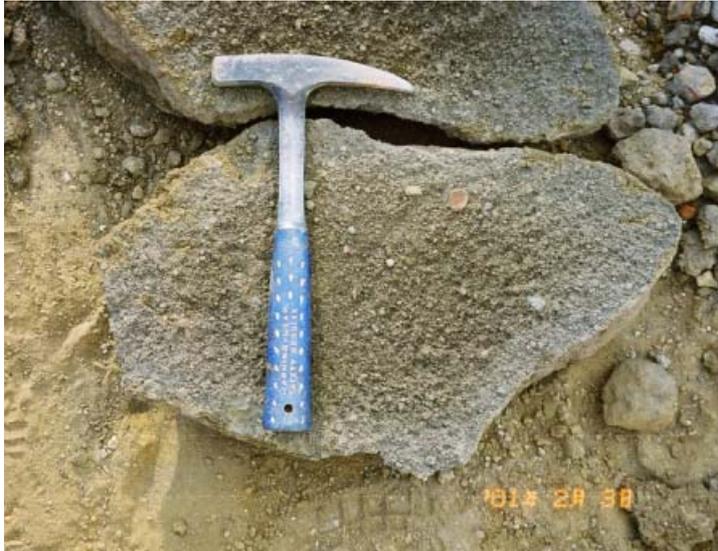
Fig. 4 A piece of lapilli tuff

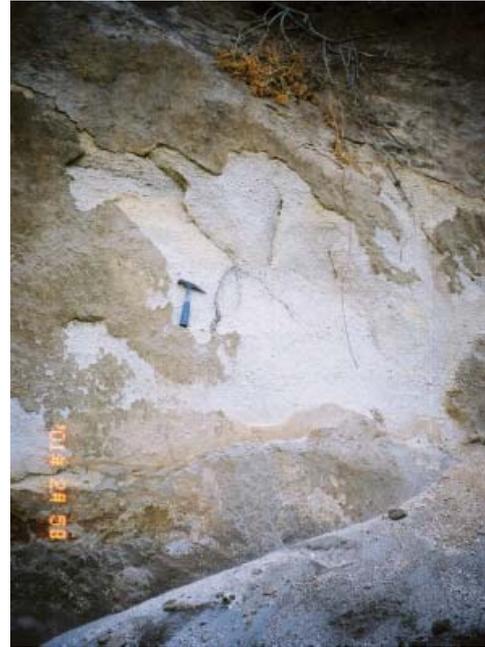
Fig. 5. Cracks and joints on the exposed intact pumice

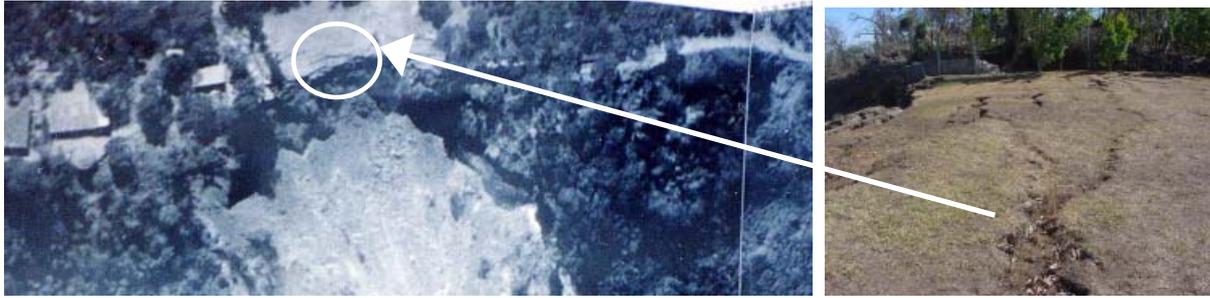
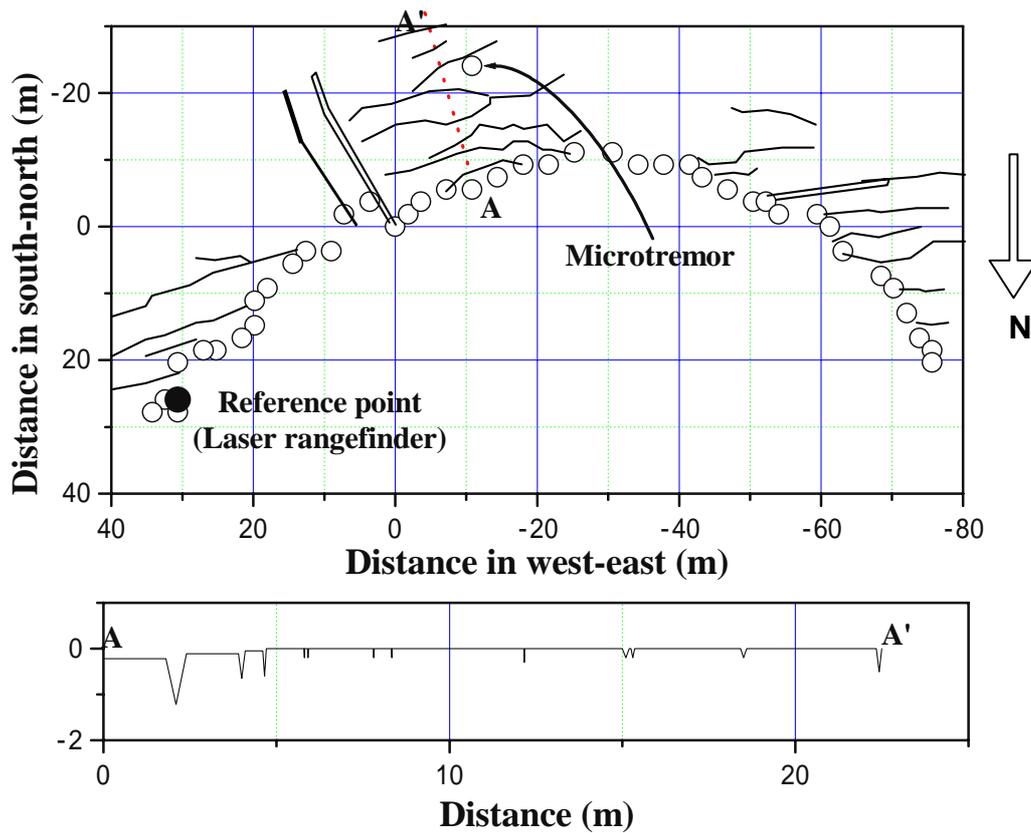
Fig. 6. Perimeter of scar, Las Colinas Landslide

Total 43 points were marked along the perimeter of the scar using a GPS receiver (**Fig. 6, next page**). Behind the scar, there were extensive cracks running in almost west-east (See **photos in Fig. 6**). Crack openings (12 visible cracks; **Table 3.2.1** and **Figure 6**) were measured along Line A-A'. Total 1.25 m's opening was reached over the 22 m's distance of Line A-A'. Namely, about 5% average strain was induced within the soil behind the scar. Extensive cracks were found along the ridge crest even in areas that did not slide (see **Fig. 14**); the cracks can certainly cause further slides.

Cracks appearing on the top terrace behind the scar (**Zone 1**): Cracks map is shown below.

Extensive cracks remaining along El Balsamo ridge are certainly the serious threat of further slides. The city of Santa Tecla was controlling the potential hazard zones, the red zone with the highest risk and the yellow zone of slightly less danger. A week after the earthquake, the number of residents evacuated from the zones exposed to the menace of possible landslides reached 14,000, and as of Feb. 3, about 4,000 refugees were still being forced to live in tents. Since the rainy season starts in April or May, necessary countermeasures should be taken because even flat-lying areas away from sudden

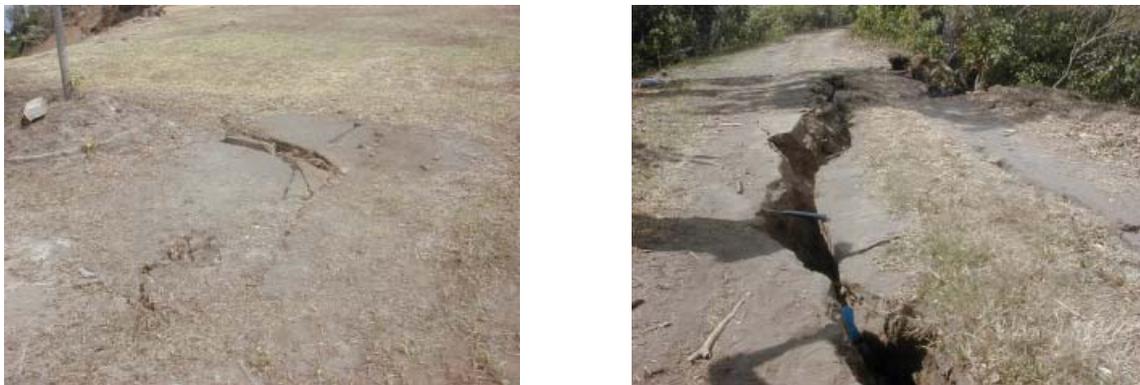
Fig. 7. Crack at the top terrace (photographed on Jan. 14 by Mr. Jose Antonio Rivas)

A pair of photos (**Fig. 7** by Jose Antonio Riva, Geotérmica Salvadoreña) was taken on January 14, a day after the earthquake. Both pictures show that edges of cracks were lightly dusted with fine sand. This fact may evidence that the landslide caused some soils to liquefy though the underground water level did not seem to be substantially high from the field observation. There was no written material available showing the possible underground water level.

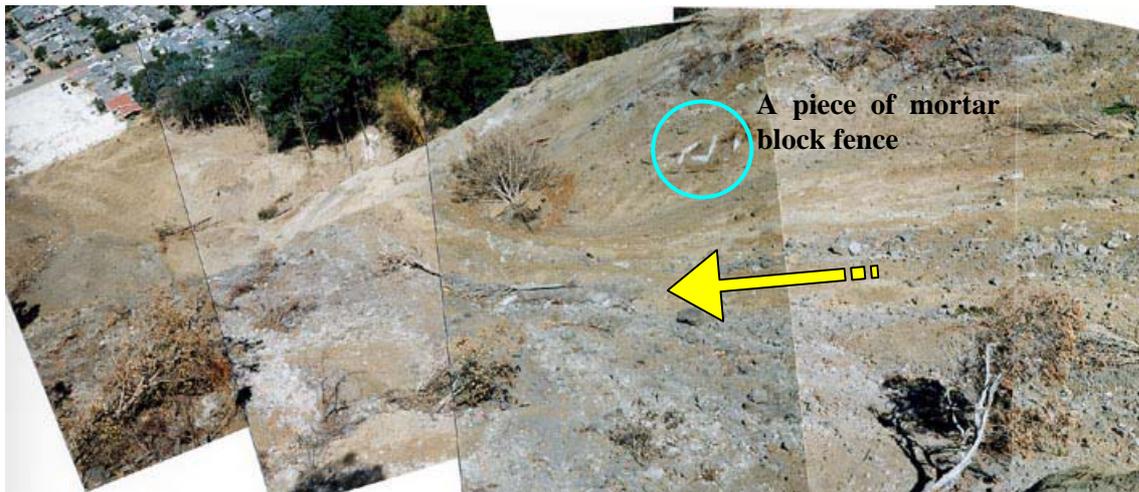
There are some downward streaks remaining on the bottom of the upper hollow (arrow in **Fig. 8**), and broken pieces of a mortar-block fence were caught on the soil mass remaining on the outer edge of the hollow (arrow in **Fig. 9**). These may evidence that most soil mass, which originally fitted into the hollow, seems to have been pushed forward, and flown down the lower steep slope. Along the streaks, a number of broken pieces of lapilli tuff and some uprooted trees were found. The largest piece of the lapilli tuff remaining there was 88 cm×64 cm×14 cm.

Fig. 8. Lower part of the hollow: A piece of mortar block fence (within the circle) is caught on the small amount of the soil mass stopped at the lower edge of the hollow.

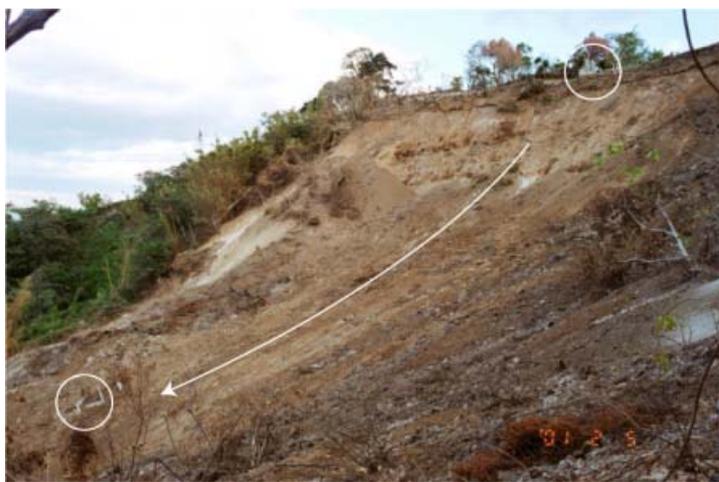
Fig. 9. Fallen block fence

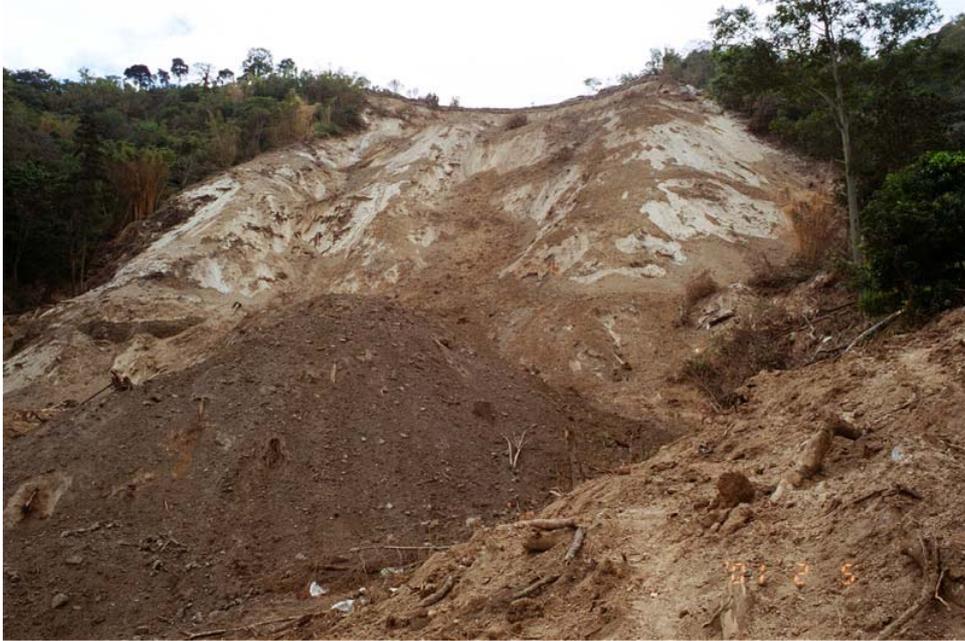
Fig. 10 shows the lapilli tuff exposed on the lower steep slope (**Zone 2**). This surface exhibits an arrangement of volcanic products in strata of varying thickness (7 to 30 cm) and about general 10 degrees dip toward the toe of the slope.

Fig. 10. Steep slope (**Zone 2**)

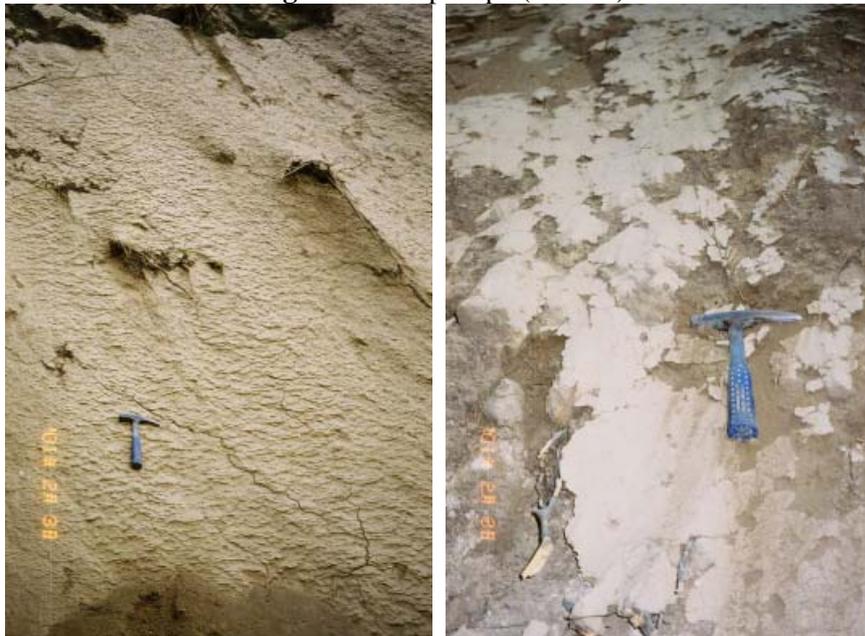
As shown in **Fig. 11**, the steepest slope in **Zone 2** was covered thin with a film of mud including porous fragments of pumice; the film was noticeably stiff after totally dried up. The film covered trees, bamboo and other plants pushed down on the slope. This fact suggests that the original slope in **Zone 2** was not scraped off, and is consistent with the result from the 3D survey of the slope configuration. This fact also suggests that the bottom surface of the slid soil mass was wet, and may have liquefied (Sassa, 2000), possibly related to some weak tephra layers spreading over less permeable paleosols.

Fig. 11. Thin mud film

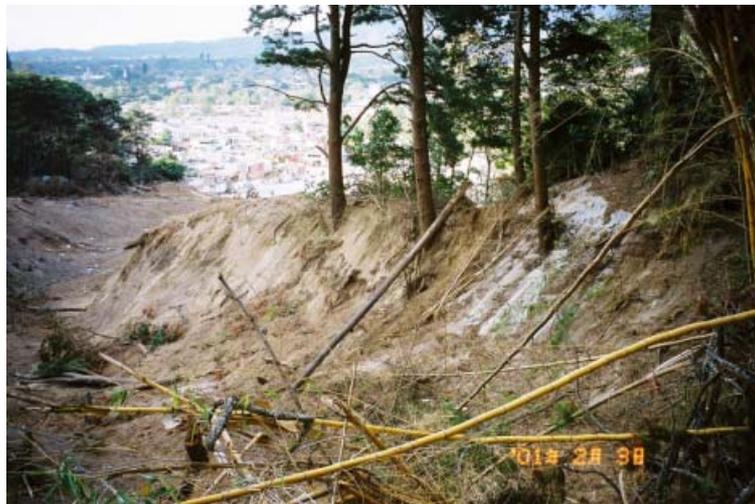
The slid soil mass seems to have surged across a small ravine coming down from east mountainside, and splashed up a small bank. Some splashes were remaining 6-8 m high on some tree trunks on this bank (Fig. 12). The huge amount of slid soil mass flooded many houses and thus caused more than 500 deaths. A complete view of Zone 3 was taken from the toe of the exposed slip surface (Fig. 13a). The slid soil mass and destroyed houses had been removed, and the cleared area was totally white with disinfectant.

Fig. 12. Photos from the toe of the slope

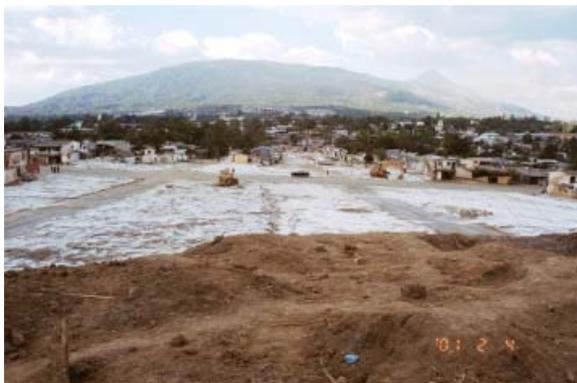
(a) Complete view of **Zone 3**
(Feb. 4, 2001)

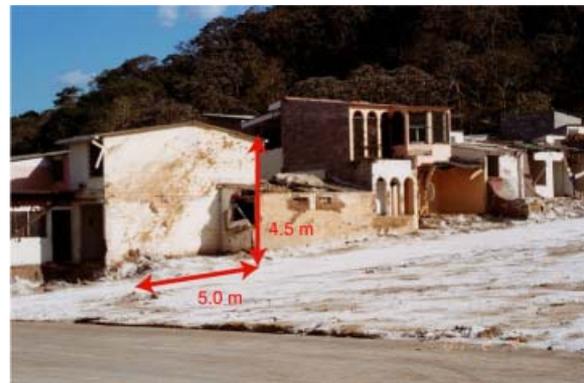
There were many splashes of mud remaining on house walls, trees and etc. In general, the splashes seem to be higher at around the toe of the slope than those in the middle or close to the distal end of the soil deposition zone. The highest splash of about 8 m was found on a trunk near the toe. Fig. 13b shows the walls of a dwelling on the eastside perimeter of the slid soil mass, the wall spotting in parabola with mud splashes. The parabola with its peak of about 4.5m high drops downward, and reaches the ground after about a 5m horizontal run. This fact suggests that the time t needed for the splashes to reach the ground from their peak height $\Delta h (= 4.5 \text{ m})$ was about 1s ($\Delta h = g \cdot t^2 / 2$), and during this time, the splashes ran about the 5m horizontal distance (5 m/s). The main stream of the soil mass flow might have faster than this speed after running through dwellings standing close together.

(b) House wall spotting with splashes

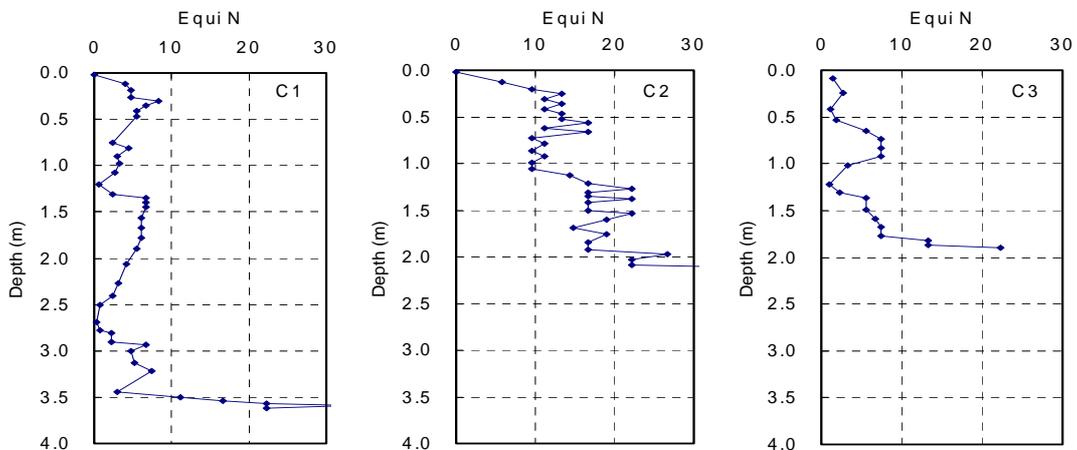
Variations with depth of the equivalent N_s -values at the three points are shown in **Figure 15**. As contrasted with other points, all equivalent N_s -values at Point C1 are considerably low as a whole. Among them, extremely low values reaching zero were found at about 1.2m and 2.5m depths. These two small N_s values suggest the presence of two weak layers, which can be the pumice and/or fragmental volcanic products judging from their depths.

Fig. 15. Equivalent N_s -values at three sites:
 $N_s = N_d / 1.5$, where N_d is the number of blows when the penetration depth of 10 cm is reached.

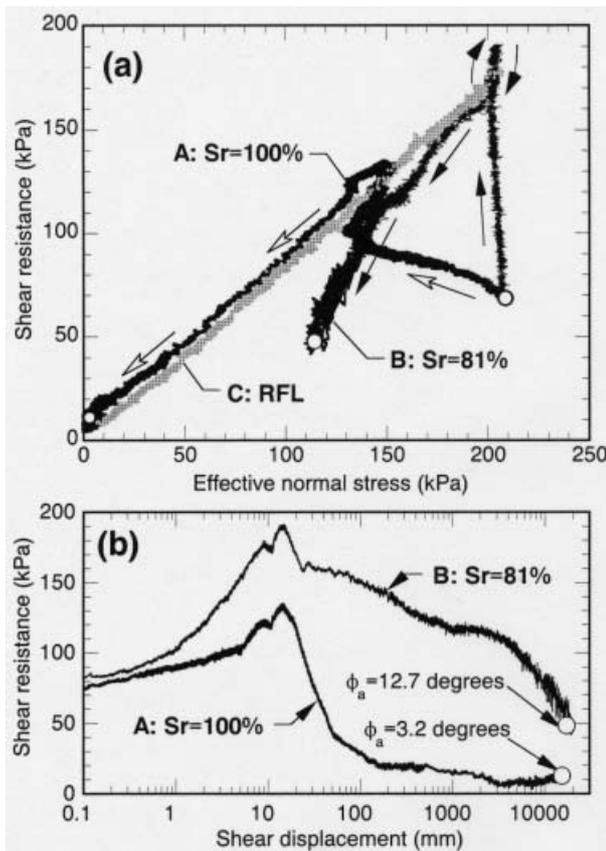
Fig. 19. Ring shear test results

Fig. 19a shows the effective stress paths for the performed two tests (arrow signs with open triangle heads for **TEST A** and solid ones for **TEST B**). As soon as the shearing of the sample started in **TEST A** ($S_r=100\%$), there appeared an excessive pore pressure buildup, which was then followed by dilation of the pumice. When the residual failure line (RFL) was reached, a sudden decrease of apparent friction angle along the RFL was observed. The drop of the shear resistance is also plotted in **Fig. 19b** with respect to the increasing shear displacement. When the twisted pumice sample had slipped 20m distance, the apparent friction angle of about 3.2 degrees was reached, the fact suggesting that a sliding-surface liquefaction occurred in the saturated soil sample (Sassa, 1996). The average slope gradient, however, was measured to be about 13 degrees over the entire travel distance, much higher than 3.2 degrees reached in **TEST A**.

For this reason, **TEST B** was carried out for smaller value of S_r ($S_r = 81\%$). In this test, the stress path went almost straight up until the RFL was reached (**Figure 19a**), and then the apparent friction angle began dropping along RFL. The path, however, deviated from the RFL as it went further down, presumably because the sensor did not keep a good track of pore pressure of the unsaturated pumice sample. Finally the apparent friction angle of 12.7 degrees was reached, the angle closer to the slope gradient; the result indicates that the soil in situ was not completely saturated.
