RESEARCH AND PRACTICES ON REMEDIAL MEASURES FOR RIVER DIKES AGAINST SOIL LIQUEFACTION

Yasushi SASAKI¹, Seiji KANO², and Osamu MATSUO³

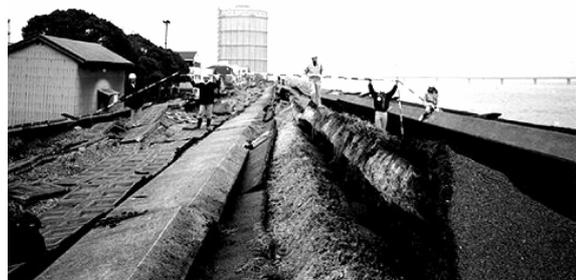
Figure 1 shows the Torishima section of the Yodo River dike just after the Kobe earthquake in 1995 (Matsuo 1996, Sasaki and Shimada 1997b). As shown in this figure, pavement at the crest was intensely inclined, the parapet wall and the concrete facing of the revetment also inclined, and traces of intense sand boiling were found near the dike.

The dike with an original height of 6.5 m settled down about 4 m at the most. The section was located near the river mouth and the hinterland was highly urbanized. There was

Fig. 1 Torishima section of the Yodo River dike damaged by the Kobe earthquake

concern about an inundation because the residual height of the dike was only 2 m higher than the maximum tidal water level.

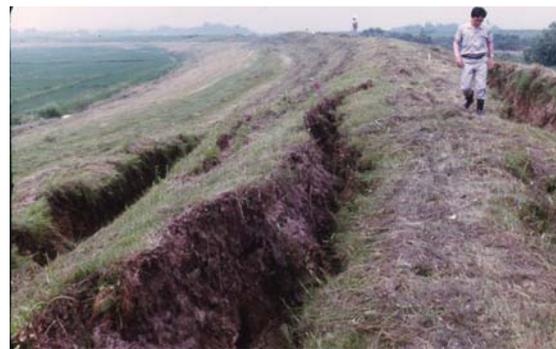
One of the most severely damaged sections was found at the Yoshida River, a branch of the Naruse River as shown in **Fig.3**. As seen in this figure, seismic damage to river dikes was generally composed of the settlement of the top crest accompanied by longitudinal fissures. But it is not so easy to get the accurate estimate of seismic settlement due to the lack of the data on measured elevations of the dike crests before the earthquake.

Fig.3 Damage of the Yoshida River dike due to the Miyagiken-oki earthquake

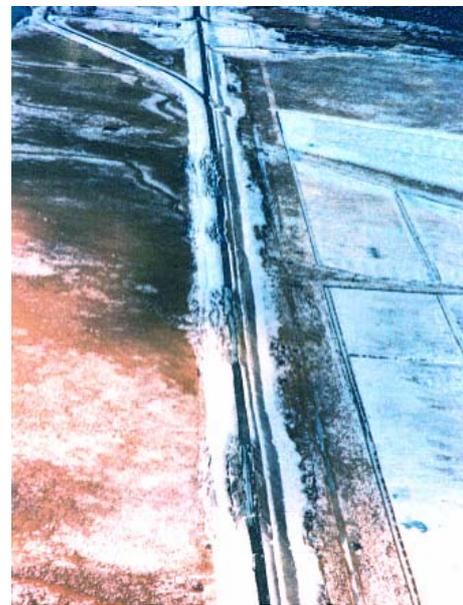
During the same earthquake, periodical occurrences of localized failure of embankments were seen in the Kushiro dike in spite of the homogeneous ground condition as shown in **Figs. 14 and 15**. **Figure 15** shows the subsidence and stretching distribution along the dike

Fig. 14 Periodical appearance of failures on the Kushiro River dike

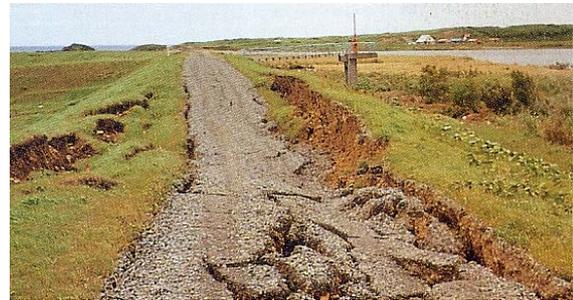
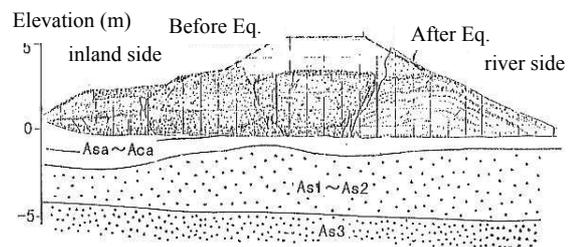
During the Hokkaido-nansei-oki earthquake in 1994, a stretching type of failure was clearly detected as shown in Fig. 17 at a damaged section of the Shiribeshi-Toshibetsu River dike (Sasaki et al. 1997a).

As Terzaghi et al. (1996) mentioned this type of failure is caused by the decrease of shear strength at the bottom boundary of the embankment due to the raised pore water pressure. When the shear resistance at the embankment bottom is lost, slippage takes place in the embankment as shown in the model dike in Fig. 18 (Sasaki and Ohbayashi 1997c). If this type of failure happens, longitudinal cracks and gaps may appear on top of the dike or on the surface of the side slope as shown in Fig. 19. It was shown elsewhere that this type of fissures may appear on the side slope near the shoulder at first (Sasaki et al. 1997a).

Fig. 17 Damage to the Shiribeshi-Toshibetsu dike

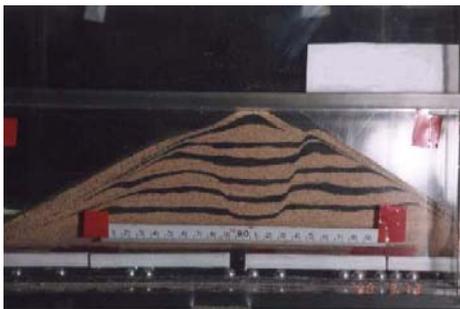
Fig. 18 Slip planes appeared inside embankment

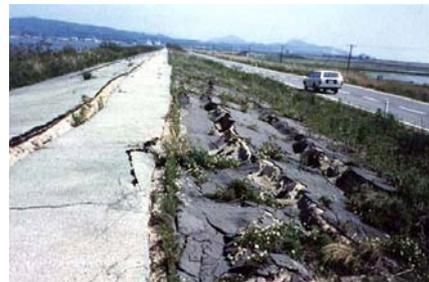
Fig. 19 Longitudinal fissures seen at the Hachirogata dike in 1983

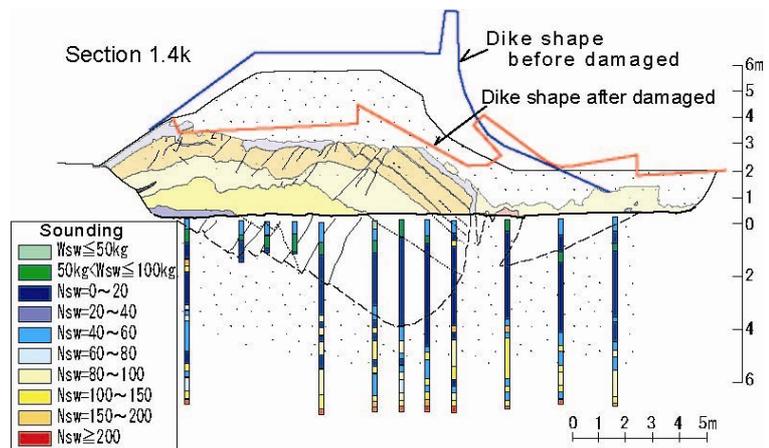
During the Kobe earthquake, a dike section of the Yodo River, named the Torishima section, was severely damaged (Matsuo 1996, Sasaki and Shimada 1997b) due to the soil liquefaction in the foundation ground as shown in Fig. 20 (Sasaki and Shimada 1997b). At this site, stretching of the embankment was also seen as shown in Fig. 20. Boundaries of the subsided embankment were surveyed by Swedish sounding and it was detected that the broken block of the dike body sank into the loose foundation layer as illustrated in this figure.

Fig. 20 Torishima section of the Yodo River dike

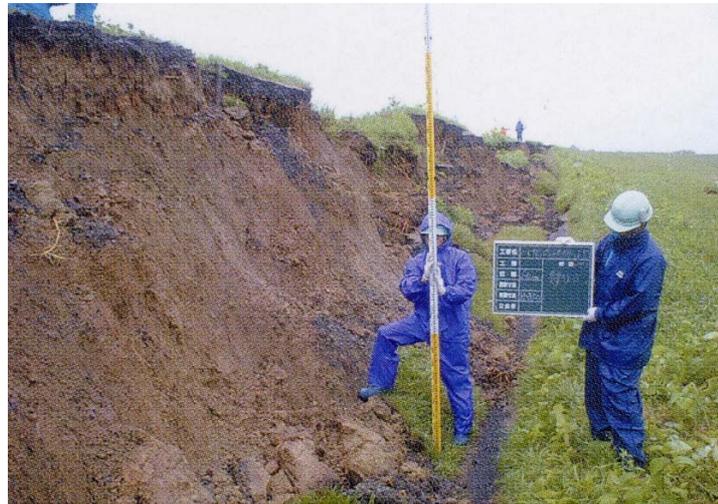
During the Miyagiken earthquake in 2003, the Naruse River dike was damaged at 66 locations. In general, the subsoil at heavily damaged dike sections is composed of alternating layers of soft clay and loose sand. **Figure 25** shows the failure at the Kimazuka section of the Naruse River.

Apparent sand boiling was not frequently observed near the damaged site and it was apparent that the embankment had high water content due to the preceding rainfall. It was detected that a sand vein was left in the embankment at the seriously damaged sites, while the dike were repaired. The deformed shape of the embankment, shown in the aerial photograph in **Fig. 26** (Kitakami River Office 2003), implies that the bulging type deformation of the dike was accompanied by slip failure.

Fig. 25 Large deformation of the Naruse River dike during the 2003 Miyagiken earthquake

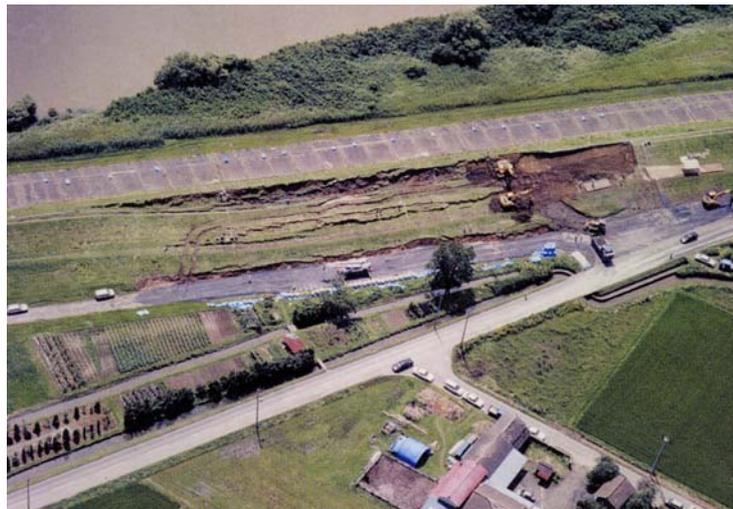
Fig. 26 Large deformation of embankment at the Kimazuka section of the Naruse River

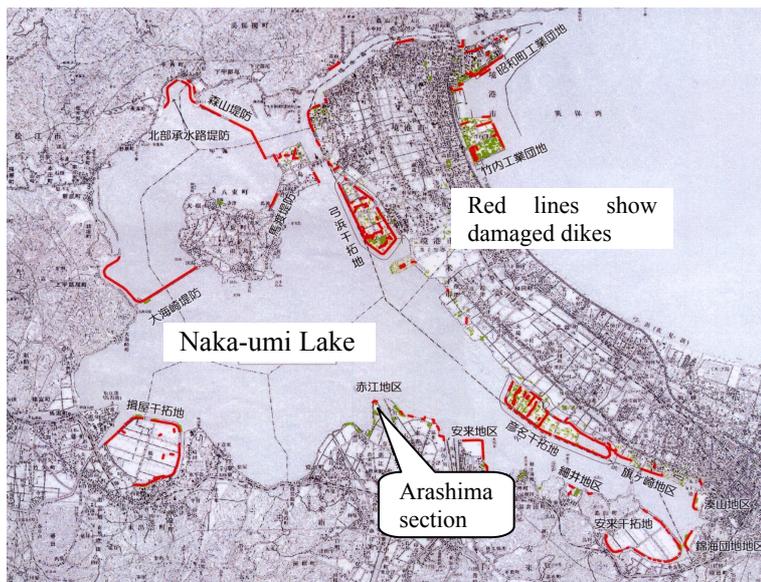
Most of these damaged sections were found on newly reclaimed land where the subsoil liquefied. Since the hinterland of these damaged sections is not so urbanized, an inexpensive remedial method was favored for the restoration work for the economical reasons. Most of the damaged sections were repaired by constructing a riprap mound counterweight at the waterfront

Fig.28 Damage to Naka-umi Lake shore dikes during the Tottoriken-seibu earthquake in 2000

Fig.30 Rehabilitation of the Naka-umi Lake shore dike by counter-weight fill

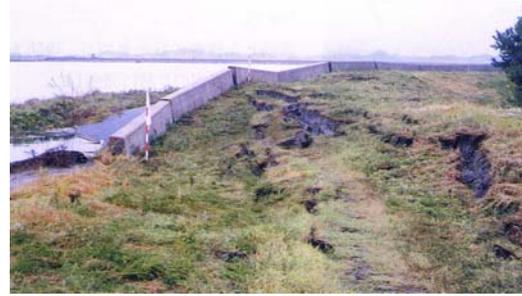
Fig.29 Kyuhin dike damaged during the Tottoriken-seibu earthquake in 2000

At some sections, soil improvement was conducted, and steel sheet piles or steel pipe piles were installed to increase the stability of the damaged dikes.

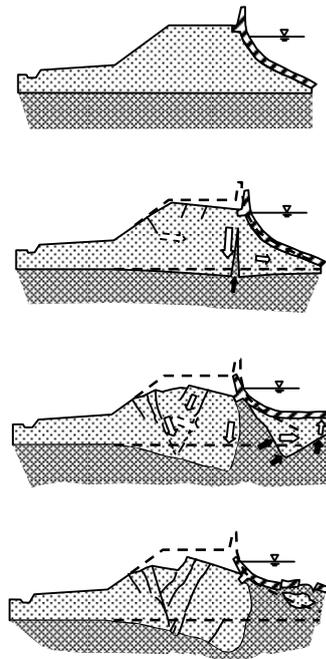
Fig.34 Deformation process of the Yodo River dike

Fig. 35 Remediation of the Torishima dike by DMM
