COUNTERMEASURE AGAINST GROUND FLOW FOR A ROAD BRIDGE (HANSHIN EXPRESSWAY)

ABSTRACT: Hanshin Expressway Public Corporation has struggled with the restoration and retrofit program for the foundations at Bay-shore Route since the 1995 Hyogoken-Nambu Earthquake. Damage to bored piles and their remediation work are overviewed here. Particularly some of the additional pile methods were discussed as one of the countermeasures against ground flow following the liquefaction.

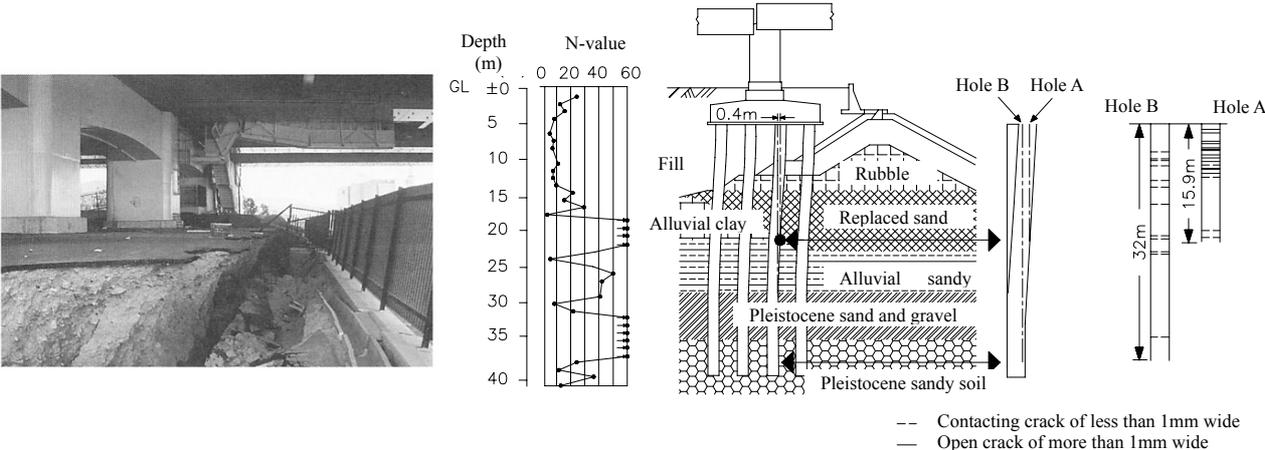
Ground near waterways markedly moved towards waterways accompanying with seawalls. As residual displacements of some bridge foundations exceeded 500 mm due to the ground flow, external forces on piles could be lager than those expected in the design codes that were effective at the time of earthquake. Figure 2 shows a typical example of damages to seawall and neighboring bridge foundation.

Fig.2 Example of damage to seawall and adjacent piles

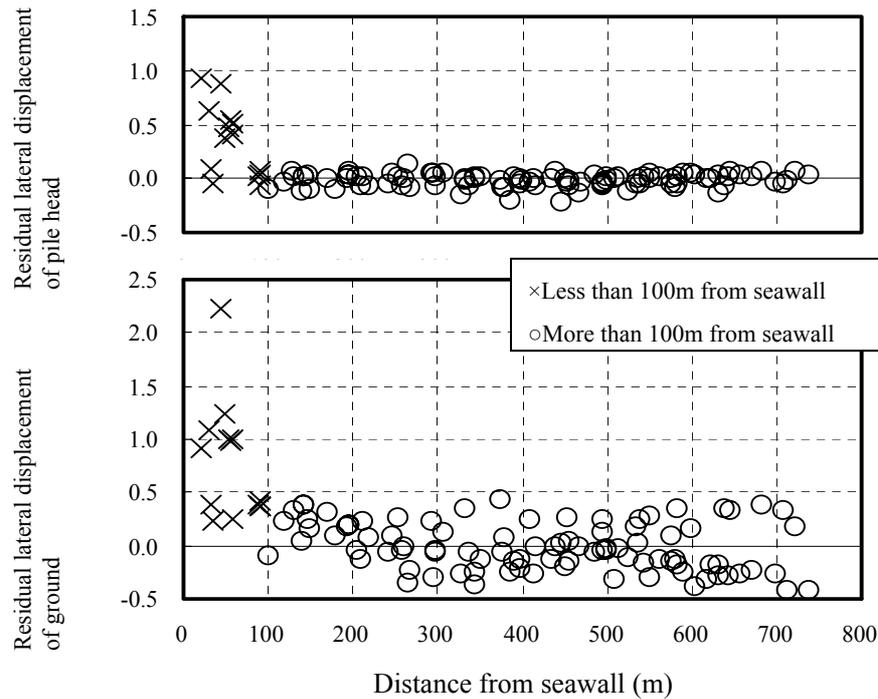
Figure 3 compares the liquefaction-induced residual lateral displacements of ground and pile head respectively versus the distance from the seawall. Lateral displacements of foundation are large within a distance of 100 m from seawall and reach about 1.0 m at the maximum. They are slight at more than 100 m far from the seawall. Lateral displacements of ground also reach more than 2 m within a distance of 100 m and less than 0.5 m at more than 100 m from the seawall. The influential distance of ground flow is, thus, estimated within about 100 m from the seawall. The design method for the lateral flow of foundation near the seawall was, then, revised in the present version of Specifications for Highway Bridges.

Fig.3 Lateral displacements of foundation/ground vs. distance from seawall

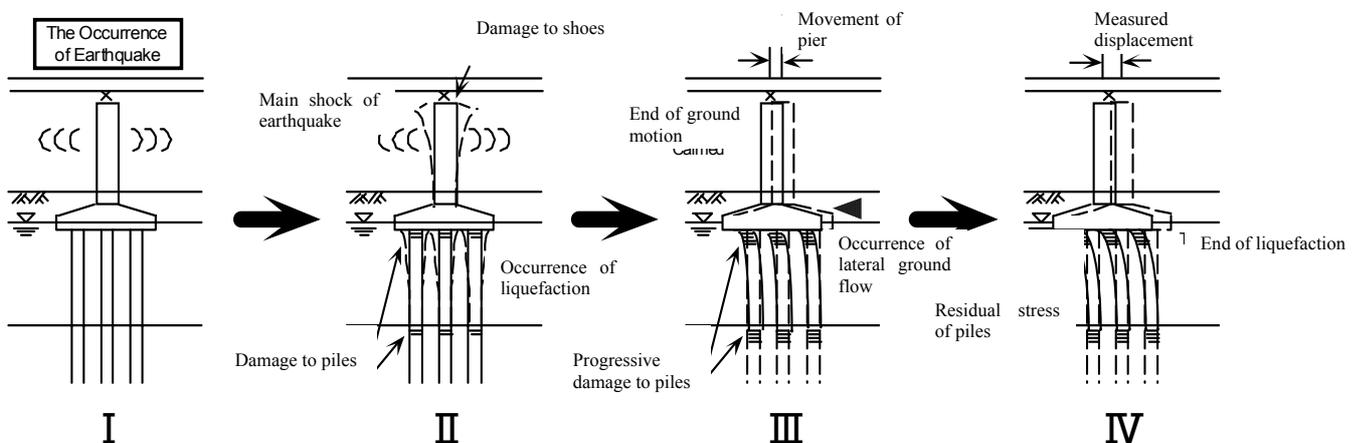
The mechanism of ground-flow-induced damage to structures was investigated prior to the design of restoration. As the result, damage mechanism consisting of the following four steps was estimated as shown in Figure 4: (I) Occurrence of earthquake and response of structures. (II) Occurrence of liquefaction, damage to shoes and hinges, damage to pile bodies following the main shock of the earthquake. (III) Occurrence of rapid ground flow propagation for back-filling, the crack between the foundation and the seawall and larger lateral pressure acting on piles following the movement of the seawall. (IV) Progress of the pile damage accompanying the ground flow. Figure 5 shows the brief design procedure of the additional pile installation method to restore the damaged foundation of bridge.

Fig.4 Mechanism of ground-flow-induced damage
