# BEHAVIOR OF LIQUEFIED SOIL NEAR BOUNDARY OF BACKFILLED BASIN DUE TO MAIN AND FOLLOWING MUXIMUM AFTERSHOCK

**ABSTRACT**: Reclaimed lands backfilled by the remainder which collected iron content in the iron ore sand deposits were liquefied in Asahi City, Chiba Prefecture due to the 2011 off the Pacific coast of Tohoku Earthquake. Based on the site investigations and the numerical analysis, the behaviors of the liquefied soil at the brinks of the backfill basins were classified into three types, namely heave, cave-in and landslide. The mechanism of these behaviors was attributed to the relationship between the predominant direction of displacement of liquefied soil and the location of the excavation boundary.

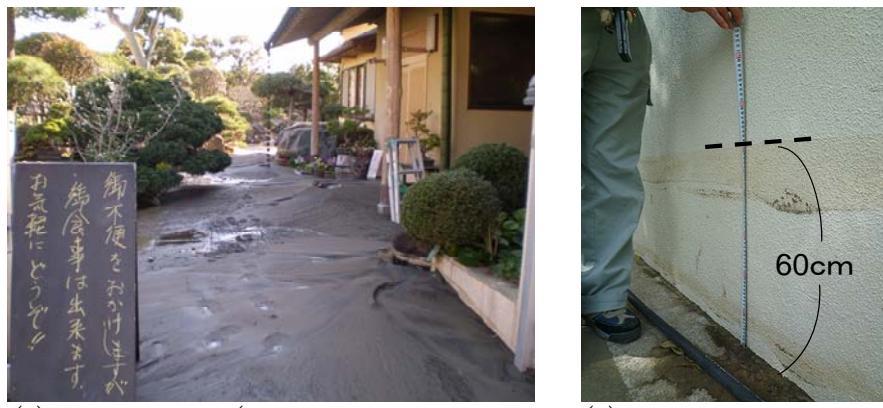
Photo 1(a) shows an example of vast sand ejected due to the main shock and Photo 1(b) shows a trace of ejected sand remaining on the wall. The trace indicates that the thickness of the ejected sand was 60 cm here. The grain size distributions of liquefied sand sampled at Ushirogusa and Hebizono are shown in Fig.3. It shows markedly inferior distribution of fine sand having a uniformity coefficient of 2. Figure 4 shows equivalent SPT N-value converted from the results of SWS conducted at the Ushirogusa and Hebizono areas. According to this figure, the depths of water table in this area are about 1.3 m and the excavation depths of iron sand ore ranges from 3.5 m to 4 m below the ground surface. The thickness of liquefied sand portion appears to be as thin as 2 to 3 m.

(a) Spouted sand (25 minutes after (b) Trace of sand spout the main event, Photo: Ikeda)
Photo 1 Sand ejecta and its trace observed at Ushirogusa area

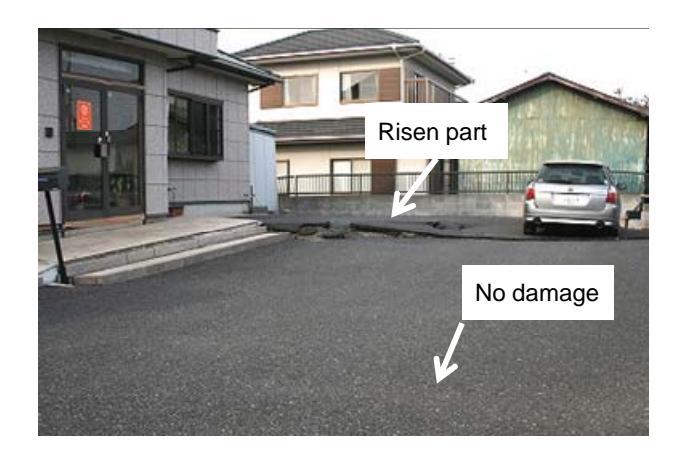
Photo 2 shows the site to the north of SWS No.2 location where sand spout was observed during the largest aftershock. Although no damage was seen regarding the ground in the near side of this photo, a crack with a level difference appeared along the line connecting the entrance terrace and the car, and the ground heaved up at far side of the line. This site is located at the upper left corner in Fig. 6 with its enlarged map. The results of level survey were shown along the three survey lines, A - A', B - B'and C - C' in Fig. 6. Photo 2 was taken at Point B viewing Point B'. According to the survey results along B - B' and C - C sections, the ground rose by 60 cm and by 38 cm, respectively, in the right side of the crack. The direction of the ridge of upheaval is almost the east - west. The ridge is parallel to the boundary between the excavated and the unexcavated lands, and the distance between them is about "Excavation boundary" in Fig.6 show the estimated 30 m. The down-ward arrows,  $(\downarrow)$ , noted as locations of the excavation boundary. The white arrows show the estimated predominant directions of liquefied sand motion. For instance, the excavation boundary is located in the direction of A'-B'-C' side for this residential land in Photo 2. Rise of the soil liquefied at the inside of the boundary means that liquefied sand at A-B-C side is considered to have moved mainly to the direction of the boundary. Cave-in means, to the contrary, that the liquefied sand moved mainly in the direction which keeps away from the boundary.

Photo 2 Upheaval of housing lot at Hebizono area

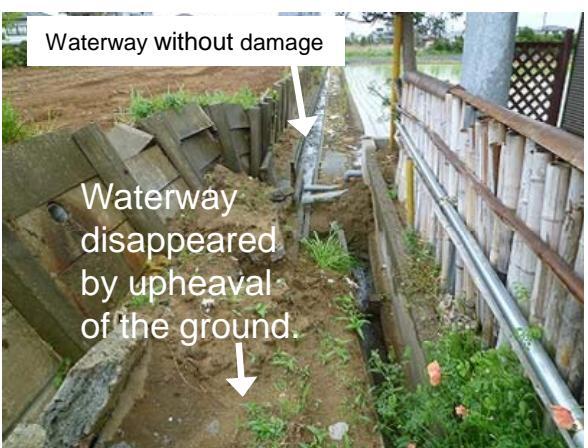
Photo 3 shows a ground deformation near the boundary. The waterway, the retaining wall on the left and the rice field on the left in far side in the figure were not damaged because they are located in unexcavated part. To the contrary, the ground heaved up and the waterway was collapsed and disappeared on near side which is located in the excavated and backfilled part. Photo 4 shows a house which was greatly bent into a mountain shape since the site heaved up near the middle of the house.

Photo 3 Boundary between unliquefied foundation and damaged foundation

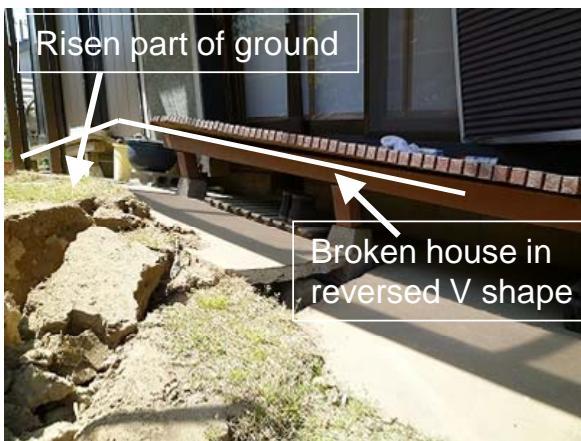
Photo 4 Destroyed house due to ground upheaval at the center of the house

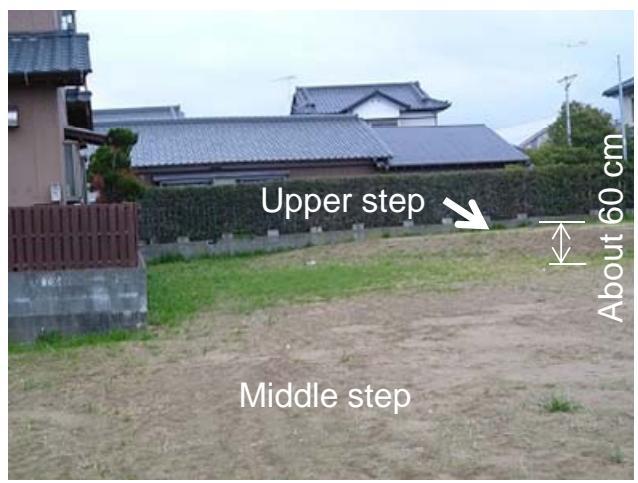
The cultivated field shown in Photo 5 is located in the excavated side and the excavation boundary is located on the left side of this photo. Although this field had been flat and no sand spout was observed during the main shock, it heaved up with ejects of sand during the largest aftershock at approximately 15:15. Photo 5 shows the middle and upper steps having a height difference of 60 cm. According to E - E' section in Fig. 6, elevations of the middle step and the upper step were 25 cm and 85 cm higher than that of Point E on the lower step which has not liquefied because of belonging to the unexcavated side. Figure 5 shows the equivalent N-value along E - E' section. The unexcavated ground is so stiff at depths deeper than 2 m that the equivalent N-values are larger than 40. To the contrary, the backfilled sand is so loose that the equivalent N-values are less than 10 in general to the depth of 6 m to 6.5 m, though they exceed 15 at some depths.

The mechanism of the ground upheaval all at once at the inside of the excavation boundary is considered to be as follows: The foundation had not reached near complete liquefaction with sand ejection, though the excess pore water pressure increased to considerably large. It liquefied almost completely and the sand was ejected during the following largest aftershock. When the liquefied soil moved toward the un-excavated foundation, it heaved up because it was blocked in the hard stratum and rose. It is imagined that the ground heaved up to the broken line indicated in Fig.5 just after rising and subsided to the solid line with increasing elapsed time. Along the survey line D - D', the maximum value of upheaval was 80cm here.

Photo 5 Up-heaved field due to liquefaction of soil

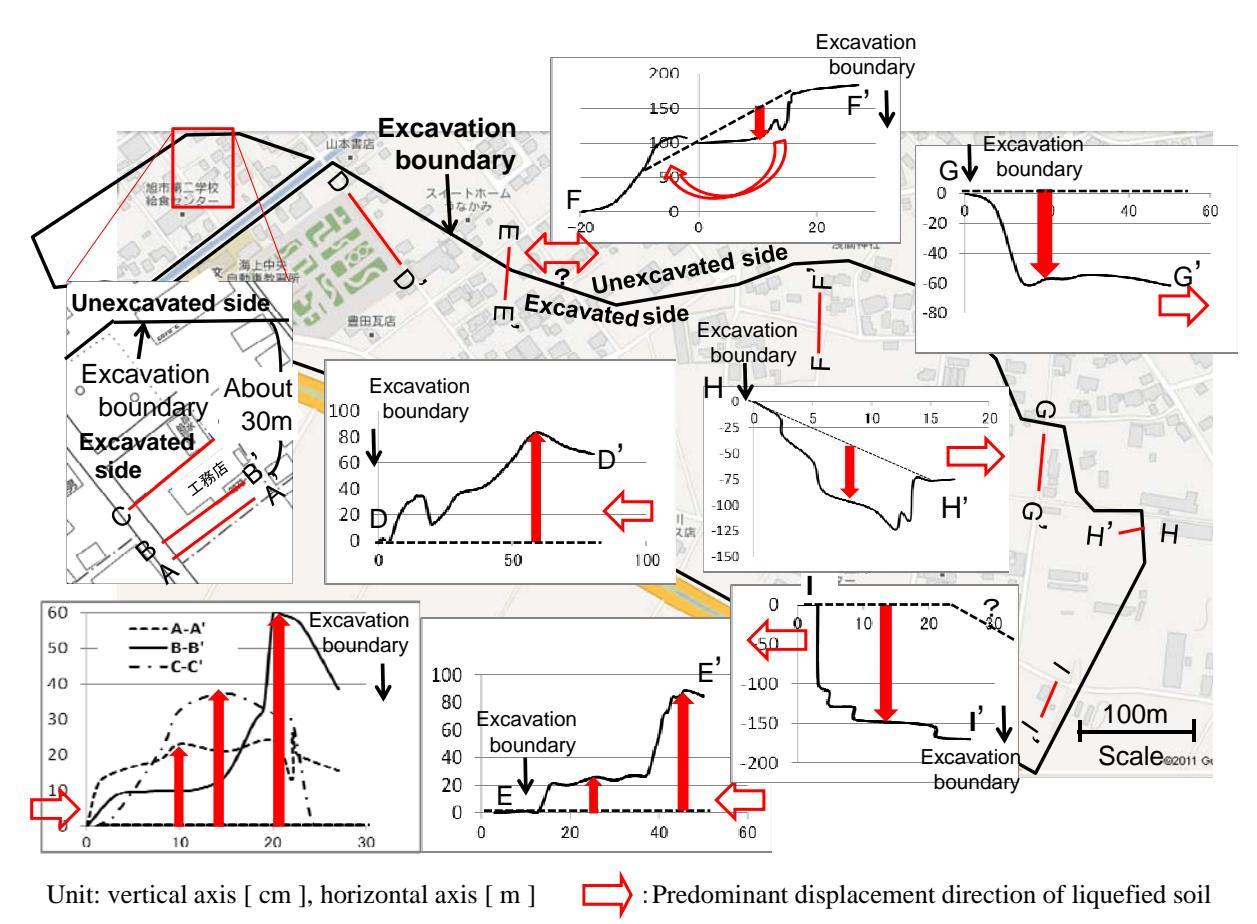
Fig.6 Upheaval, cave-in and slope failure due to liquefaction at the periphery of backfilled discarded iron ore sand (Nakasone zone in Hebizono area)

Along F - F' survey line in Fig.6, the slope failure with the main scarps were observed as indicated in the schematic picture. A tremendous amount of ejected sand was observed in the field around Point F. Therefore, the slope failure is considered to be caused by the liquefaction of foundation.

Although no damage to house or ground were observed outside the boundary along the survey line G - G', the foundation settled by 60 cm at the inside of the boundary as indicated in Fig.6. This subsidence at the inside of the boundary was considered to have occurred because the liquefied layer at the inside of the boundary moved mainly in the opposite direction to the boundary.

Along the survey line I - I', a main scarp whose height difference was about 1 m appeared at Point I in Fig.6. Furthermore, several openings and gaps were created in the housing lot, resulting a total subsidence of 170 cm in height along the line I - I'. A purified water tank of the sewage heaved up and many traces of sand eject were observed in the neighboring yard. This cave-in was considered to be caused by the combined effect of landslide due to liquefaction of the foundation and movement of the housing lot toward the opposite direction to the excavation boundary.

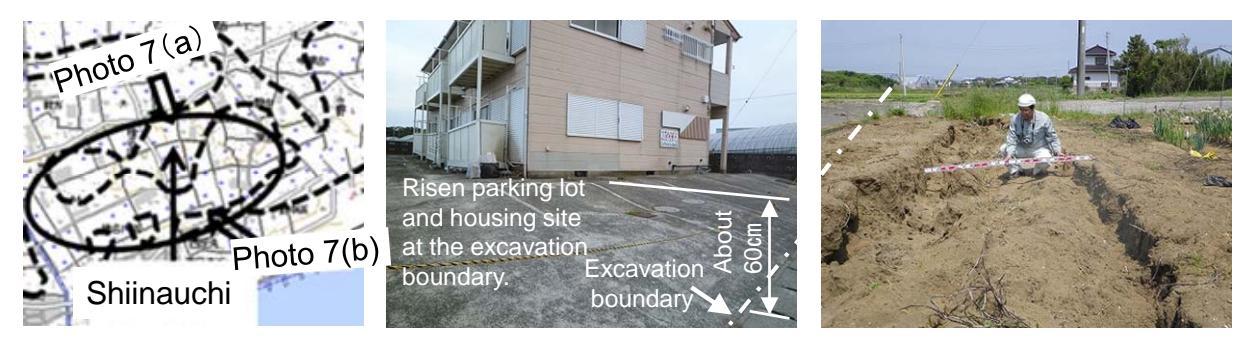
Figure 7 shows the excavation boundary and the liquefied zone at Shiinauchi area. The apartment house in Photo 7(a) was located at the inside of the excavated area and the road was located outside of it. The apartment house undulated and deformed, and the parking lot heaved up by 60 cm, though no damage was observed in the road. The dominant displacement direction of liquefied soil here is considered to be toward the road though the liquefied soil was hindered its movement by the stiff layer under the road and heaved up. To the contrary, Figure 7(b) shows a cave-in occurred at the opposite boundary in the Shiinauchi area. The foundation here was considered to have moved mainly toward the opposite direction to the excavation boundary.

(a) Upheaval at north boundary (b) Cave-in at south boundary Fig.7 Map of Shiinauchi area. Photo 7 Upheaval and cave-in at the inside of the excavation boundary
