EFFECTS OF LOCAL SITE CONDITIONS ON LIQUEFACTION DAMAGE IN MIHAMA WARD OF CHIBA CITY

Toru SEKIGUCHI¹ and Shoichi NAKAI²

ABSTRACT: The distribution of liquefaction damage in Mihama ward of Chiba city during the 2011 Great East Japan earthquake was investigated by conducting an exhaustive search for all the public roads and parks immediately after the earthquake. The effects of local site conditions on the damage distribution in the region were examined based on the research, microtremor measurements, the boring logs and the aerial photography.

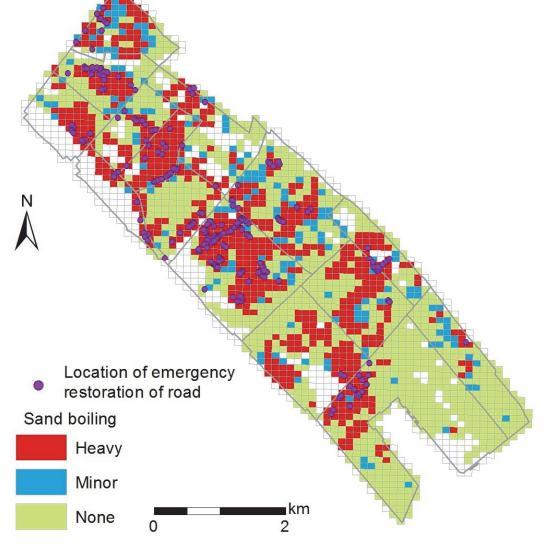
Fig. 2 Distribution of sand boiling

Fig. 2 shows the distribution of sand boiling using 100 m square grids together with the locations of emergency restoration of road conducted by the Chuo-Mihama civil engineering office. White grids mean the areas which could not be entered. Heavy sand boiling and road restoration locations are densely distributed in the coastal area when compared to the inland area. Many spots with minor sand boiling are found in the inland area. The districts where widespread heavy sand boiling was found are Nakase, Hibino, Isobe, Takasu, Takahama and western part of Shinminato shown in Fig. 1. On the other hand, there are some districts where small sand boiling was found in areas such as Utase, the area between Isobe and Takahama and the inland part of Shinminato.

Fig. 3 shows the distribution of liquefaction during the 1987 East-Off-Chiba earthquake (Wakamatsu, 1991) and contour lines of basement depth of alluvial deposit (Kaizuka, 1993). Most of the past liquefaction areas are included by the damage area in Fig. 2. The liquefaction damage area of the earthquake in 2011 is more widespread than that of the past earthquake.

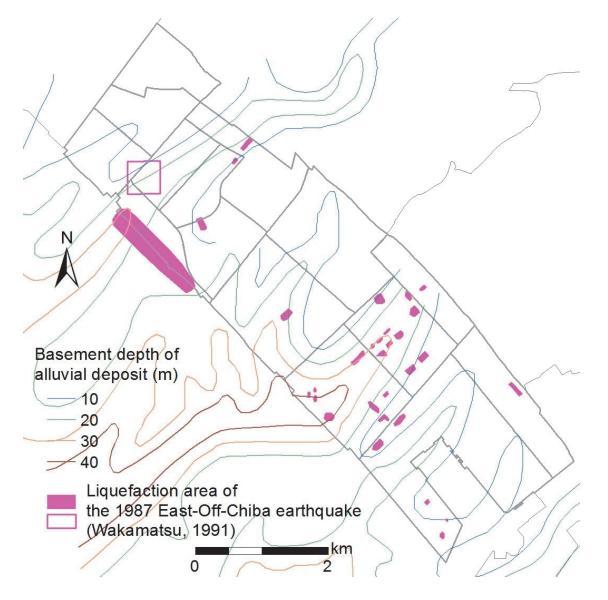
Fig. 3 Map of historical liquefaction sites and contour lines of basement depth of alluvial deposit

At the districts of Nakase, Hibino, Takasu and Takahama where heavy sand boiling was found, the basement depth of alluvial deposit is deep and the districts are on the valley which is accumulated by thick alluvial deposit. The districts of the northern part of Isobe and the western part of Shinminato where heavy sand boiling was also found are, however, situated on the ridge in the old times presently covered with thin alluvial deposit.

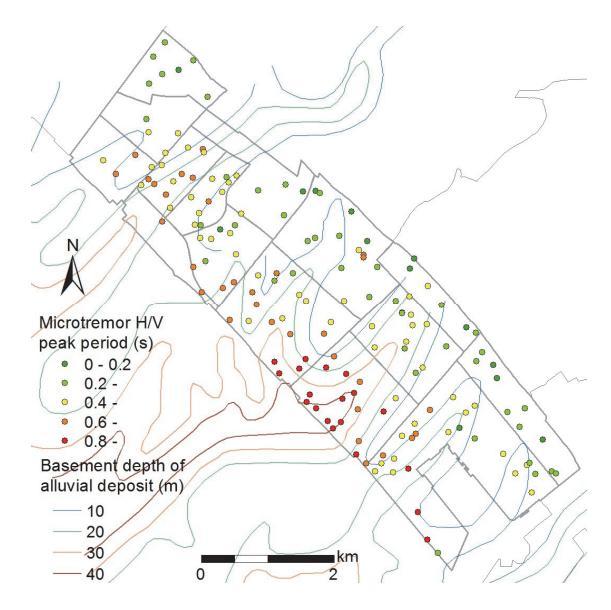
Fig. 4 Distribution of microtremor H/V peak periods

In order to estimate the natural period of the surface soil, microtremor measurements with a three-component sensor were conducted at 163 sites in Mihama ward. Fig. 4 shows the peak periods of H/V spectra calculated from the three component motions of observed microtremor. The peak periods of microtremor H/V spectra are in fairly good agreement with the basement depth of alluvial deposit. The peak periods in the coastal area tend to be longer than those in the inland area. The peak periods at the districts of Nakase, Isobe, Takahama and the western part of Shinminato with heavy sand boiling tend to be longer than those at the other district. In addition the peak periods at Utase district with small sand boiling are short. But small sand boiling was found at the area between Isobe and Takahama in spite of the long peak periods of microtremor H/V spectra.

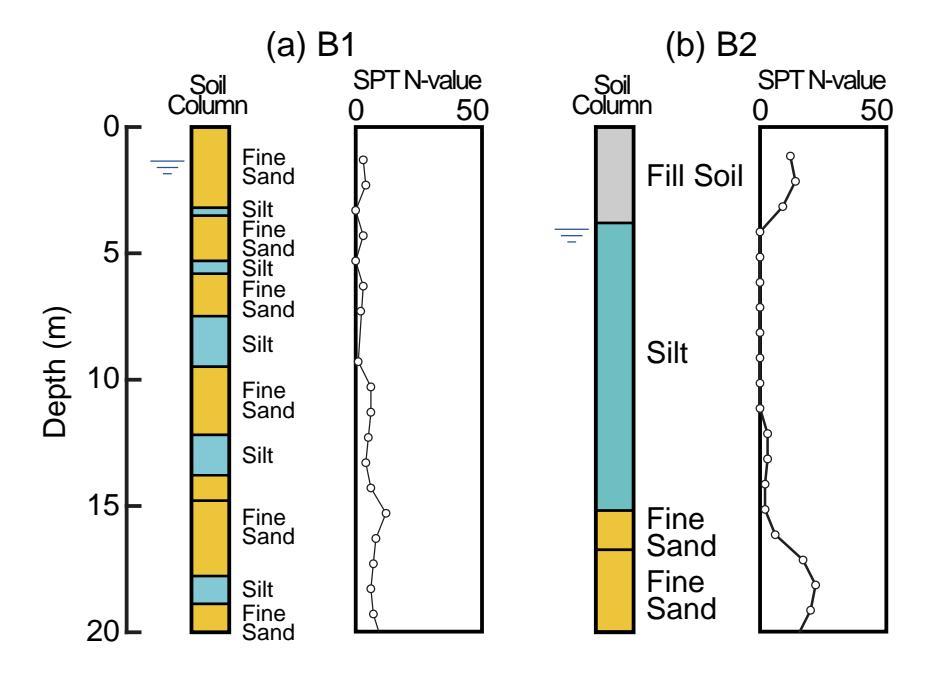
Fig. 5 Boring logs in Isobe district

Fig. 5 shows the borehole logs at site B1 with heavy sand boiling and site B2 with no sand boiling shown in Fig. 1. The thickness of the reclaimed soil are estimated to be 5 - 10 m at the district. At site B1 with heavy sand boiling whose natural period is estimated to be long from microtremor measurements, fine sand and silt with low *N* values accumulate alternately. At site B2 with no sand boiling whose natural period is also estimated to be long, the surface soil, in contrast, consists of fill soil with *N* value of about 10 and silt with low *N* value with a thickness of 11 m, which is underlain by fine sand with *N* value of more than 10. It seems that this is a reason why the liquefaction damage is different between the two site in spite of the similar peak periods of microtremor H/V spectra.

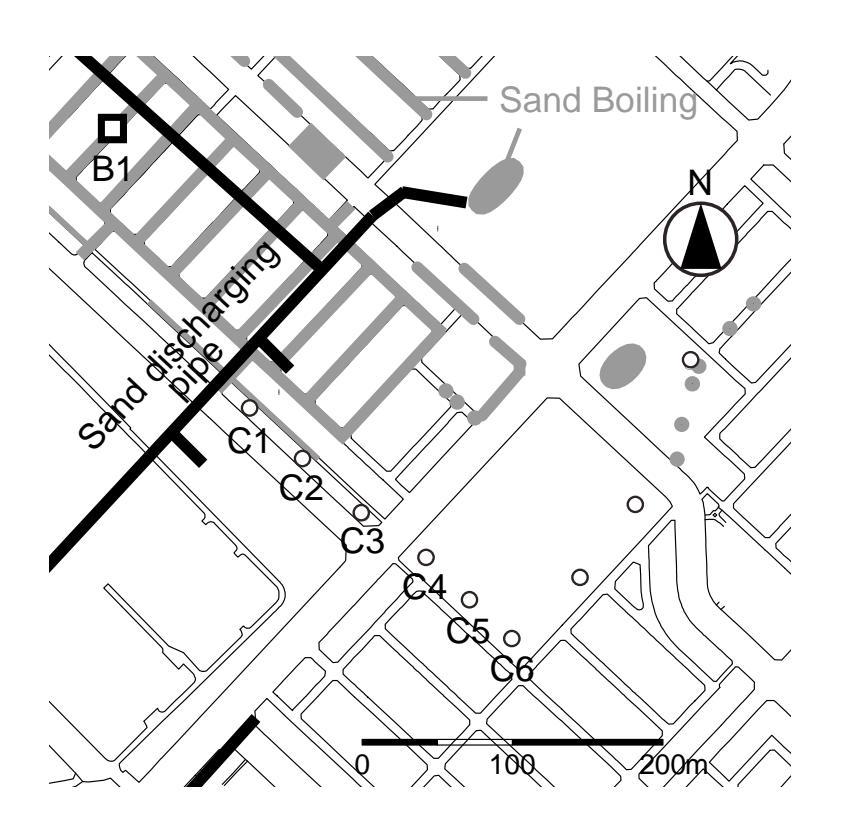
Fig. 6 Locations of sand boiling, CPT logging and sand discharging pipe in Isobe district

Longitudinal research using CPT logging was conducted along heavy and less damaged area in Isobe district shown with the area where sand boiling occurred in Fig. 6. Fig. 7 shows the estimated profiles of soil types based on CPT logging at 6 sites. At sites C1 and C2 near the damaged area by sand boiling, sand is predominant to a depth of about 10 m. At sties C3, C4, C5 and C6 with no sand boiling, silt and clay are predominant to a depth of 20 m except for site C4.

Fig. 8 shows the aerial photography of Isobe and Takahama district shown in Fig. 1 at the time of land reclamation in 1972. The sand discharging pipes are found in this photography and are indicated by black lines. The pipe layout are also indicated in Fig. 6. In Fig. 6, the sand boiling damage is found near the pipes such as sites C1 and C2. In Fig. 8, sites C3 and C4 whose surface soil mainly consist of silt are located between the pipes.

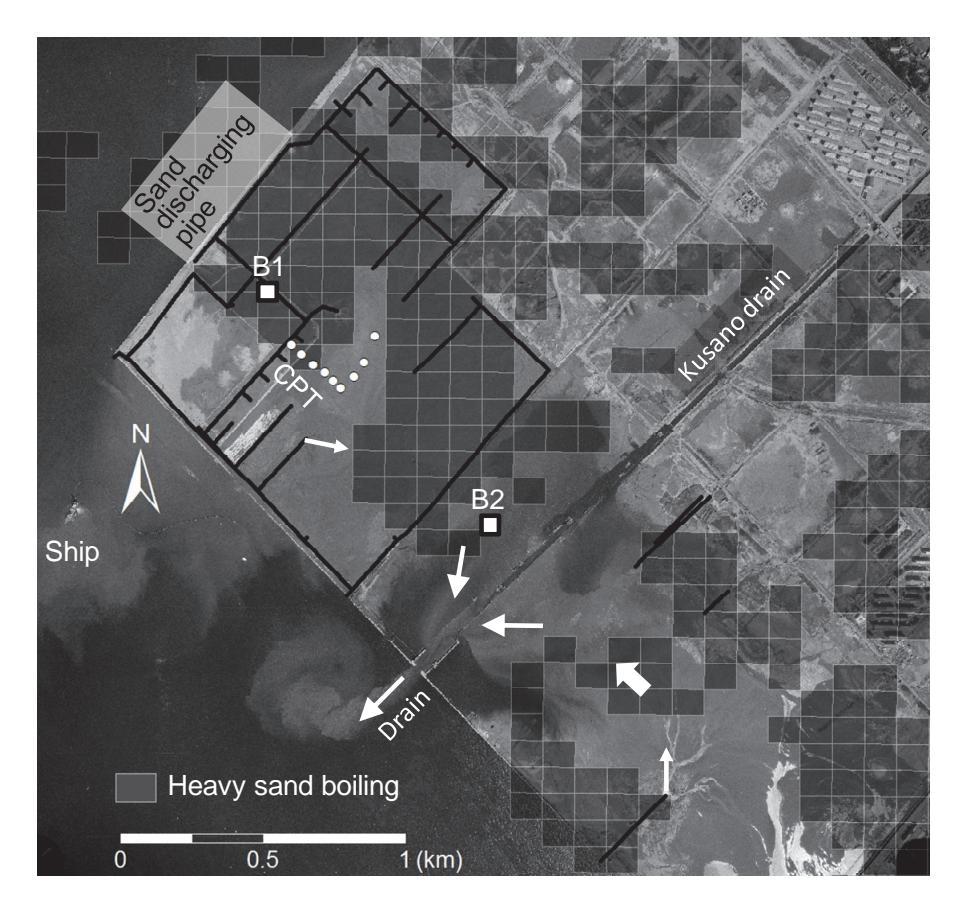
Fig. 8 Aerial photography of Isobe and Takahama district at the time of land reclamation in 1972, showing sand discharging pipes

There is a drainage canal called Kusano canal that runs between Isobe and Takahama district crossing the reclaimed ground from landside to Tokyo Bay shown in Fig. 8. The surplus water which was pumped with the dredge soil was drained away through Kusano canal to Tokyo Bay. There are storage reservoirs which precipitate fine graces in the drained water at the both side of Kusano canal. It seems that site B2 whose surface soil mainly consists of silt is located in the reservoir.
