# DAMAGE SURVEY ON BUILDINGS AND THE LESSONS FROM THE 2011 EAST JAPAN EARTHQUAKE

## Toshimi KABEYASAWA

**ABSTRACT**: Damage survey on buildings is outlined, which was conducted as a part of reconnaissance activity of AIJ, Architectural Institute of Japan after the 2011 East Japan Earthquake. Typical types and levels of damages to building structures are classified, both by the ground motions and the tsunami waves, based on the field observation data on buildings in the affected regions. The damage rates in the selected area are analyzed and discussed based on the statistical data of the inventory damage rates, as well as in relation with calculated seismic performance indices.

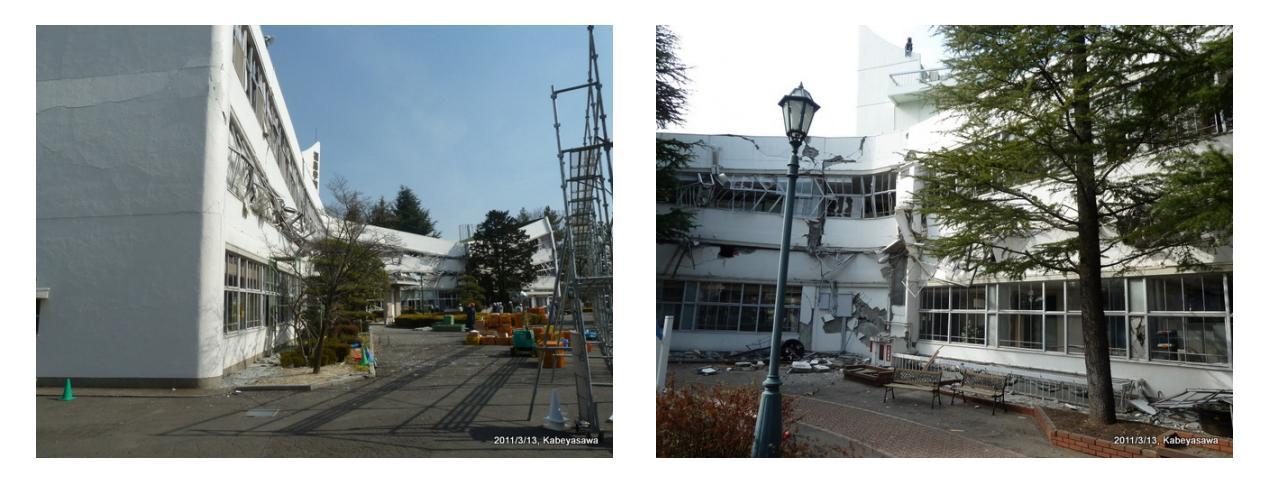
Collapse of a building, so-called pancake crush, was observed, as shown in Photo 3, in F-college located north of Fukushima city, which was three-story reinforced concrete building for administration built in 1965. Although the JMA seismic intensity around the site was classified into V+, the site was close to the area of VI lower, and also it was indicated from aftershock observation that the ground motion might be higher in the site than the center of Fukushima city. The building had a Y-shaped plan with a stair hall in the center and three longitudinal blocks spread to north, east and west directions as equivalent triangular. It is estimated that the concentration or unequal distribution of the lateral earthquake loads might have occurred among the three blocks, due to the difference of the inner column heights, by which the severe collapse was induced peculiar to this building.

Photo 1 Damages to F-college building

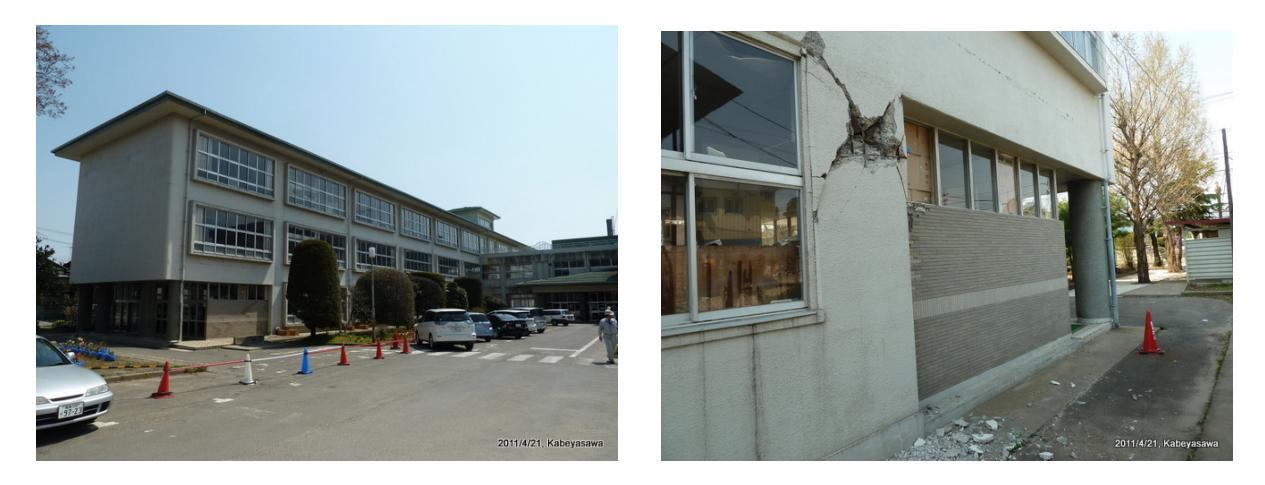
Severe brittle failure of a short column at the entrance hall was observed in N-elementary school 3-story RC building constructed in 1968, as shown in Photo 2. The seismic intensity at the site was estimated as  $V_+$  and the seismic performance index was calculated as Is=0.42, though the heavy damage was concentrated to the short column. Moderate damages to other columns were observed and the damage level was classified into severe, so that the building is to be demolished and replaced.

Photo 2 Damages to N-elementary school building

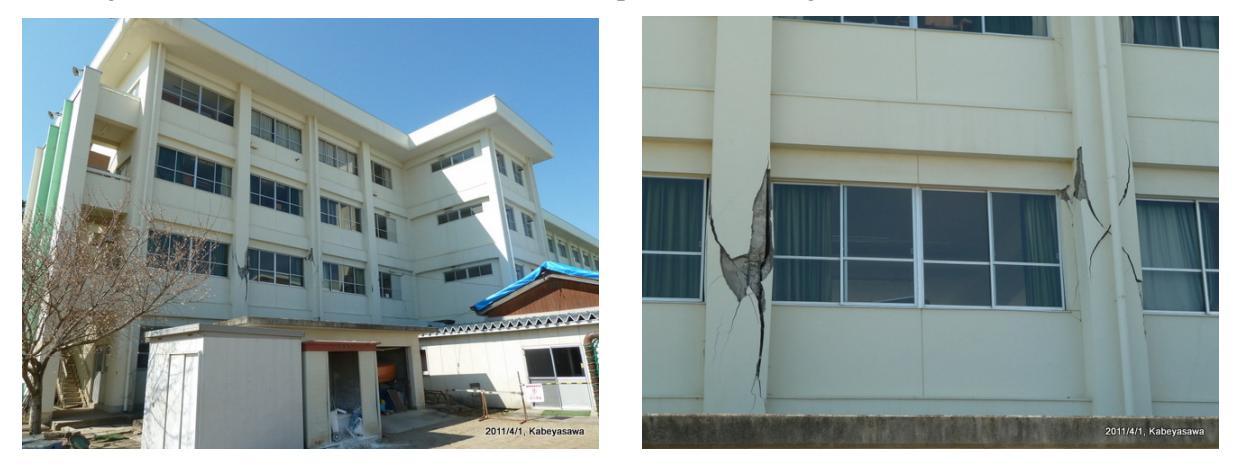
Severe brittle failure of short columns in the north frame was observed in H-high school 4-story RC building constructed in 1970, as shown in Photo 3. The intensity of the motion around the sight was VI lower. The shear failure is mainly due to less hoop ratio based on the old code,  $9 \phi @250$ mm. The damage level was classified into severe and the building is to be demolished. Calculated Is was 0.39 in the second story and measured concrete strength was 16MPa. The damage level of the other 3-story building with Is=0.47 was moderate and is to be repaired and strengthened.

Photo 3 Damage to H-high school building

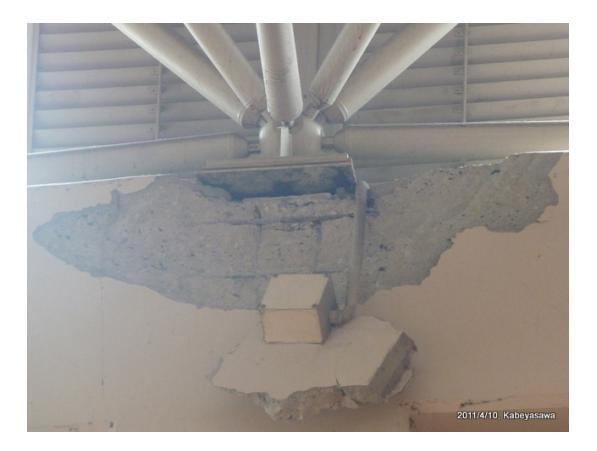
Spalling off of concrete was observed at the base anchorage of roof truss fame in D-gymnasium in north Fukushima. The structure is reinforced concrete column-wall system with steel truss-frame roof. The administrator said that the damage of spalling off was induced by the aftershock of April 7, when refugees occupied the gymnasium to stay day and night. It was fortunate that the refugees barely escaped from injury during the aftershocks. Also the detailed post-earthquake inspection is necessary to avoid the secondary damages. Though it is not considered even in the current code, the author have suspected that much higher expanding forces might have acted to the joint than estimated from design calculation, not only in this case but also in many other cases, where the steel beams were connected or anchored to the cantilever columns or walls, which could be induced by the different phases of responses on the opposite sides, as like as shown in Fig. 5(a). The difference could not be estimated from elastic/symmetric modes but might be possible in inelastic/asymmetric modes with insufficient stiffness on the roof. The possible maximum forces should be investigated further through analytical and experimental studies.

Photo 4 Damage to D-Gymunasium

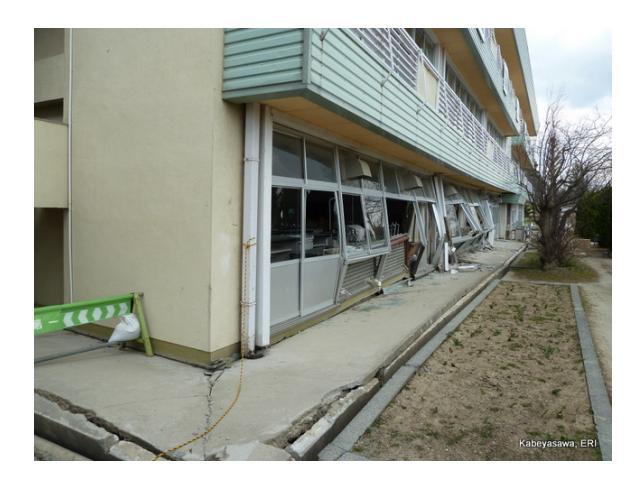
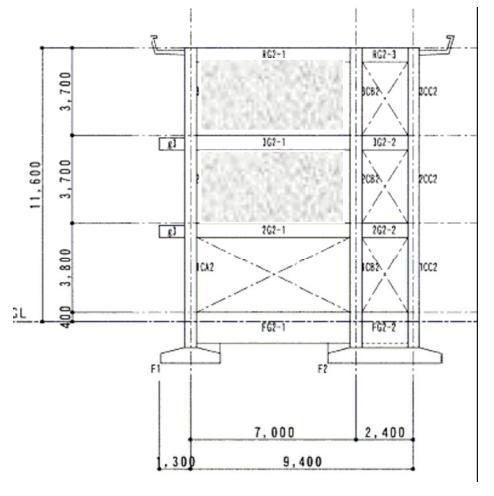
Near collapse failure was observed at M-junior high school building, 3-story built in 1966, as shown in Photo 5, where the JMA seismic intensity recorded as 5+. The shear walls from base to top are located as partitions between classrooms in the span direction except for two frames in the first story, as shown in Fig. 5(b), by which large varying axial loads were generated to the isolated columns during earthquakes and the near collapse failure was induced.

Photo 5 Damage to M-junior high school building

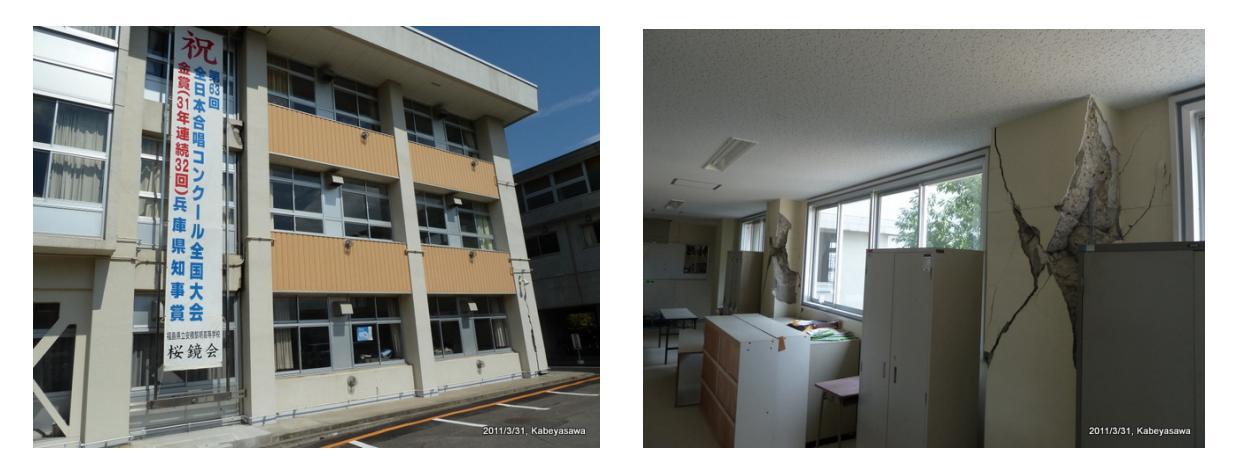
Severe shear failure in short columns are observed in A-high school, 3-story RC building built in 1964. The structure was bare from original with very low seismic performance index (Is=0.17) and suffered the severe damage, as shown in Photo 6. The building is to be demolished. The damaged building was connected with expansion joint to the adjacent building in west, which had been retrofitted at the time of the earthquake. The building was originally built in 1966 and the seismic index before retrofit was evaluated as Is=0.25, which had been strengthened with steel braces exceeding the standard required level of Is=0.7. The retrofitted west building suffered no damage, as shown in Photo 7. The effect of retrofit on the actual seismic performance was indisputably evident in the case.

Photo 6 A-high school building (Bare east part, 1964)

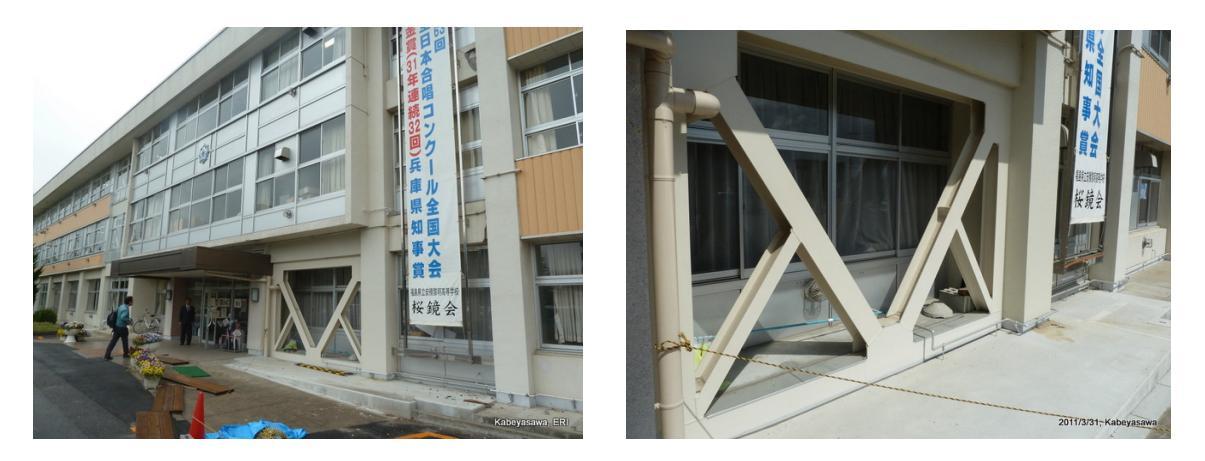
Photo 7 A-high school building (Retrofitted west part, 1966)

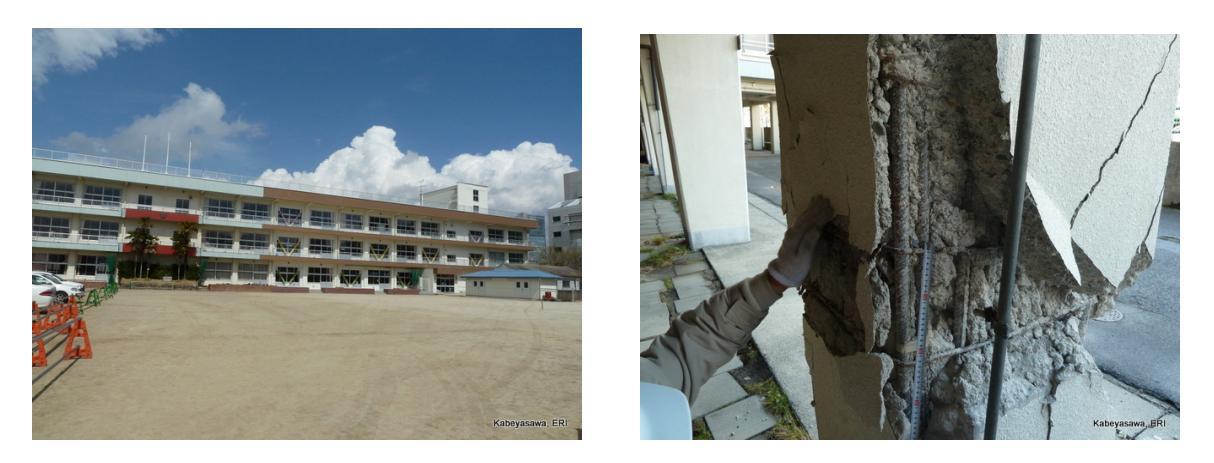
The effect of retrofit was also verified in K-elementary school, which was structurally continuous but had been partially retrofitted at the time of earthquake. The building was built in 1969, and the bare west part, waiting for retrofit in 2011, suffered severe damage, while the east part had been strengthened with steel braces and resulted in no damage, as shown in Photo 8 and Photo 9. In this case, the retrofit was found to be effective partially to the frame nearby the strengthening, but the rigid slab assumption was not much effective in case of the longer building the longer longitudinal size.

Photo 8 K-elementary school building (Bare west part, Severe)

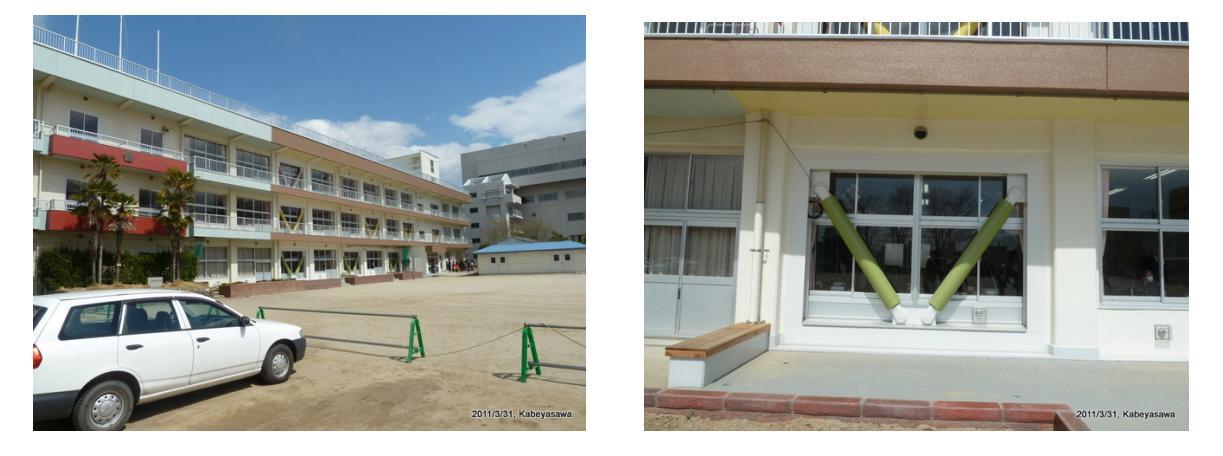
Photo 9 K-elementary school building (Retrofitted east part, No damage)

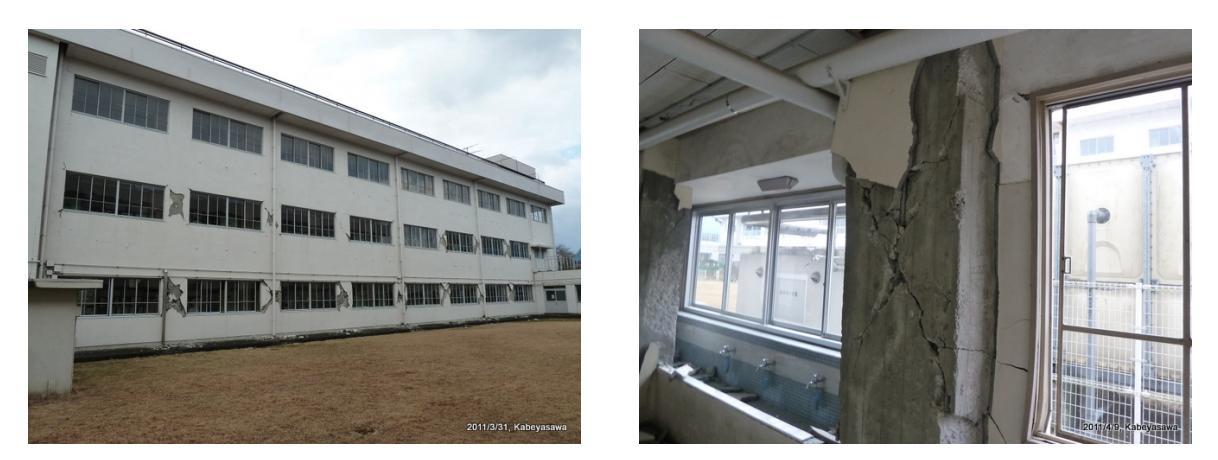
Severe damages to columns to north frame were observed in S-elementary school buildings, consisting of four three-story RC buildings built in 1965, as shown in Photo 10. The JMA seismic intensity was 6+ at the station 1 km east from the school. The  $I_s$ -value was 0.46 with the space of column hoops was 300mm.

Photo 10 Damages to K-elementary school buildings

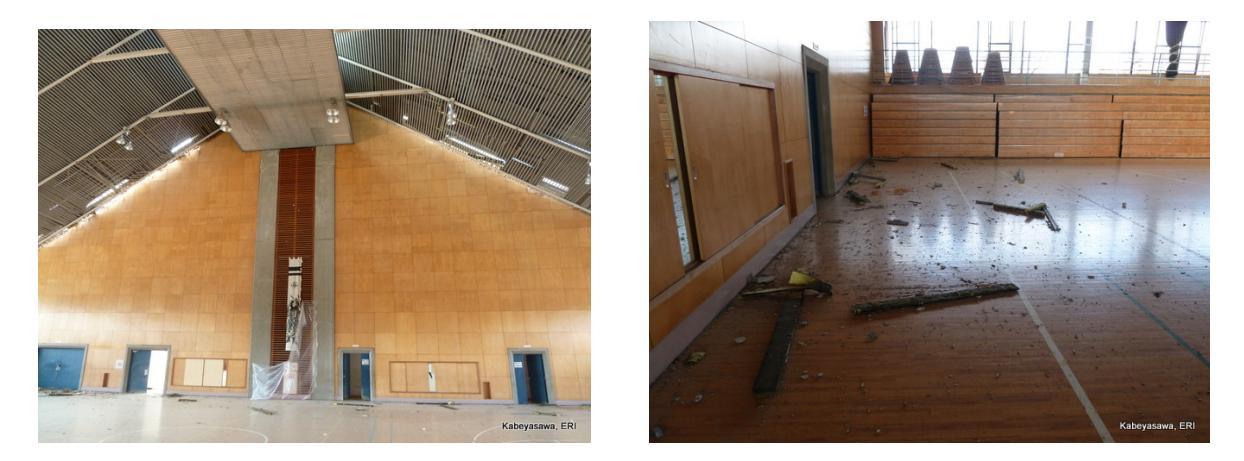
The gymnasium with RC walls and Steel keel beam and roof built in 1985 suffered moderate structural damage to the joint concrete on the roof, as shown in Photo 11. The joint behavior and the design should be investigated in detail further as indicated for the damage of D-gymnasium above.

Photo 11 Damages to S-junior high school gymnasium

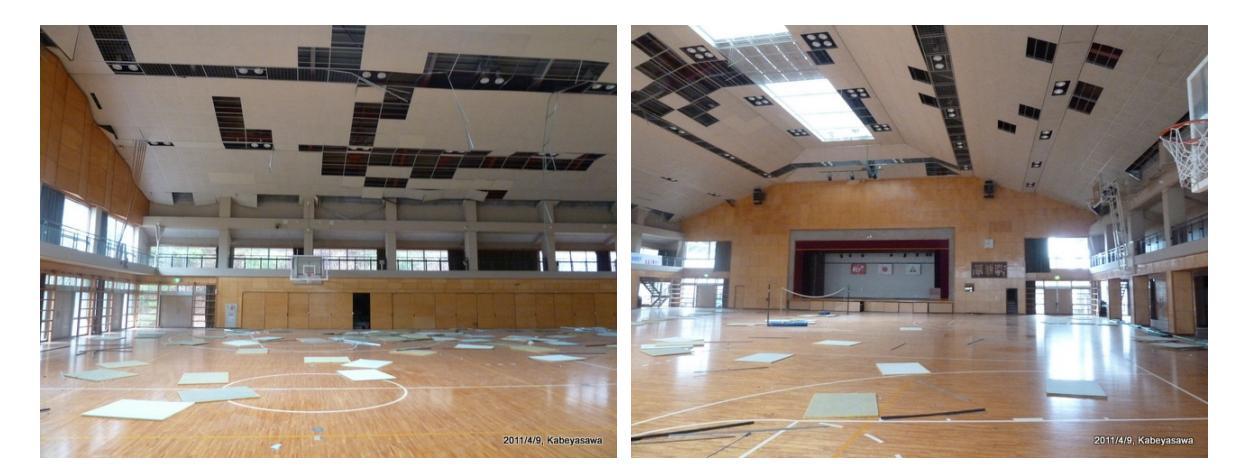
It was not functional in use long time after the earthquake due to damages to ceilings in a gymnasium of I-training center, which was in accordance with the current code and almost with no/slight structural damages, as shown in Photo 12.

Photo 12 Damages to I-training center gymnasium

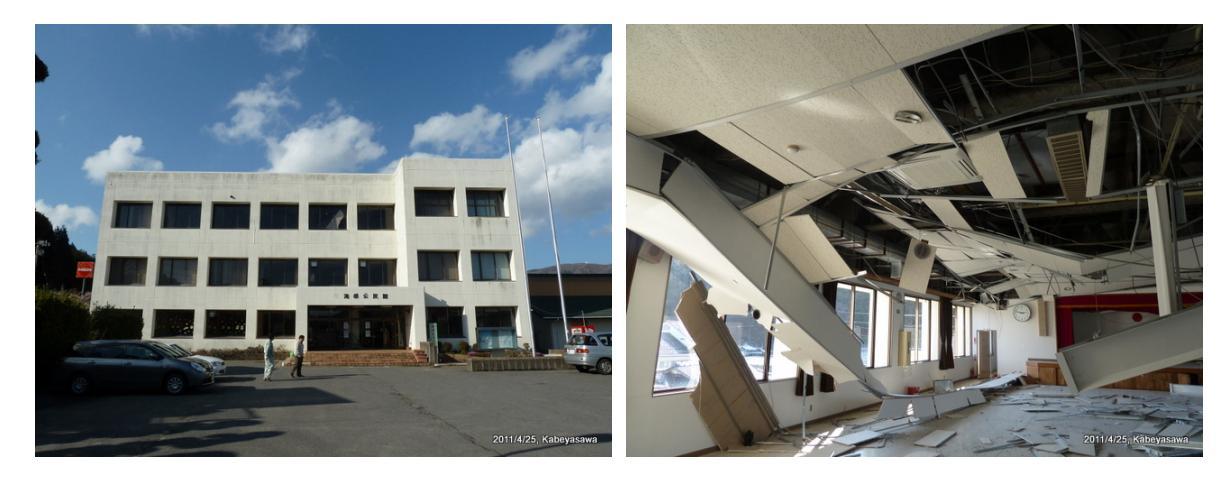
Structural damages to the south façade in T-public hall were slight though serious damages were observed in the third-story conference room with the falling of ceilings, as shown in Photo 13. The building was built in 1967 up to the second story with RC frames, as a public hall of Tamura city, and the third story was added in 1980 with RC columns, steel beams and PC lightweight roof-slabs. The joint concrete at beam ends spalled off, probably due to the out-of-plane expanding behavior of cantilever columns, which might not had been taken into account in design analysis. The damage was evaluated as moderate, though the heavy repair construction would be required.

Photo 13 Damages to T-public hall building

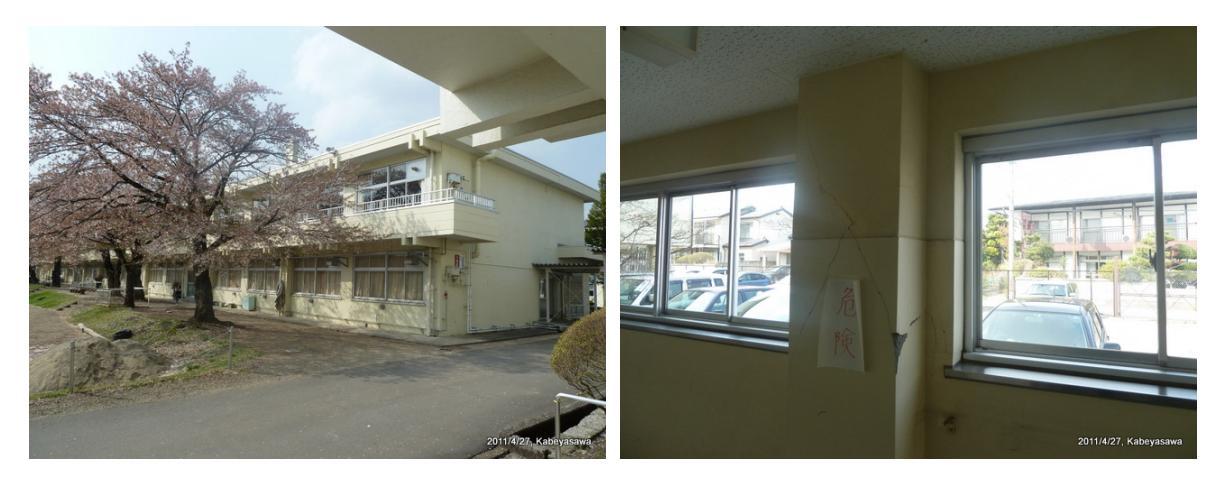
Damage to a short column was observed in S-high school building, 2-story RC built in 1964, as shown in Photo 14. The intensity of the ground motions in the region was VI+ and relatively high. The acceleration response spectra recorded in Shirakawa exceeded 4G at around the period of 0.25 sec., which might be estimated not to be effective to the damages to the buildings.

Photo 14 Damages to S-high school building

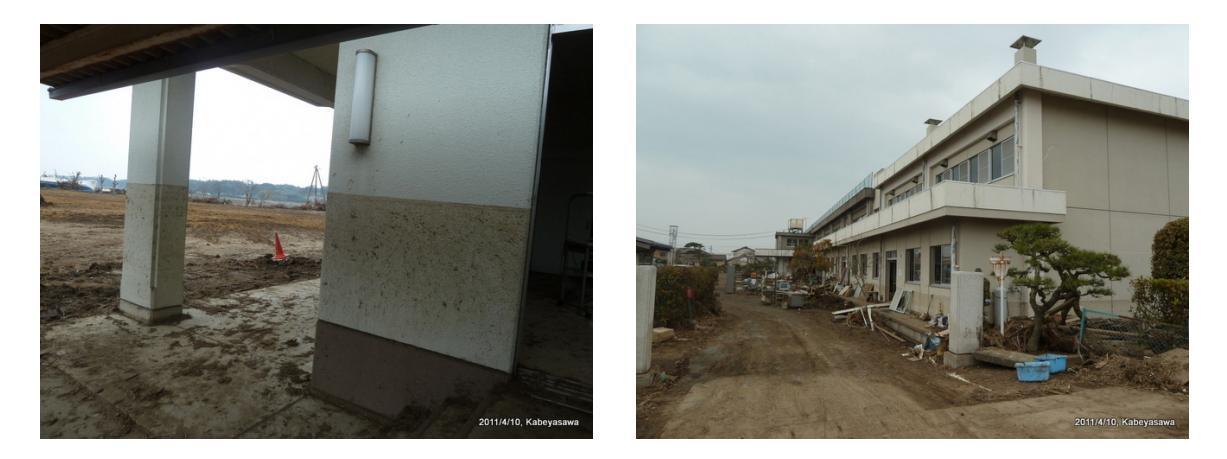
Damages by Tsunami wave were observed in S-elementary school building, 2-story RC built in 1975 and gymnasium, RC with steel roof, built in 1992. The height of the Tsunami wave was up to 1.6m at the site in Minami-soma, which was located about 3km west from the coast, as shown in Photo 15.

Photo 15 Damages to S-elementary school building and gymnasium

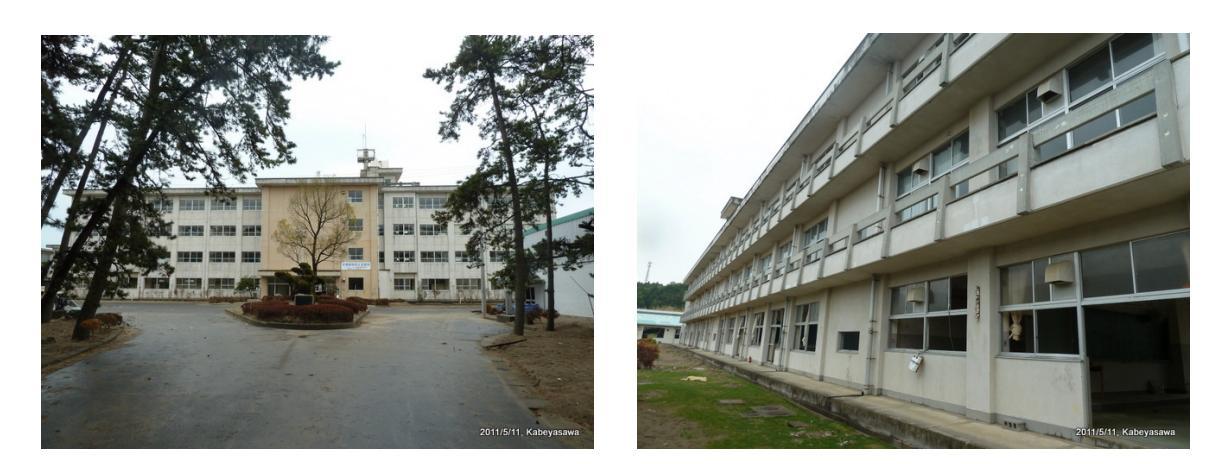
Damages by Tsunami wave was observed in IK-high school buildings, originally as fisheries high school, 3-story and 4-story RC main buildings built in 1979-80, as shown in Photo 16. The height of the Tsunami was up to the ceiling of the first story of 3.5m, where the site was located along the coast of south Iwaki. The structural damages were not observed in the RC buildings. Heavy damages to external walls were observed in other twenty buildings, one- or two-story, RC or steel structures, while structural members remained though residual deformations are observed in some steel members, as shown in Photo 17.

Photo 16 Damages to IK-high school RC buildings

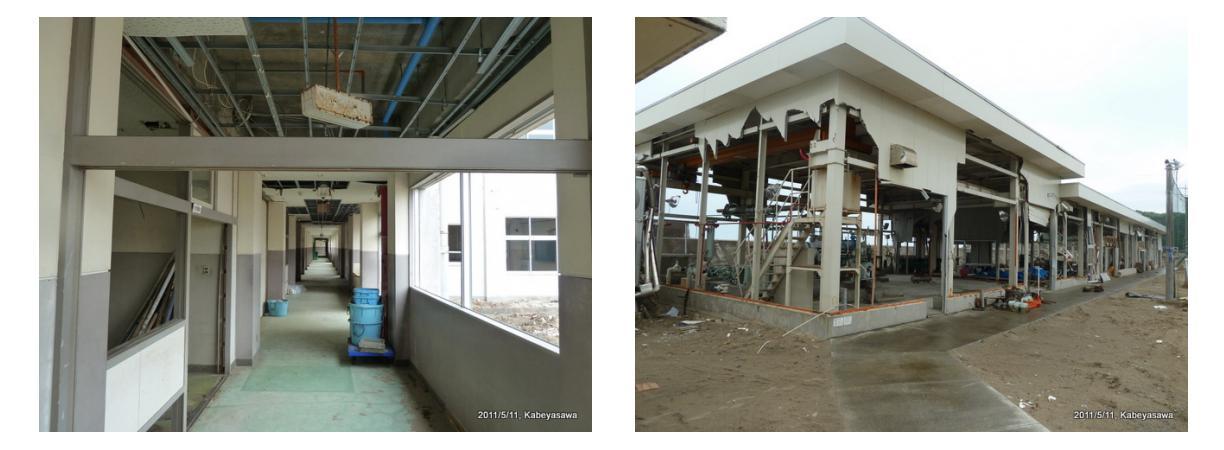
Photo 17 Damages to IK-high school buildings

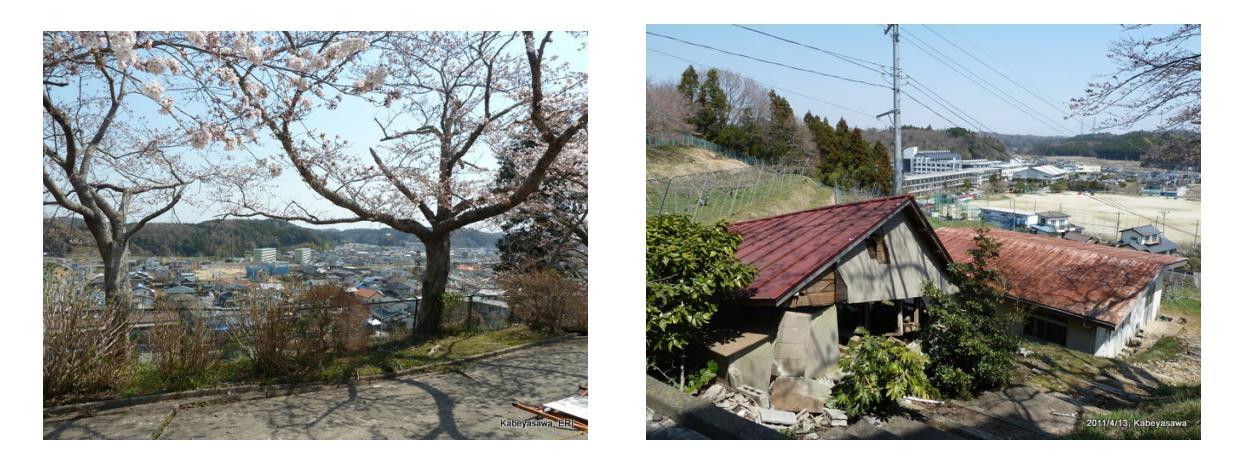
Photo 18 Site on the hill of I-high school buildings

Relatively severe damages of near collapse were observed to the columns in I-high school buildings as shown in Figs. 18 through 20. Four RC buildings with 4-/3-/2-/2-story were constructed from 1973 to 1975. The column hoops were 13mm bars at the spacing of 100mm. The seismic indices Is-values had been calculated as 0.59, 0.64, 1.08 and 1.44. It was expected from these values that the damages would not be so heavy under the main shock of the seismic intensity 5- around. However, it was also expected that the high amplification of the ground motions could be induced due to the hill site effect. Actually observed damages were relatively severe or moderate with the residual seismic capacity of R=33, 47, 73, 72%.

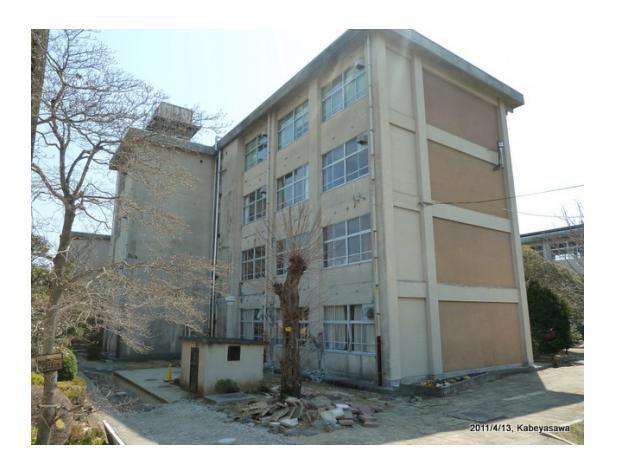
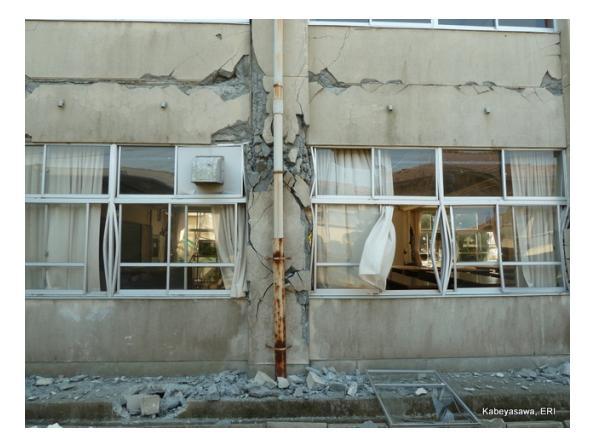
Photo 19 Damages to I-high school buildings

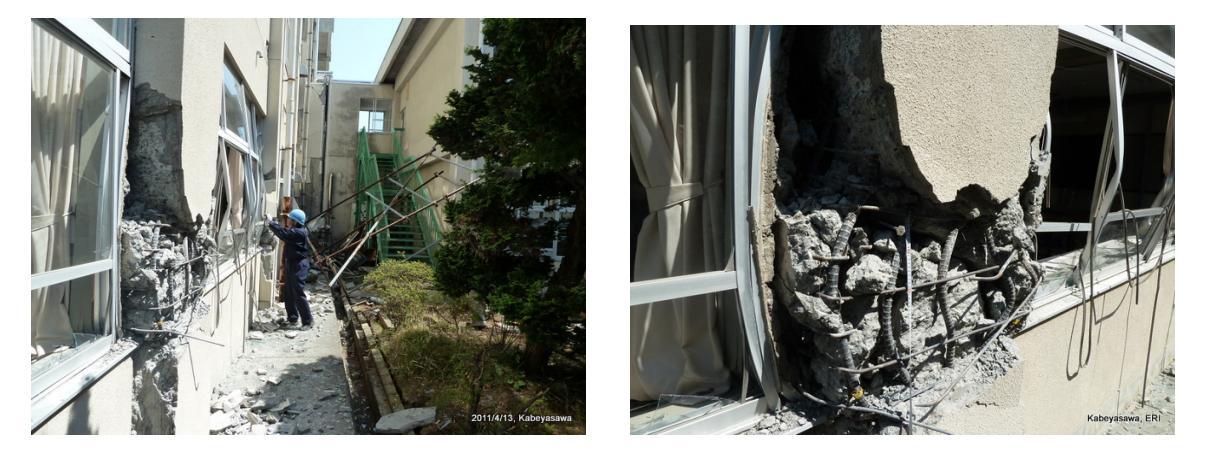
Photo 20 Damaged columns in I-high school buildings
