LIQUEFACTION IN TOKYO BAY AND KANTO REGIONS IN THE 2011 GREAT EAST JAPAN EARTHQUAKE

Kenji ISHIHARA

Key Words: Mega earthquake, Liquefaction, Lateral flow, Settlements

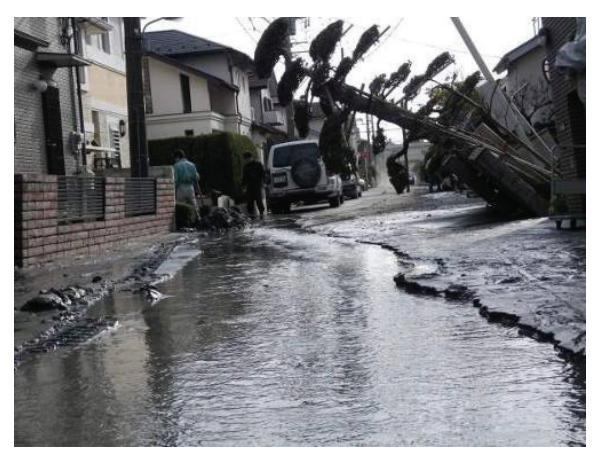
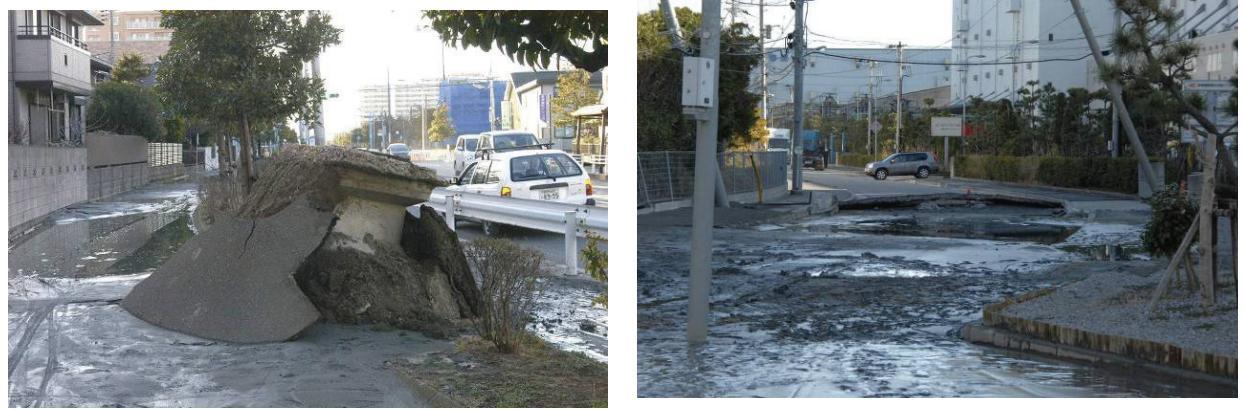
Fig. 12 Destruction of the ground due to liquefaction (Offered by Urayasu city office)

Several of photos showing the ground devastation by liquefaction are shown in Fig. 12. Fig. 12(a) shows tilting of trees and inundation of spurted muddy water over the road in Mihama residential section. Shown in Fig. 12(b) is uplifting of a sewage manhole on the sideway about 1.5m above the ground. The features of the ground damage in general are shown in Fig. 12(c).

(a) Ground devastation in a residential section

(b) Floating of sewage manhole

(c) Spreading of sand over the road

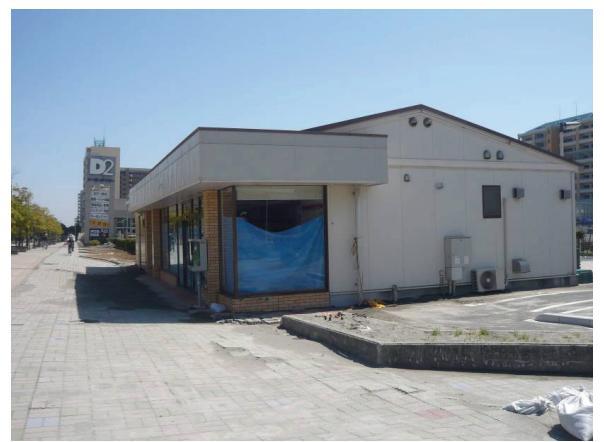
It should be noted that the ejected sand was mostly laden with silt and clay, making it easier to flow and spread over the ground surface. Fig. 13(a) shows a photo indicating settlement and tilt of a house. Fig. 13(b) shows a house tilted and settled as a result of liquefaction. In the building supported by firm foundations such as piles, considerable vertical offset developed relative to the surrounding ground surface, as typically displayed in Fig. 13(c). The gap about 50cm between the building foundation and the subsided ground in its vicinity did result in breakage or tear-off of several pipelines and cables entering the buildings such as water and gas supply, sewage pipes, and electricity and telecommunication cables. The breakage of the lifelines as above was fatal for continued living for residents for some weeks because of lack of operational conditions for the buildings.

(a) Settlement and tilt of a house

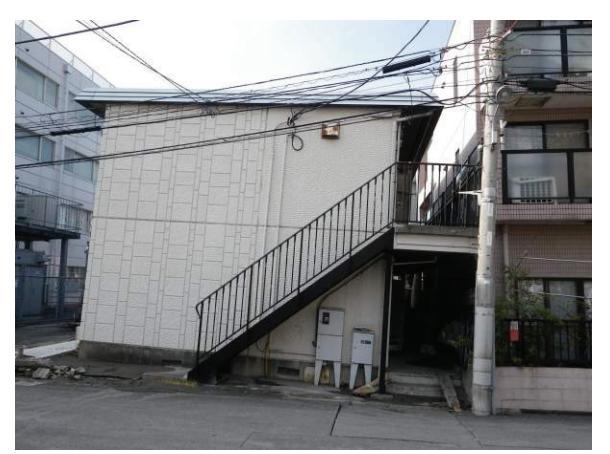
(b)Sinking of an apartment house

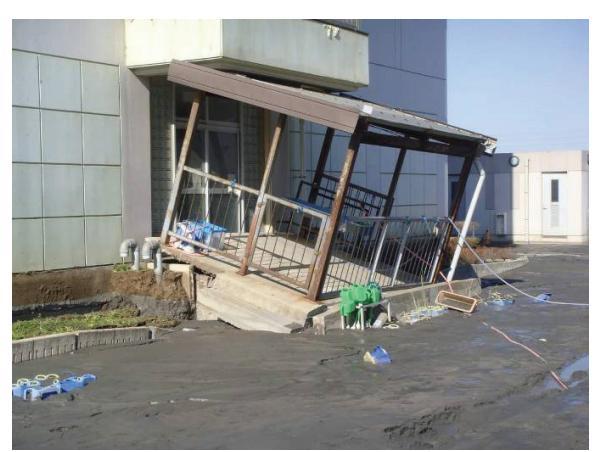
(c) Offset between an undamaged building and settlement of the surrounding ground

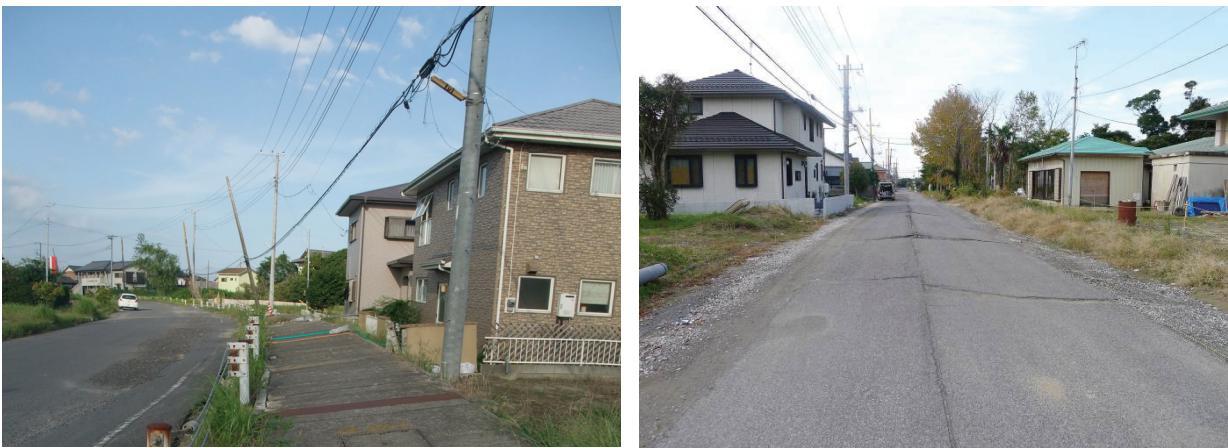
Fig. 19 Damage to houses and roads in Hinode

As a result of strong shaking lasting for 1-2 minutes, liquefaction did develop extensively over the area of Hinode. The accelerations recorded at the nearby Edozaki K-NET station showed the peak acceleration as much as 400gals. Particularly notable was the tilting and settlements of private houses, uplifting building and sinking of road surface, and uplifting box-type water-draining channels buried beneath the sideway, accompanied by sand boiling and some lateral displacements. Fig. 19(a) shows a settlement of about 50cm with 1° tilt of a 3-storey house located in Hinode-5 in Fig. 18. The damage to the road in Hinode-5 is displayed in Fig. 19(b) where the central part is seen being lifted about 20-30cm relative to the sideway. This appears to have resulted from floating of old water channels used for draining water out of the lagoon at the time of the drain-off.

(a) Tilting of a house

(b) Heave at the center of a road

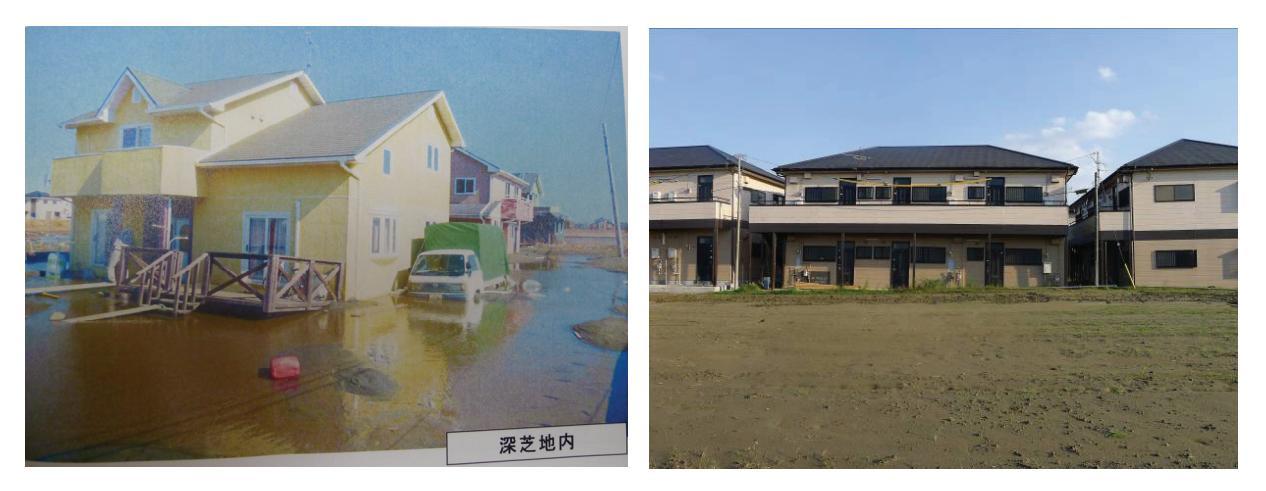
Fig. 22 Damage to houses in Kamisu

In Fukabori district, the gravel layers were excavated in 1950~1960 to a maximum of 10m depth even below the ground water table to take gravels for construction purposes. Later on, the large pit areas were buried by borrow sands. Then, they were transformed into residential district. When houses were built in 1980's, there was no compaction efforts expended to stabilize loose sand deposits for providing competent bases and foundations. The consequence of liquefaction was truly disastrous as seen in a photo shown in Fig. 22(a) where houses look as if they were afloat on a lake water. Fig. 22(b) shows another example of houses tilted on the liquefied ground.

(a) Mud water around private houses

(b) Apartment house unt tilted and subsided
