# TOHOKU TSUNAMI-INDUCED BUILDING DAMAGE ANALYSIS INCLUDING THE CONTRIBUTION OF EARTHQUAKE RESISTANT DESIGN TO TSUNAMI RESILIENCE OF MULTI-STORY BUILDINGS

Gary CHOCK<sup>1</sup>, Ian ROBERTSON<sup>2</sup>, Lyle CARDEN<sup>3</sup>, and Guangren YU<sup>4</sup>

**ABSTRACT**: The structural details of numerous buildings in the Tohoku region were documented by the American Society of Civil Engineers. Tsunami flow depths and velocities were determined based on analysis of video records and the effects on simple benchmark structures in the flow. Failure analysis of several buildings was then used to evaluate design equations for hydrodynamic loading conditions. These findings will influence the design objectives of the forthcoming chapter on Tsunami Loads and Effects in the ASCE 7 Standard, Minimum Design Loads for Buildings and Other Structures.

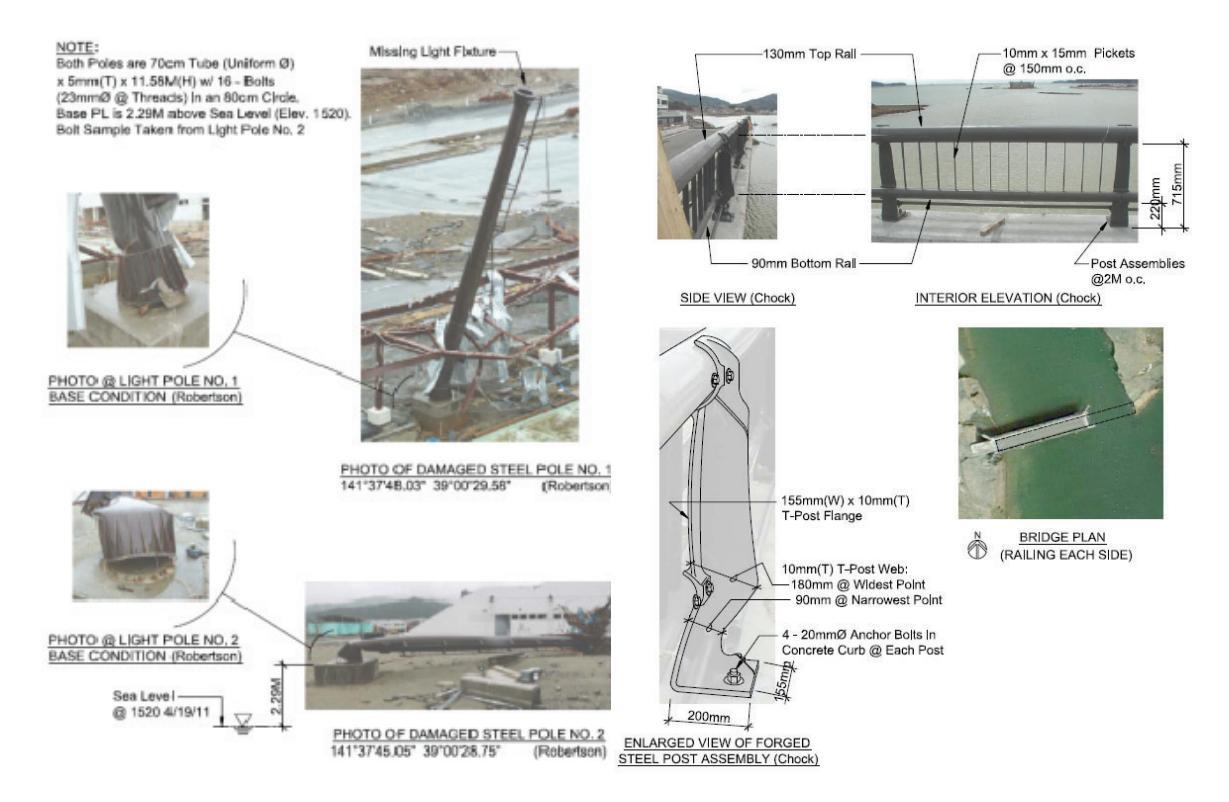
The utility of "flow surrogate" simple structures adjacent to a more complex building failure is illustrated by the case of a large-scale wall blowout in the Takada Matsubara building in Rikuzentakata. Two large light standards stood on either side of the building, and a section of undamaged bridge was also nearby (Figure 2). The maximum inundation depth measured by fishing debris on the building was less than the elevation of the light fixture on top of the pole. Based on structural analysis, the pushover of the light standards during the 10 meter deep inflow had the following sequence. Under flexural bending, an initial buckling of the thin pipe walls above the base plate stiffeners resulted in rotation of the pipe until the initially dry light fixture frame at the top of the pole was lowered into the flow and captured debris. This debris load at the top of the pole greatly increased the moment at the base and initiated much more rotation until it generated tensile rupture of the anchor bolts. The bolt anchorage group had higher moment capacity than the flexural local buckling strength of the pole. A depth-averaged flow velocity of at least 7.25 m/s was determined from structural analysis of the pole in order to create the initial buckling. In the same vicinity, the undamaged railings of a bridge were analyzed to provide an upper bound for the flow velocity of 7.75 m/s at this location. Thus, at this location we have estimates that the flow velocity to be greater than 7.25 m/s but less than 7.75 m/s.

Fig. 2 Flow "surrogate structures" next to the Takada Matsubara Building in Rikuzentakata

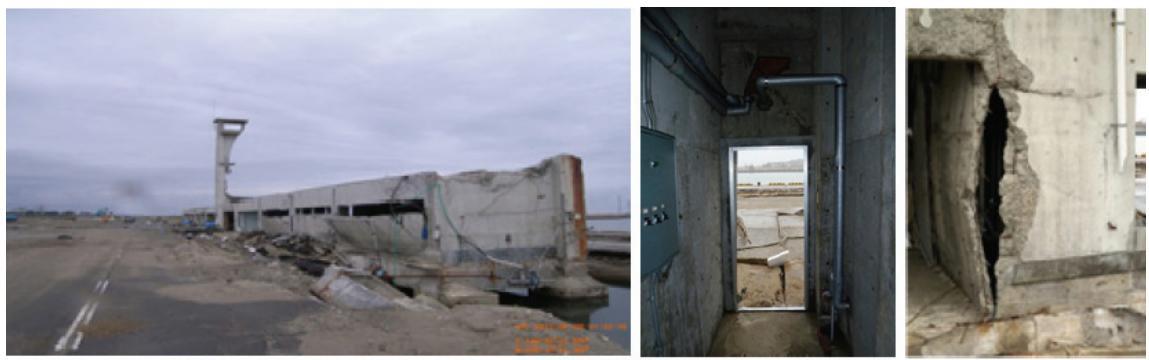
A large morning fish market building was located directly at the wharf area at the harbor of Yuriage (Figure 3). The building consisted of a large 120 m long by 20 m wide steel-truss framed single story high-bay building with a smaller attached one-story single bay of reinforced concrete bearing walls and concrete roof slab. The steel-framed main building was stripped off. A reinforced concrete utility closet for equipment had its sole door opening oriented towards the incoming tsunami, and was thus subjected to the internal pressure resulting from stagnation of the flow. Reinforcing bar samples tested to be equivalent to JIS G3112 SD 390 with 400 MPa average yield strength. In order for the failures shown here to have occurred, flow velocity would have been at least 7.5 meters/second.

Fig. 3: Wall corner joint and flexural failure by internal hydrodynamic pressurization

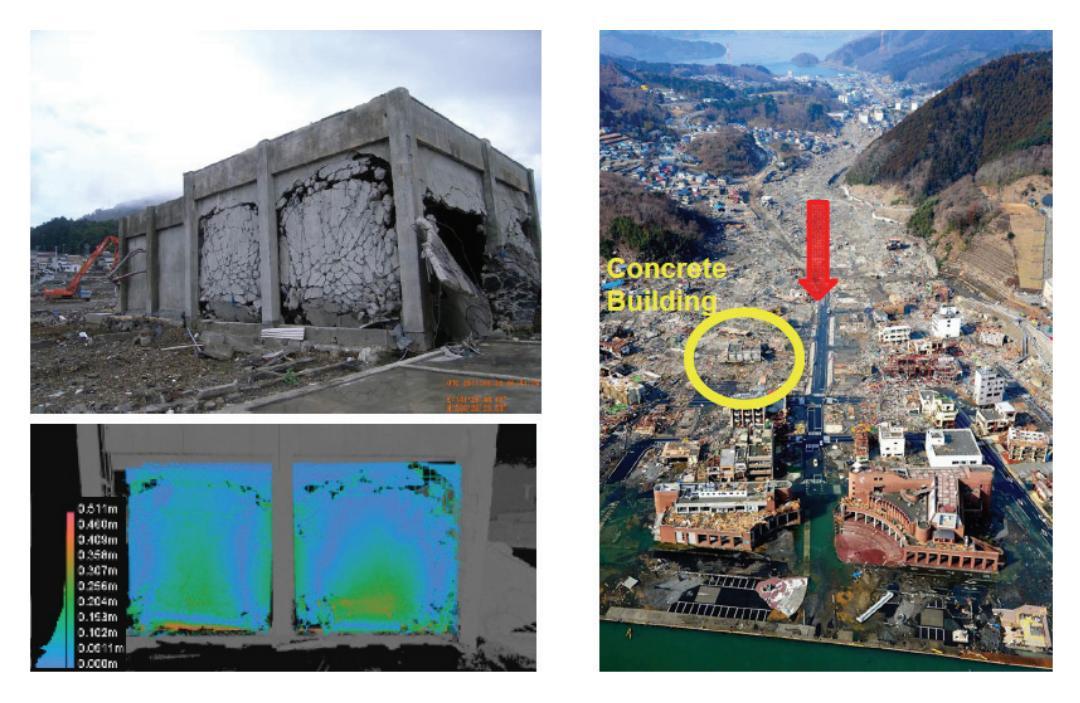
This case study was used to estimate flow velocity during the drawdown phase of the tsunami at Onagawa. The concrete warehouse building shown in Figure 4 had three sides enclosed and became

internally pressurized by flow stagnation during tsunami drawdown. The 3D laser scan shows large deformations of over 0.5 m in the larger wall panels, while the smaller panels had negligible lateral deformations. Analysis based on a stagnated hydrodynamic load was able to show that the larger panels in the exterior walls failed after flexural yielding of the panels followed by formation of a catenary membrane, then shear failure around the perimeter of the wall. The flow velocity for such a condition was at least 5.5 m/s. Some cracking due to yielding around the perimeter of the walls was observed in the smaller wall segments, but the segments did not fail. The shorter vertical spans resulted in reduced bending moments in these wall segments. It was calculated that a flow velocity of around 7.5 m/s would have been required to fail the smaller wall segments.

Fig. 4 Concrete warehouse wall failure due to internal pressurization in Onagawa. (a) Photograph, (b) 3D laser scan model (c) Building location

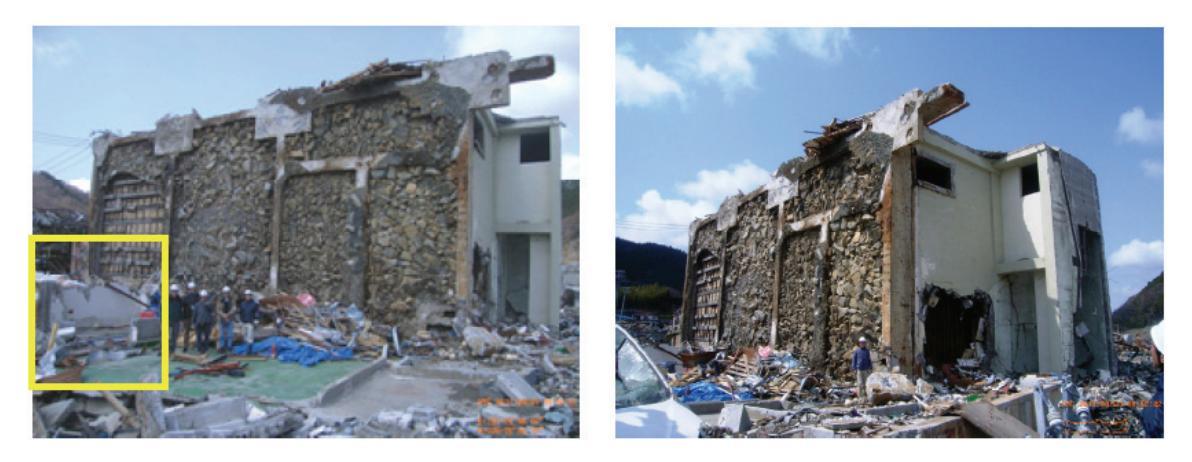
The building shown in Figure 5 was lifted by hydrostatic buoyancy off of its pile foundation, which did not have tensile capacity. This building was approximately 22 meters by 8.7 meters by 12 meters tall. Based on extensive field measurements and a concrete density of 2400 kg/m<sup>3</sup>, the total deadweight of the structure was 8995 kN. The refrigerated space on the ground floor was effectively sealed off, leading to a neutrally buoyant condition as soon as the water inundation depth reached 7 meters. The building was lifted off its original site and carried over a low wall (photograph on the left), before being deposited about 15 meters inland from its original location. It was apparently flipped over by contact with the top of the wall that it damaged in the process. The low wall had its top edge broken off. A large opening was chipped into the wall to access the interior of the building after the tsunami.

Fig. 5 The ASCE Tohoku Tsunami Reconnaissance Team at the Onagawa uplifted and overturned 2-story reinforced concrete cold-storage building

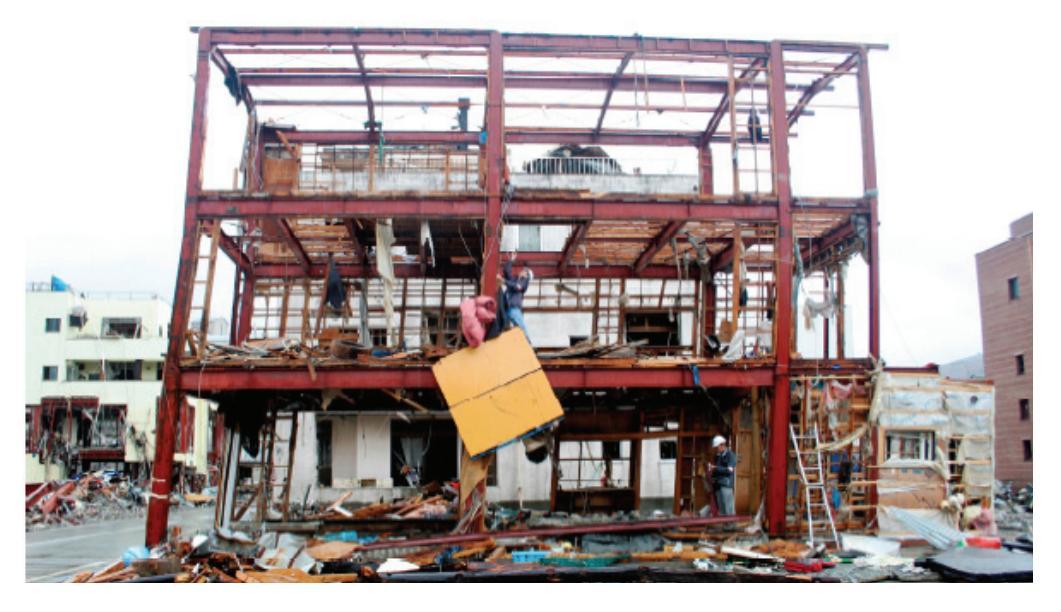
The three-story steel moment-resisting frame in Figure 6 was exposed to flow returning to the ocean estimated from video analysis at about 8 m/s. This flow was sufficient to yield the top and bottom of the second story columns and top of the first story columns with an estimated 67% blockage of the original enclosure, either from cladding still intact or debris damming. At the first yield point of the system, the calculated lateral drift at the third floor would be about 30 cm. Subsequently sustained flow induced further displacement. A subsequent LiDAR scan of the frame shows a third floor drift of up to 50 cm. Therefore, it is proposed that once yielding of the structure had occurred, with significant inelastic deformation, the blockage percentage reduced until loss of all cladding reduced the building's projected area , relieving the structure of much of the lateral pressure. Without such load shedding, collapse would have occurred.

Fig. 6 Onagawa 3-Story Steel Frame Pushover

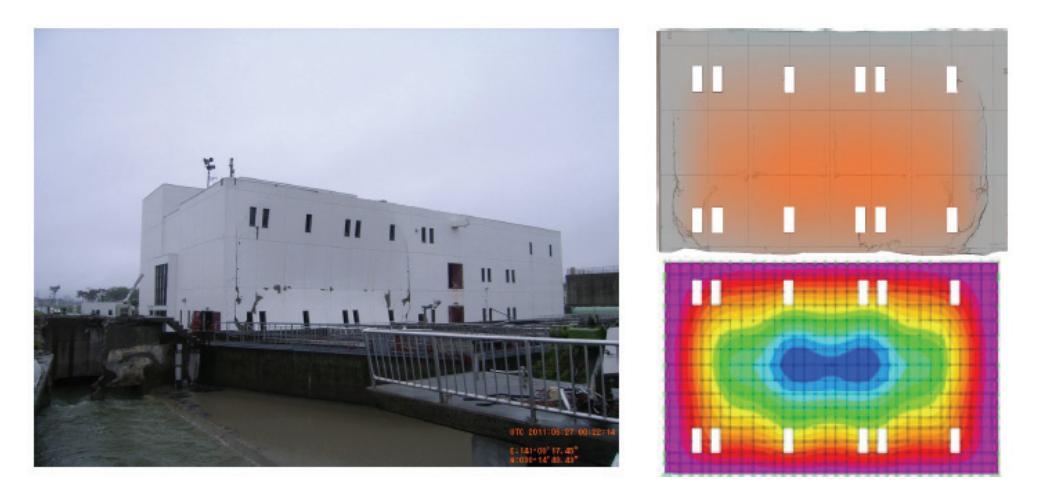
The Minami Gamou Wastewater Treatment plant building shown in Figure 7 is a three-story reinforced concrete building, located on the Sendai coastline south of the main port and approximately 350 meters from the coastline. Video of this facility in Sendai showed a tsunami bore directly striking the longitudinal walls of buildings. The ocean facing wall of a two story high-bay on one side of the building failed through out-of-plane flexure due to the large hydrodynamic forces.

Using inundation depth estimates by the Joint Survey Group and video footage, the resulting pressure distribution was applied to a nonlinear finite element model (FEM) of the reinforced concrete wall. A tsunami bore travelling over standing water and striking a wall is addressed by the method of Robertson, Paczkowski, and Riggs (2011) for structural walls oriented perpendicular to the flow direction with a width greater than  $3h_b$  or  $3h_j$ , whichever is smaller, as shown in Figure 8. The transient lateral load per unit width of wall is given by Eq. (1).

Structural drawings for the damaged buildings were obtained from the plant management. The bore forces were found to be sufficient to create the mid-height and top and bottom flexural yielding (Figure 9). The bore impact forces were also found to exceed the surge and hydrostatic forces resulting from the rising tsunami surge. It is concluded that repeated bore impacts were likely to be responsible for the amount of deformation found in this wall and another building nearby.

Fig. 7 Reinforced concrete wall at the Minami Gamou Wastewater Treatment Plant Pump Station damaged by direct strike from tsunami bore (a) exterior view, (b) LiDAR view (c) Analysis Plot

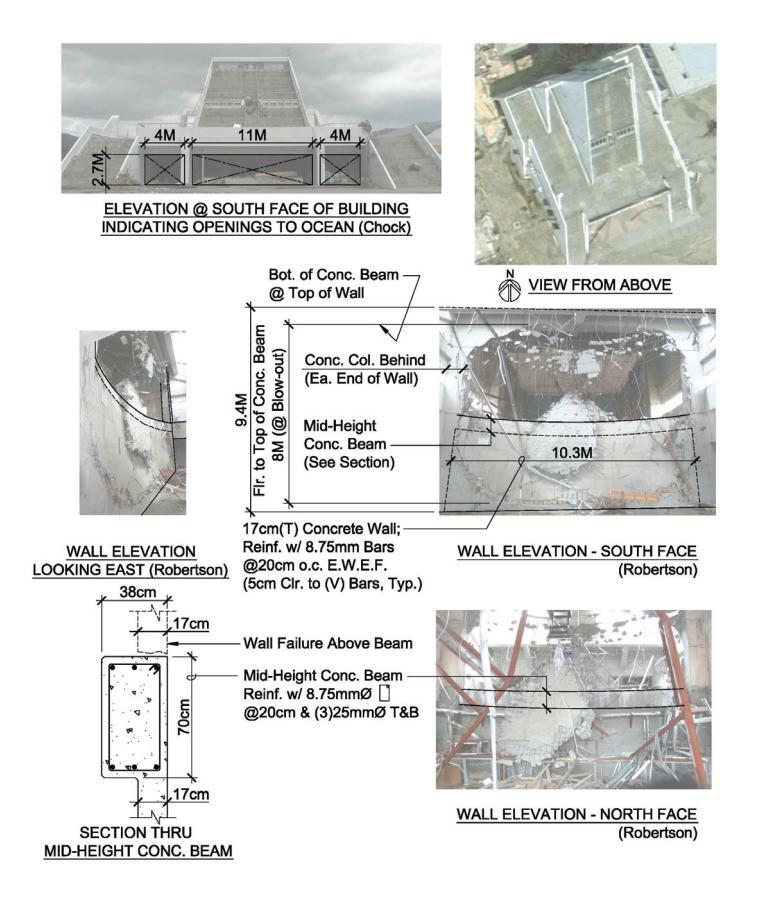
The Takada Matsubara Road Station in Rikuzentakata shown in Figure 9 endured a 10.5 meter tsunami inundation depth with flow of about 7.5 meters/second, but suffered a failure of its principal transverse shear wall due to unbalanced hydrostatic and hydrodynamic forces of the incoming tsunami. The wall was at the rear face of a three-sided concrete box with the opening in the fourth side being a main entrance into the building at the front facing the ocean. Reinforcing steel was sampled and tested at 510 MPa average yield strength, consistent with JIS G3112 SD 490.

Fig. 9 Large Wall Failure in the Takada Matsubara Building in Rikuzentakata

The probable sequence of nonlinearities ultimately leading to failure was found by stepwise nonlinear analysis of the progression of unbalanced hydrostatic and hydrodynamic loading to be:

- 1. Flexural yielding of the base of the wall as soon as the flow level reached 1.6 meters.
- 2. Bottom half of side edge supports of the wall and the two ends of the horizontal beam yield when the flow level reached 2.2 meters.

- 3. The top and upper portions of the side supports of the wall yield and concrete shear cracks occur at the bottom when the flow reaches 2.7 meters. Shear friction of the double dowels from the wall base foundation maintains stability of the bottom portion the wall.

- 4. Side supports and horizontal beam supports reach concrete shear failure cracking when the flow reaches 7.2 meters. The flexurally yielded wall essentially became a membrane.

- 5. The top and upper portions of the side supports reach concrete shear failure cracking when the flow reaches 9.5 meters. The top half of the wall is hanging in tension from the top beam.

- 6. At 10.5 meters, the upper portion of the concrete walls hanging in tension drops down and relieves further loading increase; the unbalanced hydrostatic forces are relieved.
