Damage of Buildings

Hitoshi Shiohara

Associate Professor, University of Tokyo, PhD, FACI Secretary, Disaster Committee, Architectural Institute of Japan (AIJ) Leader, Reconnaissance Group, Kanto Branch of AIJ

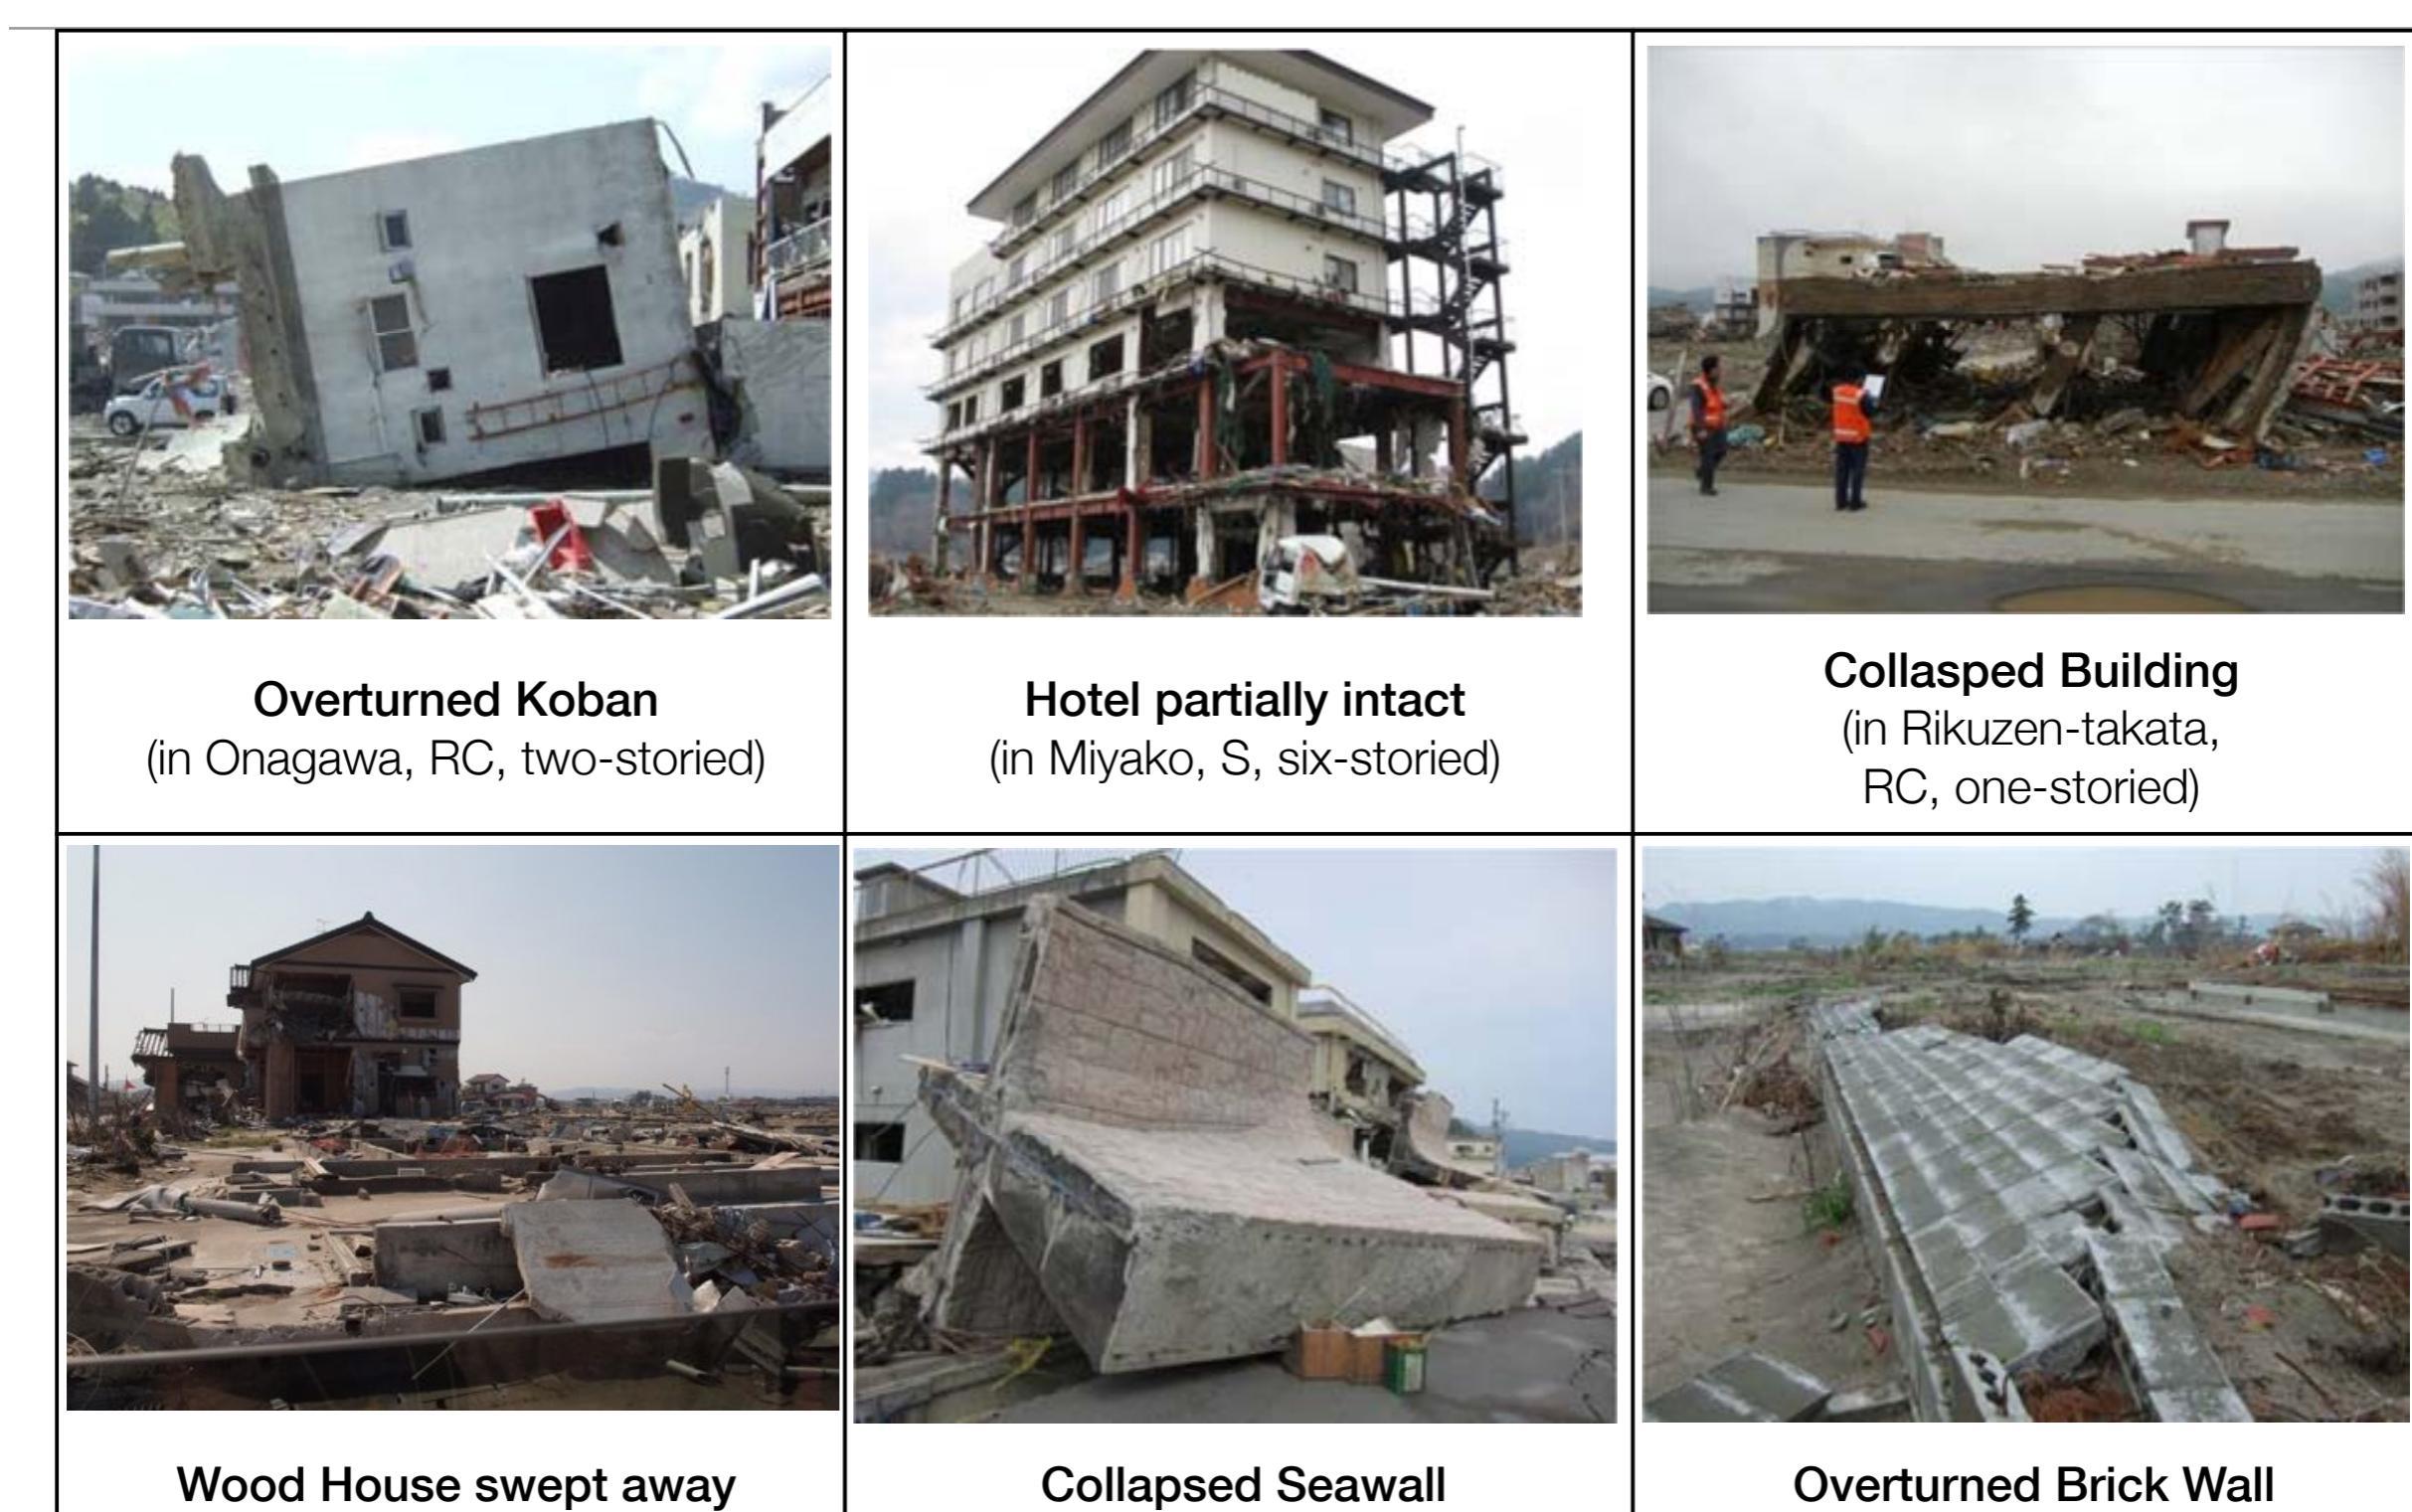
Typical Tsunami Damage to Buildings

(in Watari, W)

(in Yamada, RC)

(in Watari, Concrete Block)

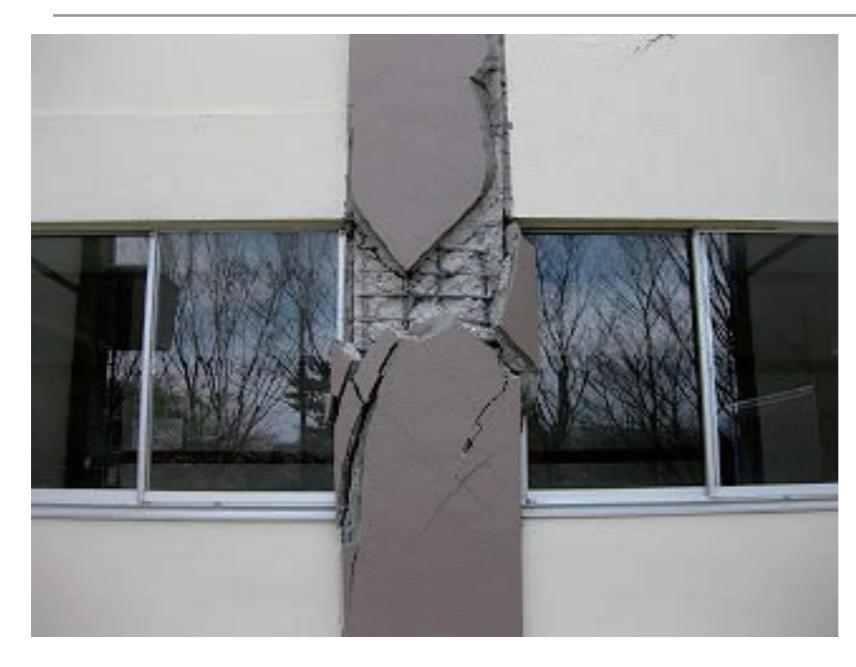
Shear Failure of RC Captive Column

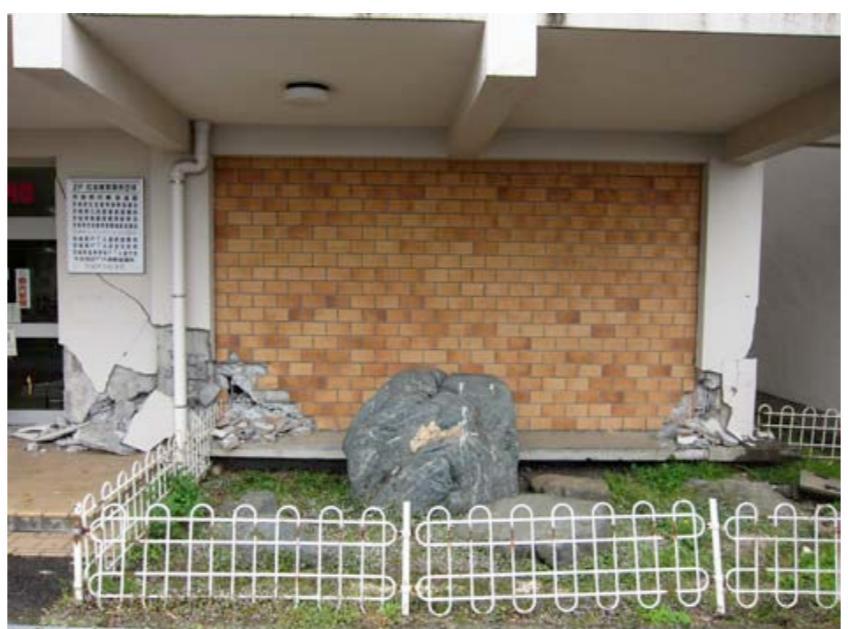
Shear Failure of RC Shear Wall

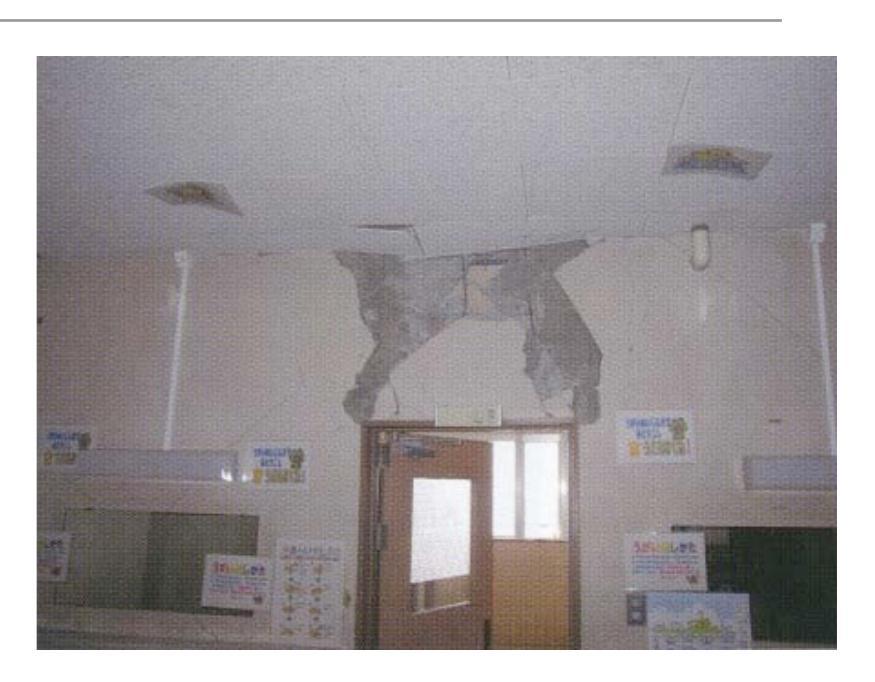
Shear Failure of RC Boundary Beam

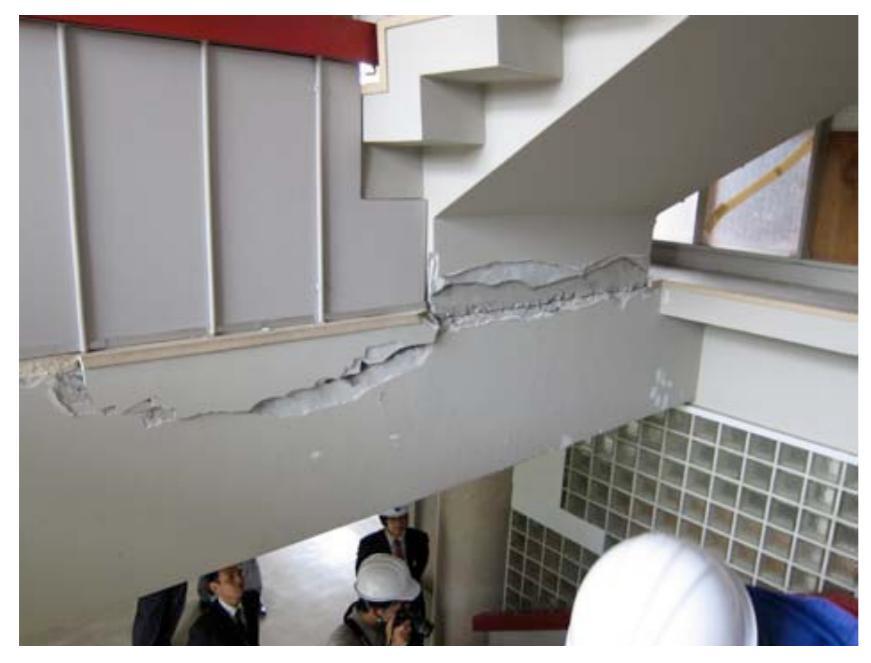
Failure of RC Stair Anchorage

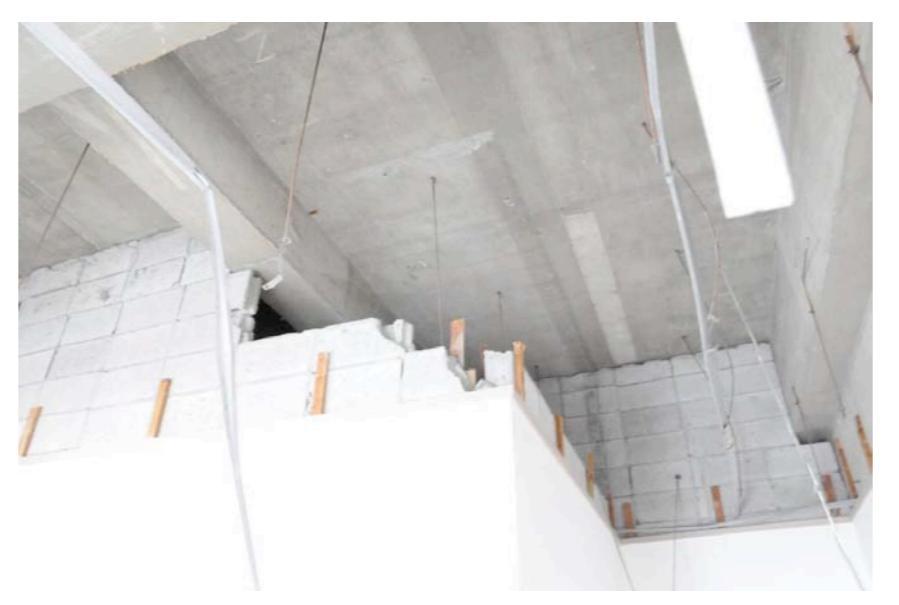
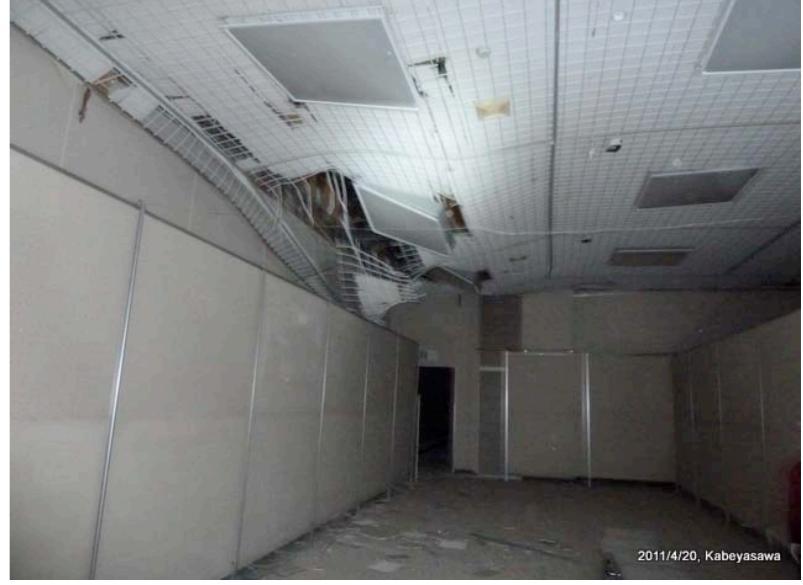
Fallen non-structural Concrete Brick

Fallen non-structural Ceiling

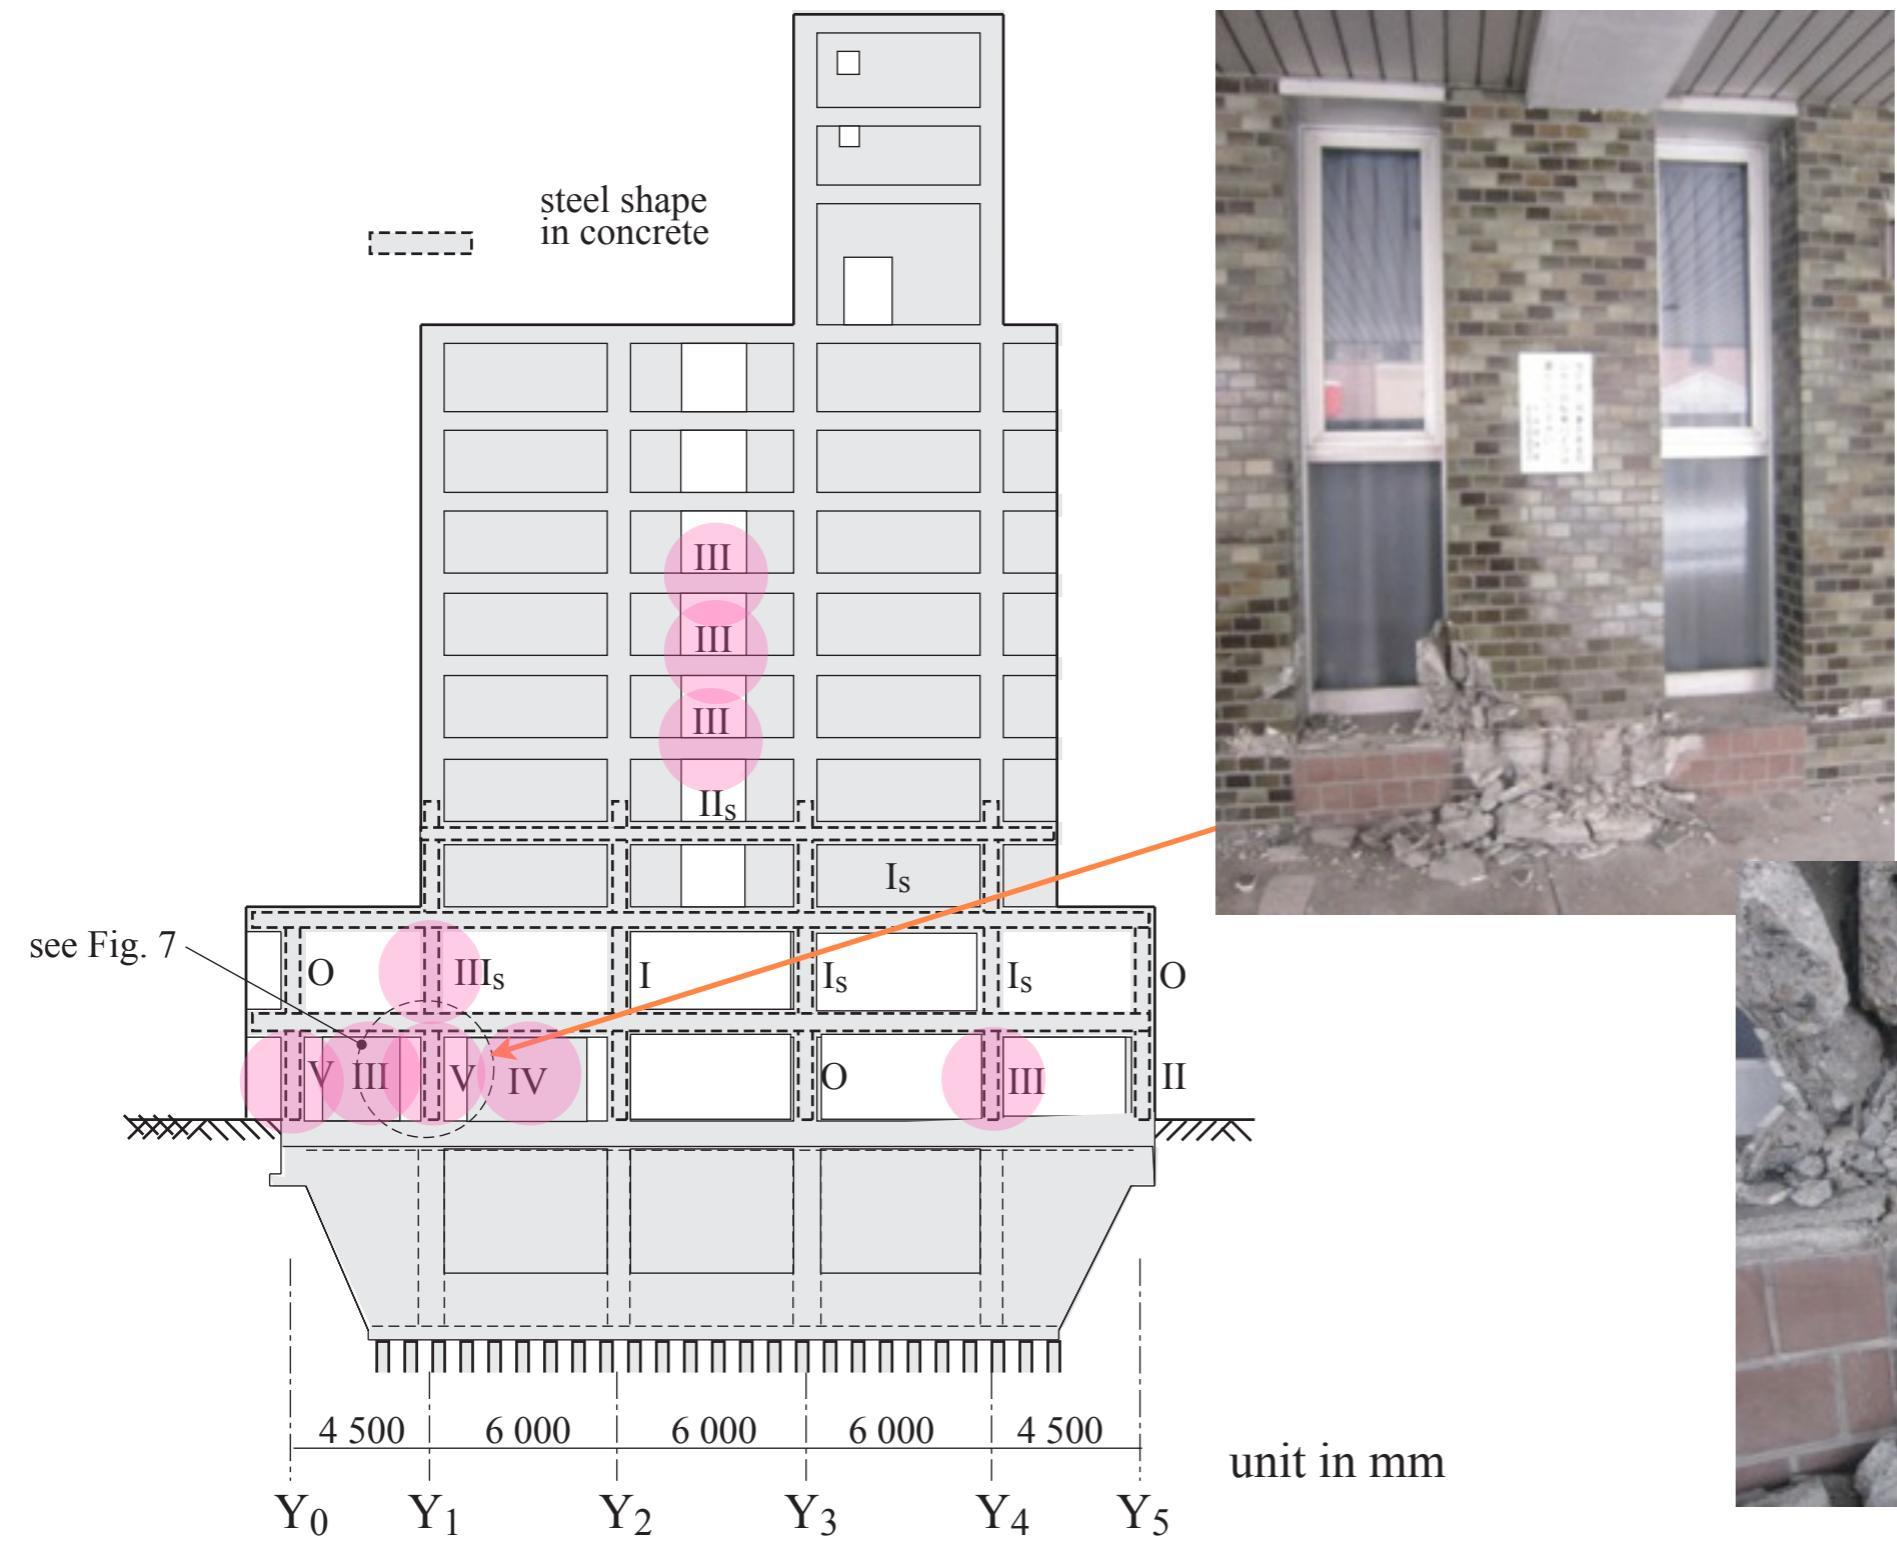
Elevation of X₁ frame in longitudinal direction

- Nagamachi Dwelling Complex Building
- Flexural failure of the first story SRC column
 - deficiency of steel lattice not embedded into the foundation which just ends at the first floor level.
 - abrupt change of section caused the damage.
- Shear failure of lightly reinforced beam-column joints.
 - calculated margin of joint shear strength is 2.0 or more.
 - column-to-beam strength ratio is in the range of 1.26 to 1.48.
 - vulnerablity of column-to-beam strength ratio between 1.0 and 1.5 are to joint shear failure.
 - problem in failure mode prediction

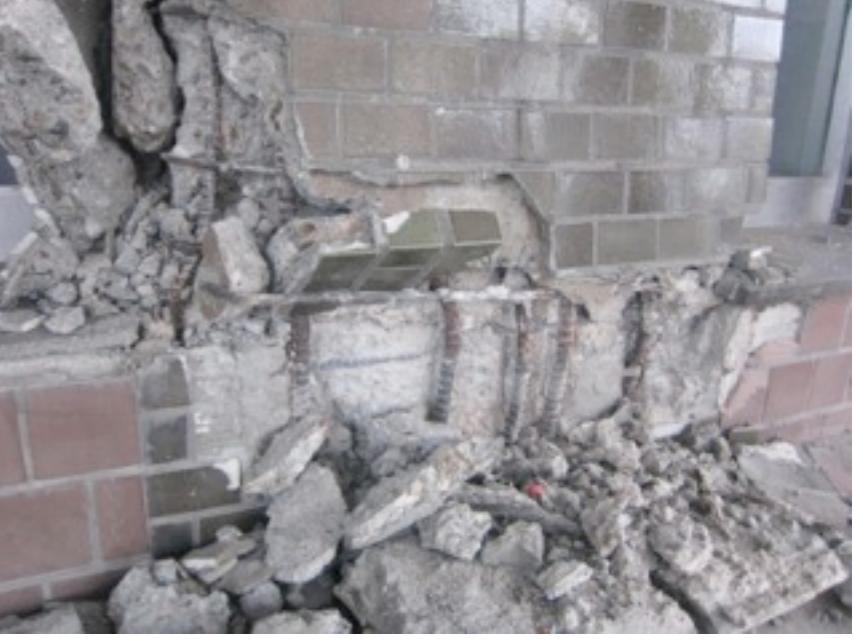
flexural failure and buckling of rebars at the bottom of column

Damage grade : V

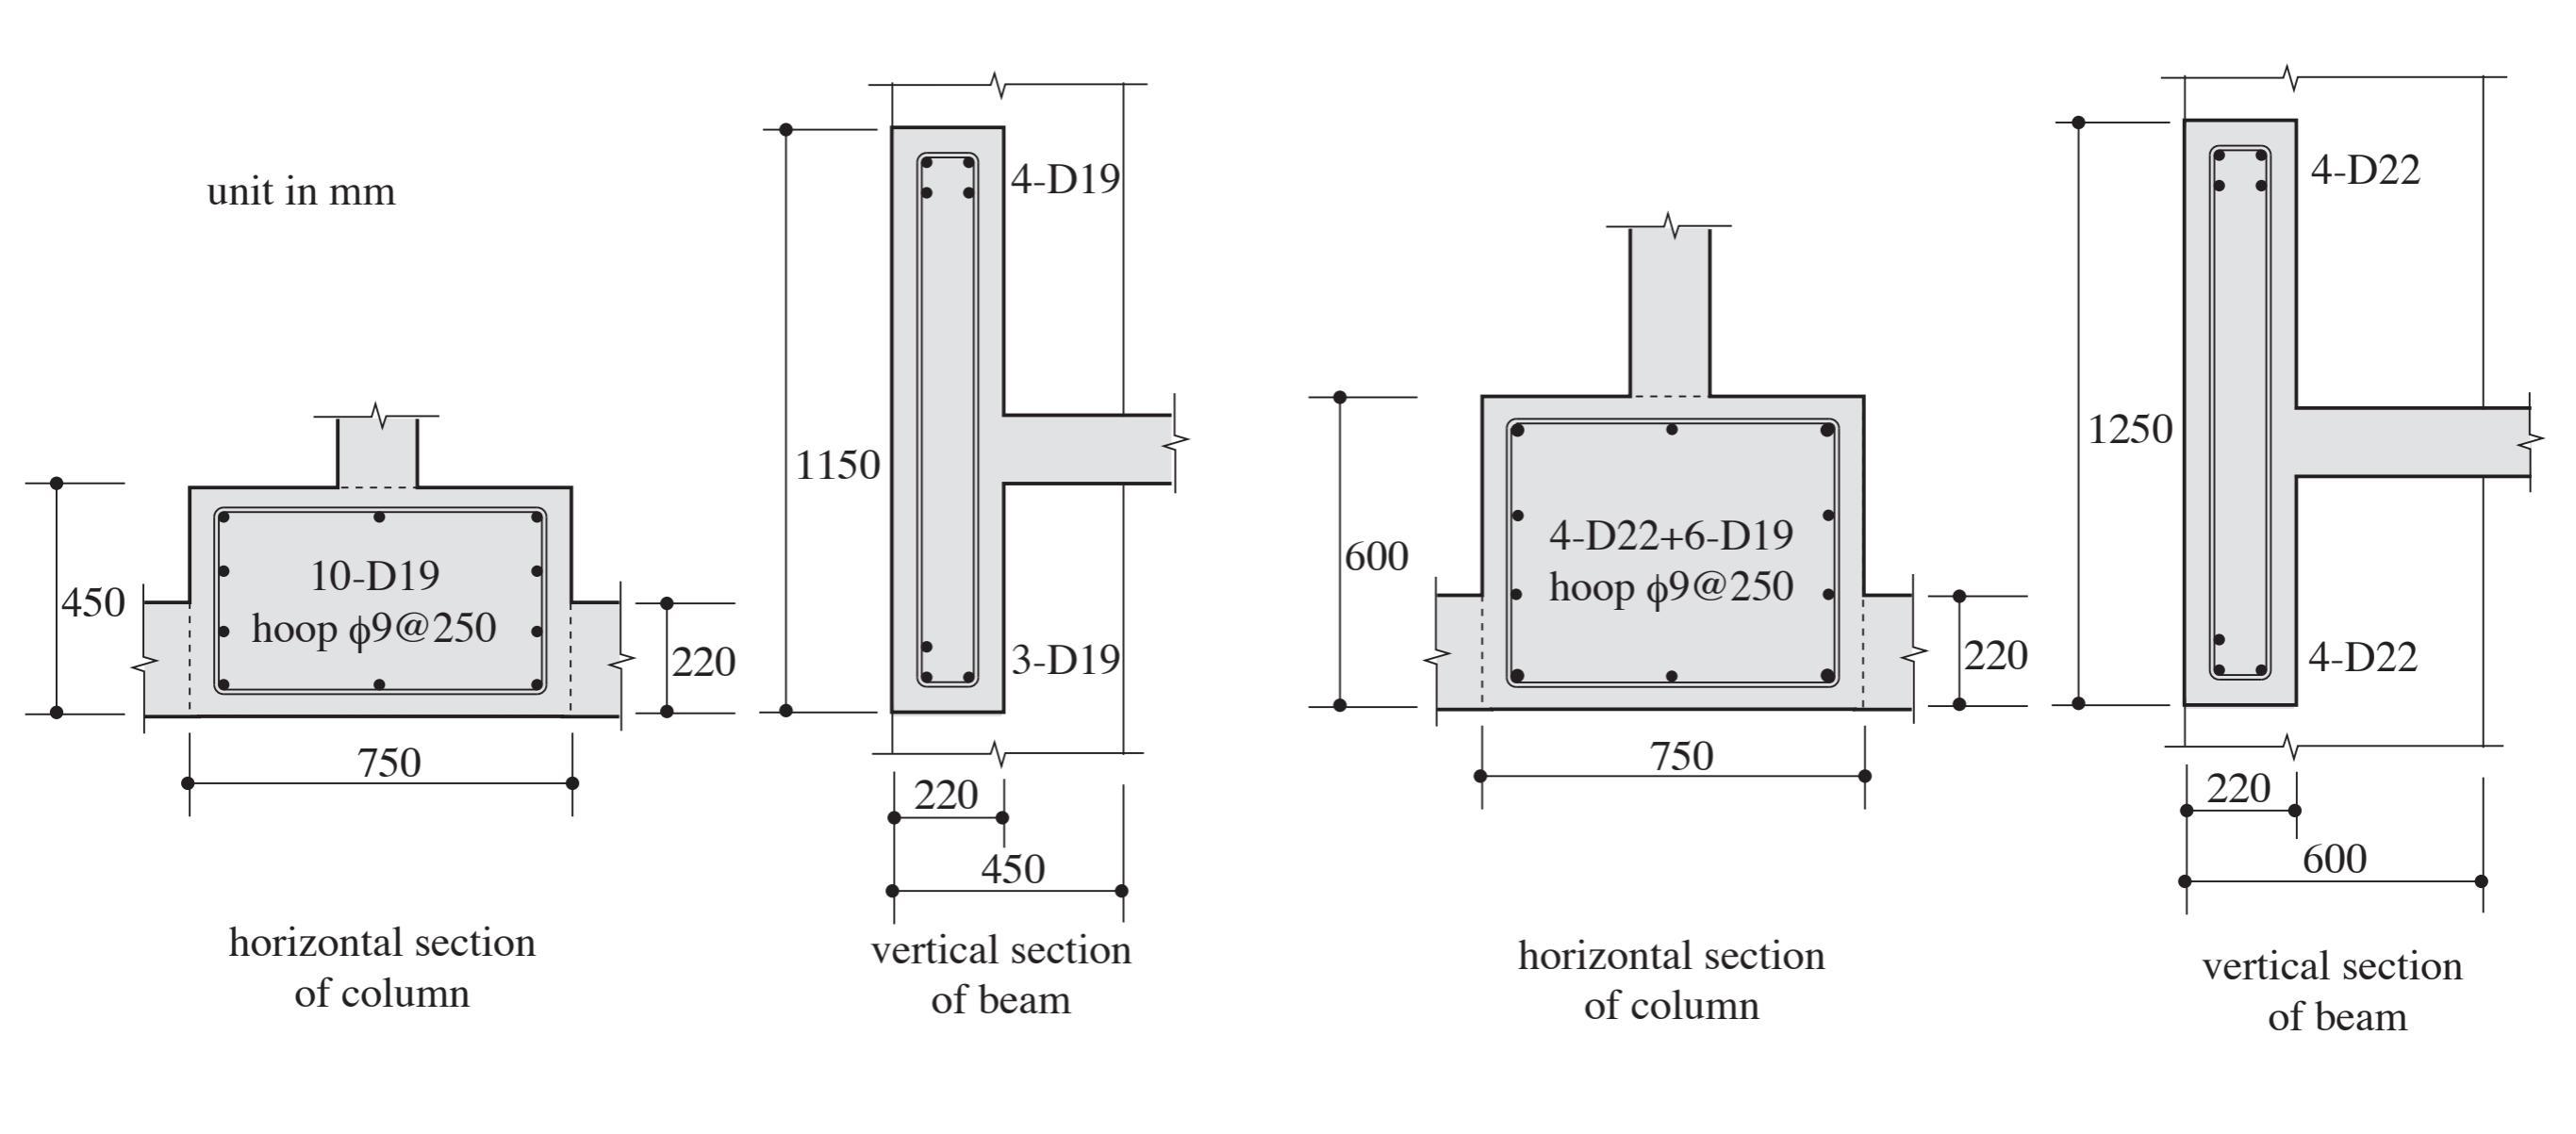
Detailing : Beam-column Joints

(a) Beam-column joint at 7F (X_5 - Y_4)

(b) Beam-column joint at $5F(X_5-Y_4)$
