A QUICK REPORT ON PAZARCIK AND EKİNÖZÜ EARTHQUAKES (TÜRKİYE) OF FEBRUARY 6, 2023

Ömer AYDAN* and Reşat ULUSAY**

15 February 2023

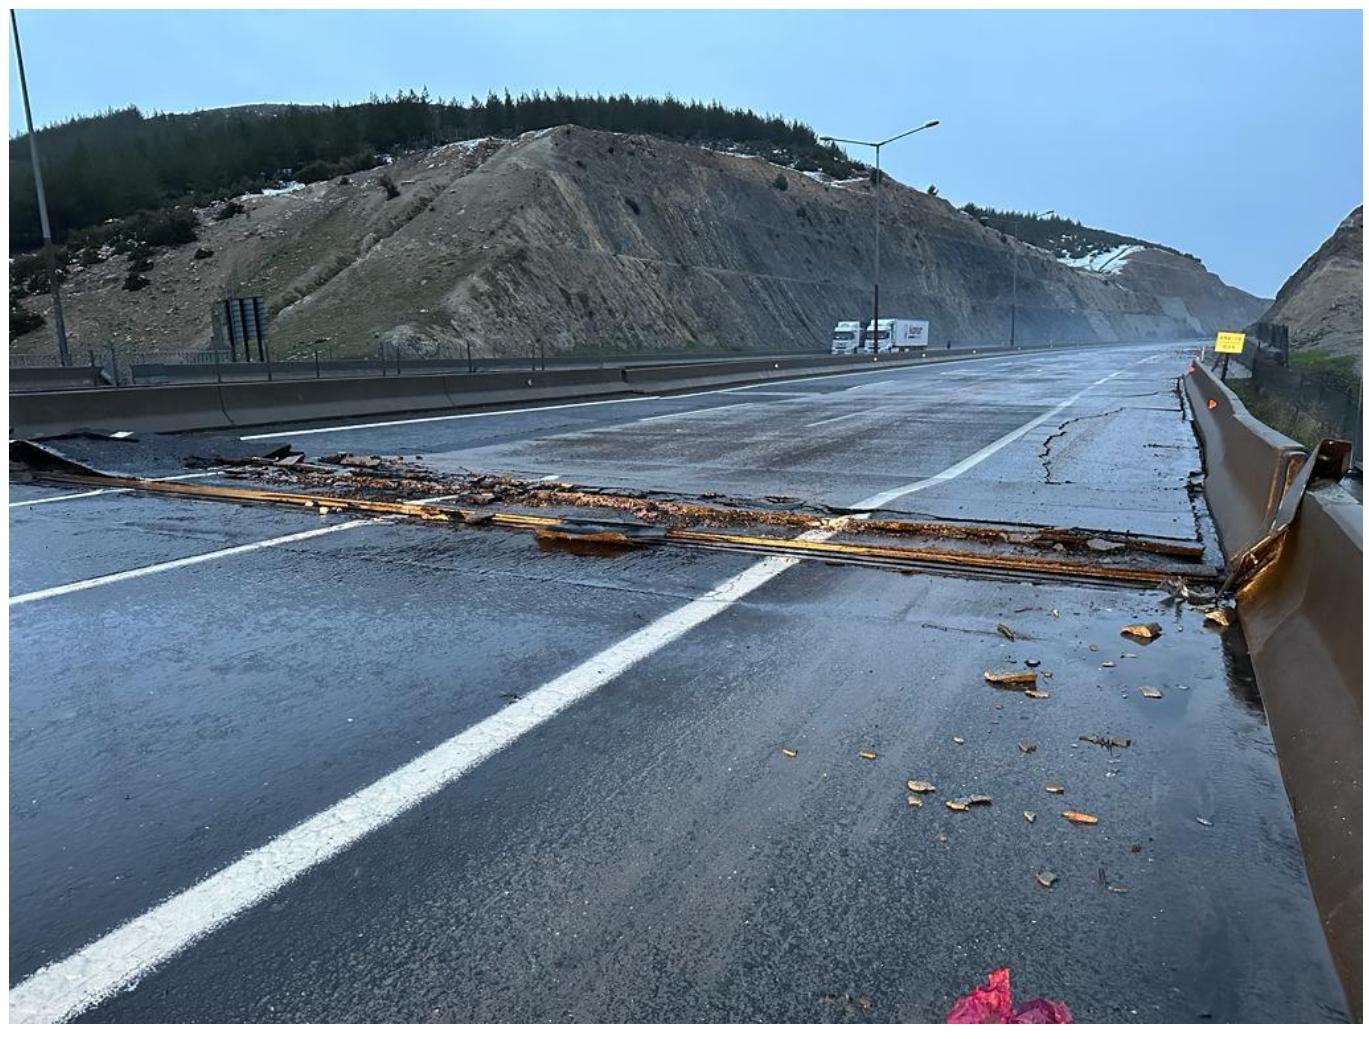
Separation or collision of bridge deck with abutments

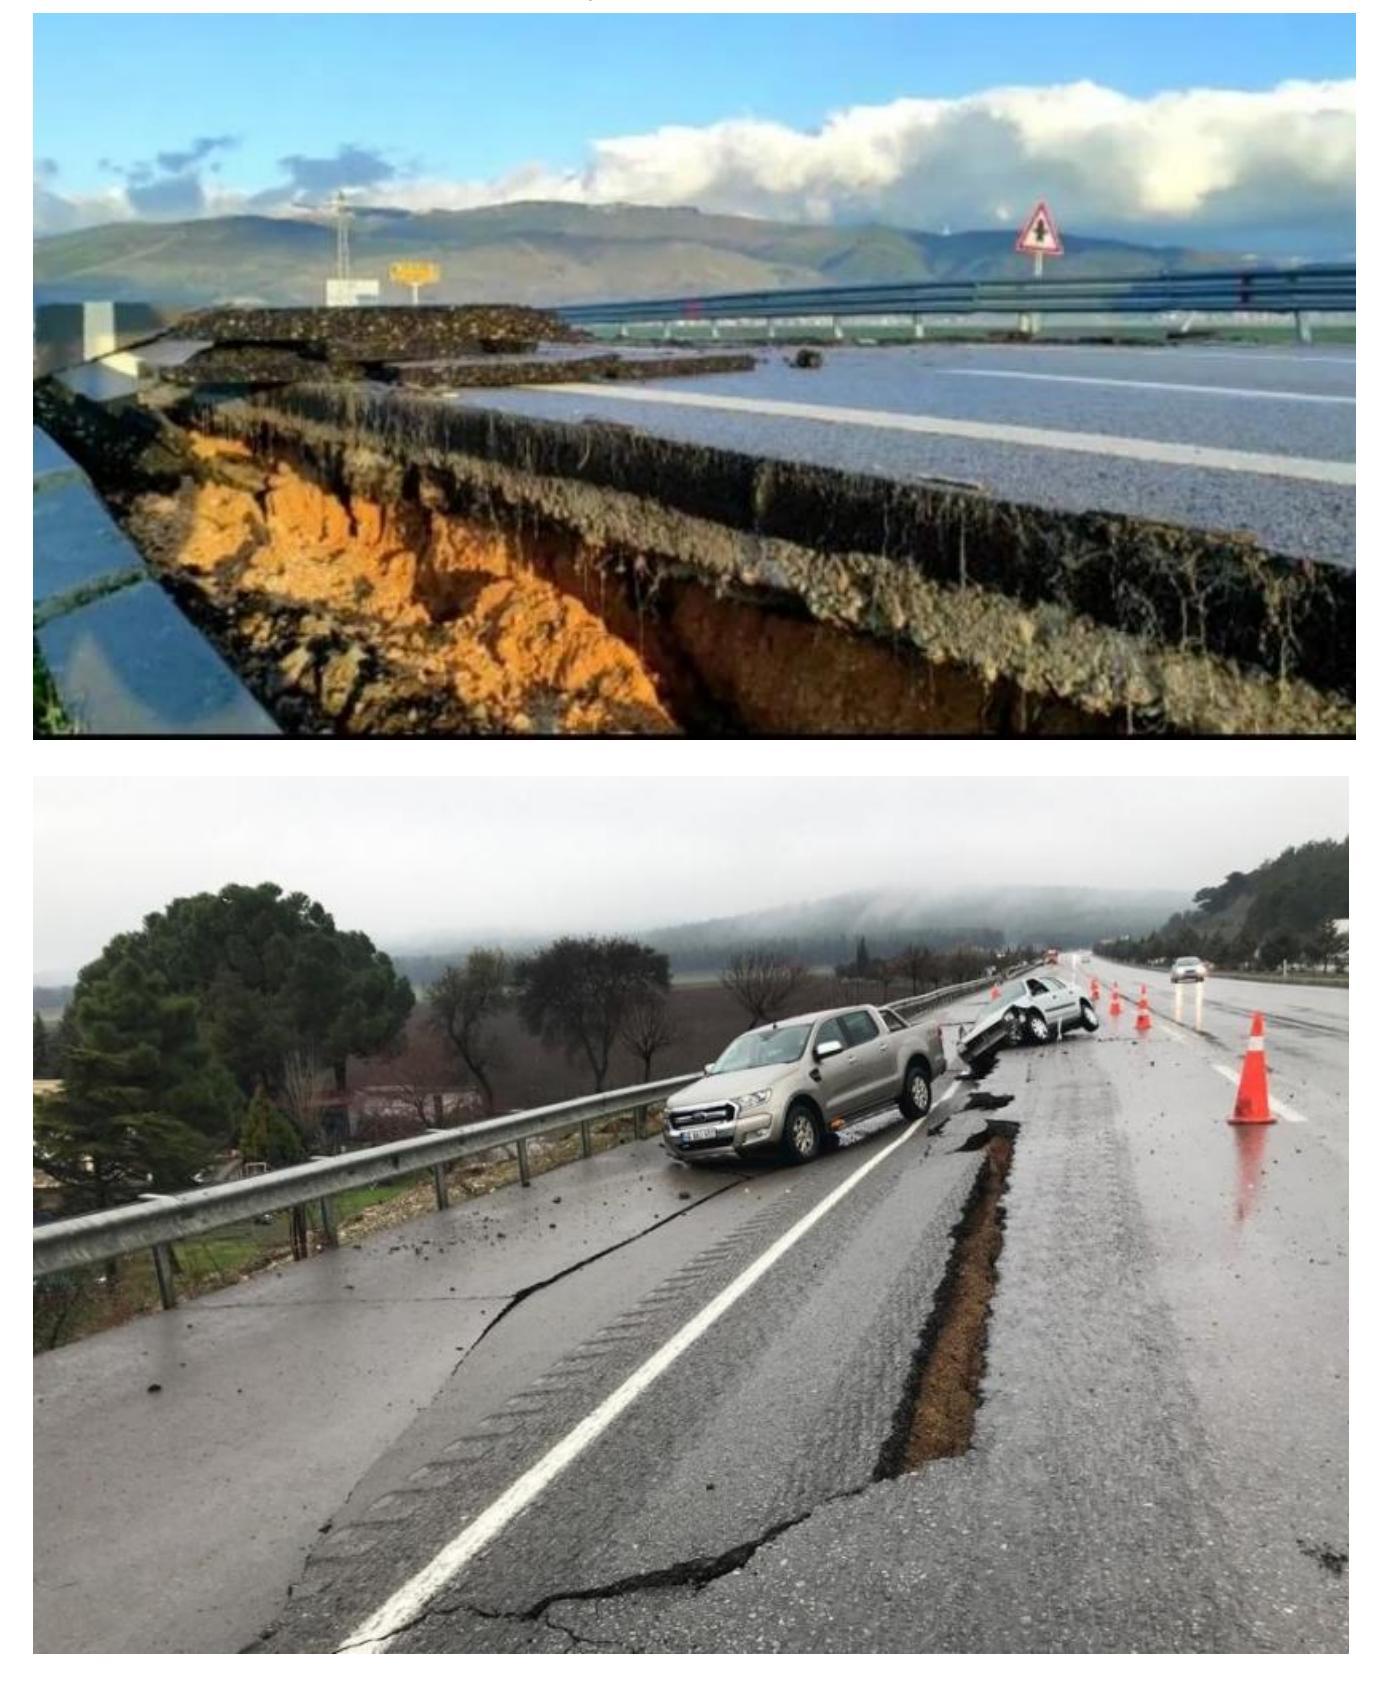
Damage of Tarsus Adana Gaziantep (TAG) near Islahiye by the fault rupture

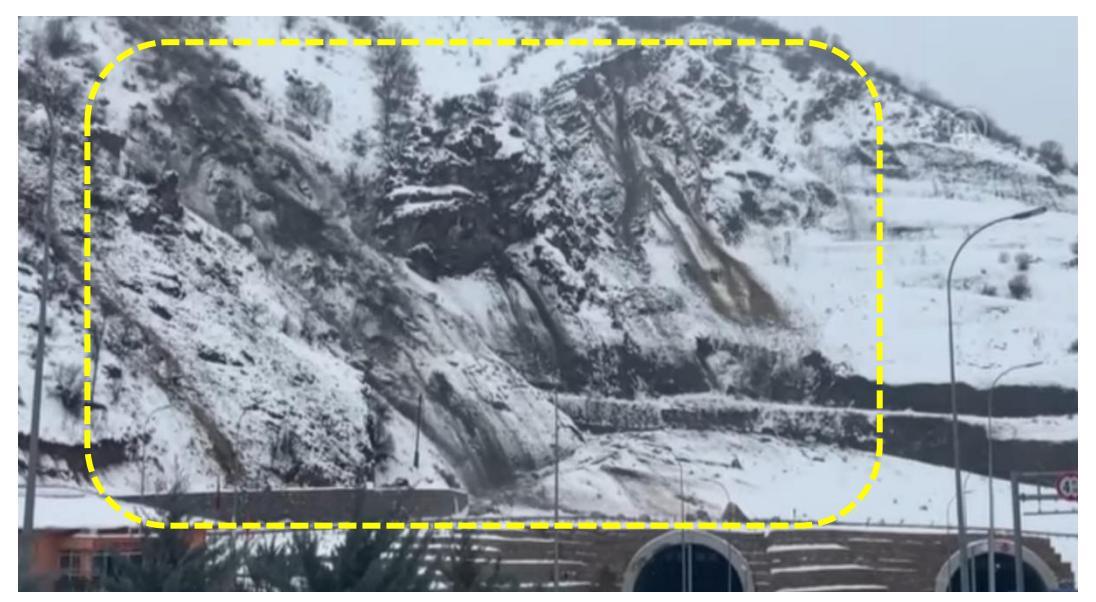
Rockfalls at the portal and spalling of concrete lining of the Erkenek Tunnel occurred as reported by KGM. One of Erkenek Tunel tubes is closed to traffic while the other is utilised for traffic despite some spalling location of the lining were reported at some locations. The tunnel was almost on the activated Erkenek fault.

Traces and Rockfalls above the portals of Erkenek tunnel (Photo: Internet)

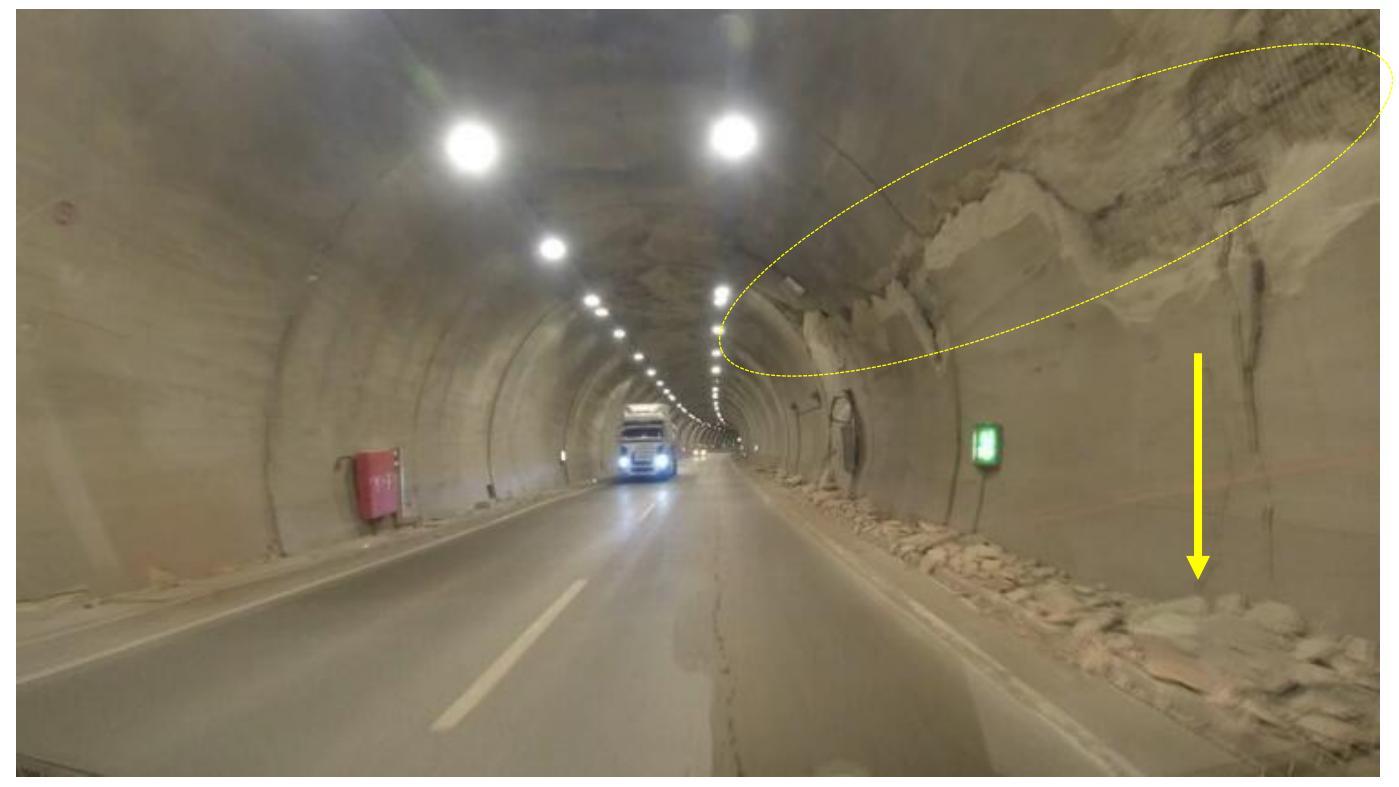
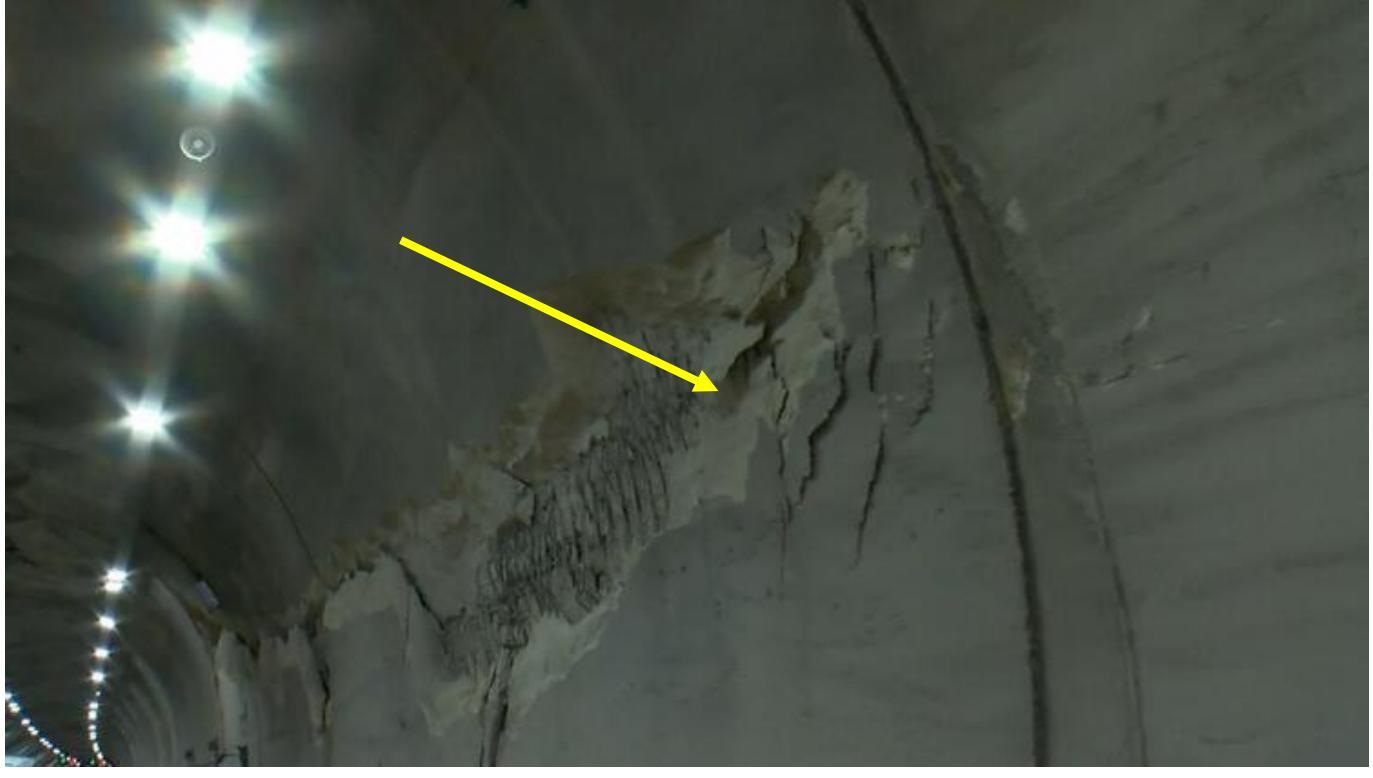
Spalling of concrete linings in Erkenek Tunnel

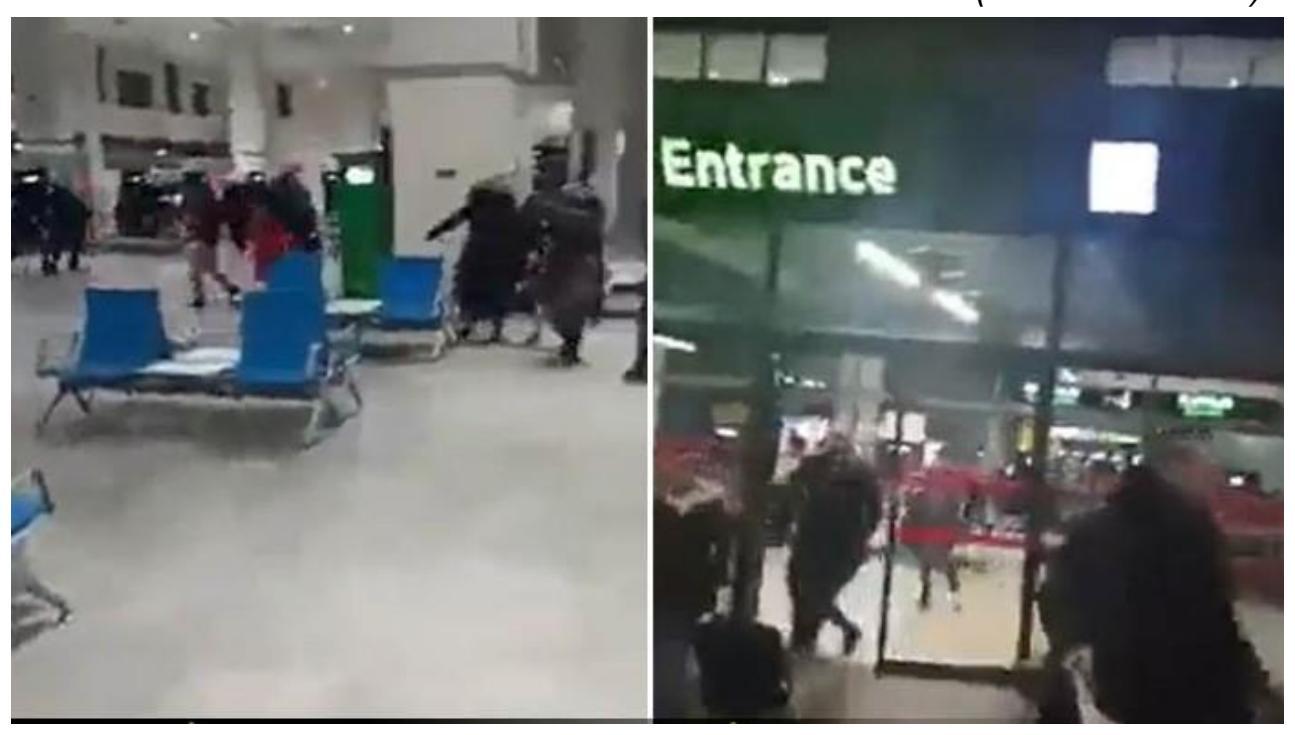
Gaziantep Airport at the time of Pazarcık earthquake occurred. Note the small pieces of debris falling from the suspended ceilings. Similar situation occurred at Malatya Airport.

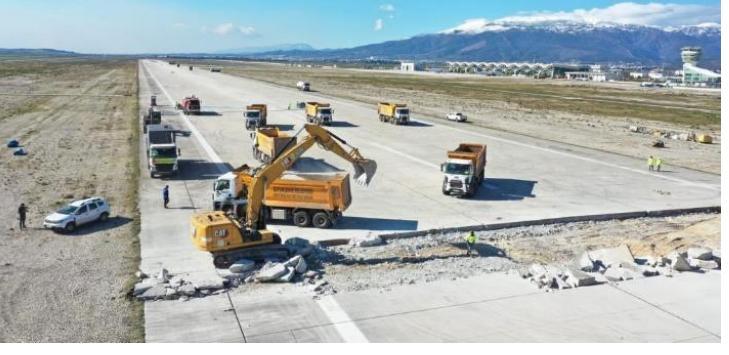
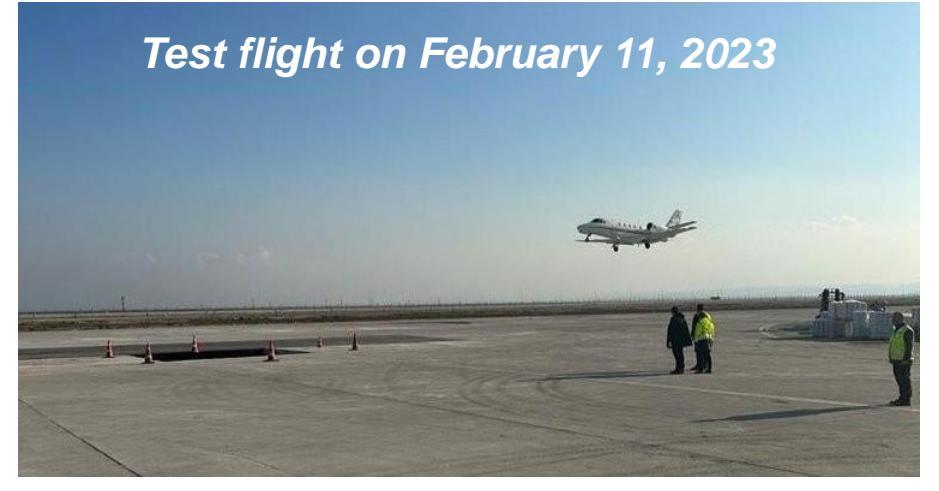
Runway buckled at Hatay Airport

Runway was repaired on February 11, 2023

First flight was done on February 12, 2023

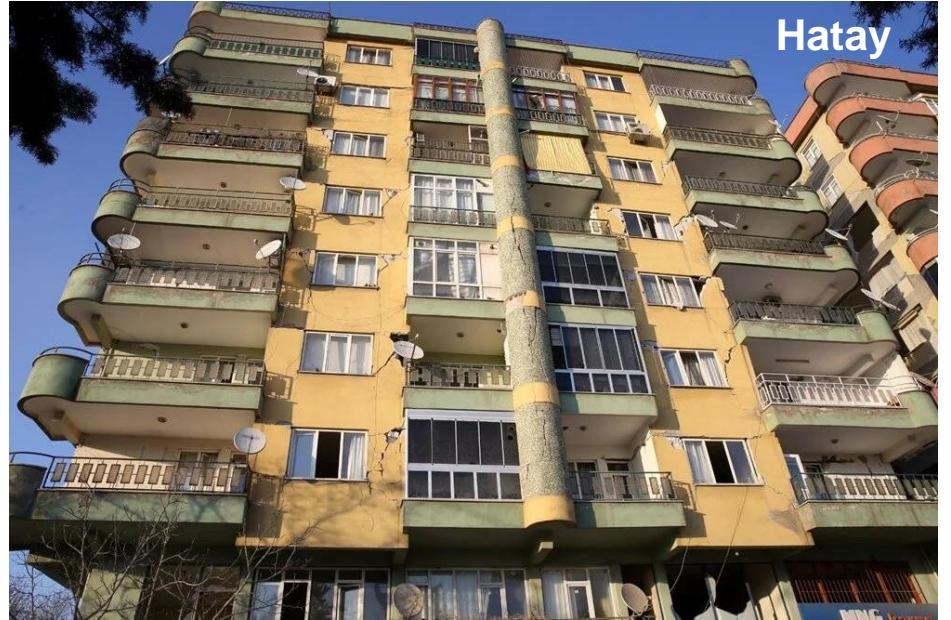
Adıyaman

Poor workmanship: There are two kinds of poor workmanship. One of them is that the connections of columns and beams were very weak since the connections of steel bars were not properly done. The second one is that the granulometry of the sand and gravel of concrete was very poor and the range was wide. In addition, big chunks of gravel blocked the concrete during casting at locations where steel connections were dense and this resulted in very porous and weak connections. During shaking, it seems that concrete at the connections first failed and this subsequently caused the buckling of steel bars at such locations and rupturing infill hollow brick walls in a brittle sense. As a result, the collapse of buildings ended up in a pancake mode.

Construction negligence and lack of moral: One of the most striking construction negligence was the confinement of concrete at the beam-column connections in-spite of the Turkish design code for seismic regions. As stir-ups were very few at such locations, the failure of concrete was very brittle and it could not absorb the work done by the earthquake forces.

Soft Story: Many buildings had shops at their ground floor. As there are generally no shear-walls to take up the load during earthquakes, the total load is transferred onto the columns. The super structure acts as a top-heavy structure on the columns and in-fill walls, which are in poor contact with columns and beams, has no effect against the earthquake loading and they fail subsequently.

Buildings with problematic issues mentioned above (Photos: Internet)
