## INITIATION OF HILLSLOPE DEBRIS FLOW AFFECTED BY CHI-CHI EARTHQUAKE, TAIWAN

**ABSTRACT:** A reconnaissance was conducted to hillslope debris flows (HDF) which affected by Chi-Chi earthquake and Typhoon Morakot. Historical PGA and cumulative - and intensity rainfalls at debris-flows initiation time were studied to figure out the initiating characteristic of debris flows. Result shows that the earthquake related HDF not only initiation in high PGA region but also in moderate PGA region (100 to 250 gal). As PGA increasing, the triggering cumulative - and intensity rainfalls of HSDF are decreasing. Shocking by Chi-Chi earthquake, rock mass developed dense cracks enhancing landslide potential and stored the material for the circumstance of HSDF.

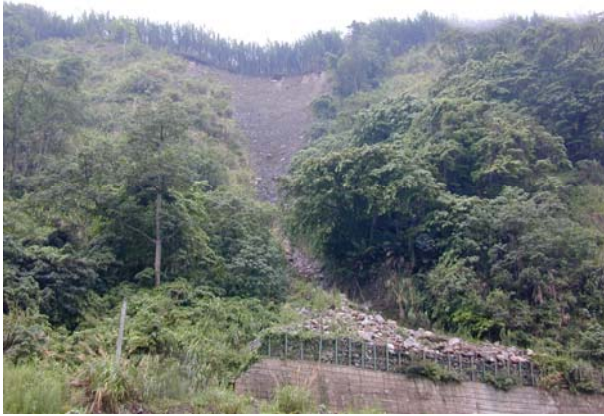
Fig. 6 HDF in Moi-Li after Chi-Chi earthquake.

Hillslope debris flows (Brunsden 1979) are one of the most common geomorphic phenomena in mountainous areas. A shallow landslide evolves into a debris flow (Bathurst et al, 1997). They have been described as the “rapid mass movement of blocky, mixed debris of rock and soil by flow of wet, lobate mass”, as “the downslope flow of debris mixed with a minor, yet significant, amount of water” (Innes 1983). Brunsden (1979) pointed out that they typically occur on slopes with abundant nonconsolidated sediments, steep gradients, scarce plant cover, and no previous rills or incised channels. Scars develop at the rupture area, and a tongue develops with lateral levees ending in a frontal lobe with imbricated, nonsorted clasts (Johnson and Rodine 1984). The earthquake and typhoon related HDF are shown as Fig. 6 and Fig.7.

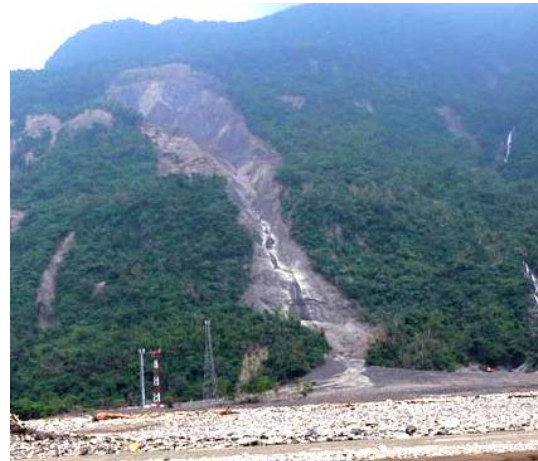
Fig. 7 Lui-Que HDF in Typhoon Morakot.

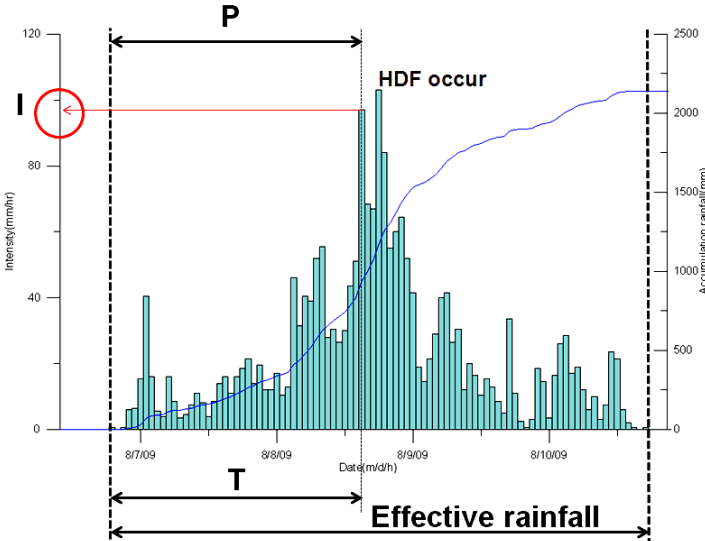
Fig.10 The schematic of triggering intensity and effective accumulation rainfall

Hours rainfall records of three typhoon events, overall gauges in Taiwan Island, were collected and developed in a database for the HDF triggering rainfall determination. We surveyed the HDF initiation times by investigation in field, News records, and reports of government agent and considered with the geomorphic factors and rainfall history. The effective rainfall composed of antecedent and present rainfall was introduced to character the triggering rainfall of HDF. The calculation of rainfall Intensity  $I$  (mm/hr) and effective accumulation  $P$  (mm) at the most possible initiation moment of HDF are illustrated in Fig. 10. There are 74 cases out of the 80 HDF cases (~ 92 %) related to high intensity rainfall with rainfall intensity exceeding 30 mm/hr. Most of Chi-Chi earthquake relating HDF cases (~ 48 %) with the effective accumulation >400 mm, oppositely, the effective accumulation are higher than 400 mm for most of Typhoon Morakot cases.

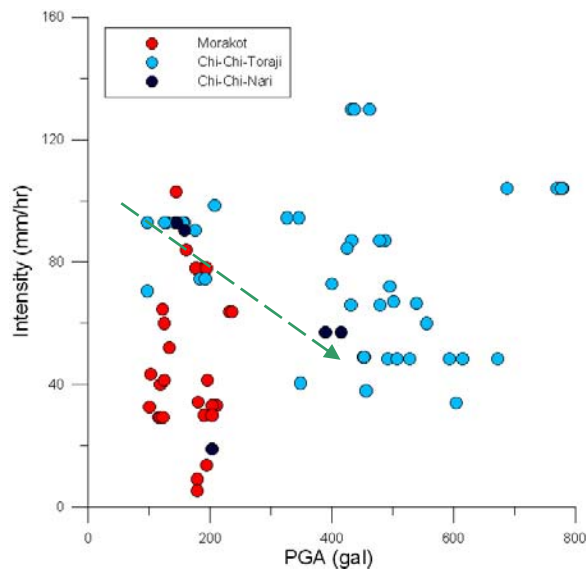
Fig. 11 The distribution on the triggering rainfall intensity and PGA of HDFs

As shown in figure 11, the HDF location distributes from 100 gal to 800 gal in Chi-Chi earthquake events, the HDF is rare in the region of PGA lower than 100 gal. There are 14 cases out of the 50 HDF cases (~ 28 %) in which PGA between in 100 to 250 gal (Level 5 earthquake intensity of CWB). It point out the potential of HDF not only initiation in high PGA region but also in moderate PGA region, the HDF potential area for disaster mitigation seen be considered to spread to the regions of PGA 100 gal and up. The threshold of HDF triggering intensity decreased, as earthquake's PGA increased. The lowest triggering intensity of is about 20 mm/hr in which PGA was 208 gal. HDFs located in the region lower than 200gal have a tendency towards higher triggering intensity, oppositely the one in high PGA region tend to lower triggering intensity.

It also showed in the figure, the HDF location distributes from 100 gal to 250 gal in Typhoon Morakot events, the HDF is also rare in the region of PGA lower than 100 gal. There are total 29 cases HDF cases in which the maximum PGA lower than 250 gal, included the Chi-Chi earthquake event, in last decade. There are not clear tendency on PGA and intensity because the HDF are also influenced by effective accumulation rainfall. Most of HDF triggering intensity was higher than 35 mm/hr despite 3 cases of effective accumulation more than 1000 mm.

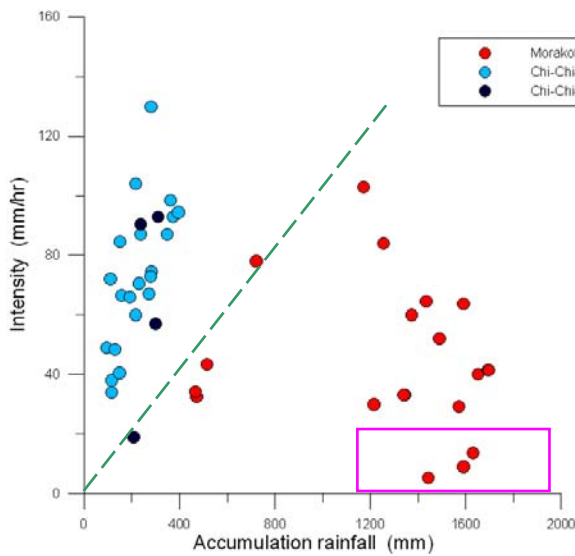
Fig. 13 The magnitude of HDF of Chi-Chi earthquake and Typhoon Morakot related

Fig. 13 shows the distribution of triggering intensity and effective accumulation of HDF. Two groups are observed in the figure, the earthquake related group shows a tendency to 74% of HDF's intensity higher than 50 mm/hr despite there were lower accumulation rainfall; in contrast, only 59% of Typhoon's HDF that the intensity was lower than 50 mm/hr but the P was higher than 1000 mm mostly. It also demonstrates the difference of HDF related to earthquake and typhoon.
