SOIL SUBSIDENCE MAP OF THE TOKYO BAY AREA LIQUEFIED IN THE MARCH 11th GREAT EAST JAPAN EARTHQUAKE

ABSTRACT: The March 11th 2011 East-Japan Earthquake has caused sand-liquefaction over a long stretch of landfills along the coast of Tokyo Bay. An attempt was made to detect soil subsidence from airborne LiDAR (**L**ight **D**etection and **R**anging) images before and after the earthquake. To cancel out deep-seated tectonic displacements and systematic errors of LiDAR, the template matching technique is used for the end-bearing pile-supported buildings chosen as the template in the source image of the target area of Urayasu. The obtained subsidence map describes the spatial distribution of soil subsidence in great detail.

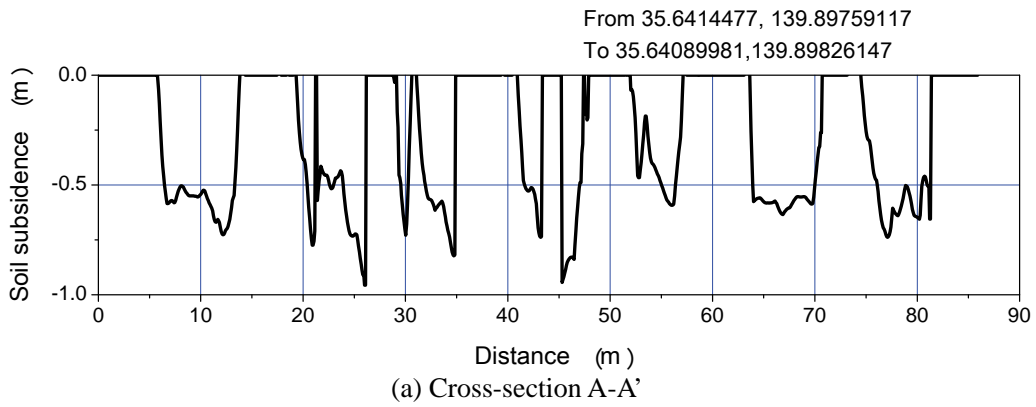
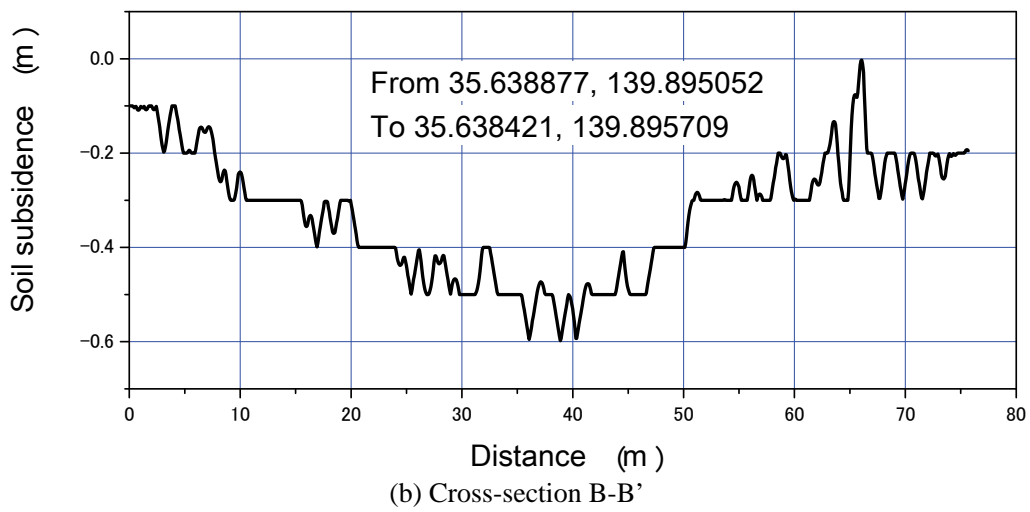
Fig. 6. Cross sections across stripe of soil subsidence that appeared in Benten residential area. Only subsidence of house roofs is shown in Fig. 6(a).

Zooming in on one of residential areas, Benten, a clear blue brush of large soil subsidence is found running across several town blocks as indicated with arrows in Fig. 5. In these residential town blocks, where strip footings and mat foundations are the most common, houses have sunken in the soil by about 0.5m in average as shown in Fig. 6(a). The southwestern extension of the brush appeared as sand blows lined up in the schoolyard of Miakegawa Primary School (Fig. 7(a)). Later, on April 24, there appeared a puddle as shown in Fig. 7(b) due to a heavy rain of April 23rd 2011. Fig. 7(b) shows a cross-section of this school yard where the deepest subsidence of about 0.5m was reached.

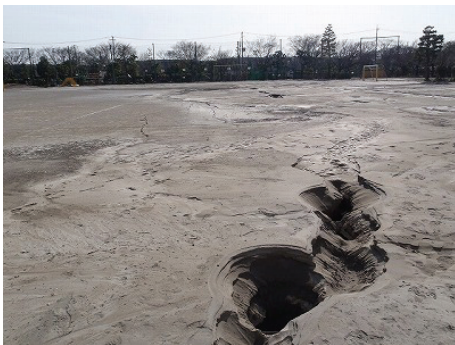
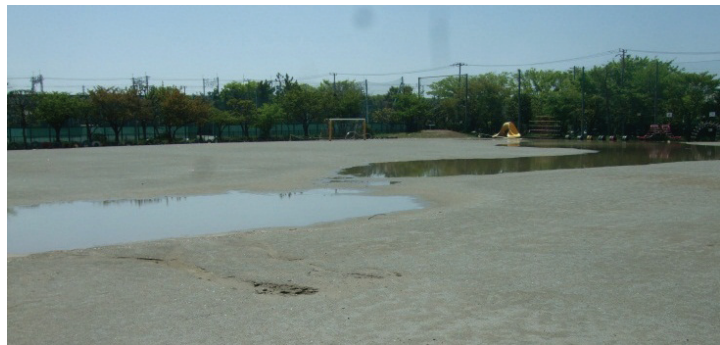
(a) Sand blows lined up in school ground
March 19th at 35.638933, 139.895619

(b) Puddle appeared in school ground
April 24th at 35.639117, 139.895471

Fig. 7 Extension of the subsidence stripe appeared in a school-ground of Miake Primary School

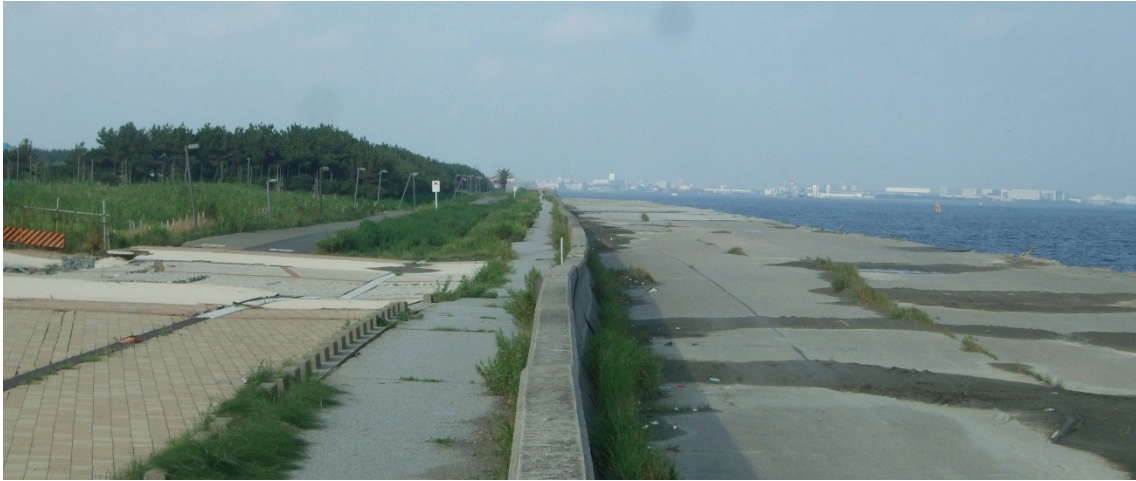
Fig. 8. Seawall pushed forward (Photo taken on Aug. 1st, 2011 at 35.63666, 139.931638)

All these observed features may suggest that the surface soil has spread laterally in the normal direction with respect to the brush of soil subsidence allowing liquefied sand to force its way easily through the crack, though no clear evidence was found there. Lateral spread of the ground was more clearly found near the southeast coast of the city as shown in Fig. 8. Cross-sections AA' before and after the earthquake are compared in Fig. 9. This figure shows that the seawall was pushed about 2m forward associated with a half-meter subsidence of its backfill. A flat foot protection work, which extends over 30m distance from the seawall towards the Tokyo Bay, was also pushed toward the bay with its pavement overriding the toe of the protection work.
