# TECHNICAL AND SOCIETAL PROBLEMS TO BE SOLVED IN GEOTECHNICAL ISSUES

**Key Words:** Great East Japan earthquake, geotechnical engineering, sea wall, liquefaction, performance-based design, policy for disaster mitigation

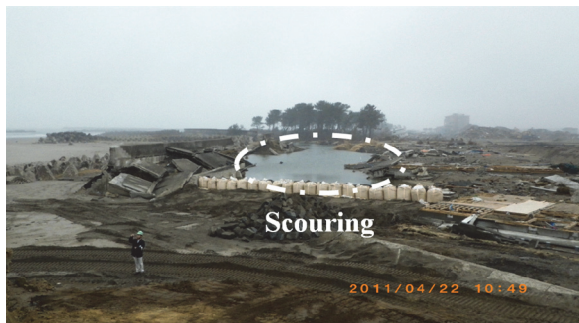
The importance and severity of tsunami-induced damage is already well-known. It is attempted here to describe additional remarks on the tsunami damage. Fig. 1 is a post-earthquake shape of a sea wall near the mouth of the Abukuma River to the south of Sendai. Evidently the soil behind the wall was lost because of scouring and this loss of passive earth pressure behind the wall allowed the wall to be removed easily under the tsunami pressure. Thus, the community that was supposed to be protected by the wall was severely destroyed.

Fig. 1 Destroyed shape of sea wall near the mouth of Abukuma River

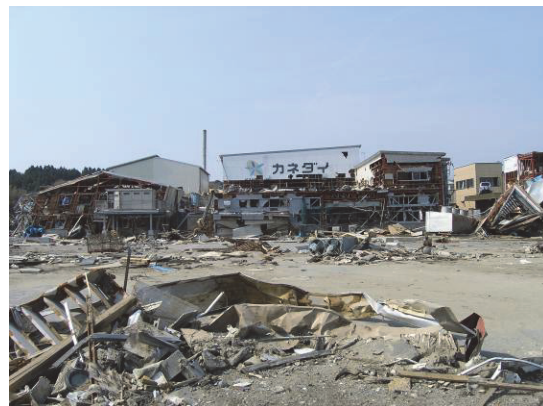
Fig. 2 Destroyed industrial area in the water-front area of Kesen-numa City

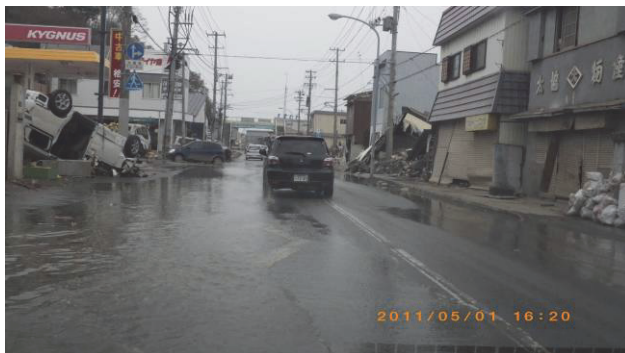
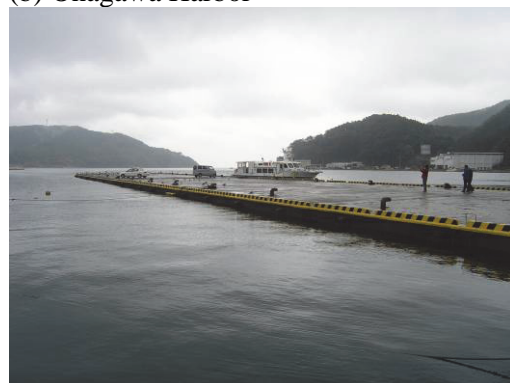
Tectonic actions upon rupture of fault mechanism are often associated with vertical displacement at the earth surface that is either upwards or downwards. In 2011, the coseismic subsidence occurred upon rebound of the hanging-wall side of the reverse fault rupture; at some distance from the fault. In contrast, the sea bed near the fault got uplifted. Coseismic subsidence is important because the ground level along the coastal line sank at maximum 1.2m (Geospatial Information Authority, 2011) and a huge area was inundated (Fig. 4). Hence, reconstruction of local community has been postponed until filling of soil and lifting up of the ground surface. Until their completion, the inundated area is vulnerable to high tide and poor drainage during storms and heavy rains.

(a) Ishinomaki City

(b) Onagawa Harbor

Fig. 4 Inundation and low ground level caused by coseismic subsidence (in Miyagi Prefecture)

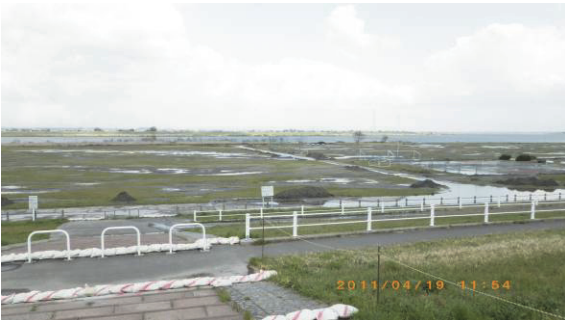
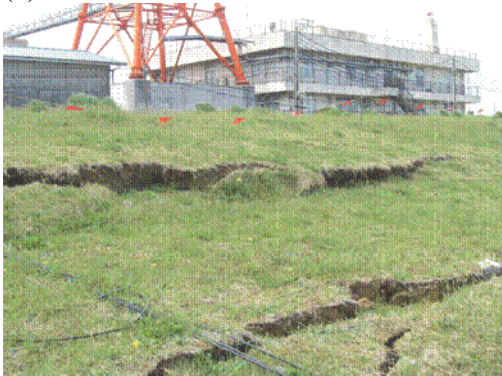
Figure 6 illustrates the distorted shape of the Tone River levee in Sawara City that is situated upon a former river channel. Because the foundation soil liquefied easily, the overlying body of embankment distorted. Levee is an inexpensive structure for which limited budget is allocated for construction and

(a) Sand boils in front of the levee

(b) Distorted levee

Fig. 6 Damaged levee of Tone River in Sawara

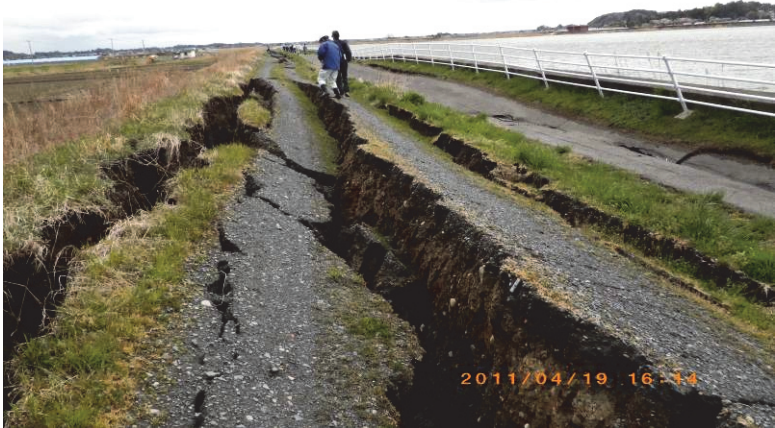
Figure 7 shows the subsidence and lateral displacement a levee of Hinuma that is one of the tributaries of the Naka River in north Kanto Region. Noteworthy is that the subsoil (Fig. 8) is totally clayey (Ac: alluvial clay) and not liquefiable. It is hence supposed that the body of the levee liquefied and developed significant distortion. To support this idea, the factor of safety against liquefaction ( $F_L$ ) in the lower part of the levee was calculated by using the method of the Highway Bridge Design Code (2002 version). The input parameters were the intensity of acceleration at the surface  $k=0.546G$  by referring to the nearby K-Net record, the depth = 4.3m, and  $SPT-N = 6$ , and  $F_L = 0.588$  was obtained. Fig. 9 illustrates another example of liquefaction in the body of a levee.

Fig. 7 Damaged levee of Hinuma in Ibaraki

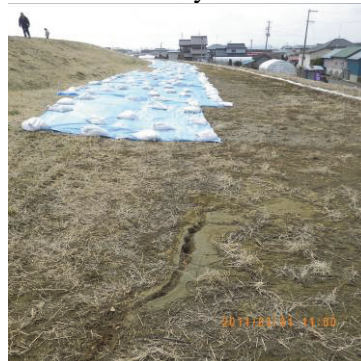
Fig. 9 Sand boils in the berm at the middle height of the Naruse River levee north of Sendai City

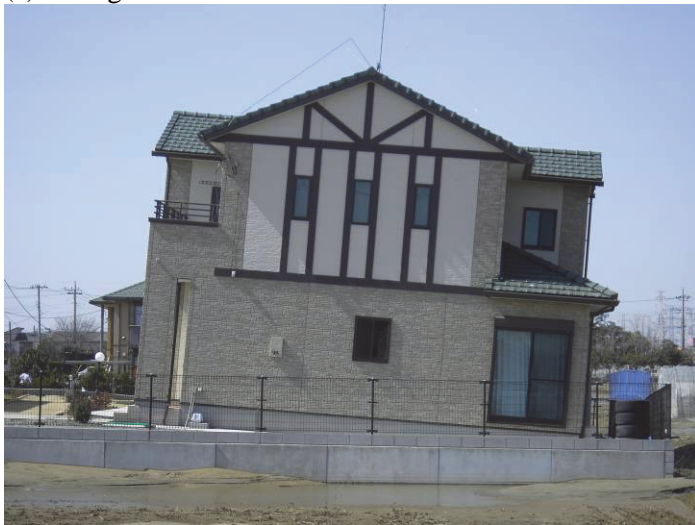
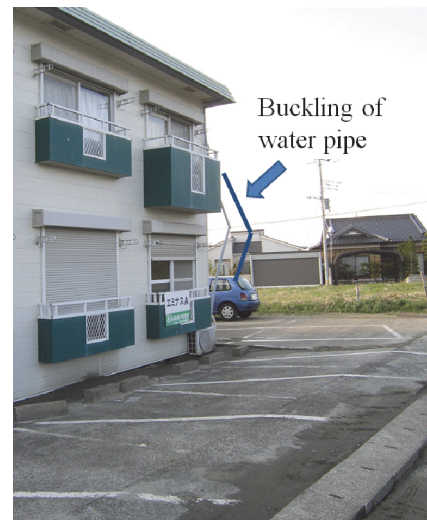
(a) Tilting

(b) Subsidence

Fig. 11 Damage of private houses caused by liquefaction

The aforementioned problem of conflict between cost and safety is encountered in a more serious manner in mitigation of liquefaction problems in residential areas. Fig. 11 indicates damage of houses that are classified into two types; tilting in Fig. 11(a) and subsidence (penetration into foundation soil) in Fig. 11(b). Damage investigation revealed that most liquefaction occurred in young (construction in the second half of the 20th Century) and loose sandy deposits with high levels of ground water (Towhata, 2011). Noteworthy is that, within heavily liquefied municipalities, there are areas where soil had been improved by densification or installation of gravel drains, and liquefaction damage was avoided (Fig. 12a). In contrast, there were heavily liquefied areas as well within a short distance from successful areas (Fig. 12b). Although the areas in Fig. 12 were constructed and sold to people by the same organization, the earthquake performance was completely different. This situation can be attributed most probably to different economic policies; the present paper never intends to justify any of them:

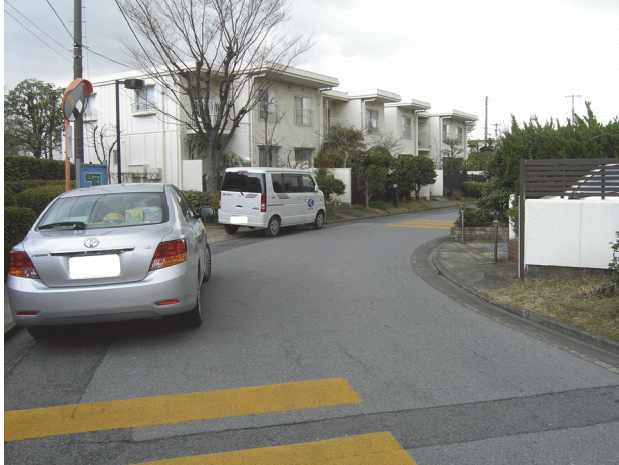
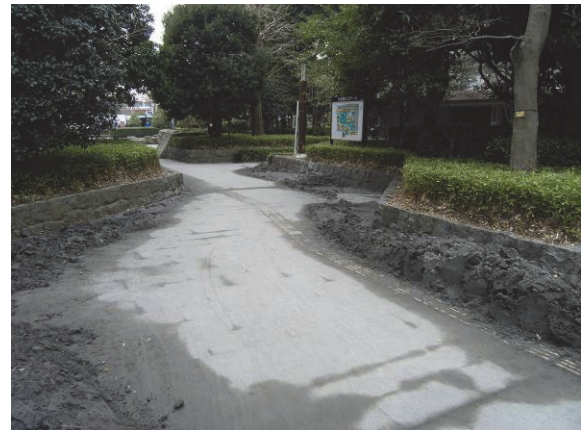
(a) No liquefaction

(b) Liquefaction and boiled sand

Fig. 12 Contrast of liquefaction in manmade island of Urayasu City

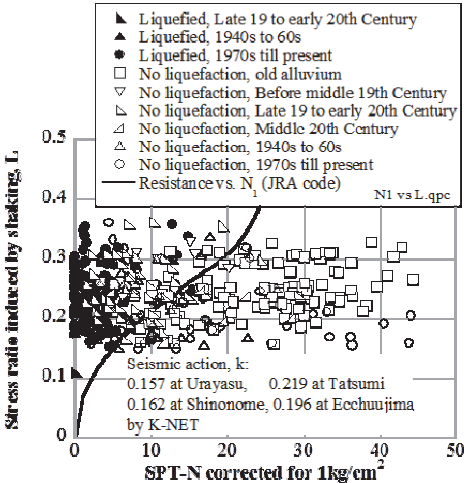
Cases with and without liquefaction were collected from the eastern part of Tokyo and Urayasu City of Chiba where the age of land reclamation is clearly known. The information on soil profile was collected from database that was developed by JGS. Fig. 14 indicates the relationship between the normalized  $N_1$  of standard penetration tests and the seismically induced stress ratio,  $L$ . This  $L$  value was calculated by using the maximum horizontal accelerations that were recorded at nearby K-Net stations. As expected, data from liquefied and unliquefied sites are separated to some extent by the curve suggested by the Highway Bridge Design Code (2002 version). The study on ageing concerns whether or not this border curve changes with the age of soil. In other words, the boundary of the factor of safety against liquefaction,  $F_L$ , between liquefaction and no-liquefaction may change with age, although the current practice assumes that this boundary is  $F_L=1$ . The  $F_L$  value was calculated by using the Highway Bridge Design Code.

The data of  $N_1$  and  $L$  in Fig. 14 changes in the vertical direction in a single borehole data. The particular plotted data correspond to

Fig. 14 Relationship between cyclic shear stress ratio,  $L$ , and the normalized SPT-N at sites with and without liquefaction.

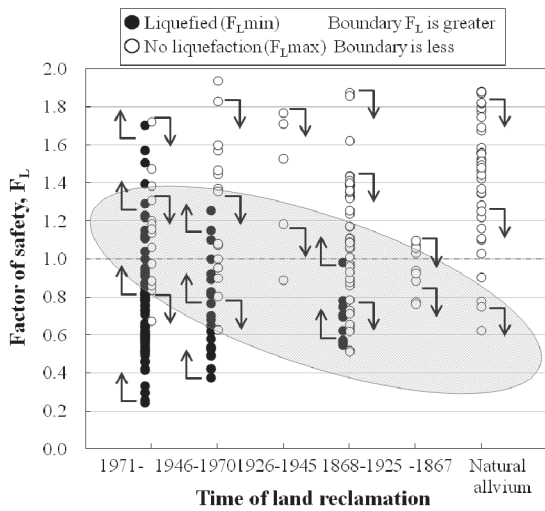
Figure 16 plots  $F_{Lmax}$  and  $F_{Lmin}$  thus defined against age of soils. Note that the boundary  $F_L$  lies between the upward and downward arrows. It seems reasonable to state that this boundary value decreases as the age increases, implying that aged soil is unlikely to liquefy even when  $F_L$  value is less than unity. In other words, SPT-N values that are employed in calculation of  $F_L$  does not account for the increase of liquefaction resistance with age.

For further discussion, the plotted data was modified or improved by considering the amplification of ground motion at liquefied soft ground. The dynamic analysis at liquefied sites of Urayasu showed that the surface motion was approximately 30% greater than the nearby K-Net record which was obtained on unliquefied soil (report to the city government, unpublished yet). In this regard, all the  $F_L$  values at liquefied sites in Fig. 16 was reduced to 75% (= 100%/130%) of the original values.

Fig. 16 Possible ageing effect on the border value of  $F_L$  between liquefied and unliquefied sites.

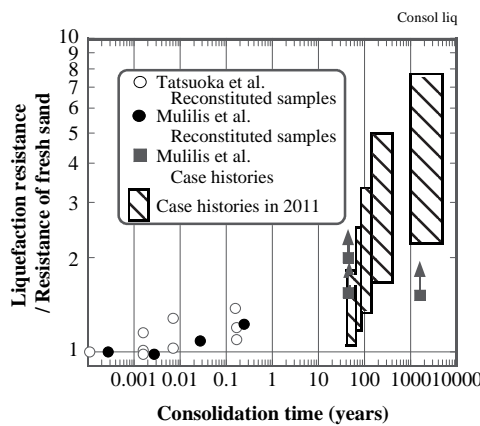
The results are presented in Fig. 17. It is more clearly shown that the boundary value of  $F_L$  decreases with increase of age and that liquefaction resistance of soil increases with age. This increase rate is equivalent to the inverse of the boundary  $F_L$ . Fig. 18 demonstrates this increase in which the range of uncertainty in both the boundary  $F_L$  and the soil age (construction period is longer than one year) are accounted for. The newly obtained data is consistent with those from previous studies.

Fig. 18 Assessed effect of ageing on liquefaction resistance of sand obtained from the cases in 2011 (arrows on symbols by Mulilis et al. implies that the true ageing effect is greater than the plotted value.)
