THE DAMAGE TO ABANDONED MINES AND QUARRIES BY THE GREAT EAST JAPAN EARTHQUAKE ON MARCH 11, 2011

Ömer AYDAN¹ and Hisataka TANO²

ABSTRACT: The East Japan Mega Earthquake with a moment magnitude 9.0 occurred on March 11, 2011 and shook almost the entire Japan. There are many abandoned lignite mines in the close vicinity of the epicentral area such as Miyagi and Iwate Prefectures and many sinkholes occurred following the earthquake. There are also reports on the delayed occurrence of numerous sinkholes in the same areas. In addition, some collapses and settlement occurred in abandoned underground quarries in Oya town of Utsunomiya City. The authors investigated damaged areas soon after the earthquake and they present their investigations results. They also discuss their implications in short and long-term performance of abandoned mines and quarries in this article.

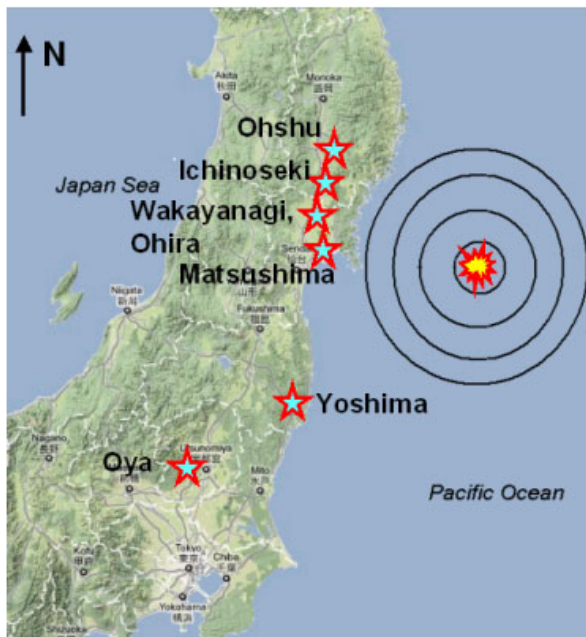
Fig. 1 Investigation locations

The East Japan Mega Earthquake with a moment magnitude 9.0 took place at 14:46 (JST) on March 11, 2011 (JMA, 2011). The earthquake was a subduction plate-boundary earthquake and the rupture area was 450 km long and 200 km wide. This earthquake caused gigantic tsunami waves, which destroyed many cities and towns along the shores of Tohoku and Kanto Regions of Japan. The casualties caused by this tsunami exceed 20,000 people. The tsunami destroyed and heavily damaged buildings of various type, transportation facilities and infrastructures. The authors visited Oya (Tochigi) in Kanto region and Iwaki (Fukushima), Wakayanagi, Ohira (Miyagi) and Ichinoseki (Iwate) in Tohoku region and made observations on the collapsed abandoned lignite and coal mines and underground stone quarries and associated damage to super structures (Figure 1).

In this article, the authors present the outcomes of their investigations in areas Oya (Tochigi) in Kanto region and Iwaki (Fukushima), Wakayanagi, Ohira (Miyagi) and Ichinoseki (Iwate). Furthermore, they discuss their implications of the observations in relation to the in short and long-term performance of abandoned mines and quarries, which are widely distributed all over Japan.

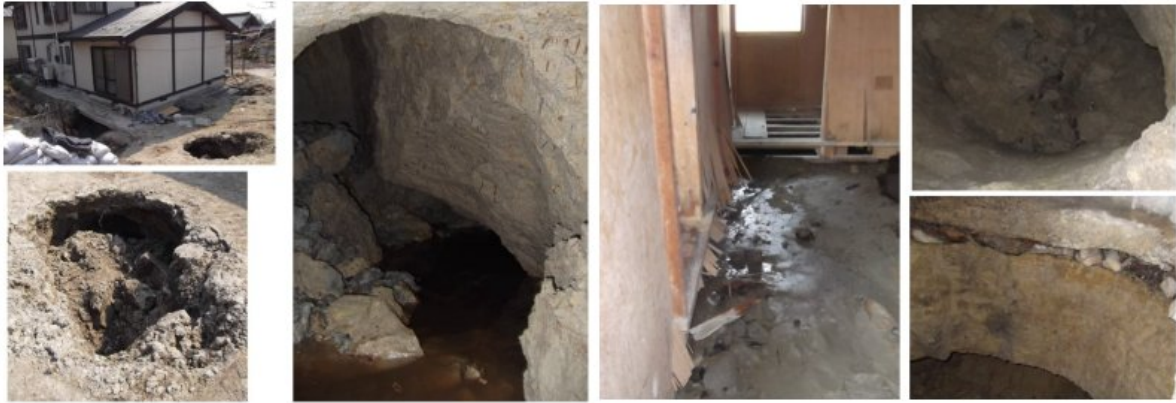
Fig. 9 Views of sinkholes and related damage in Wakayanagi town

In Wakayanagi town of Kurihara City, 5 sinkholes occurred in residential area as seen in Figure 9. Luckily , these sinkholes did not cause the collapse of the residential houses on the ground surface. However, the fracturing of the base concrete occurred and one corner of the building was overhanging with a slight tilting. The overburden of the sinkholes ranged between 1 m to 3 m at this locality.

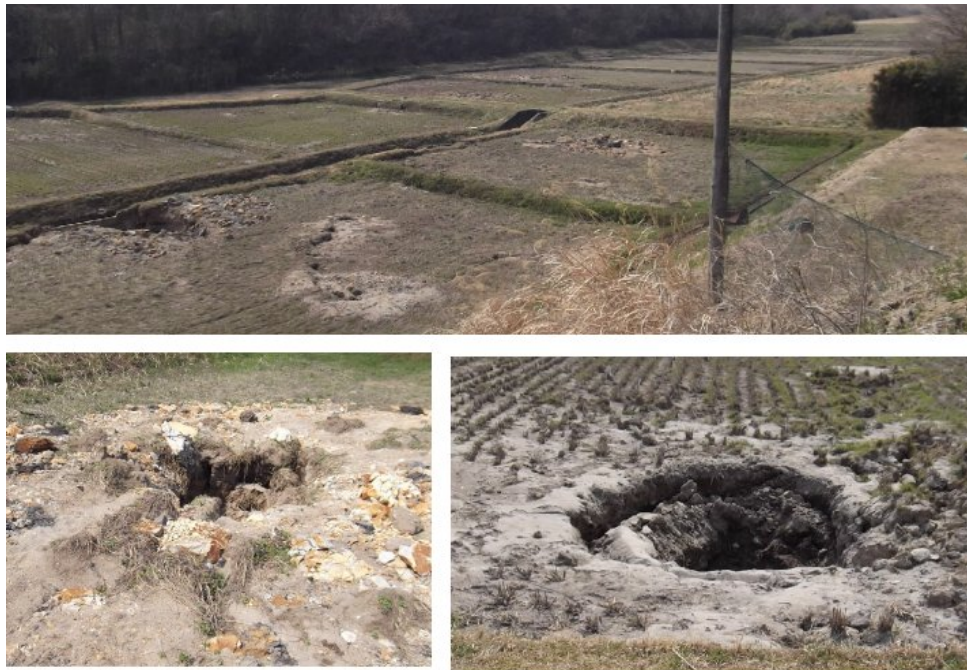
Fig. 10 Views of sinkholes in a rice field near Ohira Village

In a large rice field near Ohira Village of Kurihara City, more than 10 sinkholes with a diameter ranging from 1 m to 5 m were observed as seen in Figure 10. Besides ground shaking, the sloshing phenomenon of ground water in the underground openings abandoned lignite mine areas contributed to the collapse of the roof layers. As a result of this phenomenon, sandy material together with fragments of rocks and lignite appeared on the ground surface and this ejected sandy material is sometimes misinterpreted as ground liquefaction by soil-mechanics researchers and engineers. The overburden of the sinkholes ranged between 2 to 4 m at this locality.

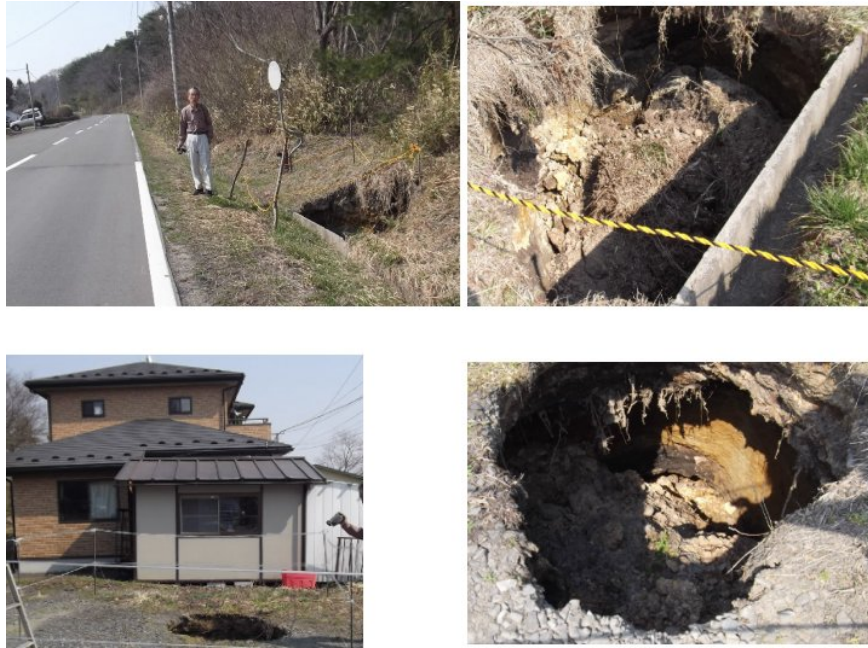
Fig. 11 Views of sinkholes along a roadway and parking lot near Ohira Village

Besides sinkholes in the rice field, some sinkholes were observed along the roadway and in the parking lot next to residential buildings as seen in Figure 11. The overburden of the sinkholes with a diameter of 2-3 m ranged between 1 to 2 m at this locality. The ground shaking caused the collapse.

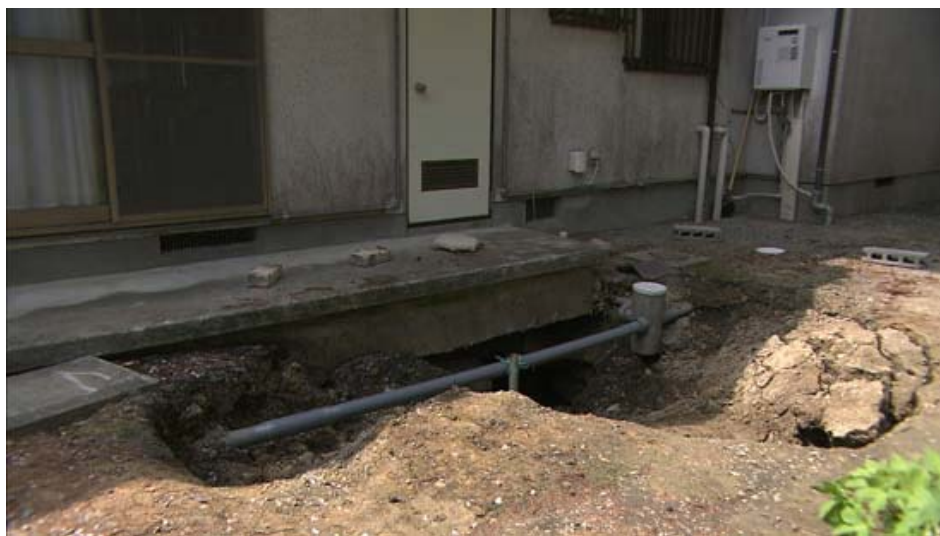
The 2011 East Japan Mega Earthquake caused a number of sinkholes in both residential areas and fields caused in Ichinoseki. The sinkholes were enlarged in size after each large aftershock. Figure 12 and 13 shows the sinkholes beneath or close vicinity of houses in Ichinoseki City. Figure 14 shows a sinkhole along a roadway in Ichinoseki City. In addition to these there were sinkholes in rice fields.

Fig. 12 A sinkhole beneath a house in Ichinoseki. (L1). The size of the sinkhole enlarged after the April 7, 2011 aftershock

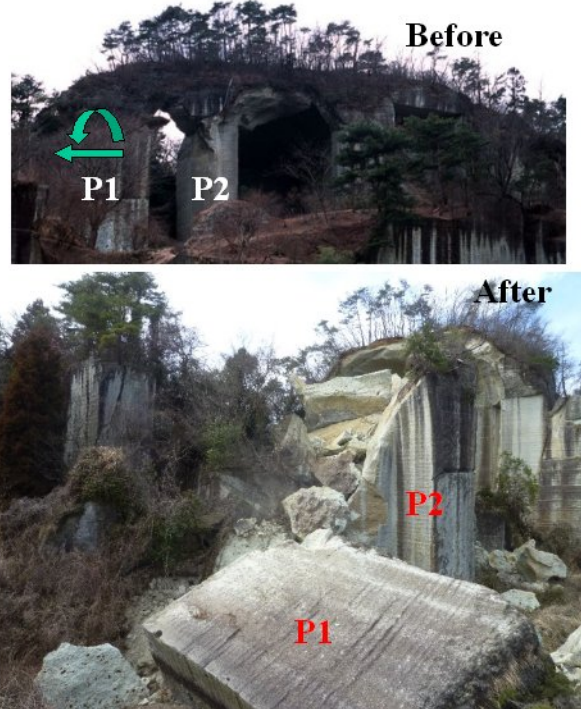
Total or partial collapse of semi-underground quarries occurred as seen in Figures 16 and 17. The toppling of pillar (P1) caused the collapse of thin roof of the abandoned quarry as seen in Figure 16. In some cases, partial collapses of the overhanging parts occurred as seen in Figure 17.

Fig. 16 Totally collapsed semi-underground opening

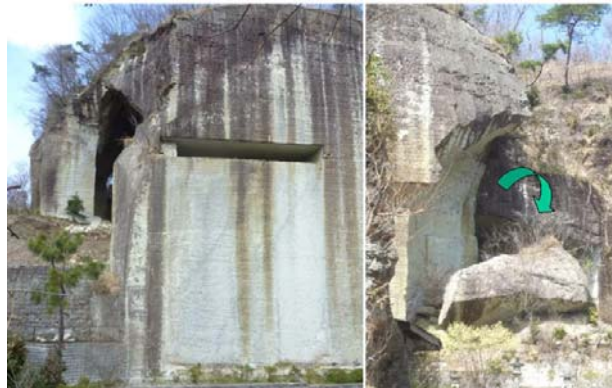
Fig. 17 Partially collapsed semi-underground opening

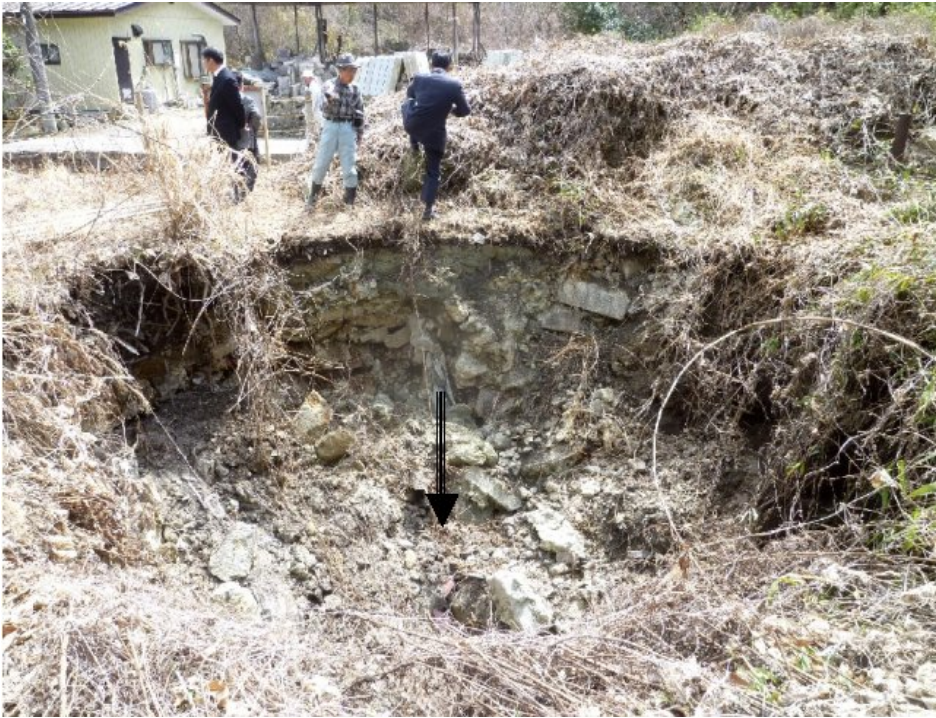
The settlement of back-filling material of three shafts of abandoned quarries occurred. In the example shown in Figure 18, the settlement of back-filling material was more than 5 m and the diameter of the shaft was about 7 m. The back-filling material was non-cohesive.

Fig. 18 The settlement of back-filling material of the shaft

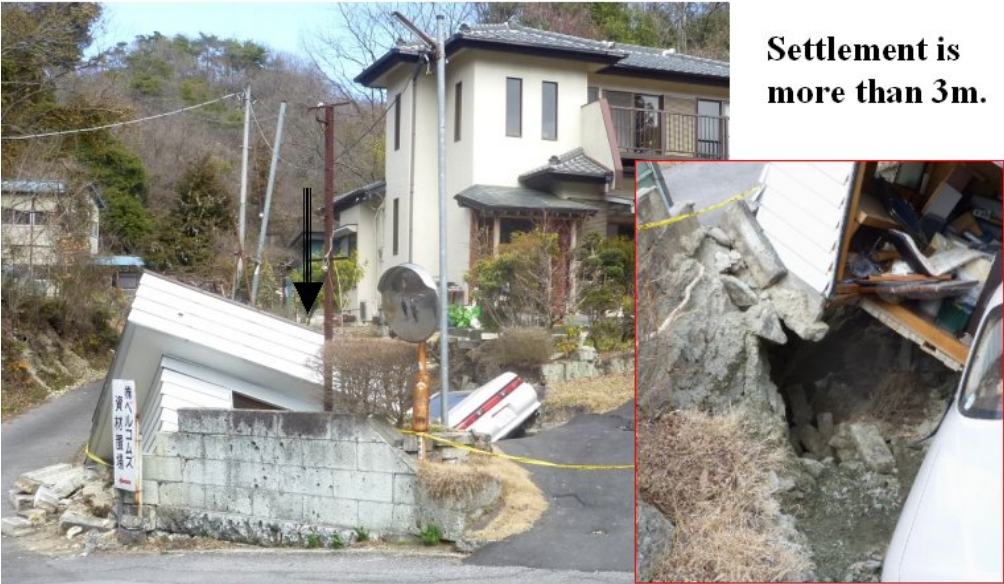
The back-filling material of the abandoned shaft settled more than 3 m as seen in Figure 19. There was a hut on top of this shaft. The hut and the car parked next to the hut was fallen into the settled shaft. These observations are very similar to those observed in Yamoto town (re-named as Higashi-Matsushima) during the 2003 Miyagi-Hokubu earthquake.

Fig. 19 The settlement of back-filling material of the shaft and the fall of the hut and car into the shaft
