# TELECOMMUNICATIONS PERFORMANCE IN THE M=9.0 OFF-SHORE EAST COAST OF JAPAN EARTHQUAKE AND TSUNAMI, MARCH 11, 2011

**ABSTRACT:** Telecommunication networks are one of the most important lifelines in a post disaster environment. Early assessment of the damages and rescue dispatches in a timely manor require telecommunication tools. Invariably telecommunication services in the impacted areas are usually hit by above normal demands, which put the service providers in an emergency operation situation even when there is no damage to the facilities and the network. Lessons learned from the special operations in this great event that covered a huge area will enhance future post disaster performance of telecommunication systems. Hardening of hardware, such as facility buildings and equipment resistance, to strong shaking based on experiences from past earthquakes has resulted reduced loss in buildings and functional equipment. However, network interconnection links that are not upgraded to the latest NTT practices are still under extensive stress from geological factors – such as ground deformation, liquefaction, land slides, etc.

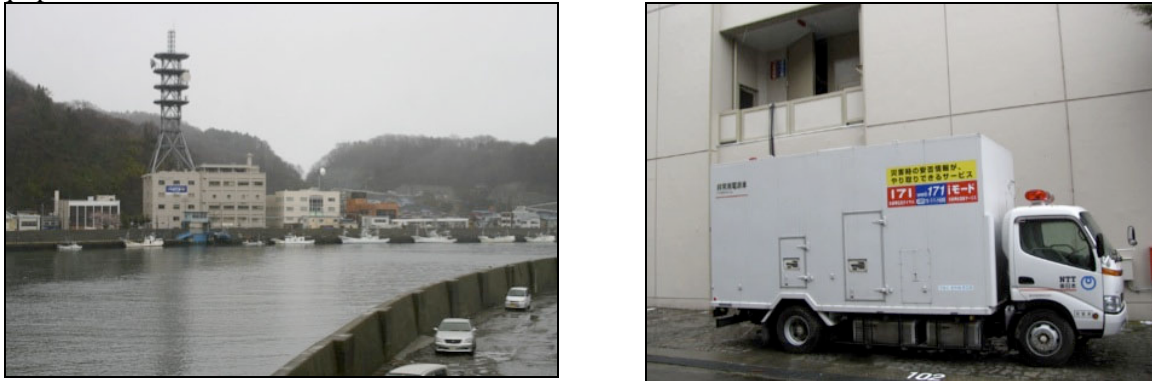
Fig. 1 Miyako CO on the left and the mobile power generator on the right

The COs at Miyako, and Ofunato all experienced power outage and mobile power generators were brought in to maintain service. It is possible that both of these COs have backup power generators, which might be inundated. Figures 1 to 2 shows the condition of the buildings and the mobile power equipment.

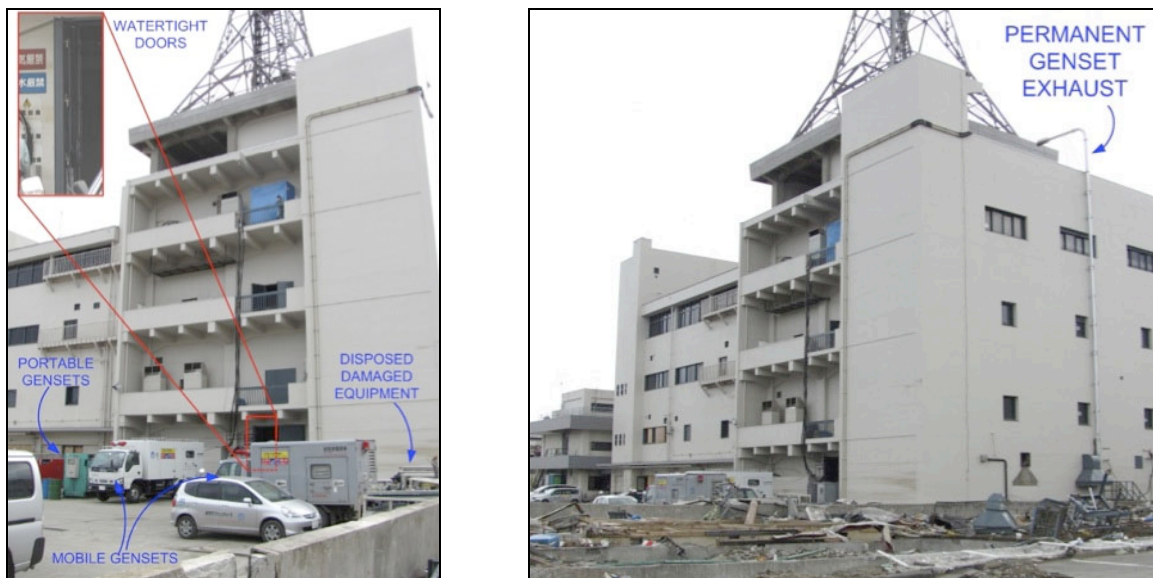
Fig. 2 Ofunato CO with more than one mobile power generators

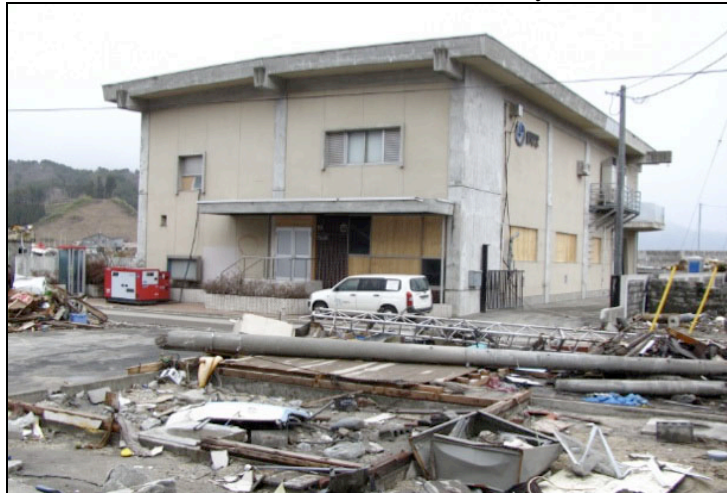
Figure 3. Yamada CO, genset on the left

The COs at Yamada, Otsuchi, and Kamaishi were serviced by portable generators. Figures 3 to 5 shows the portable genset on site to provide power. At Kamaishi, a fuel truck nearby was to provide fuel, indicating the expectation of a very long duration of power outage in the area.

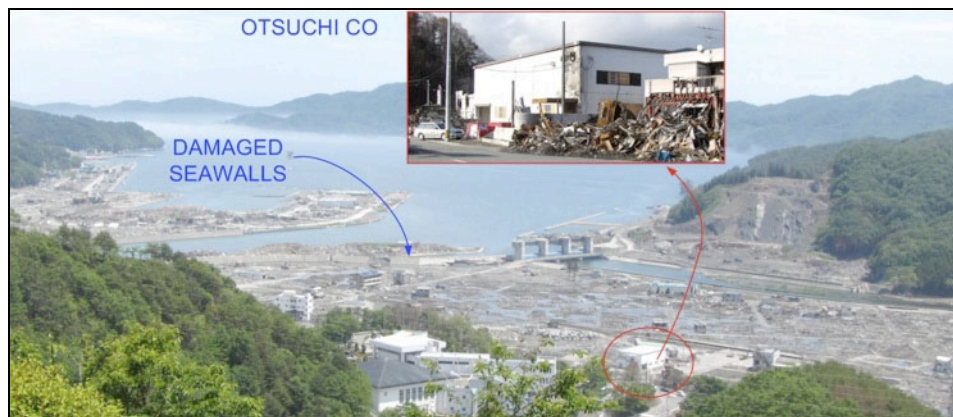
Figure 4. Otsuchi CO

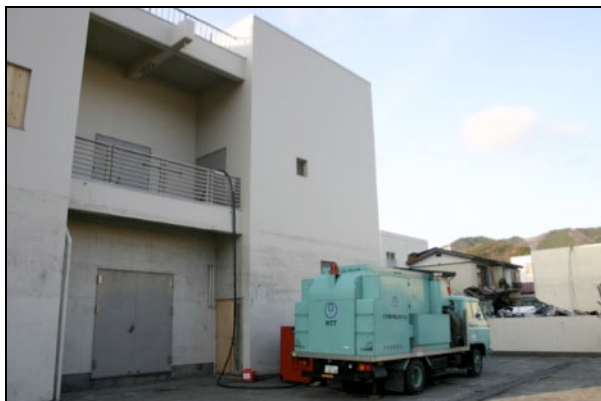
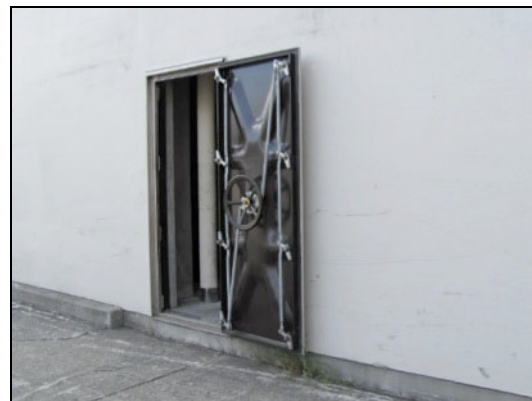
Figure 5. Left: A portable genset at Kamaishi CO with a truck of additional diesel storage expecting very long autonomies. Right: Watertight door at Kamaishi CO.

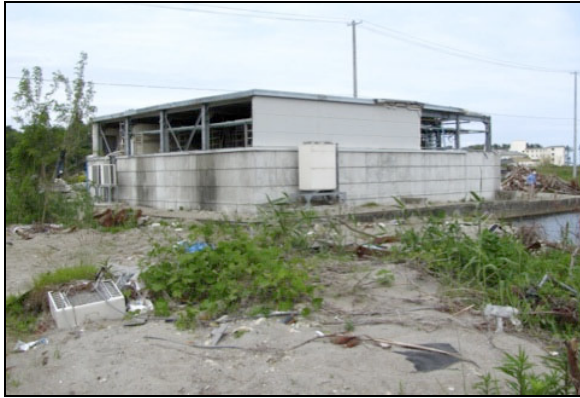
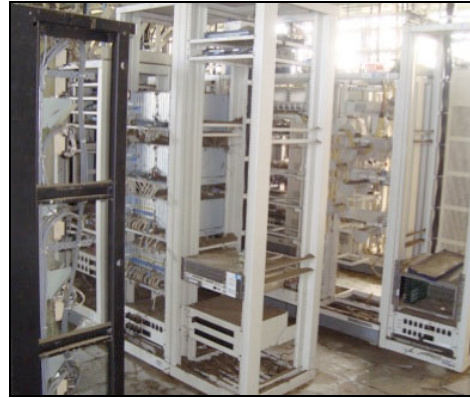
Figure 6. Noburi CO was gutted by the tsunami

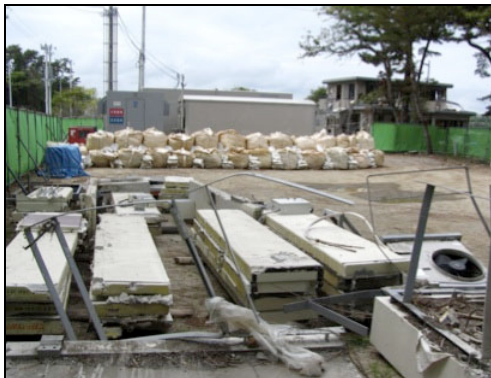
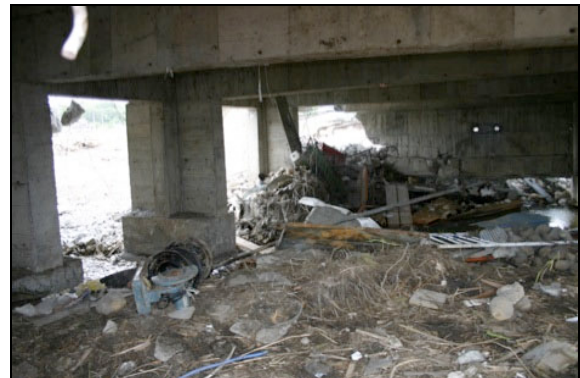
In addition to power outage, which had the biggest impact to the PSTN network, total destruction of COs by tsunami were also observed. It was hard to separate any earthquake damage from the water damage after the tsunami. In order to effectively utilizing the resources to provide service, many of these destroyed COs were left unattended. Nobiru CO building (Fig. 6) had all the upper third portion of its outer walls destroyed by the tsunami. Shichigahama 2-floors concrete CO building (Fig. 7) was

entirely uprooted from its foundations and carried 500 m inland by the tsunami.

Figure 7. Shichigahama CO. Left: The original location of the building with the temporary huts used to restore service. In the front are the remains from the original building. Right: Foundations of the original building carried 500 m. inland by the tsunami.

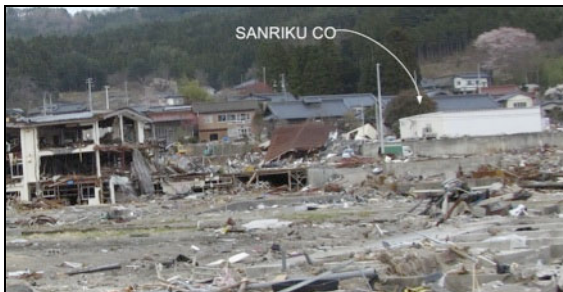
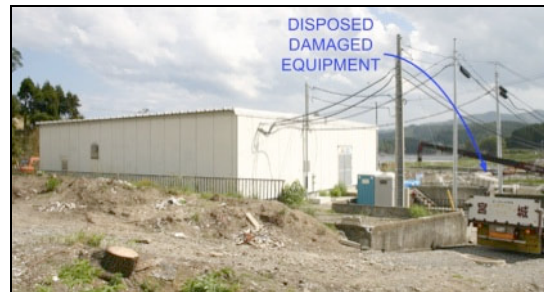
However, in Sanriku (Fig. 8), Shizugawa (Fig. 9), Onagawa (Fig. 10), and Rikuzentakata (Fig. 11), the CO buildings show relatively little external damage and are one of the few remaining standing buildings in the town, which suggest an adequate CO building performance considering the tremendous magnitude of the tsunami—notice that the CO building in Onagawa has the remains of a home on its roof. In Unosumai (Fig. 12) the CO building walls and roof were destroyed but the foundations and inner supporting structure, such as metal beams and columns, remained in place.

Figure 8 Sanriku CO, left is the side view, right is the back view

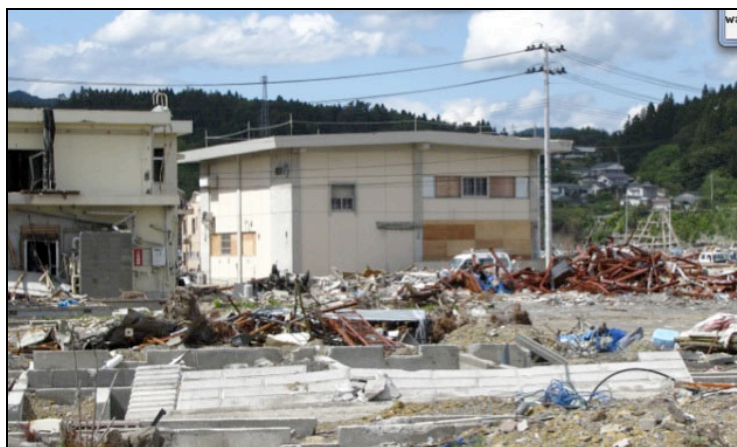
Figure 9 Shizugawa CO

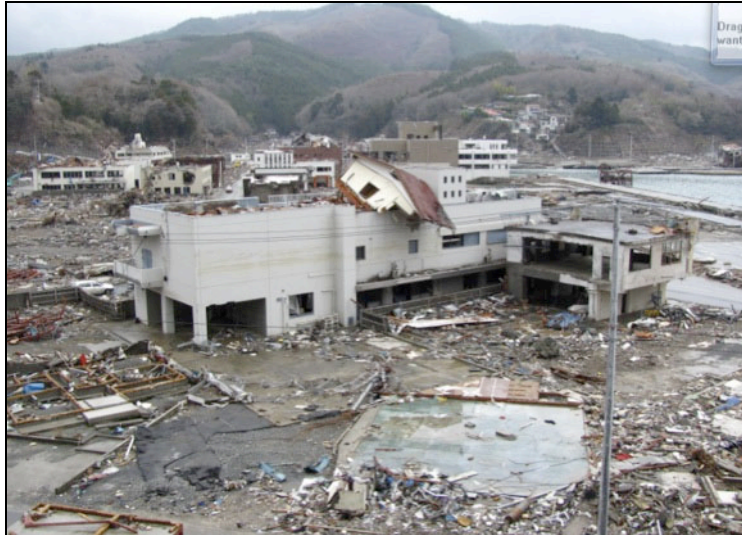
Figure 10. Onagawa CO with a roof of another house on its roof.

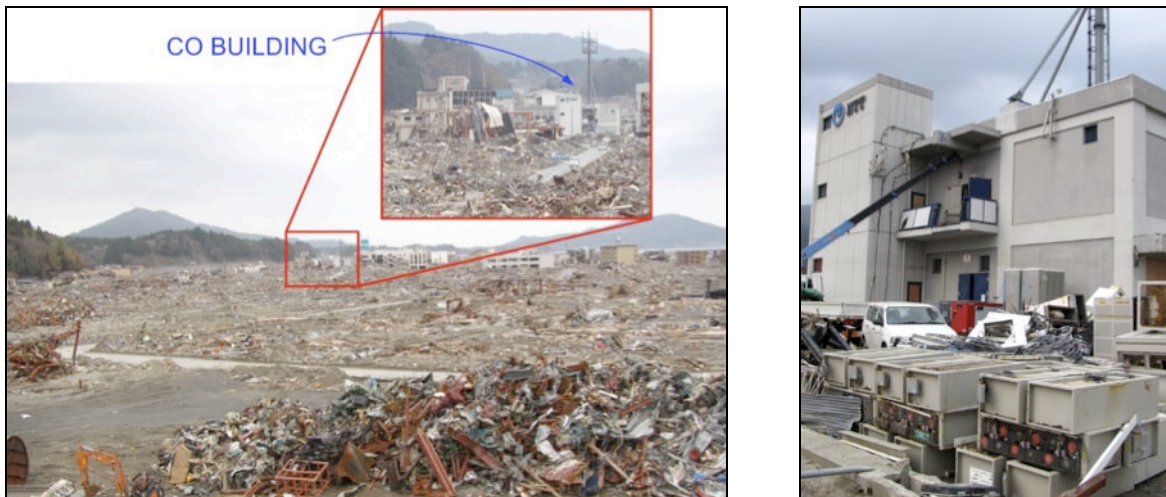
Figure 11 Rikuzentakata CO. Right: Disposed water damaged batteries.

shelter with switching equipment at the original location of the CO building. Yet, another approach used in Rikuzentakata, was to host most of its switching services in a neighboring undamaged CO—in the case of Rikuzentakata, its switching services were transferred by Kesen Yokota CO, a small remote switching office.

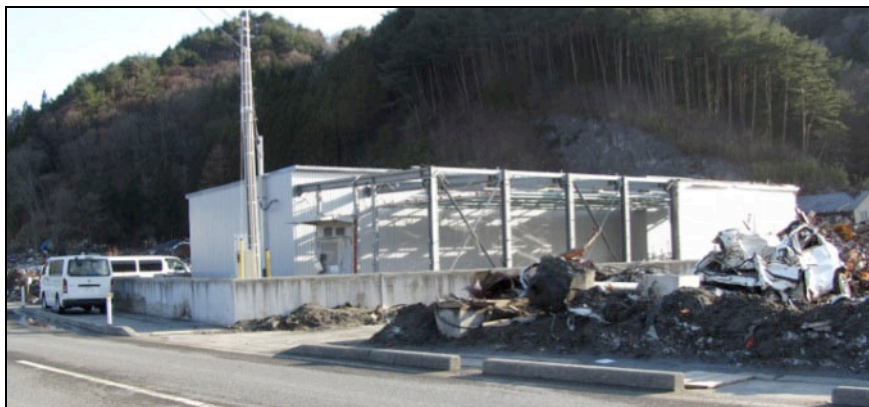
Figure 12 Unosomai CO, side and roof were replaced on the back half of the building

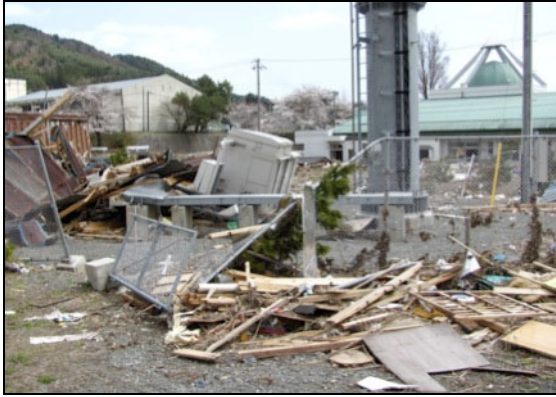
Many newer antenna towers such as those shown in Figures 13 and 14, stood up to impact of debris from the tsunami. However, many unanchored equipment enclosures expectedly performed poorly. As many base stations also act as repeater stations, the impact on the network was substantial. With dense mesh network, redundancy, satellite phones, and fast emergency response, the duration of inconvenience to subscribers was much less in a disaster of this scale.

Figure 13. Destroyed cell site at Sanriku

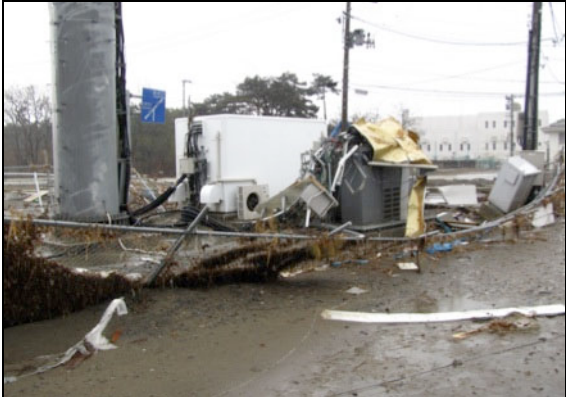
Figure 14. Destroyed cell site at Ishinomaki

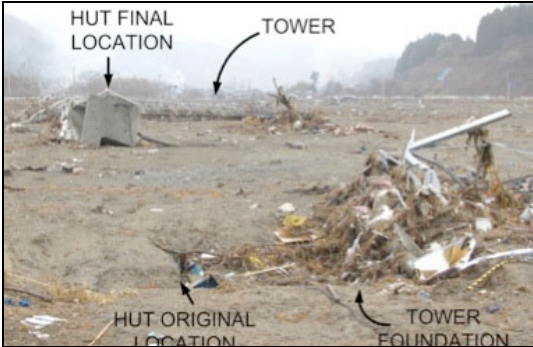
Figure 15. Cell site destroyed by the tsunami in Rikuzentakata

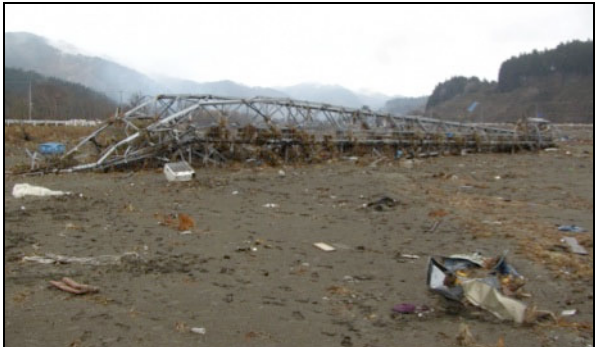
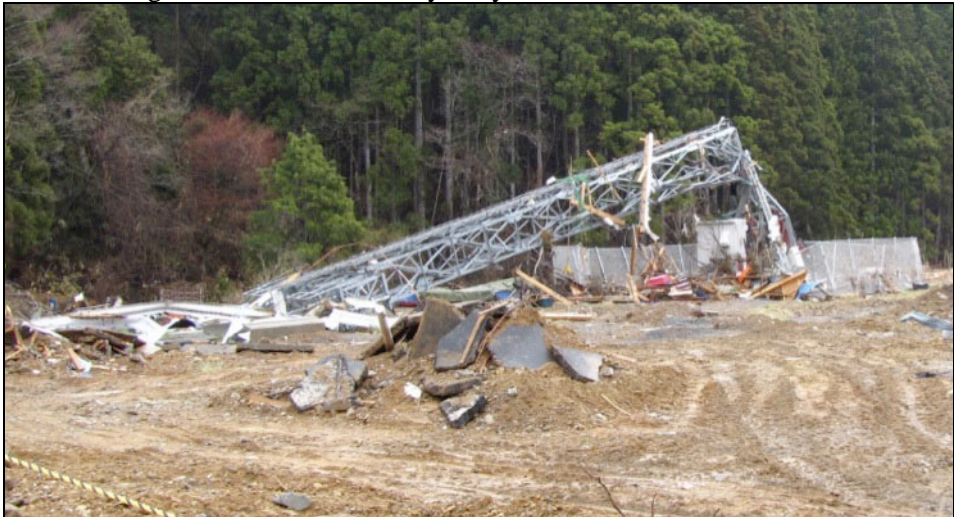
Causes identified that led to failure mode #3 include failed (twisted and fractured) braces in lattice-type towers, and foundation failures and bucked poles of sites using monopole towers.

Figure 16. A collapsed tower of a base station located in the Karakuwa Peninsula.

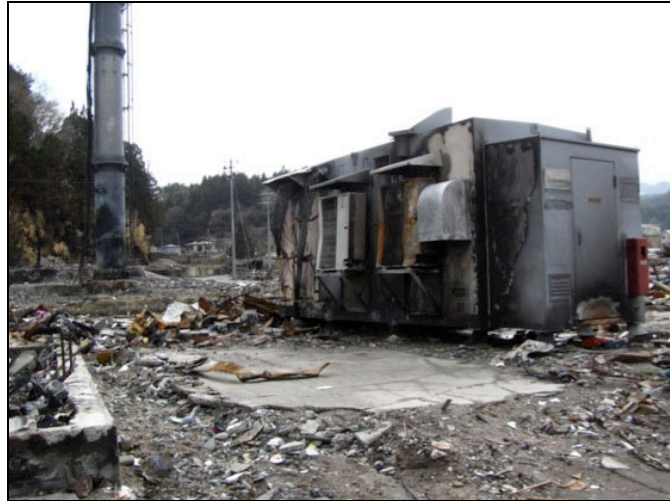
In addition to power outages many base stations near the coastal areas that were hit by the tsunami were destroyed. Figures 13 to 17 show the conditions of the base stations after the tsunami. There was at least one case of fire at a base station in Yamada, Figure 17. COWs and microcell were quickly installed to provide coverage and new equipment was installed to restore service in the heavily damaged areas, Figures 18 to 20. Small gensets were also in place where microcells were set up, as

Figure 17. This base station in Yamada was also damaged by fire in addition to tsunami damage
