SEISMIC RESPONSE AND DAMAGE OF HIGH-RISE BUILDINGS IN TOKYO, JAPAN, DURING THE GREAT EAST JAPAN EARTHQUAKE

ABSTRACT: We report seismic response, damage and emergency response of high-rise buildings in the Shinjuku Station area in Tokyo, Japan, for the 2011 Great East Japan Earthquake (Mw 9.0), using strong motion data, numerical simulation, and questionnaire/hearing surveys. Even though the shaking of buildings was not very strong and there was no structural damage, nonstructural elements suffered damage: falls of ceiling and plaster boards, deformation of partition walls at higher floors and so on. A couple of elevators had been stopped for weeks, because of twisted cables and/or broken parts.

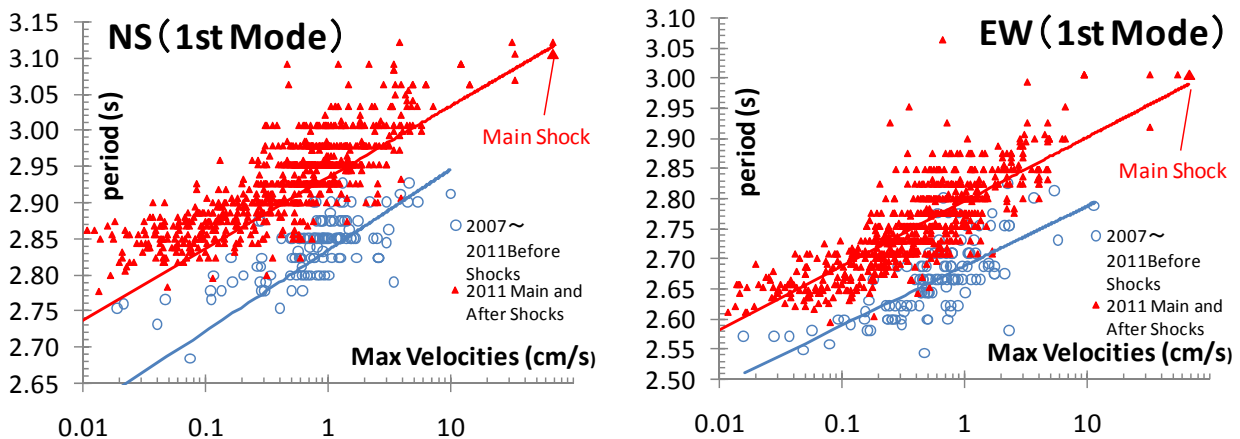
Fig.7 Dependency of natural periods on the maximum velocities of the 29th floor of the university building

We checked the dependency of the natural period on the maximum amplitude of the building response. Figure 7 shows the natural periods of the 1st modes versus the maximum amplitudes of velocities of the 29th floor. We used the two data sets: one for small earthquakes before the 2012 main shock, and the other for the main-shock and after-shocks. The larger the building response is, the longer the natural period becomes. In particular, the former dataset from small earthquakes shows shorter natural periods than those of the latter including the main shock. This is probably caused by relaxing non-structural elements, such as partitions and curtain walls during the main-shock.

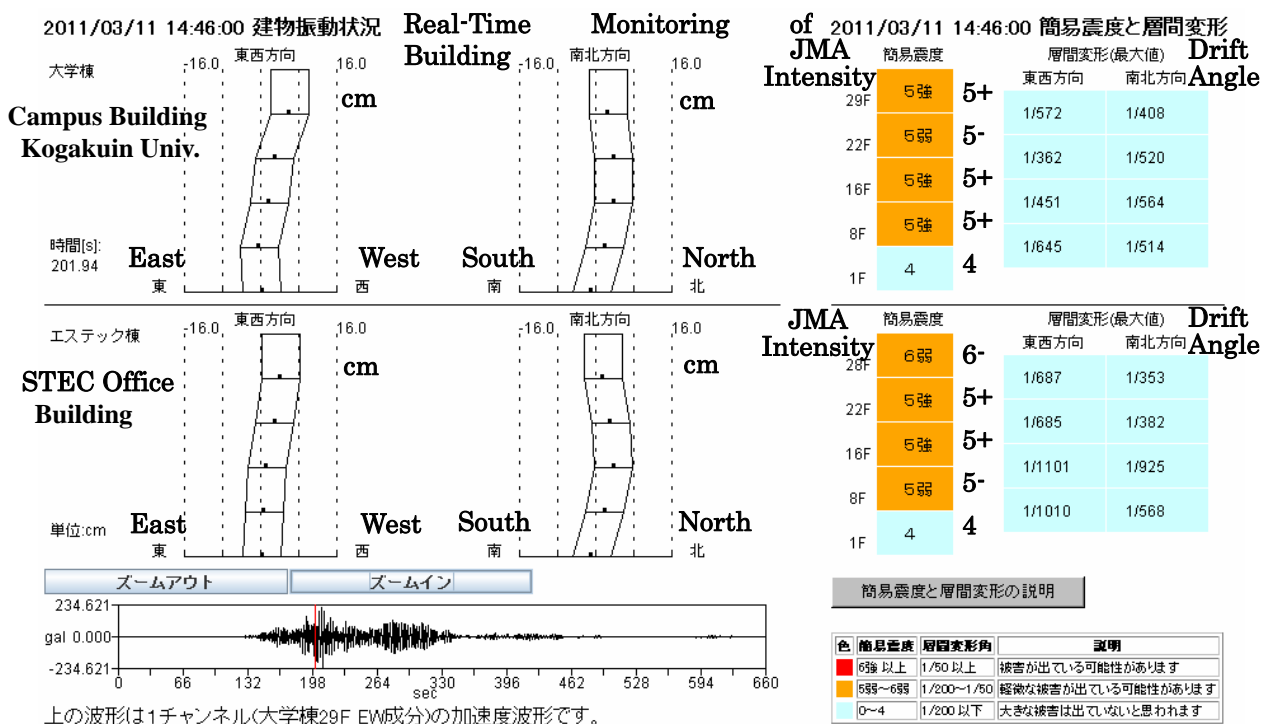
Fig.11 RMS (Real-Time Strong Motion Monitoring System) after the 2012 East Japan earthquake at Kogakuin University

Figure 9 shows the popup window of the RMS (Real-Time Strong Motion Monitoring System) of Kogakuin University, which shows the real-time information of the building response: the arrays of estimated JMA intensities, and drift angles (Kubo, 2011). Using this system, the emergency control center quickly knew that the building was structurally safe, and made prompt announcements to stay at safe places.

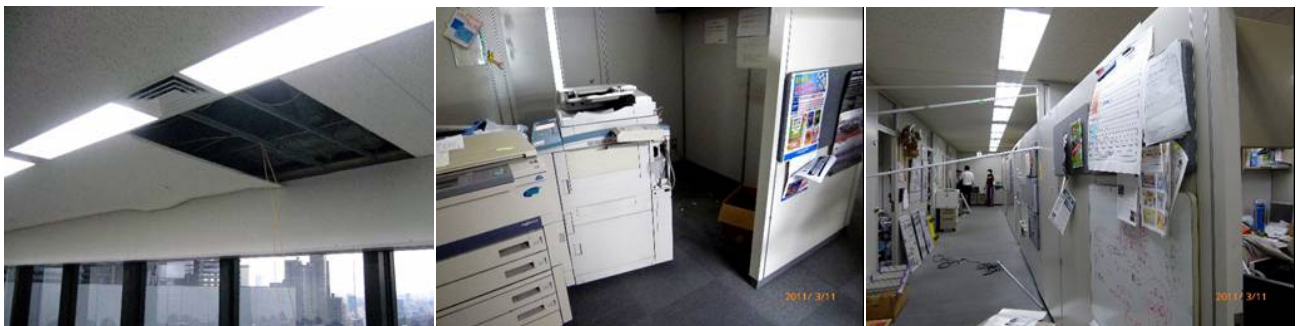
Even though there was no severe damage in the university building, several non-structural elements and equipments suffered damage, as shown in Pictures 2: fall and deformation of ceiling panels and plaster boards, deforming of partition walls, fall of unsettled objects, and so on. In addition, an emergency elevator stopped the service for about three weeks, because the main cables were twisted,

(a) Fall of ceiling panels (b) Movement of a copy machine (c) Deformation of a partition wall

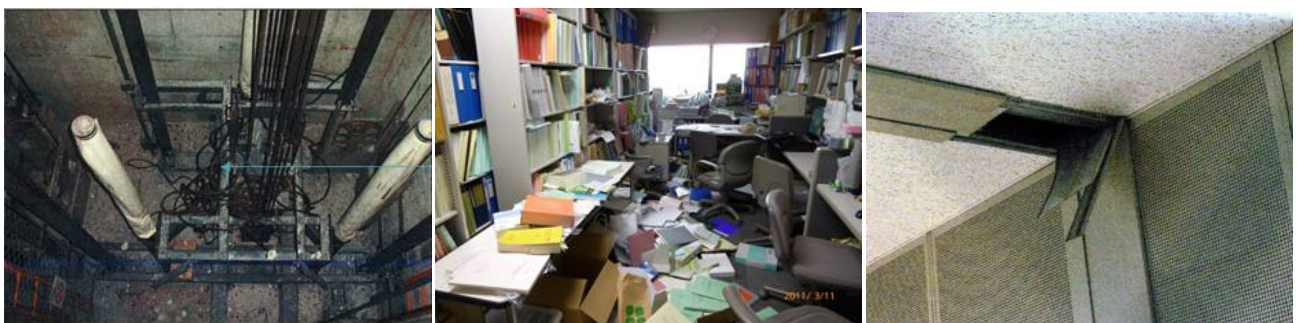
and it was difficult to obtain the replacement parts.

(d) Tangled elevator cable (e) Fall of unsettled objects (f) Fall of cover of EJ

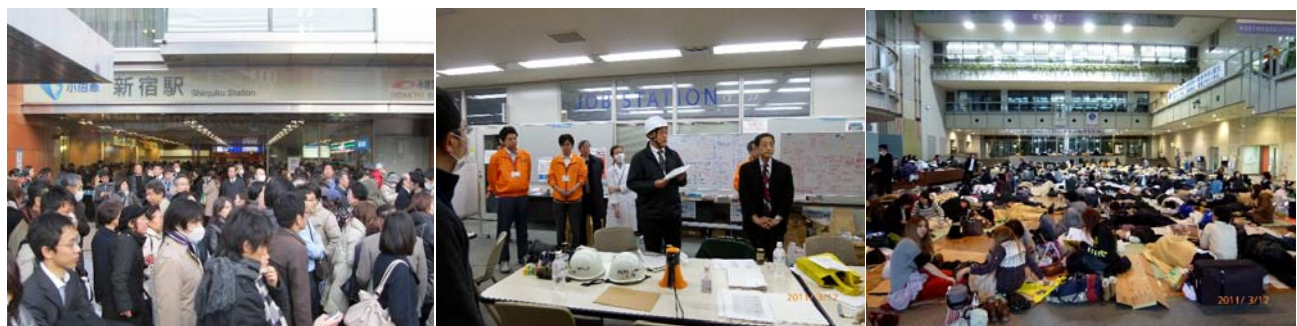
Pictures 2 Various damage and situation in and around Kogakuin University and the Shinjuku station area

(g) Evacuees from the Shinjuku Station (h) Disaster Control Headquarter of Univ. (i) Evacuees at Kogakuin Univ.
