SOIL LIQUEFACTION OBSERVED AT KATORI CITY LOCATED ALONG THE LOWER STREAM OF TONEGAWA RIVER DURING 2011 GREAT EAST JAPAN EARTHQUAKE

ABSTRACT: The earthquake reconnaissance investigations were conducted at Sawara district of Katori City, Chiba, located along the lower stream of Tonegawa River, where the extensive soil liquefaction and associated phenomena were observed following the main shock of 2011 Great East Japan Earthquake of $M = 9.0$ that occurred at 14:46 on March 11, 2011, and also the subsequent aftershocks. A series of Swedish weight sounding tests were carried out at the site subject to damages inflicted by lateral spreading, and the soil profiles responsible for such damages were identified. Another series of Swedish weight sounding tests were carried out at the dry river bed of Tonegawa River, and the soil profiles spanning from Sawara district to Tonegawa River were demonstrated along with a help of SPT data. The soil profiles responsible for widely spread soil liquefaction were discussed in detail.

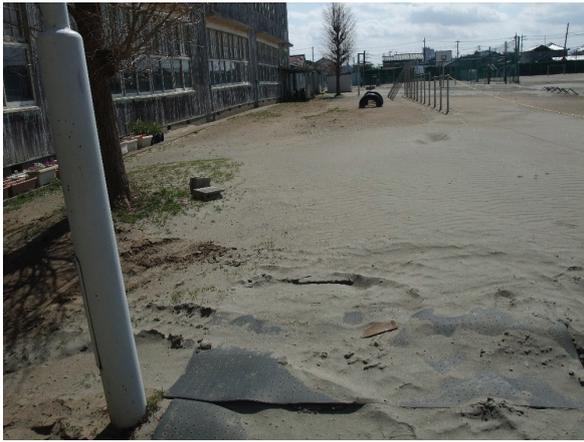
The damages on infrastructures are widely spread. The surface of the athletic ground of Sawara Junior High School was covered by erupted sand boils, and the post-liquefaction settlement was observed, causing the gap between the pile-supported school building and the surrounding ground surface, as shown in Figs. 4 and 5. The subsurface liquefiable soils were erupted from the river bed of local Yukken-gawa River and the floor of the river bed became full of such erupted sand boils, as shown in Fig. 6. The extensive soil liquefaction was observed even at the dry river bed of Tonegawa River, covering the entire surface of the ball park, as shown in Figs. 7 and 8.

Fig. 4 Sand boils over the school ground of Sawara Junior High School

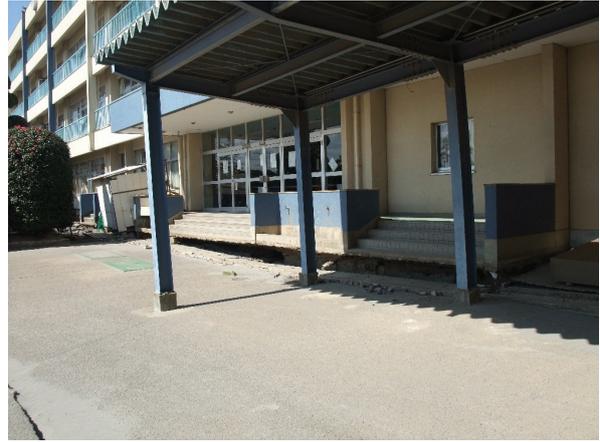
Fig. 5 Post-liquefaction ground settlement at Sawara Junior High School

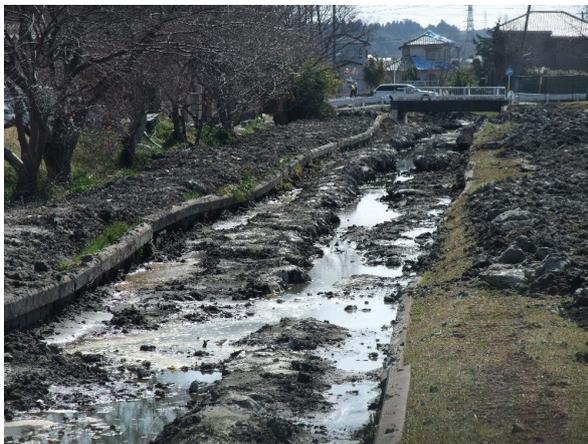
Fig. 6 Erupted sand boils at Jukken-gawa River

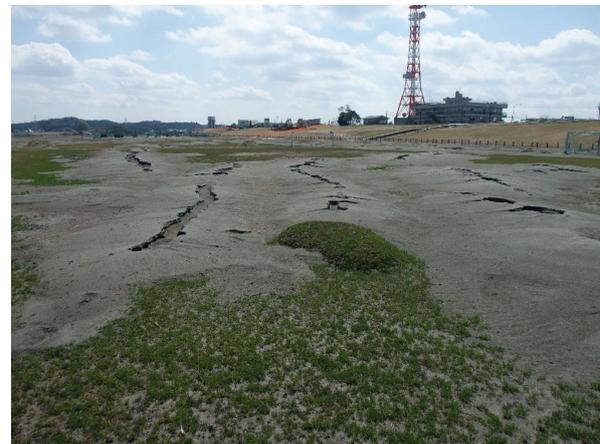
Fig. 7 Sand boils at the dry river bed of Tonegawa River (view towards river embankment)

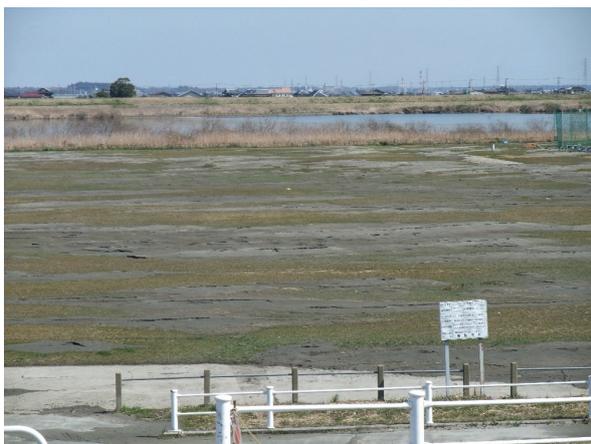
Fig. 8 Sand boils at the dry river bed of Tonegawa River (view towards river)

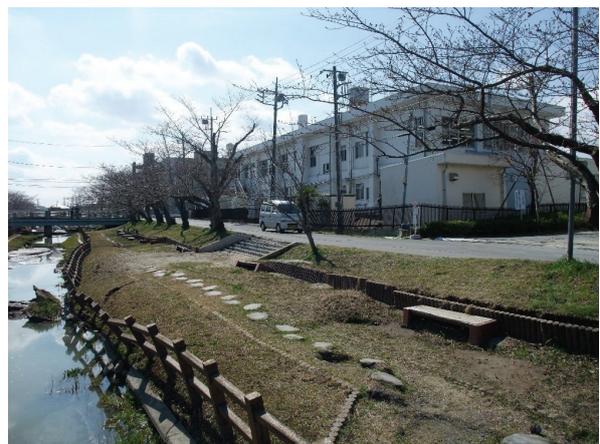
At one of the sites along local Jukken-gawa River, where the river bed was full of sand boils, the ground surface was laterally spread, causing erroneous bends of the road behind and possibly subsidence and tilt of the hut further behind, as shown in Figs. 9 and 10. A series of Swedish weight sounding tests were carried out at this site on August 4, 2011, as shown in Fig. 11. The details of Swedish weight sounding tests are described by Tsukamoto et al. (2004) and Tsukamoto (2009). Figure 12 shows the results of the field penetration tests, and the soil profile estimated. One of the advantages in using static penetration tests such as Swedish weight sounding tests, compared with dynamic penetration tests such as SPT, lies in the fact that they can easily detect weak thin strata, though they would not accompany sampling of soils with depth and accurate monitoring of a ground water depth. In Fig. 12, down from a depth of 4 metres to 8 metres, there exists an extremely weak stratum of natural sand deposits, overlain by what is estimated to be a relatively weak stratum of a possibly old reclaimed fill. It is most likely that this old reclaimed fill has been erupted as sand boils

Fig. 9 Lateral spreading along Jukken-gawa River (view towards southeast)

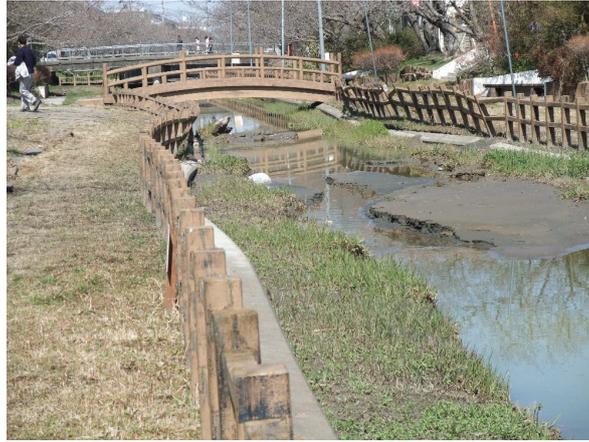
Fig. 10 Lateral spreading along Jukken-gawa River (view towards northwest)
