# LONG-TERM MONITORING OF AMPLITUDE DEPENDENT DYNAMIC CHARACTERISTICS OF A DAMAGED BUILDING DURING THE 2011 TOHOKU EARTHQUAKE

**ABSTRACT:** This paper describes the amplitude-dependent dynamic characteristics of a nine-story building in Sendai before, during, and after the 2011 Tohoku earthquake. The dynamic hysteresis characteristics are investigated using actual observations. Findings on induced higher harmonics on the basis of wavelet analysis suggest partial uplifting in the transverse direction. These features are consistent with the damage. Using long-term monitoring data from micro to strong motions in the building (40 years since its completion), the historical changes in the dynamic characteristics are also explored.

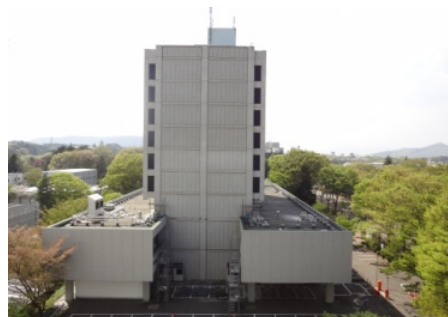
Photo 2 Damaged building viewed from the east side

The authors observed significant damage to all the base of the four corners columns on the 3<sup>rd</sup> floor during a survey conducted the day after the 2011 Tohoku Earthquake. Photos 2–4 show the damage to the building. The base of the columns was heavily damaged because of the varying axial forces due to the bending vibration of the east–west gable shear walls (multi-story shear walls). Buckling of the steel web and fracturing and buckling of the main bars was also observed. In addition, from the cracks in the gable walls in the 3<sup>rd</sup> floor (Photo 4), the authors considered the possibility of partial uplifting of the upper part from the 3<sup>rd</sup> floor after the column base's failure, and analyzed the observed waveform focusing on the induced higher harmonic frequency contents<sup>12)</sup>. After the April 7 aftershock, the authors confirmed the peeling of the cover concrete of middle column on the east side and buckling of the main bar; although, in the survey taken the day after the main shock on March 11 the authors did not observe peeling of the cover concrete of the middle column.

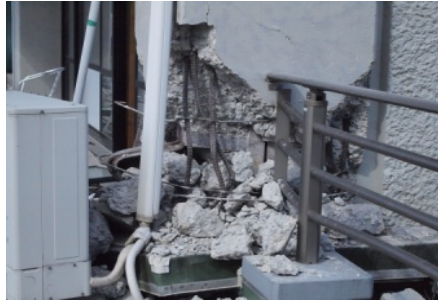
Photo 3 Heavily damaged southeast corner column base

The authors inspected the condition of the exposed main bars of the heavily damaged columns' base a day after the main shock of Tohoku Earthquake, and confirmed the existence of rust in the failure sections due to past earthquake and also new failure due to the Tohoku Earthquake.

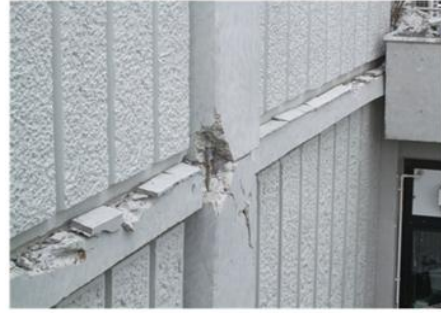
Photo 4 Crack in the 3<sup>rd</sup> floor shear wall
