MODAL IDENTIFICATION OF A HEAVILY DAMAGED NINE-STORY STEEL-REINFORCED CONCRETE BUILDING BY AMBIENT VIBRATION MEASUREMENTS

ABSTRACT: Modal parameters of a nine-story steel-reinforced concrete building damaged heavily by the 2011 off the Pacific coast of Tohoku Earthquake were identified from ambient vibration data using frequency domain decomposition (FDD). The characteristics of the identified three-dimensional mode shapes, torsional component of the mode and deformation ratio of the mode were discussed with respect to the seismic damages. In addition, we identified the mode shapes by two kinds of FDD: one for a general viscous damping system, and the other for a proportional damping system. The influence of a viscous damping condition on the identified mode shapes was discussed.

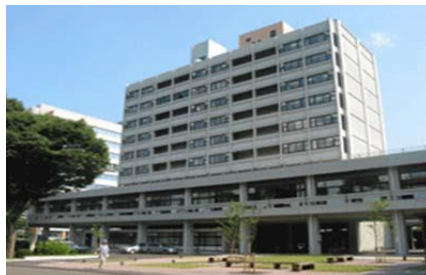
Photo.2.1 Building selected for study

Sendai, Japan (Photo 2.1). It was constructed in 1969 on a pile foundation with moment-resistant frames and shear walls. The structure consisted of a 32.9-m-tall nine-story building and two-story pilotis along both sides of the building. The building often experienced major earthquakes and was once retrofitted from July 2000 over six months. The 2011 Tohoku earthquake heavily damaged the building, and emergency rehabilitation was carried out two months later. A summary of the building damages after completion of construction and reinforcement works is shown in Table 2.1. Fig. 2.1 shows the plan of the lower and upper floors. The span for the longitudinal (*LG*) direction is 8.0 m for both the lower and upper floors, and that in the transversal (*TR*) direction is 10.05 m and 6.75 m for the lower and upper floors, respectively.

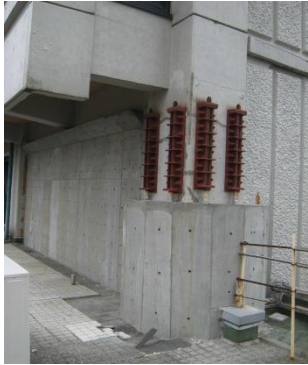
Photo 2.3 Emergency rehabilitation (on third floor)

During the 2011 Tohoku Earthquake, the maximum acceleration (903 cm/s²) was observed on the ninth floor. The main shock caused all the corner columns on the third floor to crash with rocking vibration (Photo 2.2). According to the post-earthquake damage evaluation reported by Sakota et al¹⁹⁾, the damage on the third floor in the *TR* direction was the most severe. The aseismic residual ratio *R* was 23%, and the damage level was categorized as “seriously damaged.” Emergency rehabilitation was carried out in May 2011. The four crashed corner columns were reinforced, and shear walls were additionally installed along the longitudinal side, adjacent to each corner column (Photo 2.3).

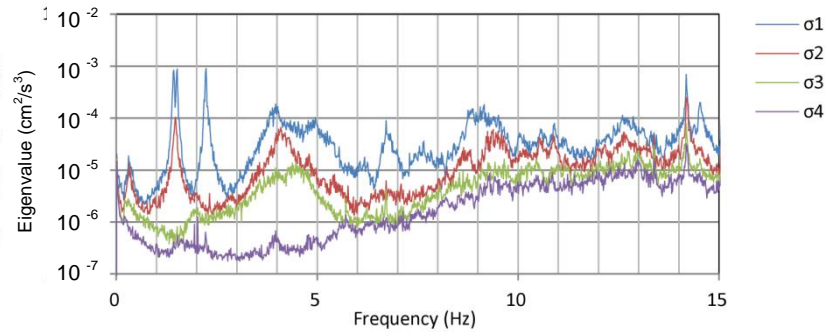
Figure 4.3. Eigenvalues of PSD matrix of response (eigenvalue spectrum)

The eigenvalues obtained from the FDD technique by Iiyama and Kurita¹¹⁾ are shown in Fig. 4.3. The horizontal and vertical axes represent the frequency and eigenvalue, respectively, and the figure shows eigenvalues from the first to fourth order. Focusing on the six peak frequencies for the first eigenvalue, i.e., 1.43, 1.51, 2.23, 3.97, 4.96, and 6.71 Hz, the corresponding eigenvectors are shown on the left side of Fig. 4.4 with respect to each location. Each eigenvector was normalized such that the maximum value was 1.0. The vertical axis represents the number of layers, and the horizontal axis represents the mode values in the components of the *TR* and *LG* directions. The right side of Fig. 4.4 shows the calculated three-dimensional eigenmodes. Here, the representative points of the three-dimensional eigenmodes are set to the centroid of the upper floor shown in Fig. 4.1(b). In this study, the calculated J was less than 1% of the following J_0 except for the third layer of the mode for 6.71 Hz. This indicates that the floor slabs can be considered to be sufficiently rigid during translational motion in the low-frequency range.

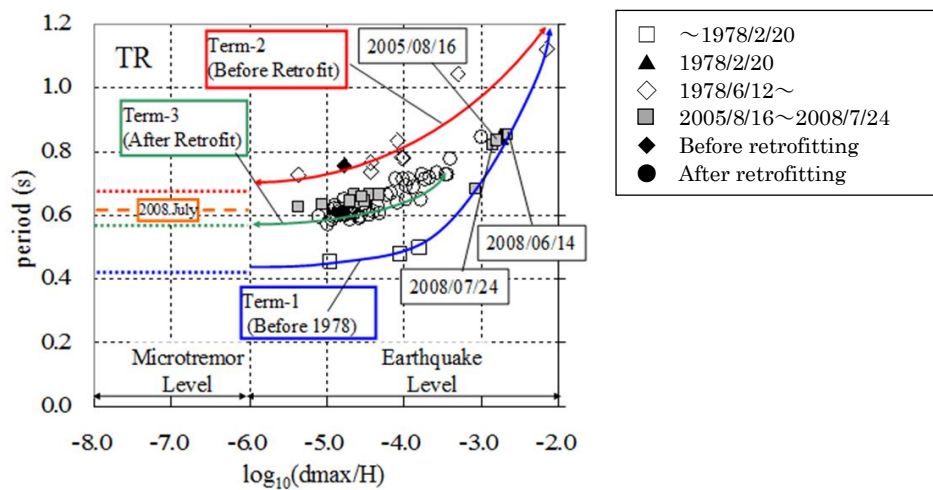
Figure 5.1. Amplitude dependence of natural frequency in *TR* direction²⁷⁾

ambient vibration measurements^{25),27),28)} have been carried out after construction was completed. By analyzing the observation records, it was found that the stiffness of the building decreased considerably after the 1978 Miyagiken-oki earthquake and increased after the seismic retrofitting during 2000–2001. Motosaka et al.²⁷⁾ analyzed the amplitude dependence of the natural frequency in the period before the Miyagiken-oki earthquake in 1978 (Term-1), after the Miyagiken-oki earthquake in 1978 (Term-2), and after the seismic retrofitting (Term-3). The results are shown in Fig. 5.1. The vertical and horizontal axes of the figure represent the first natural period in the *TR* direction and the maximum deformation angle of the building, respectively. They clarified that the amplitude dependencies changed after significant stiffness reduction, indicating that the amplitude dependence differed for the three terms as shown in Fig. 5.1. In addition, they revealed that the natural periods obtained from ambient vibration records corresponded to the lower limit of the period range. Although the frequency would change at all times because of wind or other environmental factors, the amount of change can be ignored because it is sufficiently small in comparison to the change by earthquakes.
