# MECHANISM OF THE GRABENS THAT FORMED IN THE ASO CALDERA DURING THE 2016 KUMAMOTO EARTHQUAKE

**ABSTRACT:** During the 2016 Kumamoto Earthquake, many special belt-like subsidences called “grabens” occurred in the Aso Caldera, and houses were severely damaged. According to the measurement results of SAR, a horizontal displacement of 2 to 3 m was generated in the area where the grabens occurred. A lake was formed in this area around 9,000 years ago. A soil investigation showed that the bottom of the old lake was bowl-shaped, and a special clay was deposited there. A residual deformation analysis showed that the soft clay flowed due to the earthquake, causing the grabens at the ground surface.

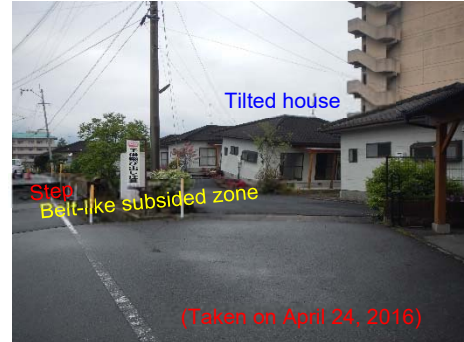
Photo 2 Damage in the Uchinomaki district

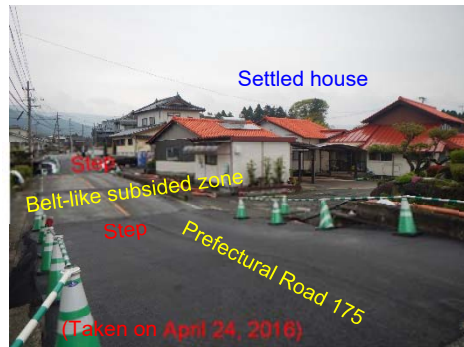
Photo 3 Damage in the Kario district

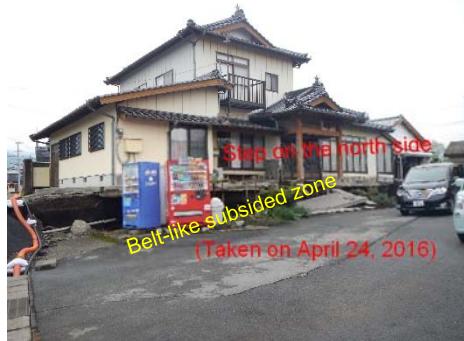
Photo 4 North side of the graben in the Kario district

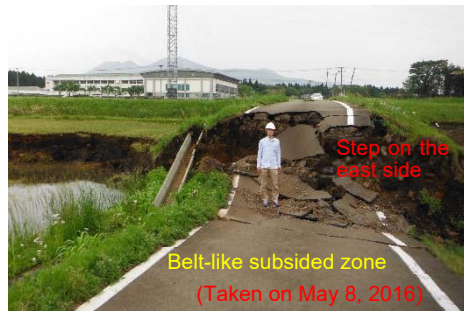
Photo 5 Damage in the Matoishi district

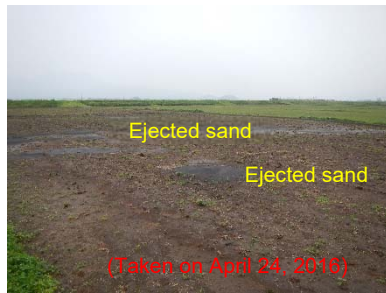
Photo 6 Ejected sands on agricultural land

When the survey was conducted on April 24, sand volcanoes were found in some parts of the agricultural land in Aso Valley, as shown in Photo 6. However, no sand volcanoes were found in the grabens. Since the field survey in Yakuimbaru was conducted about a year after the earthquake, the situation immediately after the earthquake is unknown, but even so, as shown in Photo 7, a graben in the north-south direction remained.

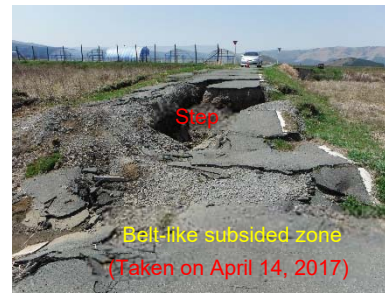
Photo 7 Damage in the Yakuimbaru

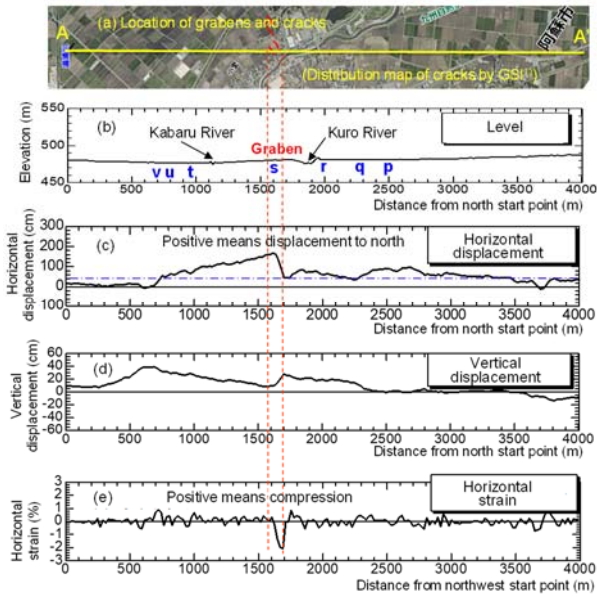
Fig. 10 Distribution of displacement and strain in the Ozato district

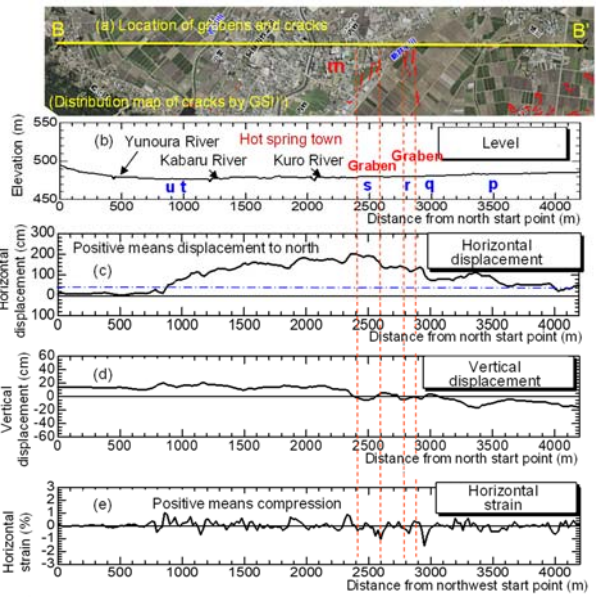
A seismograph by Kumamoto Prefecture is installed at the Uchinomaki branch in Aso City at point **m** in (a), and records have been taken at the time of the main shock<sup>13)</sup>. In the acceleration waveform of the NS component, a spike-like peculiar behavior appears around 20 seconds. When the displacement waveform is estimated by integrating this waveform, a maximum displacement of about 3.5 m occurred in the north direction after 20 seconds, and a residual displacement of about 2.5 m occurred after 60 seconds<sup>14)</sup>. According to the measurement by SAR, the displacement amount was about 2 m, and the two are in good agreement.

Fig. 11 Distribution of displacement and strain in the Uchinomaki district

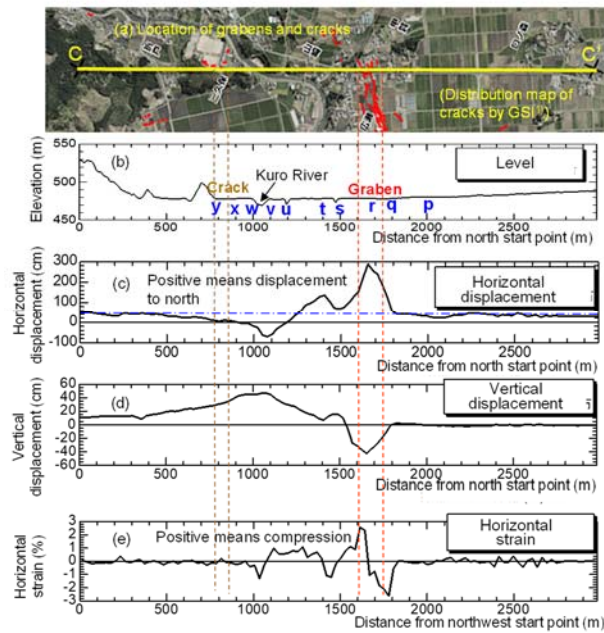
**(3) Kario district:** The ground surface gradient drops slightly northwest from **C'** at the southeastern end to the vicinity of point **r** in the graben section, at  $-0.8\%$ , and from there to the Kuro River, it is almost flat at about  $-0.2\%$ . There is a long and narrow ridge from somma to the northwest of the Kuro River, which is complicated, but the survey line hits the ridge near point **y**. In the range from the Kuro River

Fig. 12 Distribution of displacement and strain in the Kario district

to point **y**, the gradient increases slightly to about 0.4%. The local horizontal displacement is zero from **C'** to point **q**, and a large displacement begins to occur suddenly in the northwest direction from there, reaching a maximum of 2.5 m at point **r**. After that, it decreases to the vicinity of point **s**, then increases again near point **t**, and decreases to zero near point **u**. On the northwest side of that, there is a displacement toward the southeast. The distribution of vertical displacement is axisymmetric to the distribution of horizontal displacement, and it subsides significantly in the graben section and rises up to about 55 cm around point **w**.

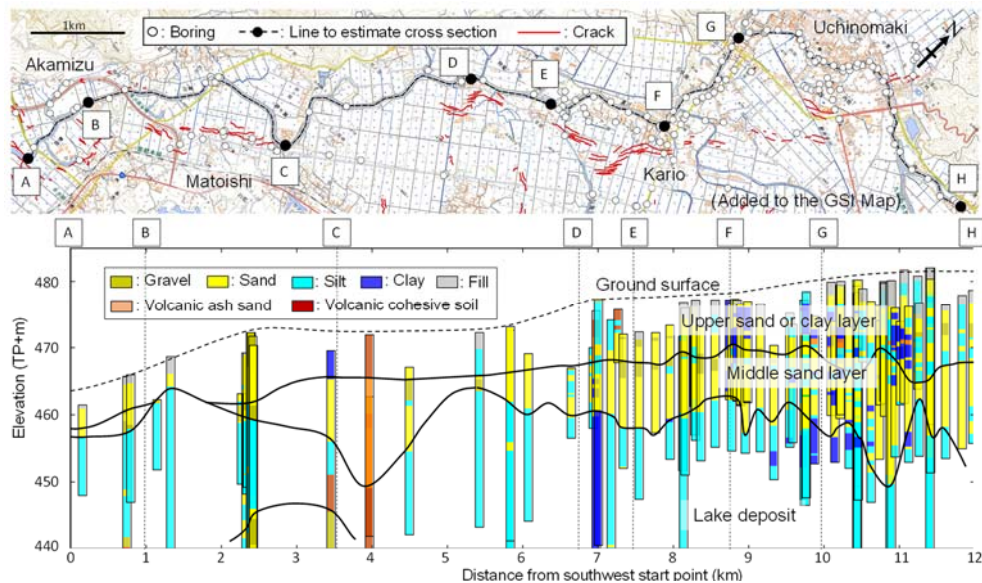
To understand the distribution of this lake deposit and the sand or clay layer above it in the area where grabens occurred, existing boring data were collected. When the authors first checked the Geoinformatic Sharing Database in Kyushu, there were only 126 boring data from the target area. Since these were not enough, the authors collected data from the Kyushu Regional Development Bureau of the Ministry of Land, Infrastructure, Transport and Tourism, Kumamoto Prefecture, Aso City, Kyushu

Fig. 14 Soil cross section along the Kuro River estimated from existing boring data

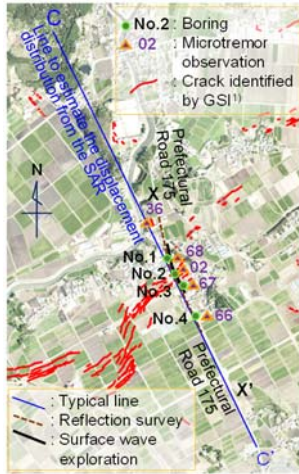
Fig. 15 Sites of soil investigations and explorations

Prefectural Road 175: the northwest side (No. 1), the graben point (No. 2), the southeast side (No. 3), and a further south side (No. 4), as shown in Fig. 15. Based on these borings, the soil cross section along about 1,300 m of the road in the section from X (Mikubo) to X' (Otohome) was estimated, as shown in Fig. 16. Unconsolidated sand or clay is deposited at an altitude of from 478 m to 461 m with a thickness of about 17 m. The soil condition on the north side differs from the condition on the south side. Sandy soil and clayey soil are unevenly deposited from point X to around 800 m. Since the surface layer at No. 2 was cracked by the earthquake, looking at the soil boring log of No. 1, the SPT  $N$  value of the clayey soil is 4 to 7, which means a little soft, though there is a thin, very soft layer with  $N = 1$  to 2. The  $N$  value of the sandy soil is about 10 to 30, which means medium dense. On the contrary, hard sandy soil with an  $N$  value of 15 to 40 is deposited on the southeastern side from around 800 m to point X'.

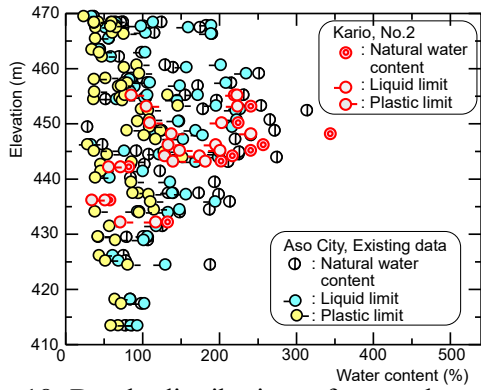
Fig.18 Depth distribution of natural water content, liquid limit and plastic limit

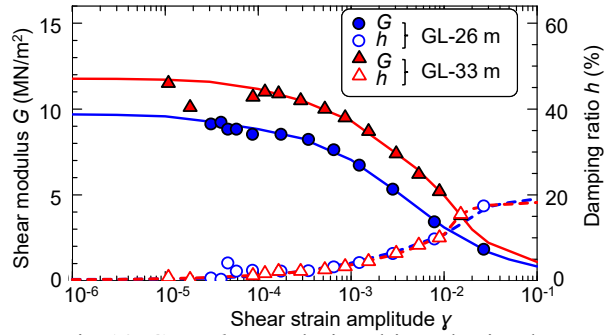
Fig.19  $G - \gamma, h - \gamma$  relationships obtained by cyclic torsional test

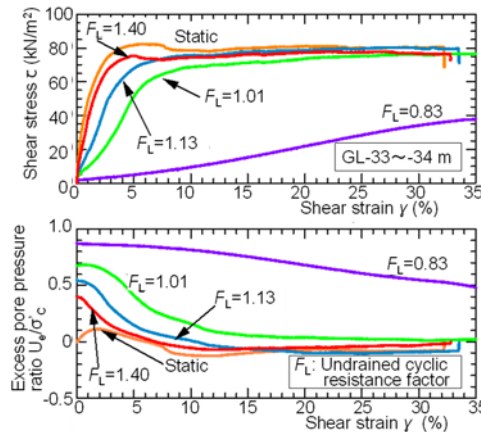
Fig. 20 Stress-strain curves after cyclic loading in different  $F_L$

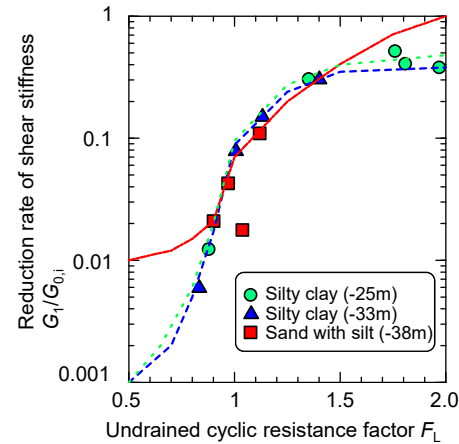
Fig. 21 Relationship between  $F_L$  and  $G_1/G_{0,i}$

**(2) Lake deposit:** i)  $\gamma_t = 12.0 \text{ kN/m}^3$  (Clay 1 to 3),  $18.0 \text{ kN/m}^3$  (Sand),  $14.0 \text{ kN/m}^3$  (Clay 4), ii)  $V_s = 140 \text{ m/s}$  (Clay 1 to 3),  $190 \text{ m/s}$  (Sand),  $150 \text{ m/s}$  (Clay 4), iii)  $G/G_0 - \gamma$  &  $h - \gamma$ : test result, iv)  $R_L = 0.755$  (Clay1 & 2),  $0.460$  (Clay 3 & 4), v) tested reduction in shear modulus (Fig. 21).

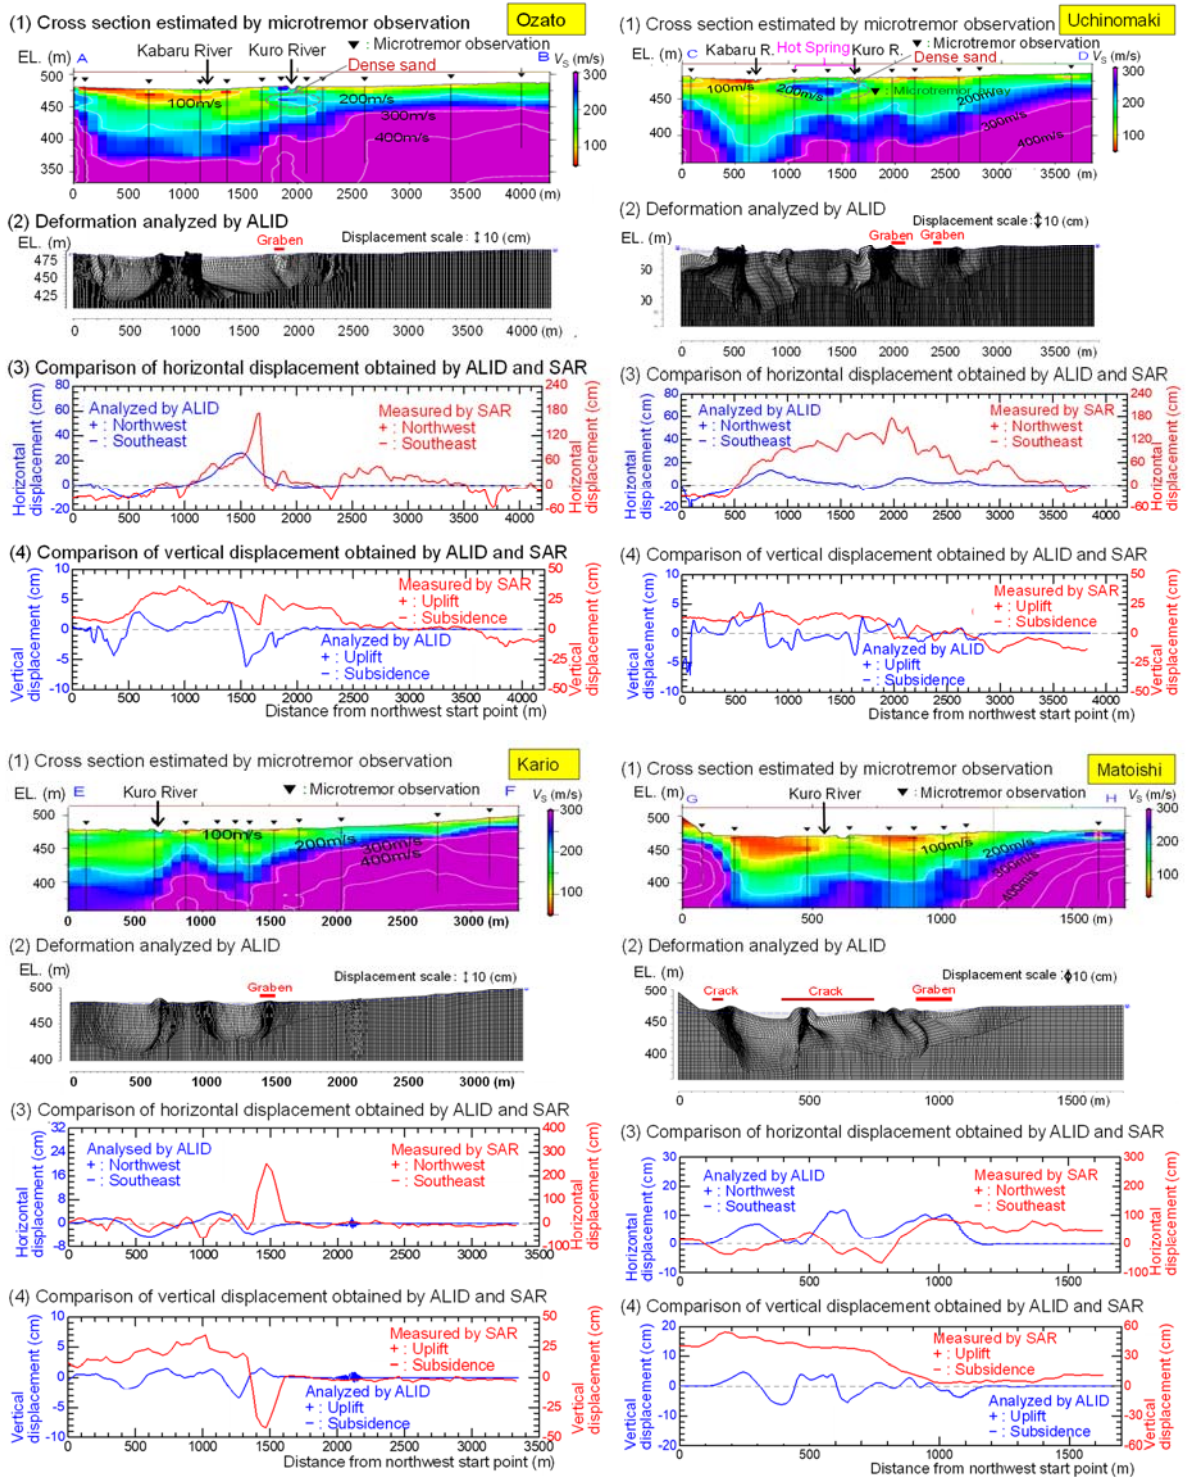
Fig. 32 Cross sections in four districts estimated by microtremor measurement and by analysis

array observation, the depth of the bottom of the old lake is intricate, and the surface layer of the Uchinomaki hot spring area contains a lens-like layer hardened by the silicification of hot spring water. Therefore, it is considered that the displacement distribution has become complicated. Residual deformation analysis also resulted in a complicated deformation. In the Kario district, as mentioned above, the northwest side from around 1,000 m is different from the survey line of the SAR. Therefore, when comparing only on the southeast side, the displacement distribution of the SAR showed a large

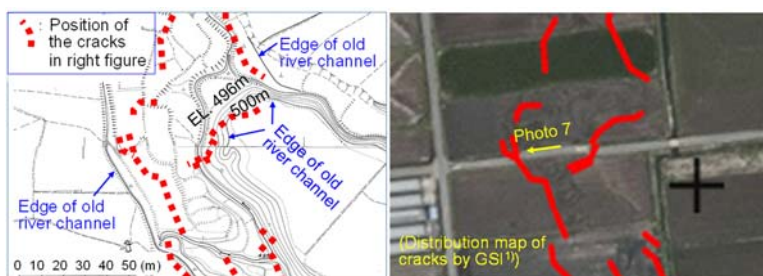
In the Yakuimbaru district, unlike the four districts of Ozato, Uchinomaki, Kario, and Matoishi, no local displacement occurred according to SAR, and the graben occurred outside the boundaries of the old lake. However, a small river once flowed northward in old topographic maps. A large-scale agricultural land development has been carried out in this area since 1970. The 1/1000 topographic map surveyed at that time by the Aso Land Improvement Agriculture Cooperative is shown in Fig. A1 with the cracks read by GSI. The location of the cracks seemed to coincide with the edge of the old small river, and the subsidence was thought to be due to the soil that filled the small river. In that case, subsidence due to liquefaction and collapse of the cavity that had been formed before the earthquake are considered. Regarding the former, the maximum depth of a small river is about 4 m, and the amount of compression when liquefied is generally about 5% of the layer thickness, so it is difficult to explain the actual subsidence of about 1 m. Regarding the latter, it is said that when burying the small river, stones were laid on the riverbed and soil was placed on the stones. Therefore, it is presumed that the groundwater flowing between the stones gradually caused the soil in the lower part of the buried soil to flow out and form a cavity, and it was thought that a depression occurred due to the earthquake motion there.

Fig. A1 Position of cracks on old topographic map of the Yakuimbaru district
