RECOVERY STATUS AND CHALLENGES IN SOUTHERN THAILAND AFTER THE 2004 INDIAN OCEAN TSUNAMI BASED ON SATELLITE IMAGES AND FIELD SURVEYS

ABSTRACT: This study aimed to understand the 20-year recovery process in the Khao Lak area of Phang Nga Province in southern Thailand, which sustained severe damage from the Indian Ocean tsunami caused by the Sumatra earthquake on December 26, 2004, using optical satellite images and results from a total of seven field surveys. This area, where tourism and fishing are the main occupations, was still in the process of recovery when surveyed 10 years after the tsunami. However, in the latest survey 20 years after the tsunami, the resort area was bustling with foreign tourists, and the number of hotels and buildings had increased significantly. Meanwhile, no hard measures such as seawalls were seen in terms of tsunami disaster prevention measures, and instead, progress had been made in installing tsunami warning sirens and evacuation towers, and setting up evacuation routes. Tsunami museums and memorial sites had also been established to pass on the memory of the disaster.

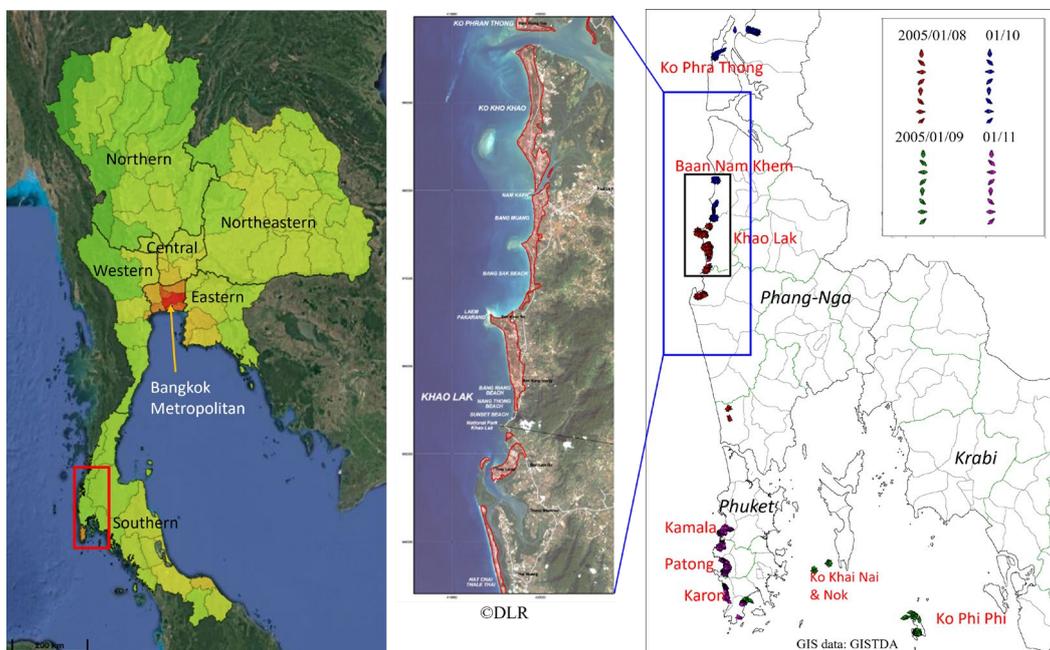
(a) Regional divisions of Thailand with the coverage of (b) in red square (b) Tsunami inundation zone¹²⁾ and field survey points⁷⁾ in January 2005 by the authors

Fig. 1 Regional divisions of the Kingdom of Thailand, field survey locations in southern Phang Nga Province, and the study area

Figure 1 shows the regional division of Thailand, the affected areas in southern Thailand by the 2004 Indian Ocean tsunami, and our first survey sites⁷⁾ in January 2005. The southern region of Thailand

consists of 14 provinces, including 6 provinces facing the Andaman Sea such as Phang Nga, and 8 provinces facing the Gulf of Thailand. The survey immediately after the tsunami was conducted by a joint survey team⁷⁾ consisting of Fumio Yamazaki (Chiba University) and Masashi Matsuoka (Earthquake Disaster Mitigation Research Center (EDM) of NIED) from Japan, Shubharoop Ghosh from ImageCat Inc. from the United States, Pennung Warnitchai from Asian Institute of Technology (AIT), Supapis Polngam and Siam Lawawirojwong from the Geo-Informatics and Space Technology Development Agency (GISTDA) from Thailand, and Masahiko Honzawa, who had been dispatched to GISTDA by Japan International Cooperation Agency (JICA). The purpose of the survey was to collect on-site validation data to interpret the affected areas from satellite images. In the survey, optical satellite images with multiple resolutions were used as maps, and GPS-linked digital cameras were used to obtain photos with location information⁸⁾. The field survey was carried out for four days from January 8 to 11 in the affected areas of Khao Lak, Phuket Island, and Phi Phi Island, and the locations and directions where the photos were taken are shown in the figure⁷⁾.

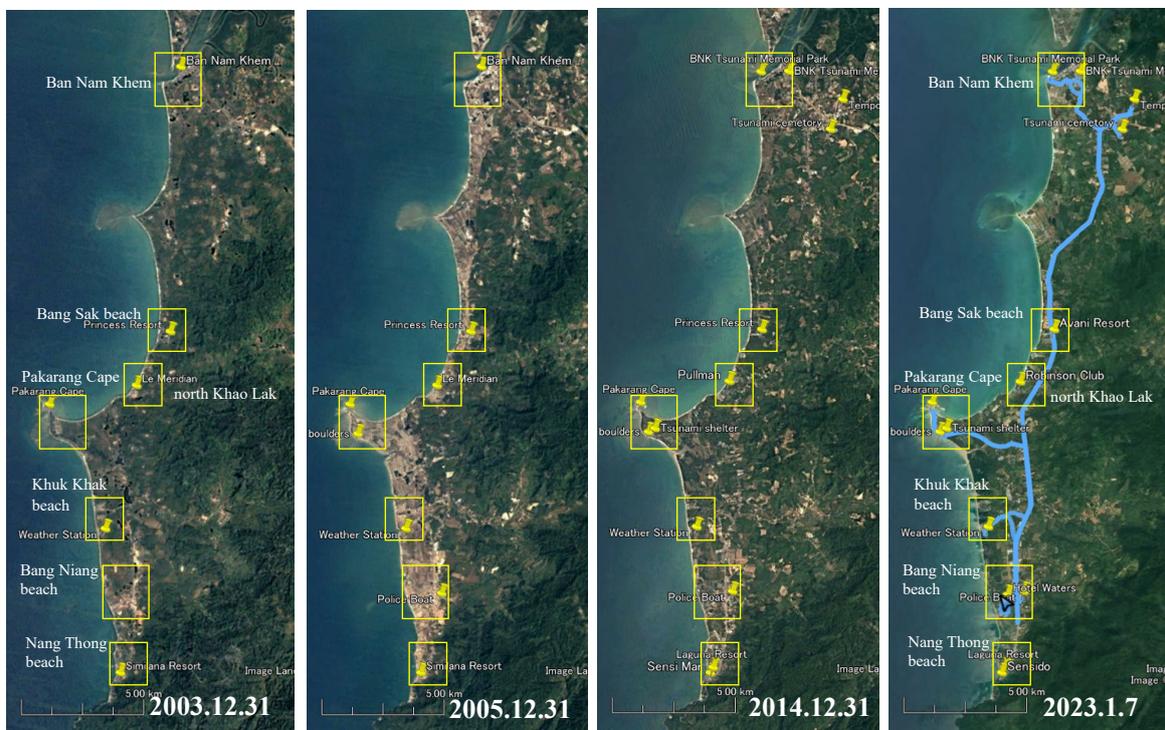
Fig. 2 Landsat satellite images of central Phang Nga province at four different times, main survey locations, and survey route in December 2024 (blue line)

The central part of Phang Nga Province, from Ban Nam Khem fishing port through Pakarang Cape to Khao Lak Lamalu National Park, is an area with lowlands along the coastline and many large resort hotels. Landsat satellite images on Google Earth covering this area over time from before the tsunami to the present are compared in Fig. 2 for the black square area in Fig. 1 (b). The survey route in December 2024 is shown by a blue line in the January 2023 Landsat image. Yellow pins are placed at the main

survey locations, and the seven areas to be examined in the time-series high-resolution satellite images are shown by yellow squares.

The first three images were all taken on December 31, and the latest image was taken on January 7, so there is almost no influence of seasonal vegetation changes. In the image from 2003, one year before the tsunami, vegetation extends to the coastline, but in the image from 2005, one year after the tsunami, the vegetation appears to have withered. Moreover, in images taken in 2014, 10 years after the tsunami, the vegetation appears to have recovered to its pre-tsunami state. Below, we will divide the area into two regions, north and south, separated by Pakarang Cape, and conduct a detailed observation of the state of recovery in these areas based on high-resolution optical satellite images and field photos.

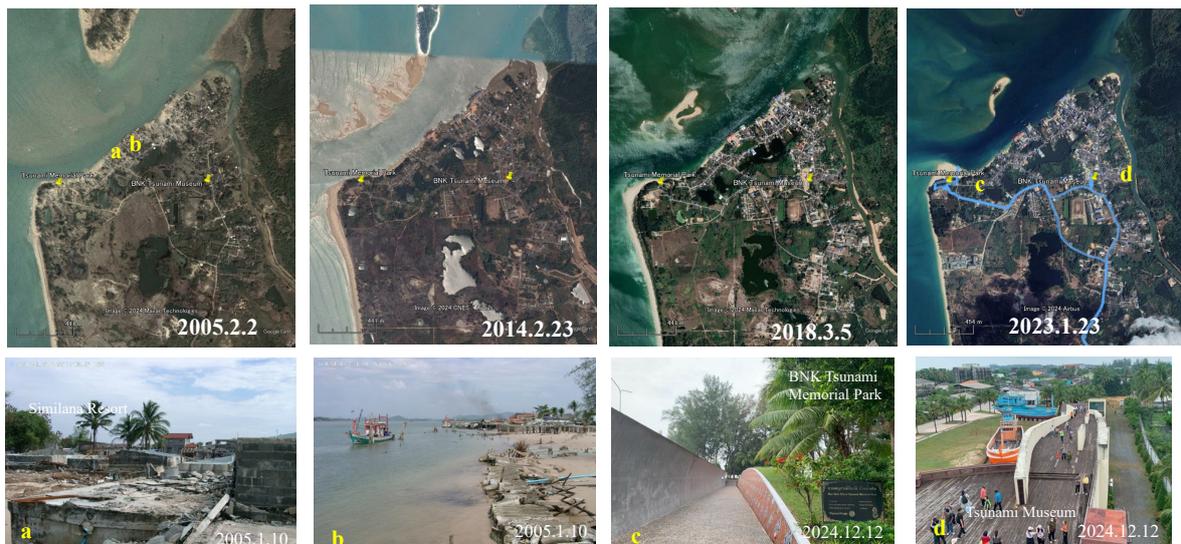
Fig. 3 Multi-temporal high-resolution satellite images and on-site photos of Ban Nam Khem fishing port area

Figure 3 compares high-resolution satellite images of the area around Ban Nam Khem fishing port taken by Maxar (on Google Earth) for four time-instants after the tsunami. The locations where the on-site photographs were taken are included in the satellite image from a similar time period. The fishing port is located at the mouth of several rivers and faces a narrow strait between the port and Khao Island. This resulted in the concentration of tsunami energy and caused severe damage (photos **a** and **b**). The satellite images also show that the southern end of Khao Island was eroded by the strong ocean currents in the latter period (2018). At the time of the tsunami, about one-quarter of the villagers, which numbered 4,200, died, and about 80% of their homes were washed away^{13), 14)}.

The village was thus designated as a model district for recovery from the tsunami, and a memorial park was opened in 2006 (photo **c**). In 2017, the Phang Nga Provincial Tsunami Museum was also built on high ground outside the tsunami danger zone (photo **d**). The red and blue fishing boats, which have become symbols of the tsunami hazard, were originally left where they washed up, but a few years later they were moved to a site outside the museum. However, due to deterioration of the wooden boats, replicas are now on display. The museum has an exhibition room for crushed cars and other items, as well as a theater where educational videos can be viewed. The roof of the building also serves as a tsunami shelter where several hundred people can be accommodated. In Ban Nam Khem, temporary housing used at the time still remains. A cemetery for tsunami victims has also been set up in the location where many unidentified bodies were kept frozen in the period just after the tsunami.

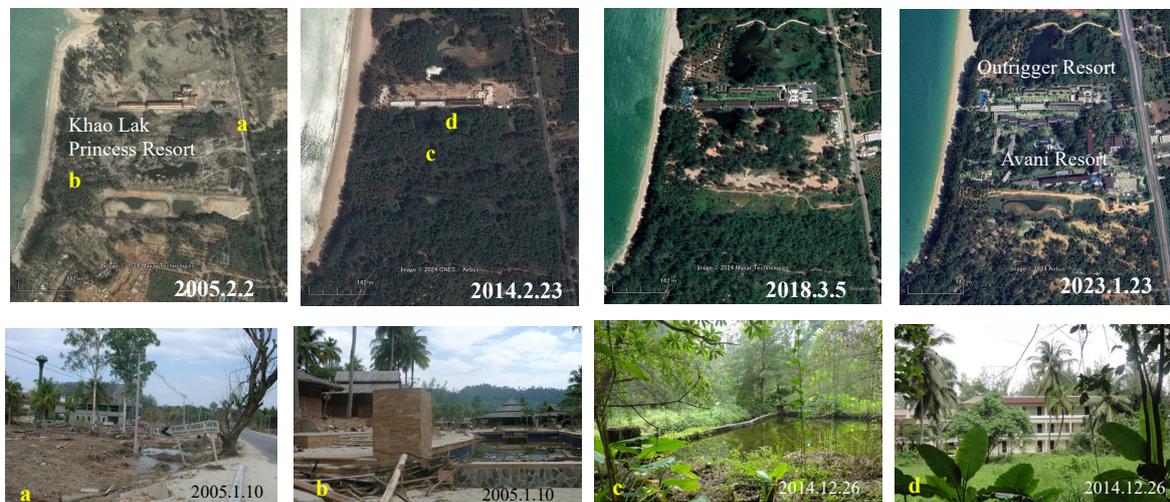
Fig. 4 Multi-temporal high-resolution satellite images and on-site photos of Ban Sak Beach area

As we head south on National Highway 4, which runs north and south through Phang Nga Province, and the road approaches the coastline, we begin to see a number of large beach resorts. One of these is the area around Ban Sak Beach, shown in Fig. 4. At the time of the tsunami, there was Princess Resort with a row of cottages here, and a large hotel was under construction just to the north, but this area was totally destroyed by the tsunami (photos **a** and **b**). We visited this area again in December 2014, and found that it had been left as it was at the time of the disaster, with vegetation overgrown and turning it into a jungle (photos **c** and **d**). Although we only drove past the area during the survey in 2024, high-resolution satellite images and Google Maps showed that the damaged hotel under construction had opened in 2018 as the five-star Outrigger Resort, a three-story reinforced concrete building. We also learned that the old Princess Resort began rebuilding around 2018, and that it was renamed the five-star Avani Resort and opened around 2021. No hard countermeasures such as seawalls or raising the ground level have been implemented, so there is a high risk if another large tsunami hit the area. However, in the case of Avani Resort, a six-story reinforced concrete main building has been built, which appears to function as a tsunami evacuation building.

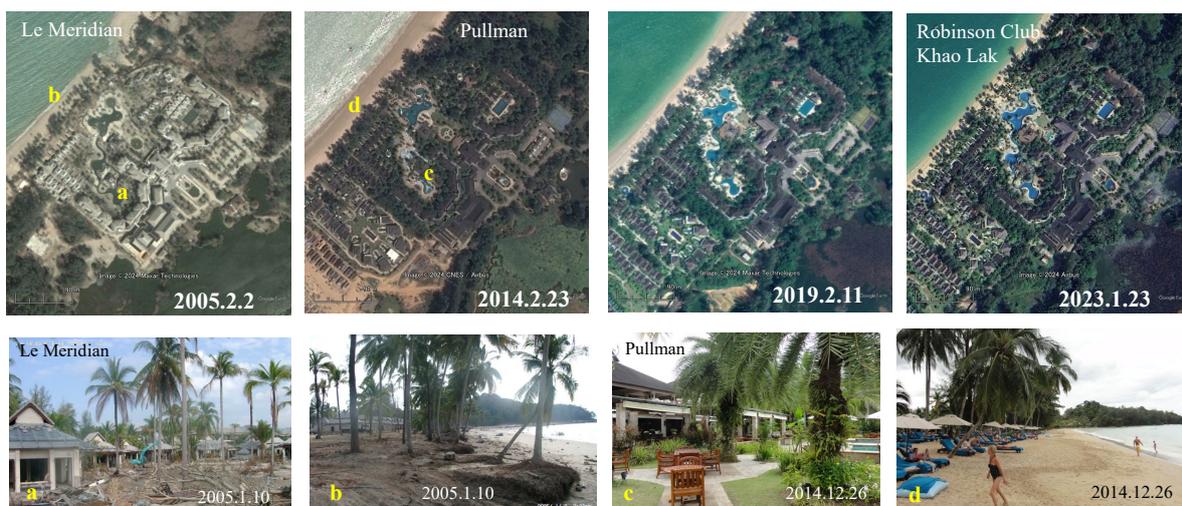
Fig. 5 Multi-temporal high-resolution satellite images and on-site photos of northern Khao Lak area

Another large beach resort has existed since 2004 along the coast about 3 km further south from Ban Sak Beach on National Route 4. This is the luxury hotel Le Meridian, shown in Fig. 5. The hotel's main building escaped the tsunami because its main entrance facing the road in front is on the third floor, but the second and lower floors, cottages, and pools were hit by the tsunami (photos **a** and **b**). However, when we visited 10 years later in December 2014, it had been renamed Pullman Resort and had been completely restored (photos **c** and **d**). Looking at Google Maps, it has now been renamed again to a five-star resort called Robinson Club.

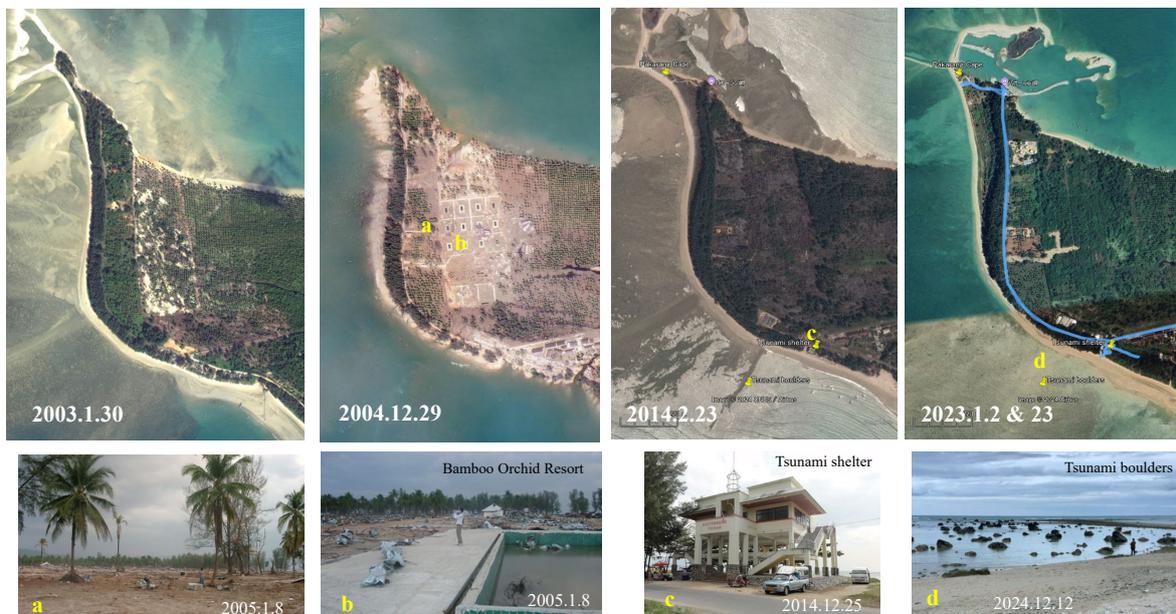
Fig. 6 Multi-temporal high-resolution satellite images and on-site photos of Pakarang Cape area

Pakarang Cape is a cape located in the northern part of the area called Khao Lak, jutting out into the Andaman Sea. Figure 6 shows Ikonos satellite images taken before and after the tsunami¹⁵⁾, and high-resolution satellite images by Maxar (on Google Earth) taken two times after the tsunami. During the 2004 Indian Ocean tsunami, the Bamboo Orchid Resort at the tip of the cape was hit by the tsunami from two directions and destroyed completely⁷⁾ (photos **a** and **b**). The tsunami height at the tip of the cape was reported to be nearly 9 m in some places¹⁶⁾. Two tsunami evacuation towers were subsequently built on the coastline of Khao Lak, one of which is located on this cape (photo **c**). One of the four evacuation warning siren towers built in Khao Lak is also located in this area.

The cape area was originally a resort with a wide sandy beach, but it was abandoned for a long time after the tsunami. However, at the time of the 2024 survey, port construction, which is thought to be the construction of a fishing port, had begun. What was confirmed for the first time during the 2024 visit was the group of tsunami boulders that spread across the west coast of the cape (photo **d**). These can be read even by enlarging the Ikonos image taken immediately after the tsunami. Goto et al.^{16), 17)} have already conducted detailed investigations through field surveys and numerical analysis, showing that the boulders in this area, up to 4 meters in diameter, are of coral reef origin and were carried by the tsunami and deposited here where the waves were broken in shallow waters and lost their energy.

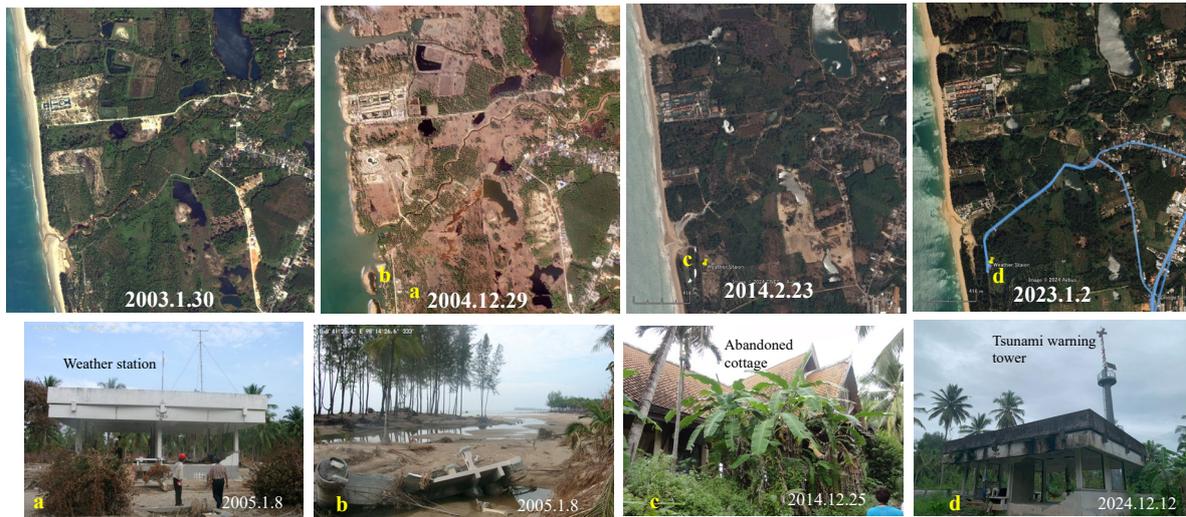
Fig. 7 Multi-temporal high-resolution satellite images and on-site photos of Khuk Khak Beach area

Figure 7 shows the surroundings of the meteorological observation facility located approximately 5 km south of Pakarang Cape. This single-story reinforced concrete building (photo a) is located approximately 200 m from the coastline and approximately 300 m from the river mouth to the north (photo b), and was hit directly by tsunamis that were higher than the roof⁷⁾. Traces of damage indicating the destructive power of the tsunami, such as bridges washed away and destroyed cottages, were spread all around the area, and as of the 2014 survey, buildings had been left almost untouched (photo c). The meteorological observatory building was designated as a tsunami memorial structure, and an evacuation warning siren tower was newly erected after the disaster next to the building (photo d).

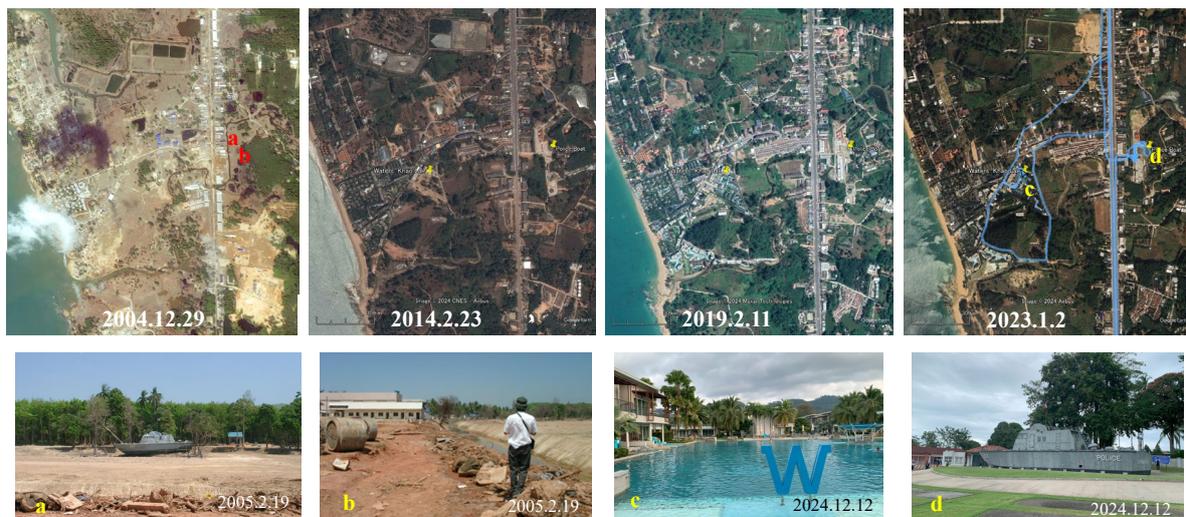
Fig. 8 Multi-temporal high-resolution satellite images and on-site photos of Bang Niang Beach area

Figure 8 shows the area around Bang Niang Beach, about 3 km south of the meteorological observatory. Flat land continues from the coastline in this area, and the tsunami came over National Route 4, which runs about 1 km inland. Because there was also a small river flowing, the tsunami went deep up the coast, and the police boat was washed up about 1.2 km from the coast (photos a and b). In recent years,

large hotels have opened one after another in this area close to the coast (photo **c**), and it has become a popular resort. The washed-up police boat was later placed on a pedestal on land, and the surrounding area is open to the public as a tsunami memorial site (photo **d**). A tsunami museum run by an NPO has also been established nearby. A tsunami warning siren tower has also been installed in this area, but experts have pointed out that it is more than 1 km away from the coastline, so the sound will not reach resort guests on the beach.

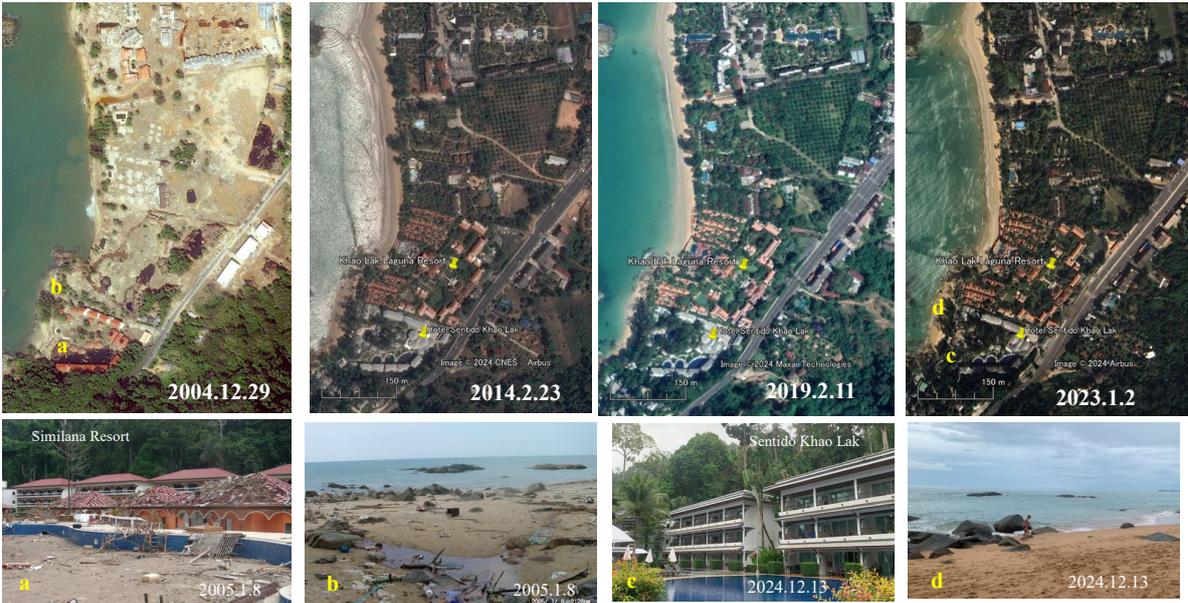
Fig. 9 Multi-temporal high-resolution satellite images and on-site photos of Nang Thong Beach area

Figure 9 shows the area around Nang Thong Beach, about 3 km south of Bang Niang Beach. The long sandy beach of Khao Lak ends here, and going further south, National Highway 4 climbs a slope and reaches the peninsula of Khao Lak Lamlu National Park. Similana Resort, which was open at the time of the tsunami, and the commercial facilities to the north were hit by a tsunami up to the height of one-story building roofs, causing devastating damage (photo **a**). The coast was also eroded by the tsunami, and debris carried by the tsunami was scattered around⁷⁾ (photo **b**).

When we visited again in December 2014, the hotel building had been renovated and was open under the name Sensi Mar, and Laguna Resort had opened to the north. The international conference to commemorate the 20th anniversary in December 2024¹¹⁾ was held at Laguna Resort. When we went to check on the hotel next door, we found that it was now operating under the name Sentido (photo **c**). The layout of the buildings and pools was the same as before, but it appears that it has undergone several renovations and has changed management. Sand has been brought in to the beach, and it has been restored to a well-maintained resort. This shows that the tourism industry has an extremely high level of resilience against tsunami disasters in Thailand.

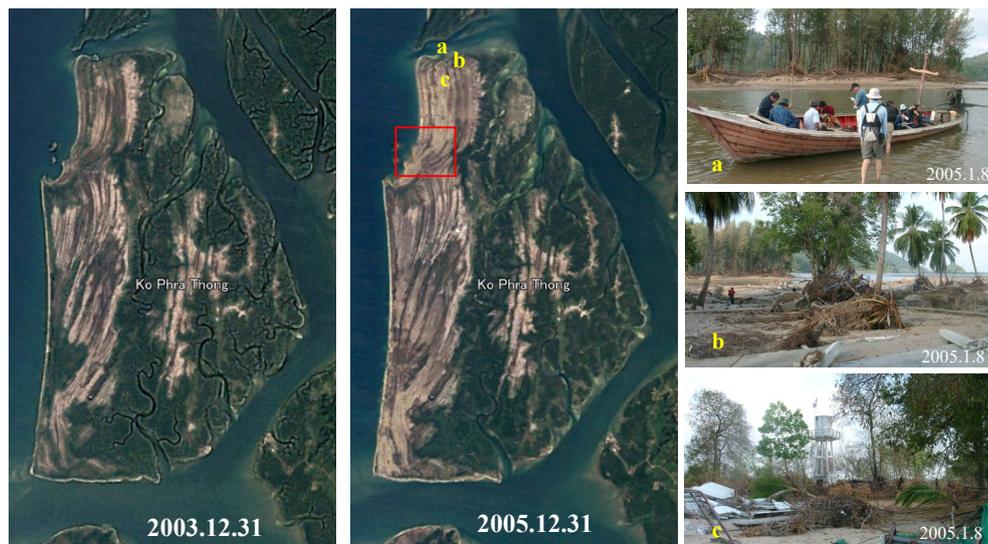
Fig. 10 Landsat images of Phra Thong Island before and after the 26 December 2004 tsunami and field survey photos on 8 January 2005 (The red square indicates the area shown in Fig. 11.)

To evaluate the tsunami hazard in southern Thailand, it is necessary to investigate the tsunami history before the 2004 Sumatra earthquake. However, there are no records of past tsunamis in this region. Therefore, researchers from all over the world investigated tsunami deposits hidden in the strata^{18), 19)}. The west coast of Phra Thong Island (Fig. 1) in Phang Nga Province was selected as a suitable location for tsunami deposit investigation because the land has not been altered much. Figure 10 compares Landsat satellite images (on Google Earth) before and after the 2004 tsunami. The image taken in December 2005 shows that vegetation on the west and south coasts had decreased compared to that of December 2003, and these areas are believed to be inundated by the 2004 tsunami. During our survey in January 2005 (two weeks after the tsunami), we landed on the north coast by a small boat and surveyed the surrounding area (photo a). The coastline was clearly marked by the tsunami impacts, and even a short distance inland, buildings had been hit by the tsunami up to the ceilings on their first stories, with

everything except the foundations and pillars being washed away (photos **b** and **c**).

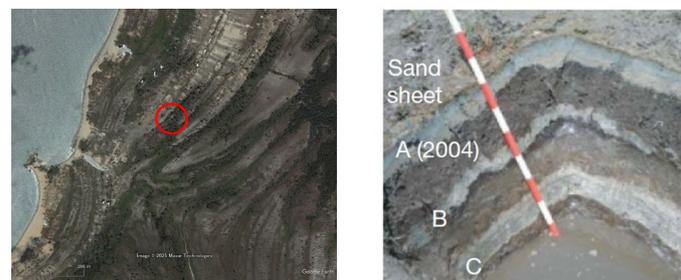
Fig.11 Excavation survey of tsunami deposits on Phra Thong Island¹⁸⁾ (The red circle in the left photo indicates the digging site of the right photo.)

Figure 11 shows an example of pit and trench excavation surveys conducted on the west coast of the island to investigate paleo tsunami deposits. Three layers of sand were identified at this site and are considered to be tsunami deposits. A radiocarbon dating has estimated that the top layer-A is from the 2004 Sumatra earthquake tsunami, the layer-B below that is 550–700 years older, and the layer-C below that is 1,500–1,850 years older¹⁸). These results are extremely important, and indicate that large tsunamis that strike southern Thailand may occur at intervals of about 500 to 2,000 years.

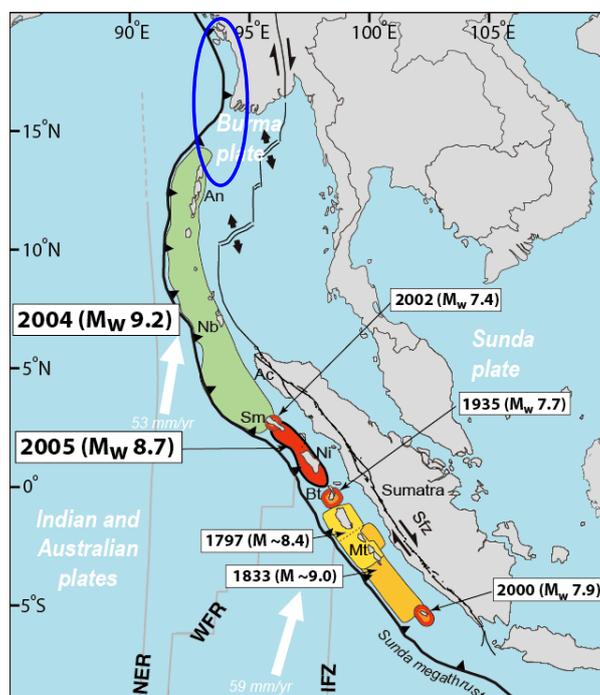
Fig.12 The trench off the coast of Myanmar where the recurrence of a mega earthquake is feared (The area of the blue ellipse)

But the possibility of a tsunami from a different seismic source has been pointed out recently. This is the possibility of a mega earthquake exceeding magnitude 8 occurring in the Sunda Trench (off the coast of Myanmar), which is further north of the source zone of the 2004 megathrust earthquake shown in Fig. 12^{20), 21)}. The Arakan earthquake of M8.5 or more was recorded in this area on April 2, 1762, and the possibility of a recurrence of this earthquake has been pointed out²⁰⁾. In order to prevent another major disaster like the 2004 earthquake tsunami, which we were completely unprepared for, it is necessary to develop emergency tsunami evacuation measures based on the latest means of information transmission.

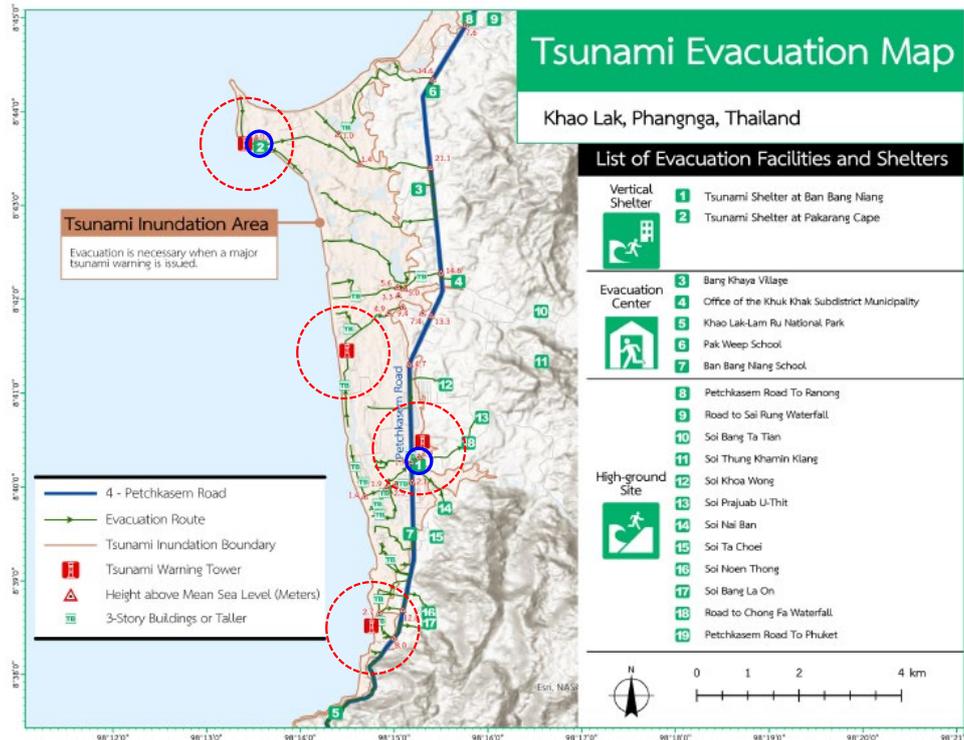
Fig. 14 Locations of the four warning siren towers in Khao Lak (the center of red circles), evacuation routes (green lines), and tsunami evacuation shelters (green squares)²⁶⁾

Figure 14 shows the locations of warning siren towers, evacuation routes, and evacuation sites in Khao Lak, where the highest tsunami actually hit. There are a total of four warning siren towers, but if the range where the voice can reach is a radius of 1 km, there are still many tsunami inundation areas that are not covered. In this regard, the current mobile phone penetration rate in Thailand is extremely high, and the smartphone penetration rate will exceed 98% in 2023. It would therefore be possible to create a system that sends warnings similar to Japan's Emergency Earthquake Alerts via mobile phones, and because social media is widely used, it is likely that people will also be able to contact family and acquaintances, so there should be no problem with transmitting information to people other than tourists on the beach.

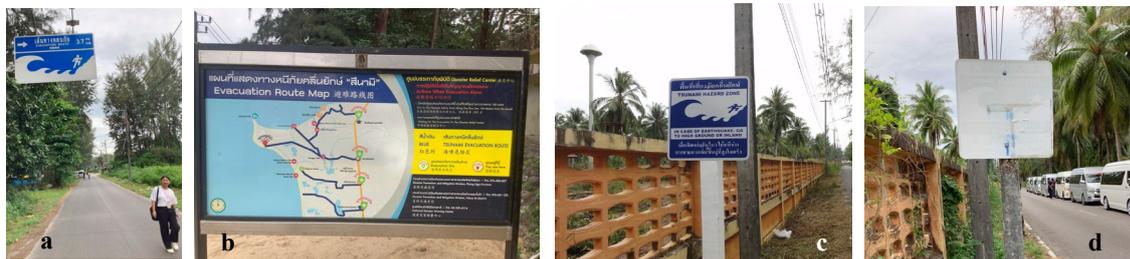
Fig. 15 Tsunami evacuation signs installed at Pakarang Cape (a, b) and a tsunami danger sign in front of the meteorological observatory (c: December 2014, d: December 2024)

There are many signs indicating evacuation routes and tsunami danger zones (Fig. 15), but some have become illegible after more than 10 years (photo d). Thus, the continuing maintenance of these evacuation facilities and equipment is a major issue. In the Khao Lak area shown in Fig. 14, the number of buildings in the flooded area in December 2004 was 2,434 in the 2003 statistics, but had almost doubled to 4,414 in the 2023 statistics²⁶⁾. As this increase includes large resort hotels, the population trapped in the flooded area may have increased several times over depending on the period of year. Providing information and guiding evacuation to foreign tourists who have no experience of earthquakes or tsunamis will be a major issue in the future.

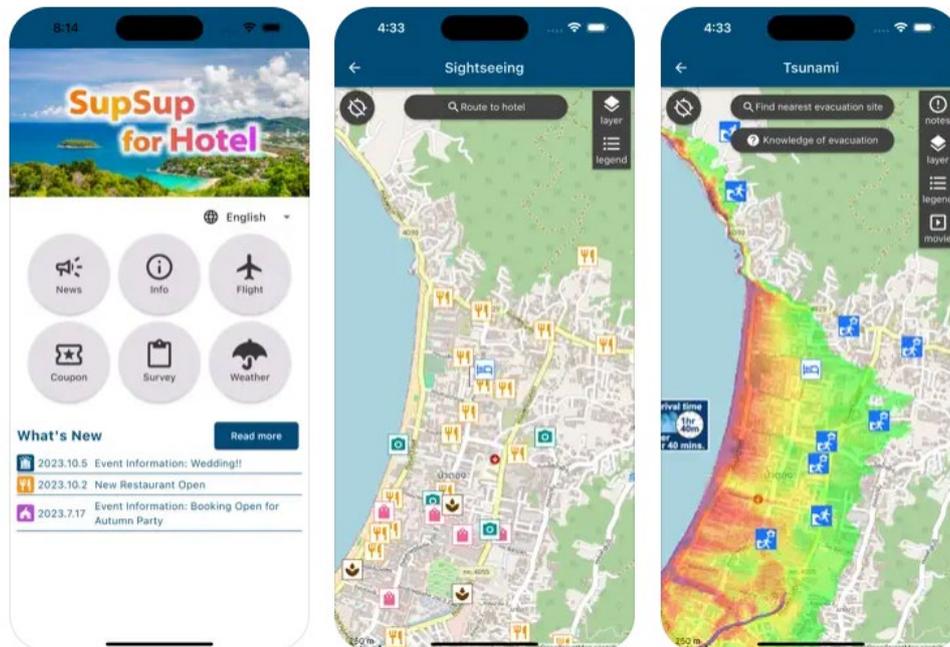
Fig. 16 Screenshots of a smartphone app developed as part of JETRO's Asia DX Promotion Project²⁹⁾ (From the left, the initial screen, tourist information, and tsunami information)

in this project, which will be introduced here. The smartphone app²⁹⁾ developed using Phuket Island as a model area provides tourists staying at hotels with various information about tourism, as well as information on how to protect themselves in the event of a natural disaster and information that will be useful in the event of illness or traffic accidents while sightseeing, as shown in Fig. 16. When an earthquake tsunami occurs, the system shows the tsunami arrival time and the safest and shortest evacuation site from the current location on a tsunami inundation forecast map. Implementing such a system in tourist destinations and working to maintain and update it is considered an important safety measure.
