TSUNAMI DAMAGE IN PORTS BY THE 2011 OFF PACIFIC COAST OF TOHOKU EARTHQUAKE

Takashi TOMITA¹ and Gyeong-Seon YOEM²

¹ Research Director, Asia-Pacific Center for Coastal Disaster Research, Port and Airport Research Institute, Yokosuka, Japan, tomita@pari.go.jp

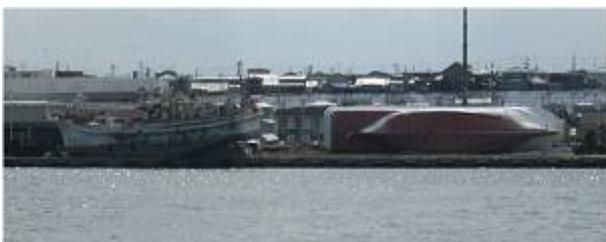
Fig. 3 Boats landed on a wharf in Port of Hachinohe

In the Port of Hachinohe, inundation heights are 5.4 to 6.4 m (2.5 to 2.9 m in the inundation depth above the ground surface) at points behind breakwaters. On the contrary, they are 8.3 to 8.4 m at the points directly facing the Pacific Ocean. The difference of the inundation heights indicates an effect of breakwater to reduce tsunami. Boats were moved and landed by tsunami action, as shown in Fig. 3, because the inundation depth is deeper than draft of the boats. Boats and ships with deeper draft were not able to be landed but moved on the sea surface in the port, following the tsunami flow.

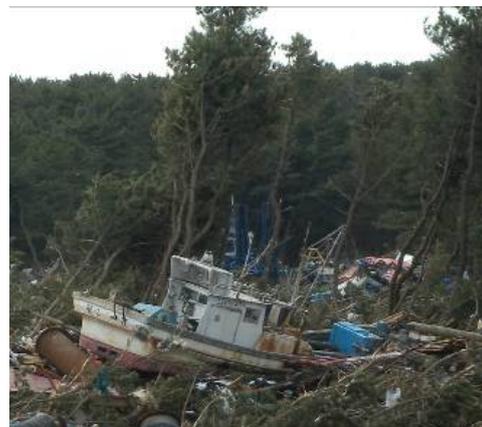
Fig. 4 Boats caught by a coastal green belt in Hachinohe

Even in the outside of the protected area by the breakwater, inundation height of 6.0 m was measured behind a coastal green belt consisting of pine trees. The green belt also mitigated tsunami flooding and further caught boats to prevent them from hitting houses as shown in Fig. 4.

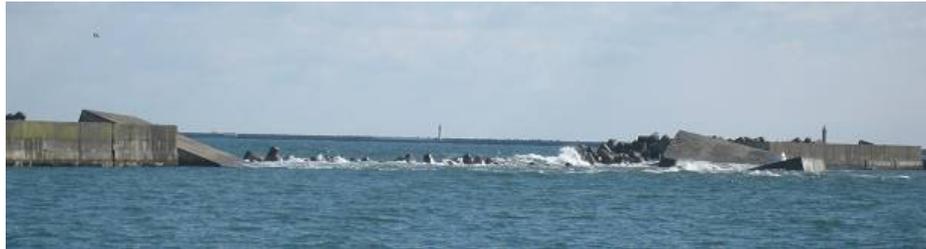
Fig. 5 Breakwater damaged in the Port of Hachinohe

Among the North Hattaro Breakwater of 3,504 m long, caissons of total 1,437 m long were moved and submerged, as shown in Fig. 5. In the figure many caissons are moved and submerged, and parts of wave-absorbing blocks installed in front of caissons can be seen above the sea surface. Figure 6 shows the tsunami overtopping the breakwater. According to the depth survey around the breakwaters after the event, parts of mound of the breakwater were scoured. Therefore, the breakwater may be damaged by not only the tsunami forces induced by difference of the water surface level in the front-side of the breakwater from that of rear side but also lack of stability of caisson induced by foundation failure due to the overtopping tsunami.

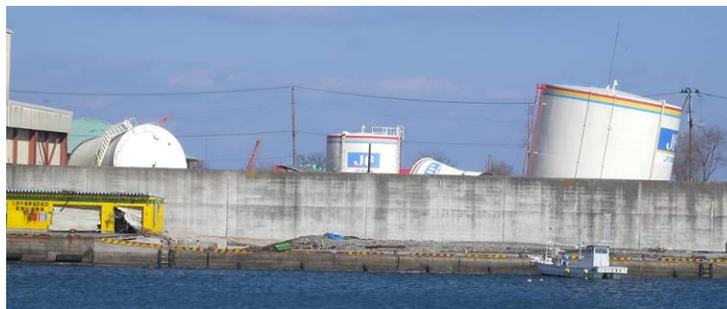
Fig. 7 Oil tanks damaged in the Port of Kuji

In the Port of Kuji the tsunami overtopped a line of tide protection wall of 3.6 m high, and flooded residential area with inundation depth of 4.4 m. Furthermore, the tsunami push oil tanks over sideways as shown in Fig. 7. The depth of water mark on the upright standing tank, which is at the center of the figure, indicates inundation depth of 4.4 m. In another city of Kesen-numa, 21 oil tanks were also damaged, floated and moved by the tsunami. The estimated amount of oil leaking from the damaged tank was 12,810 m³, according to a report of City of Kesen-numa. The oil was one of causes of fire in the city.

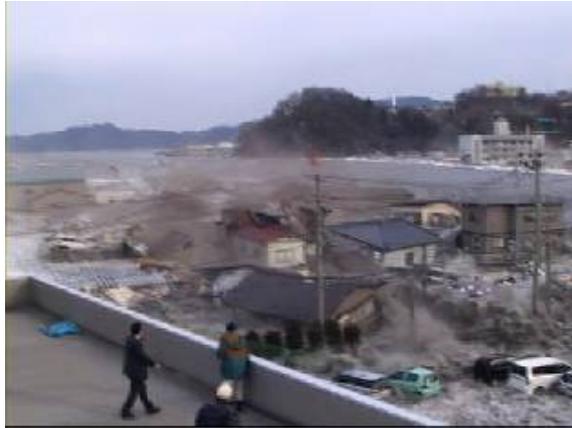
Fig. 8 Destruction of houses in Kamaishi

In the Port of Kamaishi, the tsunami inundation heights were 7.0 and 8.1 m (5.7 m and 3.5 m in inundation depth respectively) near coasts. The deep tsunami on land floated and crushed wooden houses, as shown in Fig. 8, which was a scene of the video taken by the Kamaishi Port Office of MLIT. Reinforced concrete (RC) buildings and large-scale grain silos were also damaged but not collapsed. Many vehicles together with debris from the destroyed houses filled roads, as shown in Fig. 9.

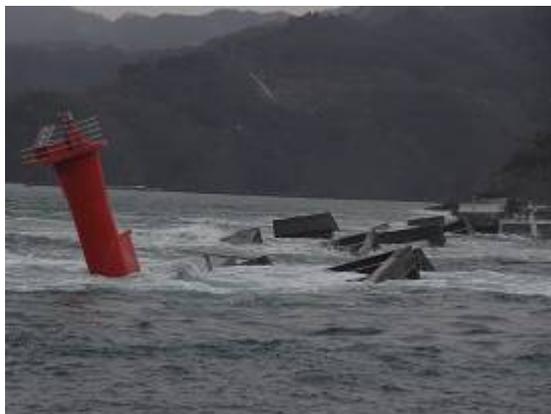
Fig. 10 North offshore breakwater damaged in the Port of Kamaishi

An offshore breakwater installed in the mouth of the Kamaishi Bay, which protected residential and industrial area in the bay together with seawalls along coastal lines against the tsunami whose height was the same as the 1896 Meiji Sanriku tsunami, was damaged by the tsunami as shown in Fig. 10. Caissons were moved and submerged by horizontal force caused by the difference of the water surface levels in the front-side of the breakwater from that of the rear side (Takahashi et al., 2011). Photo analysis indicates that the water surface rose up to T. P. +11.8 m at least and overtopped the breakwater whose crown height was T. P. +5 m, in which T. P. is the datum of altitude in Japan.

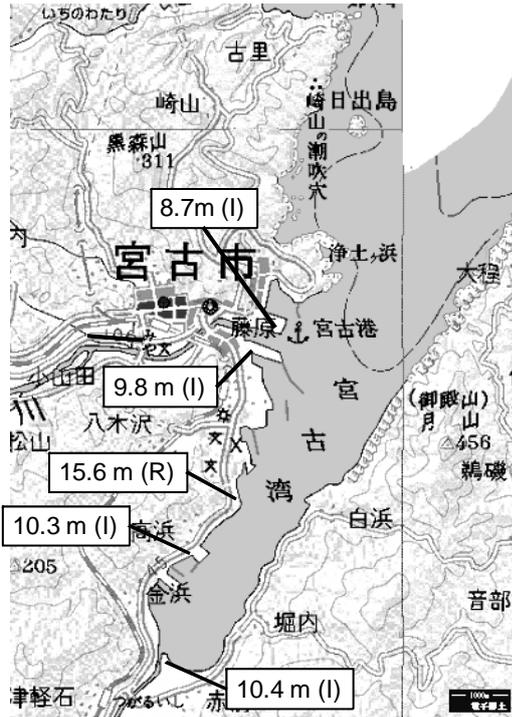
Fig. 12 Tsunami heights in Miyako Bay

Tsunami inundation heights were almost same in the Miyako bay, as shown in Fig. 12. The tsunami of 10 m high overtopped a protection dike along the coast and inundated residential areas as shown in Fig. 12. Boats were landed on wharfs in the Port of Miyako. Logs and vehicles were also floated and impacted houses, as shown in Fig. 13.

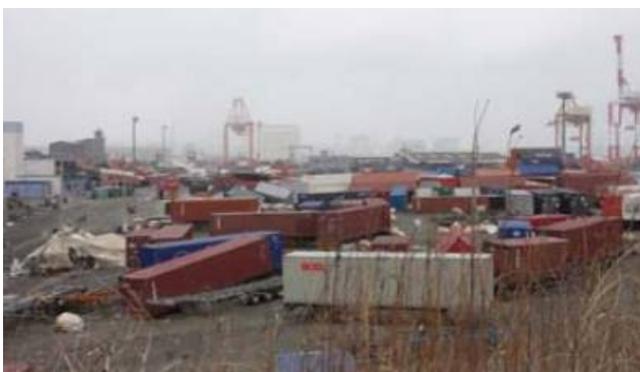
Fig. 15 Scattered containers in the Port of Sendai-Shiogama

Tsunami debris is not only vessels, automobiles, oil tanks, logs but also shipping containers. In the Port of Sendai-Shiogama, many containers were scattered by the action of tsunami, as shown in Fig. 15. In the Port of Hachinohe, about 700 containers were also floated and moved, as shown in Fig. 16.
