RECURRENT LIQUEFACTION INDUCED BY THE 2011 GREAT EAST JAPAN EARTHQUAKE COMPARED WITH THE 1987 EARTHQUAKE

ABSTRACT: The M_w 9.0 destructive earthquake that occurred March 11, 2011, in Japan was associated with widespread liquefaction within a 500-km long zone that extended from Iwate to Kanagawa Prefectures in the eastern part of Japan. Based on reconnaissance surveys of the Great East Japan Earthquake of March 11, 2011, recurrence of liquefaction at the same sites was identified at sites where liquefaction had occurred during the M_w 6.7 Chibaken Toho-oki earthquake of December 17, 1987; the surveys also compared observed liquefaction effects with those of the 1987 earthquake.

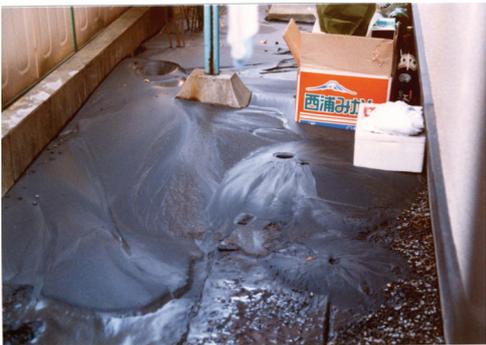
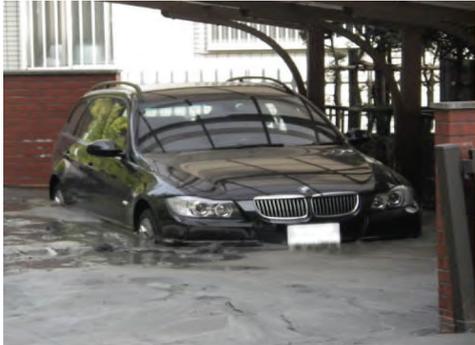
(a) 1987 earthquake

(b) 2011 earthquake (Urayasu City, 2011)

Photo 1 Sand boils due to repeated liquefaction in 3-chome of Urayasu City

Along the shoreline of Tokyo Bay, land reclamation has been performed since the Edo Era, especially since the 1950s. Extensive violent sand boils occurred in artificial fill along the Tokyo Bay, particularly in the areas from Urayasu to Chiba, during the 2011 earthquake in places where surface effects of liquefaction occurred during the 1987 Chibaken toho-oki earthquake. Repeated liquefaction was identified to occur at a total of 6 sites in Mihama 3-chome, Kairaku 1-chome, and Irifune 4-chome, located in seaside areas of Urayasu City that were filled in between 1965 and 1971. During the 1987 earthquake, a lot of sand boils erupted and water flowed out from the ground in the roads, parks, and residential lots; minor damage took the form of settlement and cracks to pavement, walls, and gateposts, but no effects of liquefaction occurred in houses and buildings (Photo 1 (a)). In contrast, liquefaction effects were severe during the 2011 earthquake: huge quantities of sand erupted and accumulated to depths of several dozen centimeters; single-family houses settled and tilted perceptibly and lifelines were damaged severely (Photo 1 (b)). Figure 3(a) shows the soil profile and SPT N-value in Mihama 3-chome, where severe sand boils were observed. The soil from the ground surface down to a depth of 8 m is fill composed of loose fine sand and silty sand with silt seams. A silt layer of sea bed sediment lies beneath the fill. The groundwater level is as high as around GL-3 m. The loose fill up to around 8 m seems to have liquefied in this area.

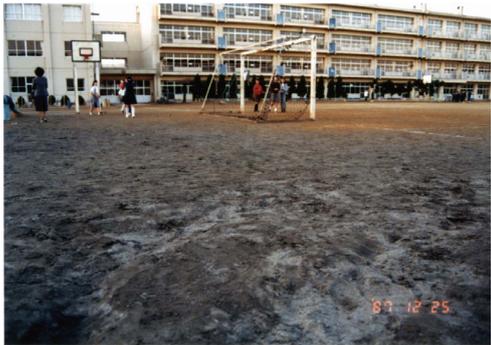
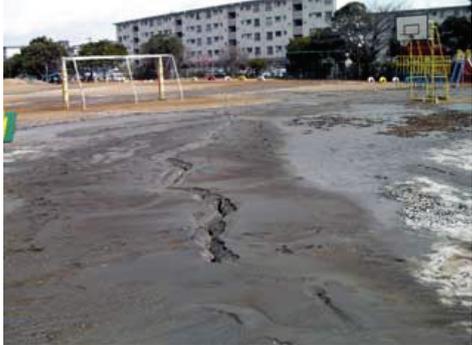
(a) 1987 earthquake

(b) 2011 earthquake (Onizuka et al., 2011)

Photo 2 Sand boils due to repeated liquefaction at Takasu-daisan elementary school, Mihama-ku, Chiba City

Repeated liquefaction at the same site was identified to occur at total of 19 sites in Mihama-ku, Chiba City (Photo 2 (a) (b)). Many sand boils and ground cracks were observed in schoolyards, parks, and the yards of housing complexes, but no damage to houses and buildings occurred during the 1987 Chibaken toho-oki earthquake. The effects of liquefaction induced by the 2011 earthquake were severe: huge amounts of sand erupted, single-family houses settled and tilted substantially, and lifelines were damaged, as was seen in Urayasu. The areas had been filled in between 1966 and 1975 and were mainly composed of loose fine sand fills with SPT N-values less than 10 from the surface to a depth of about 7 m as shown in Fig. 3(b). The loose sandy fills at a depth of 2 to 7m presumed to have liquefied during the earthquakes.

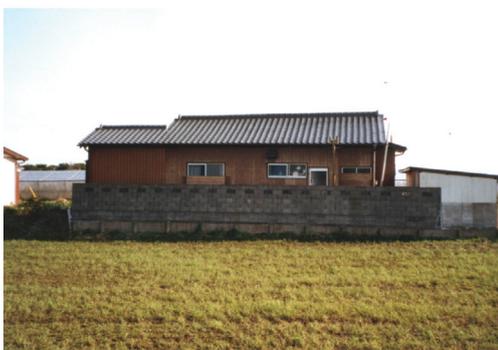
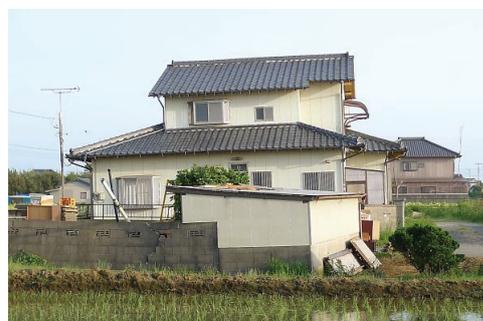
(a) 1987 earthquake

(b) 2011 earthquake

Photo 3 Damaged to a residential house due to repeated liquefaction in Ashikawa, Asahi City

Photo 3 shows damage to a house in Ashikawa, Asahi City, due to repeated liquefaction. The house in Photo 3 (a) settled about 30 cm and tilted northward (toward the front of the photo), and the base of the house was separated from the foundation during the 1987 earthquake; two nearby houses were also affected by liquefaction. Water bubbled up in the surrounding farms and flooded them for a while. The house in Photo 3 (a) was rebuilt after the 1987 earthquake, but the ground of the lot sank as a result of the repeated liquefaction during the 2011 earthquake and the newly-built house was severely damaged again (in Photo 3(b)). Seven nearby houses, including the two houses damaged during the 1987 earthquake, were severely affected by liquefaction. According to the owner of the house in Photo 3, his lot had been excavated for sand iron mining around 1960, and then backfilled, and had been used as paddy field. Around 1975, the land was filled up by about 1 m to be used for housing lot.

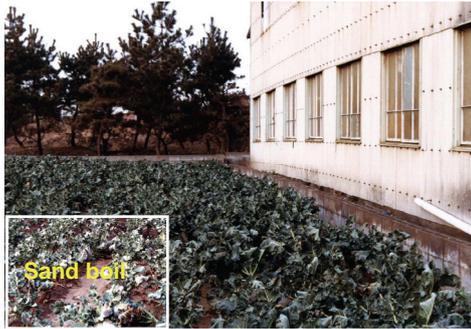
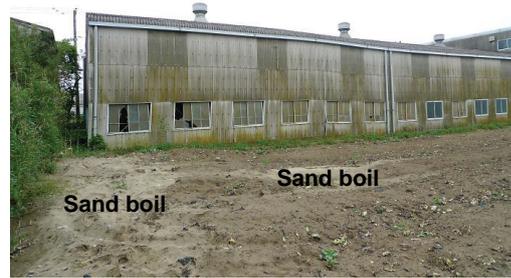
(a) 1987 earthquake

(b) 2011 earthquake

Photo 4 Sand boils and damage to a factory due to repeated liquefaction at Sangawa, Asahi City

At a farmland plot adjoining a factory in Sangawa, Asahi City, sand erupted during both the 1987 and 2011 earthquakes (Photo 4). The factory building settled differentially, and the floor slab showed a crack about 3 cm wide after the 1987 earthquake. The settlement of the factory building increased and

the frames of the windows were distorted substantially in the 2011 earthquake. Around the factory, 17 single-family houses were severely damaged due to liquefaction. According to a resident, no houses were damaged during the 1987 earthquake and small cracks appeared in the pavement.

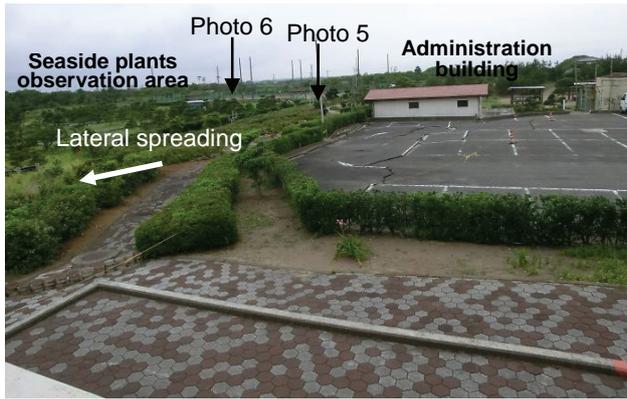
Photo 5 View of an athletic park in Yoshizaki-hama, Sosa City (taken in June, 2011)

Photo 5 shows an aerial plan view of an athletic park in Yoshizaki-hama of Sosa City, with an area of 27,541 m² near the Pacific Ocean. In the 1987 earthquake, sand boils with diameters of about 6 m were observed at nine sites in multipurpose open space with an area of 2879 m² as shown as Photo 6 and liquefaction-induced lateral spreading occurred in seaside plant observation area. Many fissures were observed in the slope of the area. The pavement of a walking path located on the ridge of the slide was cracked vertically and settled, and moved slightly downward as shown in Photo 7 (a). No damage occurred in the administration building of the park, which was supported by a pile foundation. Similar but more extensive liquefaction effects recurred during the 2011 earthquake: a large quantity of sand erupted; numerous ground cracks and subsidence occurred everywhere in the park; and liquefaction-induced lateral spreading recurred in the seaside plant observation area in the same manner as during the 1987 earthquake (Photo 5). Photo 7 (b) shows the crack in a walking path with about a 85 cm slump which occurred at the same point as in Photo 7 (a). The damage mode is remarkably-similar to that in 1987. According to the Yokaichiba City (the former city name before a municipal merger in 2006) government at the time of the 1987 earthquake, the lot on which the park was created had been an iron mining field, and then had been used as paddy field before being filled in 1981 for construction of the park.

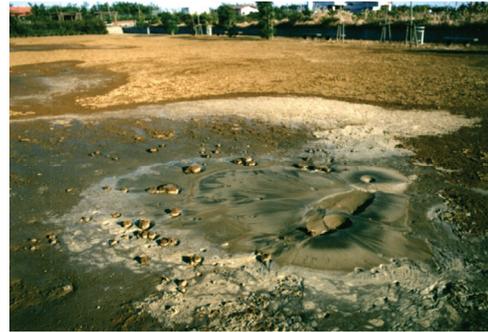
Photo 6 Sand boils in multipurpose open space generated by the 1987 earthquake

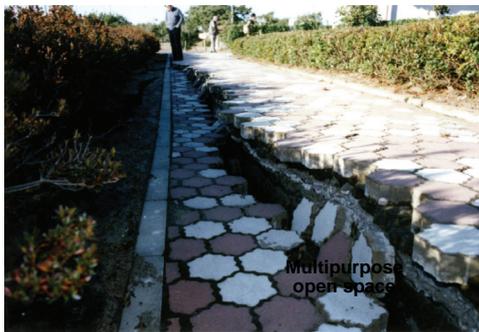
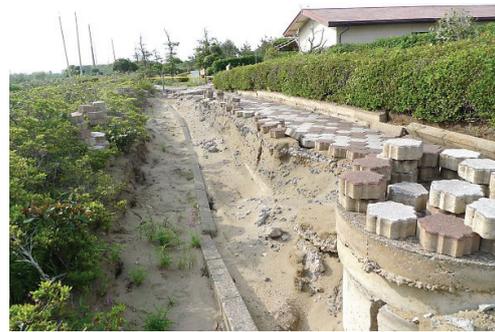
(a) 1987 earthquake

(b) 2011 earthquake

Photo 7 Damage to a pavement of walking path of the athletic park due to repeated liquefaction in Yoshizaki-hama (see Photo 5 for location)

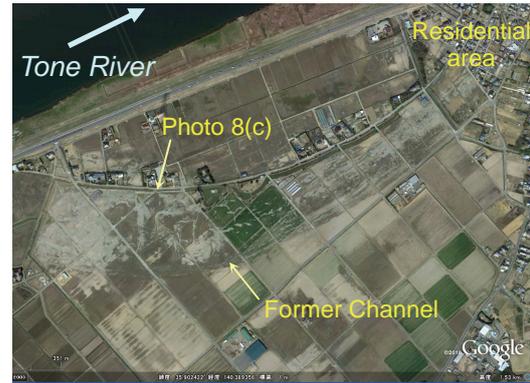
(a) 1987 earthquake (modified from Kotoda and Wakamatsu, 1989)

(b) 2011 earthquake (satellite image taken on March 29, 2011 by Google Earth)

Fig. 6 Distribution of sand boils in former river course in Mukouya, Kozaki Town, Chiba Prefecture due to repeated liquefaction

Violent sand eruptions and numerous large sand craters occurred with diameters of 1 to 3 meters in the paddy fields during the 1987 earthquake. These effects predominantly developed within the filled channels and ponds. Figure 6 (a) shows the distribution of sand boils observed in the former river course in Kozaki Town, as identified by field survey and aerial photographs taken after the earthquake. Numerous large sand boils were formed on the former channel, as shown in Photo 8 (a) and (b); it seemed that the surficial ground had completely liquefied, but no effects of liquefaction were observed on the small channels flowing along both ends of the former river channel. A few small sand boils were also formed on the point bar in the convex bank of the former channel where the dredged sand had not been filled, whereas no surface effect of liquefaction were observed in the concave bank.

Figure 6 (b) shows an aerial photograph taken eighteen days after the 2011 earthquake. The greater part of the former channel was covered with thick sand boil deposits, and the small channel flowing at the northern end of the former river channel was completely filled with boiled sand, as shown in Photo 8 (c). According to a local resident, a road north of the channel was flooded by water ejected after the earthquake. A number of large sand boils, with a maximum hole-diameter of 4m, occurred on the point bar in the convex bank along the former channel, in places where a few small sand boils were formed during the 1987 earthquake, but no surface effects of liquefaction were observed in the concave bank as was the case during the 1987 earthquake. A residential area located at the lowest end of the former

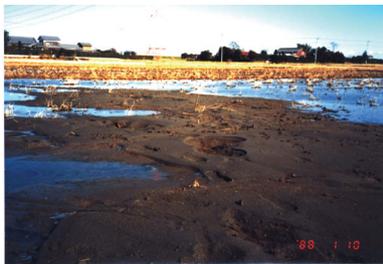
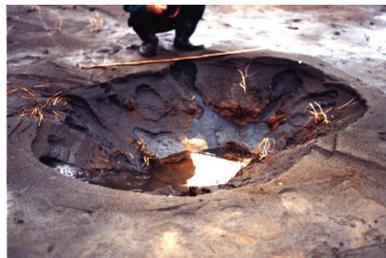
(a) 1987 sand boils from fissures near B-2 in Fig 6 (a)

(b) 1987 sand boils crater near B-4 in Fig 6 (a)

(c) 2011 sand boils filled up a channel (see Fig. 6(b) for location)

Photo 8 Sand boils in a former river course due to repeated liquefaction in Mukouya, Kozaki Town

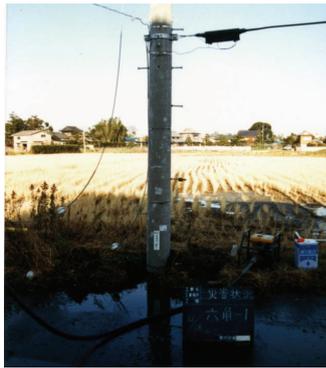
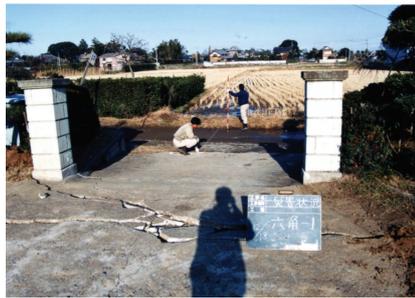
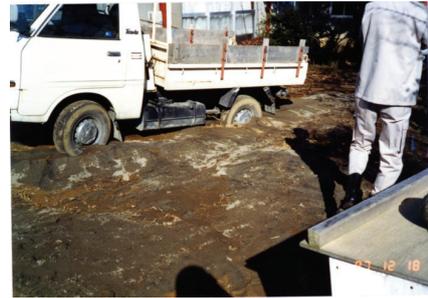
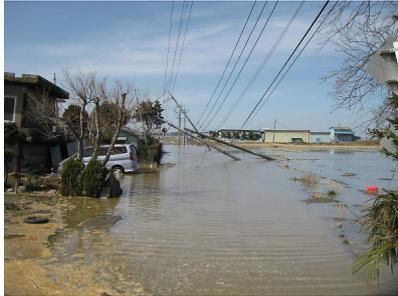
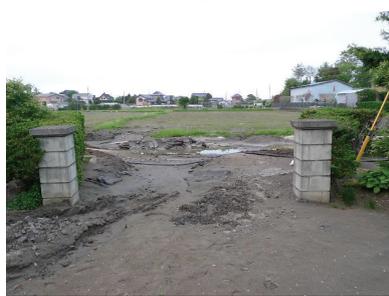
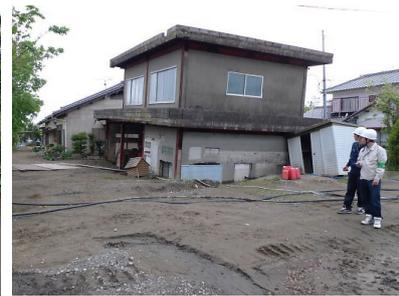
Photos 9 (a) to (c) show liquefaction-induced damage in Rokkaku, Inashiki City, during the 1987 earthquake, and Photos 9 (d) to (f) show the damage at the same sites during the 2011 earthquake. Rokkaku had been a small pond named “Guru-gawa”, with a depth of about 2 meters, that was filled in 1959 with dredged sand from the Tone River by the Construction Ministry. Beginning in the 1970s residential houses were built after farmland utilization. According to officials of Azuma Village (the former city name of Inashiki before municipal merger in 2005), more than 20 houses were damaged due to liquefaction during the 1987 earthquake. The most striking effects occurred at the Photo 9 site: telephone poles sank, with their height reduced to around 2 m, and the road subsided below the surface of the adjacent paddy field (Photo 9 (a)); gateposts tilted slightly (Photo 9 (b)); a small truck parked in a yard was buried by boiled sand (Photo 9 (c)).

Liquefaction-induced damage was also the most serious at the Photo 9 site during the 2011 earthquake: telephone poles sank down and became extremely tilted; roads and farms subsided and were flooded by ejected water to the extent that the former pond reappeared (Photo 9 (d)); gateposts settled by as much as 20 cm (Photo 9 (e)); a house built on the lot shown in Photo 9 (c) sank up to 1 m (Photo 9 (f)).

Photo 9 Damage due to repeated liquefaction in Rokkaku, Inashiki City (for location see Fig. 5)

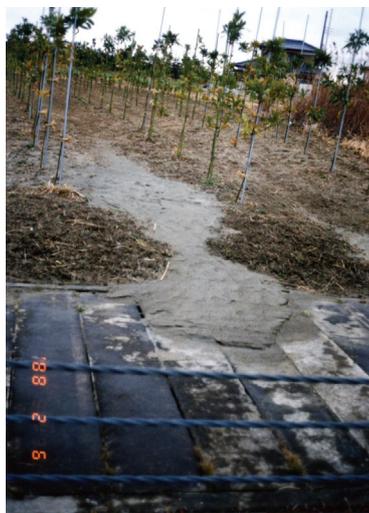
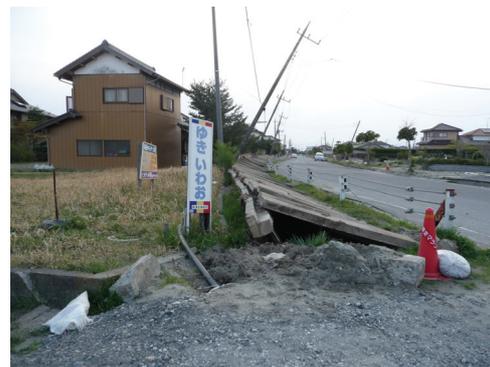
(a) 1987 earthquake

(b) 2011 earthquake

Photo 10 Damage due to repeated liquefaction in Hinode, Itako City

After the 2011 earthquake, severe and widespread liquefaction effects were observed in the greater part of fill-up areas including the area of the 1987 liquefaction, as shown in Fig. 8. Photos 9 (a) and (b) are a comparison of the damage at the same site in the 1987 and 2011 earthquakes. Covers of the gutter along a street were heaved up as a result of liquefaction, a number of telephone poles were dramatically inclined, and a house tilted slightly in the 2011 earthquake (Photo 10 (b)); whereas during the 1987 earthquake sand boils occurred in the farm adjacent to the street but no effects were observed on the covers of the gutter (in the front part of the photo 9 (a)).
