DAMAGE DUE TO THE 2011 TOHOKU EARTHQUAKE TSUNAMI AND ITS LESSONS FOR FUTURE MITIGATION

Fumihiko IMAMURA¹ and Suppasr ANAWAT²

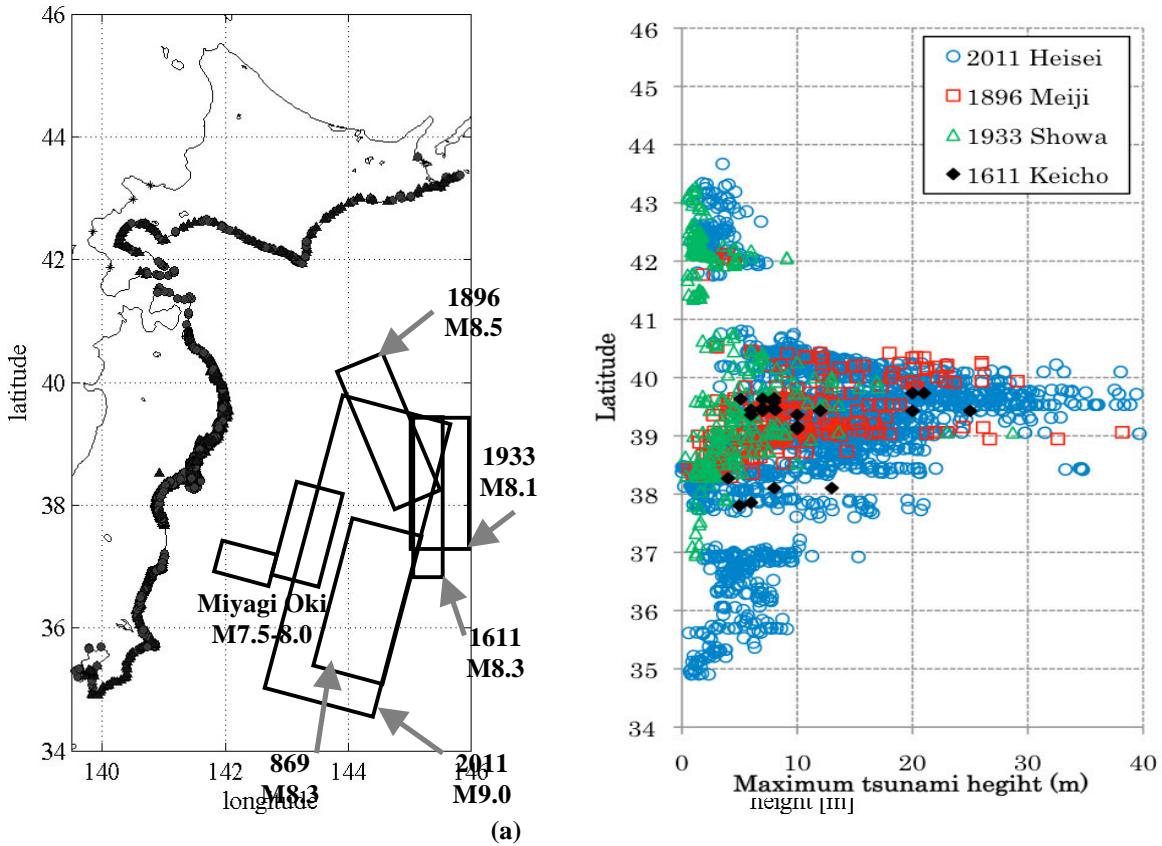
Figure 1 Left: Major historical tsunamis and the expected Miyagi-Oki earthquake and location of the main shock; Right: tsunami height distribution of the 2011 Great East Japan tsunami (the 2011 Tohoku Earthquake Tsunami Joint Survey Group, 2011) and of the historical 1611 Keicho, 1933 Showa-Sanriku and 1896 Meiji-Sanriku tsunamis (Tsunami Engineering Laboratory, 2011)

Figure 1 shows the distribution of tsunami runup heights measured along the coast are ranging the 7-15 m in Sendai and Fukushima with the simple beach geometry and the 10-30 m in Sanriku with the complex one of a coast. Maximum run-up heights of up to 39 meters m were reported from the Sanriku region, where the saw-toothed coast is characterized by narrow V-shaped bays and steep coastal geomorphology. Tsunami heights near the coastlines of the flat coastal plains facing to Sendai Bay reached around or more than approximately 10 m, and run-up distances (i.e., inundation area) in these coastal lowlands extended more than 4 kilometers km. In our survey, we also observed that inland heights of March 11, the 2011 tsunami was almost same or 1.5 as large as those of the 1896 Great Meiji tsunami. It could be mentioned that the tsunami death toll of 11 March 2011 tsunami is lower in relative terms compared to the population size. Hence tsunami protection and mitigation measures and public education could be effective in reducing loss of life, which should be discussed more detail in later with the available data.

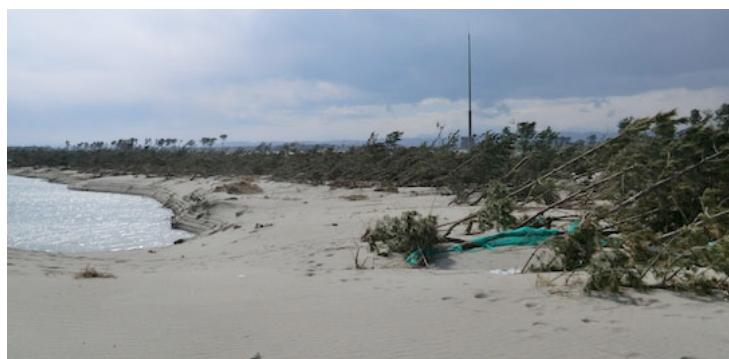
Photo 1 Damage on the forest control area due to the tsunami at Sendai

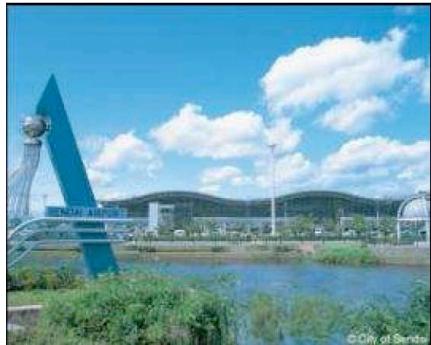
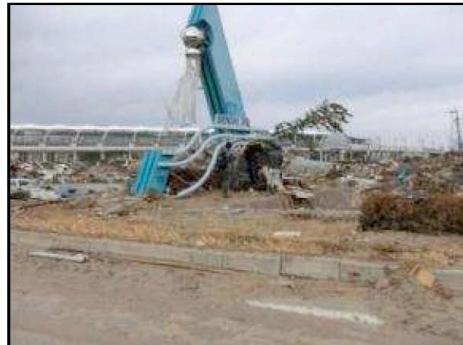
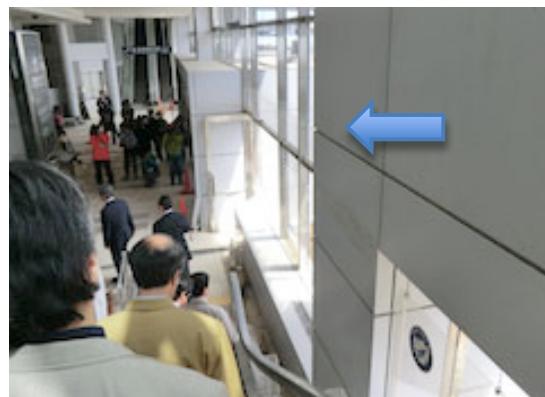
Photo 2 Sendai international airport before and after the 2011. The first floor was inundated causing serious damage on the operation system

Sendai airport is located in Natori city, Miyagi prefecture near the Pacific Ocean coast on center of south part of Miyagi prefecture. The airport is about 20 km south from the Sendai port with protected by sandy coast and control forest ;pine tree, all along the coast. The airport stopped their service due to the damaged at the first floor by the tsunami on around 11,000 people were stranded within the terminal until 13th March 13 2011, when they were evacuated. The airport was clean up

with support from the US army until 4th April 4 and re-opened with a limit number of flight on 13th April 2011.

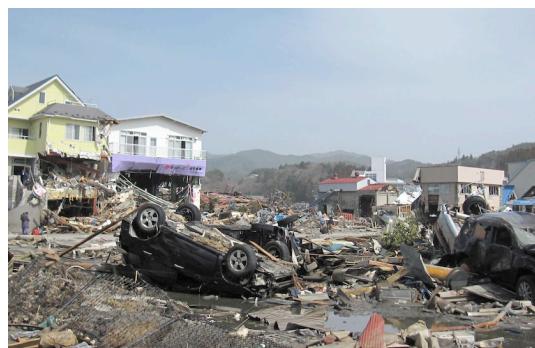
Photo 3 Damage on the residential and fishery area due to the tsunami attacks and floating debris such as cars and ships at Kesennuma

The ports at Hitachinaka, Hitachi, Soma, Shiogama, Kesennuma, Ofunato, Kamashi and Miyako were also damaged and closed to ships. All 15 ports reopened to limited ship traffic as of 29 March 2011. A total of 319 fishing ports, about 10% of Japan's fishing ports, were damaged in the disaster. Photos 3 and 4 show the damage at the port and its surrounding area, caused by the tsunami. Not only direct tsunami effect but also floating material such as the debris and boats and fire cause the secondary damage.

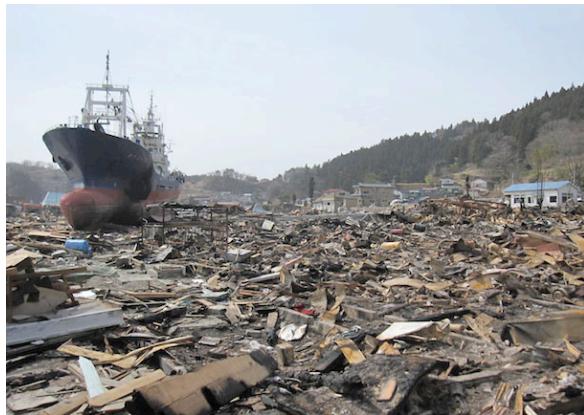
Photo 4 Ships moved by the tsunami and fire at the residential area at Kesennnuma

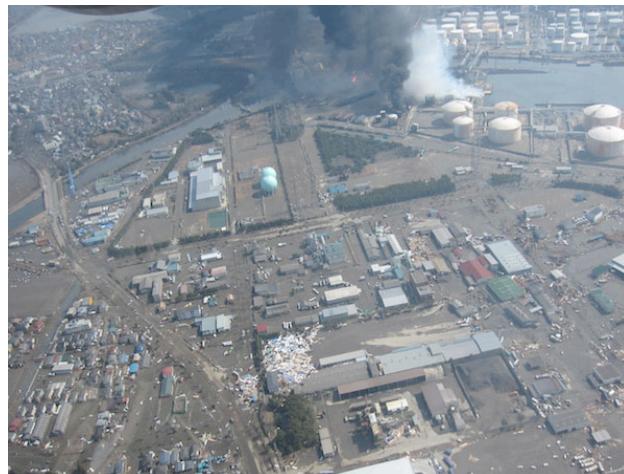
Photo 5 Damage due to the tsunami followed by fires at Sendai port

In 1964, there was a plan to construct a new industrial city around the Sendai port region, which was started to build by digging the sand for the purpose of forming an industrial area coastal to lowland swamp and surrounding the site of Navy. It was opened in 1971 providing function as a commercial port and also later has become a distribution center in the Tohoku region, Miyagi Prefecture and Sendai City area or the outer harbor. Sendai Port was also used for international beach volleyball competitions. As one of a few ports in the northeast region, Sendai port can handle a 40ft container including crude oil, automobiles, fuel oil as cargo handling various types of products and liquefied petroleum gas. In 2006, the port handling capacity of about 37 million tons and 7,024 vessels were entered. The port is also served for passengers by ferry between the Port of Nagoya and Tomakomai Port in Hokkaido.
