Damage Investigation of Sanriku Railway Suffered from the 2011 off the Pacific Coast of Tohoku Earthquake

Key Words: the 2011 off the Pacific Coast of Tohoku Earthquake, transportation infrastructure, Sanriku railway, evacuation facility

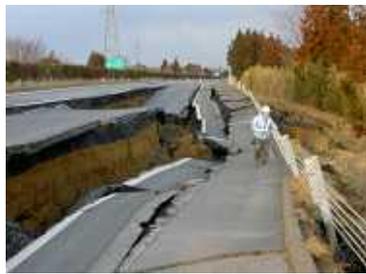
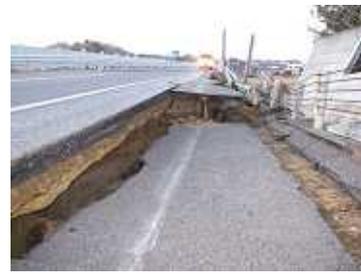
Fig.1 Damage of Expressway (Joban Expressway)

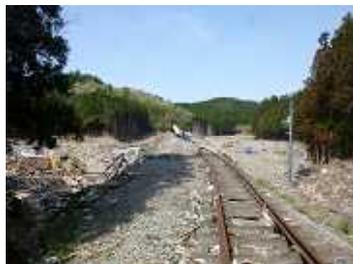
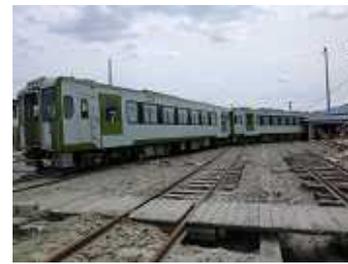
Fig.2 Damage of Railway line (JR Kesenuma line(left), JR Yamada line (right))

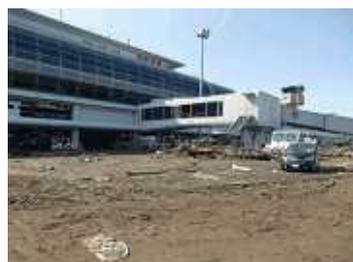
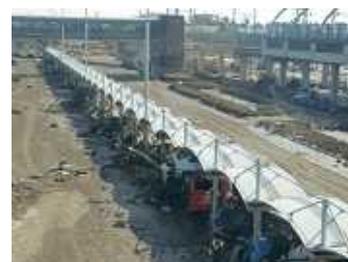
Fig.3 Damage of Sendai Airport (Passenger Terminal (left), Car park (right))

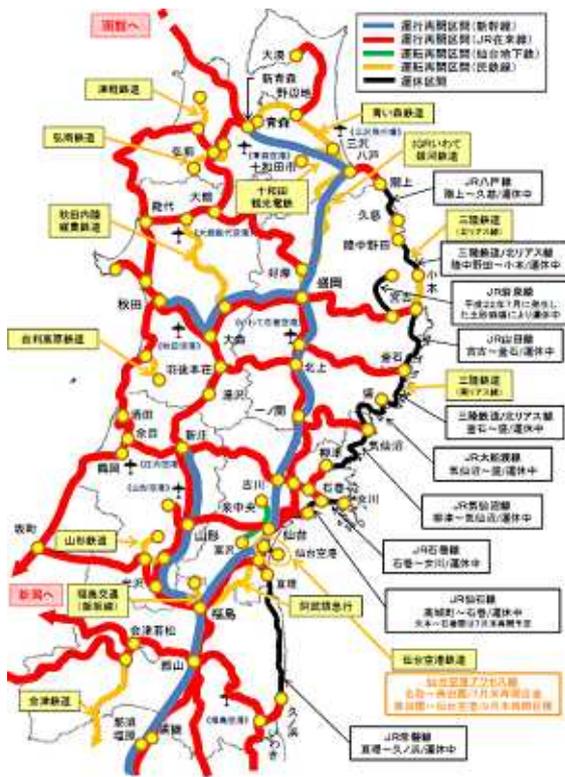
Fig. 4 Status of railway operation in Tohoku area

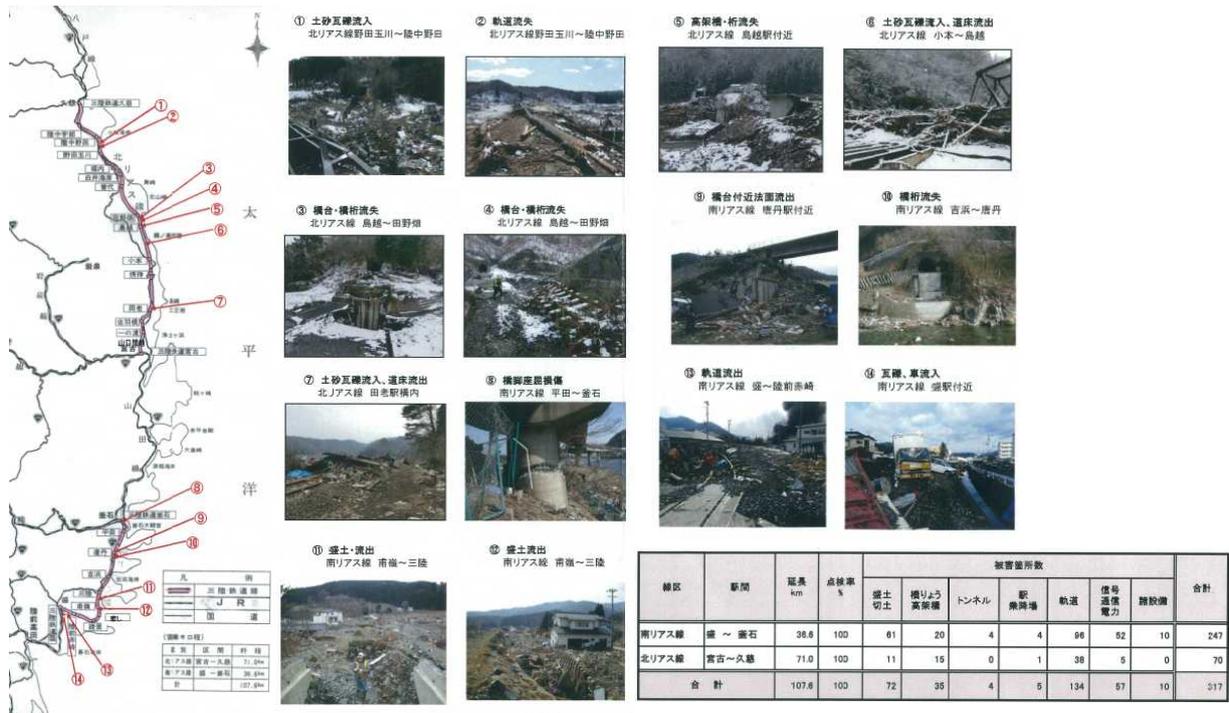
Fig. 8 details and place of damage

There is several of damage in Sanriku railway. Sanriku railway suffered from Tsunami damages which are washout of railway, bridge, embankment and stations. Fig. 8 shows details and place of damage. Whole damage of Sanriku railway is 317 points. About 40% of whole damages are washout of bridge and embankment which is civil infrastructures. About 42% of whole damages are washout and displacement of railway line which is railway structure. Finally, about 13% of whole damages are communication line, railway signal and electronic machine which are electronic infrastructures. Authors conducted field survey of Sanriku railway. Fig. 9 and 10 show damage of Sahimanokoshi station which located Kita riasu line. Fig. 11 and 12 show Shimanokoshi station which is photo of before earthquake and Tsunami. Fig. 14 and 15 show Taro station which does not have serious damage. So, Taro station starts to operate on March 20th, 2011.

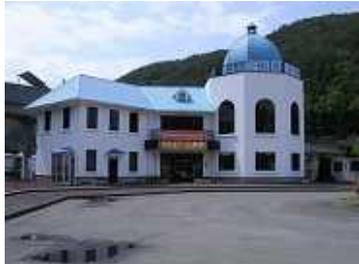
Fig. 11 Shimanokoshi Sta. (before)
