LIQUEFACTION IN THE 2011 GREAT EAST JAPAN EARTHQUAKE: LESSONS FOR U.S. PRACTICE

Ross W. BOULANGER¹

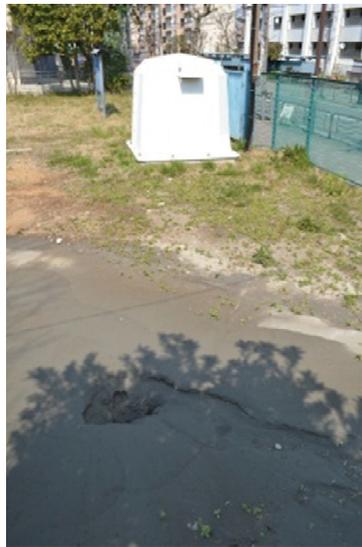
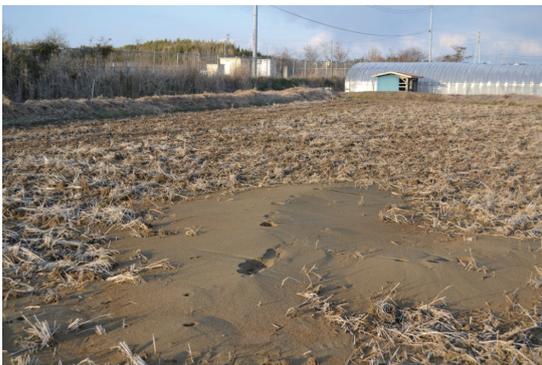
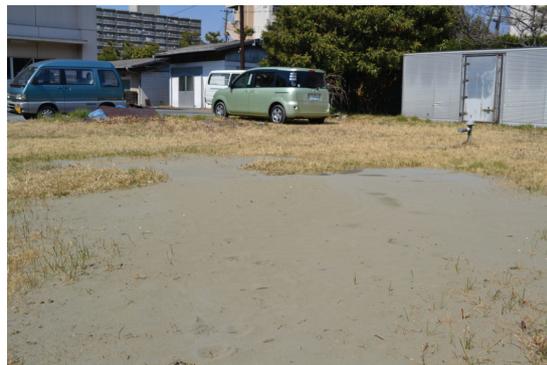
Fig. 1 Sand boils at three strong ground motion recording stations (GEER 2011)

Evidence of liquefaction was observed at seven strong ground motion recording stations in the Tokyo and Kanto Plain areas; photos of three of these sites are shown in Fig. 1. Another seven recording stations with soil profiles that would be considered susceptible to liquefaction did not exhibit surface evidence of liquefaction. The recorded motions at the ground surface show clear evidence of liquefaction in some cases, but in other cases the characteristics of the motions do not clearly exhibit any signs of significant softening or cyclic mobility during the time of strong shaking. The data from these sites with and without liquefaction will provide an excellent basis for evaluating the capabilities and limitations in one-dimensional nonlinear dynamic site response models.

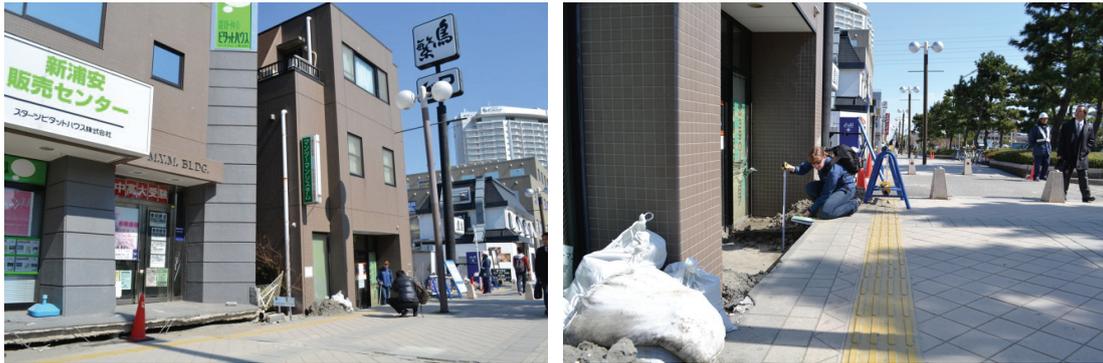
Fig. 2 Differential settlements between a building on piles (gray building on the left), a building on a shallow foundation (brown building on the right), and the ground surface in Urayasu (GEER 2011)

Liquefaction at communities around Tokyo Bay and along the Tone River caused extensive damage to light residential and light commercial structures in many of the areas visited, with the magnitudes of the settlements and tilts for structures on shallow foundations being larger than often observed for such light structures. The photographs in Fig. 2 illustrate a case in Urayasu where the sidewalk and street settled approximately 30 cm relative to a building on piles, while an adjacent three-story building on a mat settled 40 cm more than the adjacent ground surface and tilted noticeably without observable damage to the superstructure. Tilts of up to 2 or 3 degrees were observed in many cases for residential homes (Fig. 3a). Many of the residential structures appear to have been founded on mat-type foundations with deep grade beams (Fig. 3b) that limited damage to the superstructures despite the large settlements and tilts.

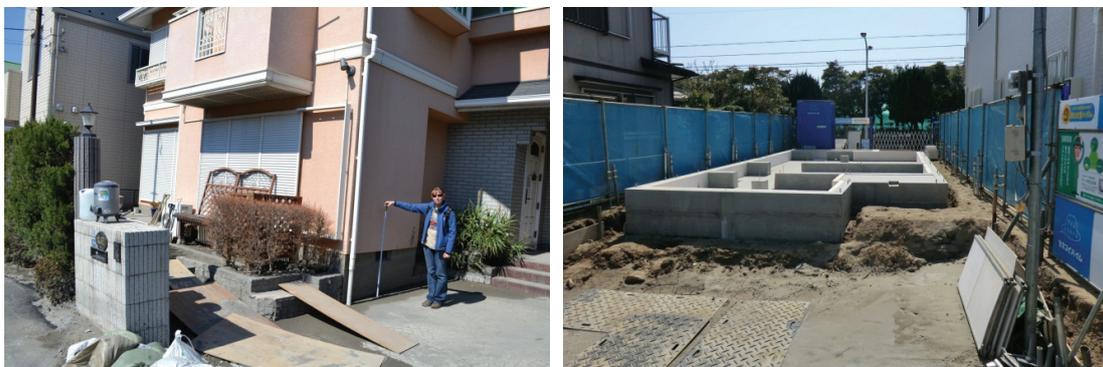
Fig. 3 Tilt and settlement of a residential home in Urayasu (left photo) and a foundation for a residential home in construction (right photo) (GEER 2011)

Shallow foundations for light residential and commercial structures in U.S. practice are often comprised of shallow spread footings with grade beam connections and a concrete surface slab. These shallow foundation systems are not as stiff or strong as the example from Japan shown in Fig. 3b. Liquefaction of foundation soils can therefore cause significantly more deformation and distortion across the foundation system and into the structure. For example, the Moss Landing Marine Laboratory shown in Fig. 4 was destroyed when liquefaction during the 1989 Loma Prieta earthquake caused the foundation to stretch by about 1.0 to 1.3 m. Stronger and stiffer foundations in areas of potential liquefaction appear to be an effective means of protecting the structure from excessive distortions even when ground settlements are relatively large. Of course, there is still the damage to the underground utilities and the cost of leveling the structure after the earthquake, but this is less expensive than the complete loss of the structure.

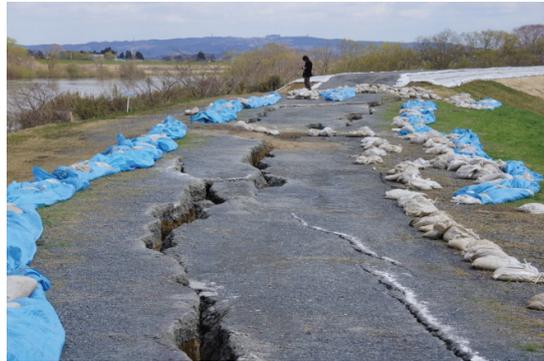
Fig. 5 Levee Damage along Naruse River Left Levee at River Kilometer 11.3 (GEER 2011b,d)

Nonetheless, numerous levee reaches sustained moderate to major damage (e.g., Fig. 5) which appeared to be related to foundation liquefaction. Settlements of 20-40 cm were observed in many areas, with greater settlements in reaches of relatively limited lengths (commonly only 100-300 m in length). Little or no flooding appeared to have resulted from the damage to the levees since water levels were low within the adjacent channels.

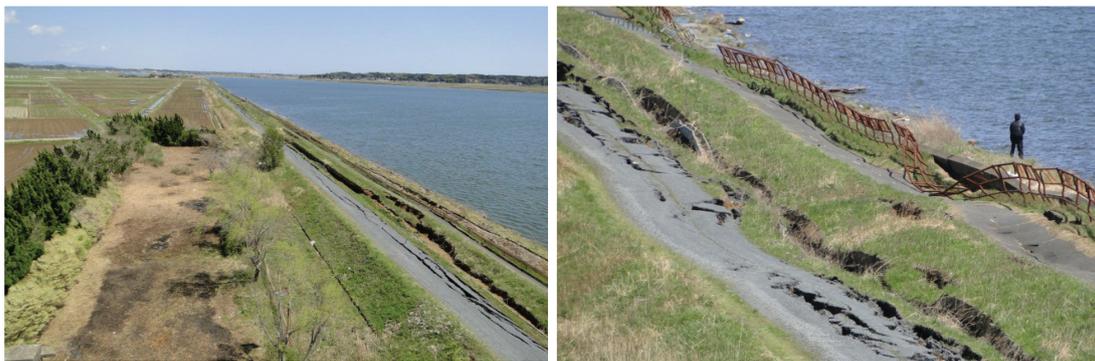
Fig. 6 Views of Hinuma River Levee Slumped and Cracked Due to Liquefaction (GEER 2011b,d)

Levees along the Hinuma River had extensive damage from foundation liquefaction (Fig. 6). These levees were apparently founded on reclaimed land, and developed extensive cracking and slumping for over 2.5 km along the western margin of the shallow, near-coastal lake. New fill had been placed after the earthquake into some reaches where it appeared that the water might breach the slumped levee. The extensive damage to these levees, as opposed to the more limited (but multiple) damaged reaches of levees in other locations, appears to reflect the presence of man-made foundation materials or of water levels high enough to saturate both the foundation and the lower portions of the embankment. In some sections, the water level appeared to be about a meter higher than the landside ground surface. Exposed embankment material in the numerous large cracks indicated that the upper fill was composed of clayey sands and gravels. However, the numerous sand boils found in the cracks were generally clean, fine to medium-grained sands, which would be consistent with the underlying foundation being reclaimed land or fills. The length of liquefaction damage has significant implications for saturated levees constructed of or on dredged material, such as those in the Sacramento-San Joaquin Delta in California's Central Valley.

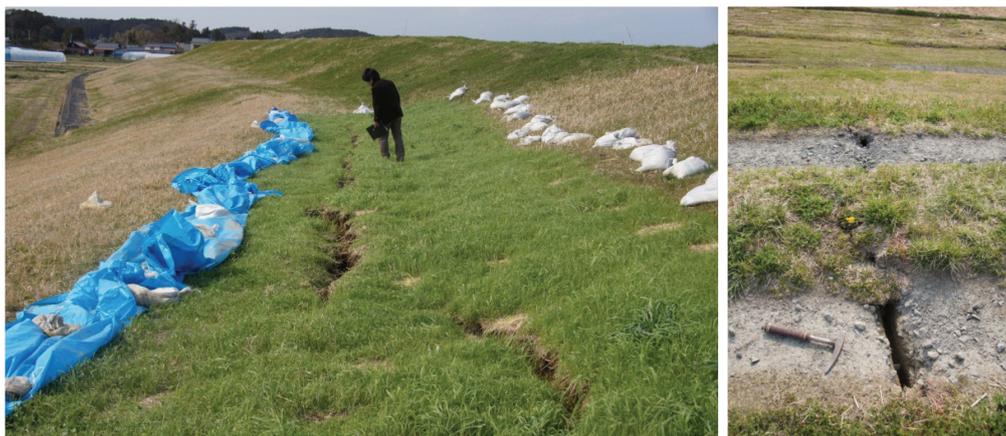
Fig. 7 View of Treated and Untreated Levee Reaches along Naruse River Right Levee at River Kilometer 15.0 - 14.7 (previously treated section in the distance; left photo). Transverse Crack at Boundary between Treated and Untreated Levee Reaches (right photo) (GEER 2011b,d)

The performance of four levee reaches on improved ground along the Naruse River was examined. These levee reaches had previously experienced major liquefaction damage during the 2003 Miyagi North Continuation Earthquake (M_w 6.2) and had been repaired with a mix-in-place soil cement foundation treatment. All four sites appeared to have performed well with no observable damage from the apparently stronger 2011 earthquake shaking. Notably, two of these sites had moderate liquefaction-related levee damage directly beyond the limits of the ground treatment (Fig. 7a). In some cases, this resulted in significant transverse cracks along the transition boundary between the treated and non-treated sections of the levees (Fig. 7b). Such transverse cracking may be expected

where the foundation stiffness of adjacent levee sections has abrupt, dramatic changes. Transverse cracks between treated and non-treated levee reaches may be an issue that needs to be considered carefully because such cracks have the potential to lead to failures by seepage erosion through the cracks if the adjacent water levels are high enough and the levee is not designed with internal details that minimize the potential for such erosion failures.
