EXPERIMENTAL STUDY ON SEISMIC RETROFIT OF RC COLUMN WITH WING WALL IN TAIWAN AND JAPAN

ABSTRACT: In this study, a series of cyclic loading tests were conducted for three full-scale specimens including an existing column and two columns strengthened with wing walls respectively fabricated using Taiwan's and Japan's structural details. The experimental results show that the existing columns retrofitted with wing wall can effectively improve seismic strength and that there is no rupture of concrete cover in the base of the column with wing walls if using Japan's structural details while the rupture does occur if using Taiwan's structural details.

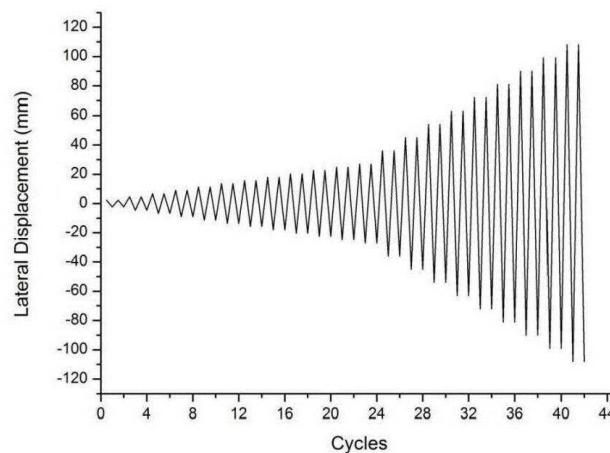
Fig. 5 The displacement time history of the actuator for cyclic loading

Fig. 4 shows the experimental apparatus installed at the Architecture and Building Research Institute, the Ministry of the Interior, Taiwan, which consists of reaction wall, strong floor, and one horizontal jack with maximum loading capacity of 2000kN. The rigid beam is placed on the top of the column and two high-strength bars are tensioned to connect to the rigid beam and strong floor such that the axial load can be applied at the column. The constant axial load applied in the cyclic loading test is 247 kN corresponding to $0.15f_c'A_g$, where A_g is column section area and f_c' is compressive concrete strength. In addition, the lateral load is applied to the specimen through the horizontal jack and controlled based on displacement. The displacement time history of the actuator for cyclic loading as shown in Fig. 5 is specified in the control unit.

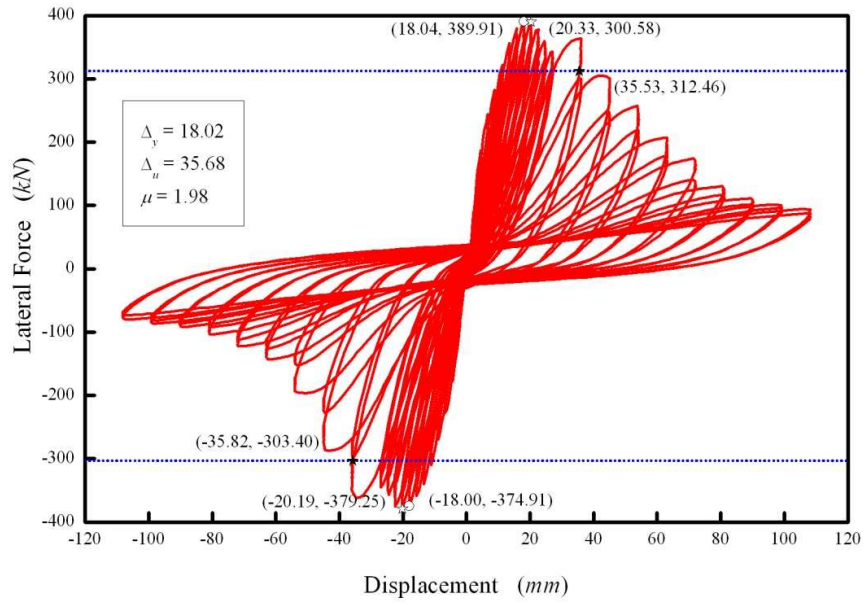
Fig. 7 Load displacement response of the specimen S4

Fig. 6, 7, and 8 respectively present the hysteretic responses for the substandard column (*i.e.* S1), the substandard column retrofitted by wing walls using Taiwan structural details (*i.e.* S4), and the substandard column retrofitted by wing walls using Japan structural details (*i.e.* S5). Table 1, 2, and 3 summarize the important phenomenon observed during the test of each specimen. In addition, the ultimate shear strength for each column is calculated by the evaluation method found in Seismic Evaluation Standard for RC buildings by The Japan Building Disaster Prevention Association [JBDPA, 2001]. The calculated shear strength and the observed shear strength and ductility ratio for each specimen are listed in Table 4.

Lateral displacement (mm)	Drift ratio (%)	Observation
20	1.125	Shear cracks were initially developed at the outmost corner of wing wall.
22.5	1.25	Narrow cracks occurred on the surface of cover concrete in the footing.
36	2	Spalling of cover concrete and exposure of reinforcing bars were observed in the outmost edge of wing wall.
45	2.5	Severe damages were observed in the bottom of wing wall and cover concrete of the footing as shown in Fig. 10.
54	3	Rebar dowels in the bottom of wing wall were pulled out, and damage in the cover concrete of the footing occurred extensively.
72	4	Wing walls lost their shear resistance
108	6	Reinforcing bars of the original column buckled.

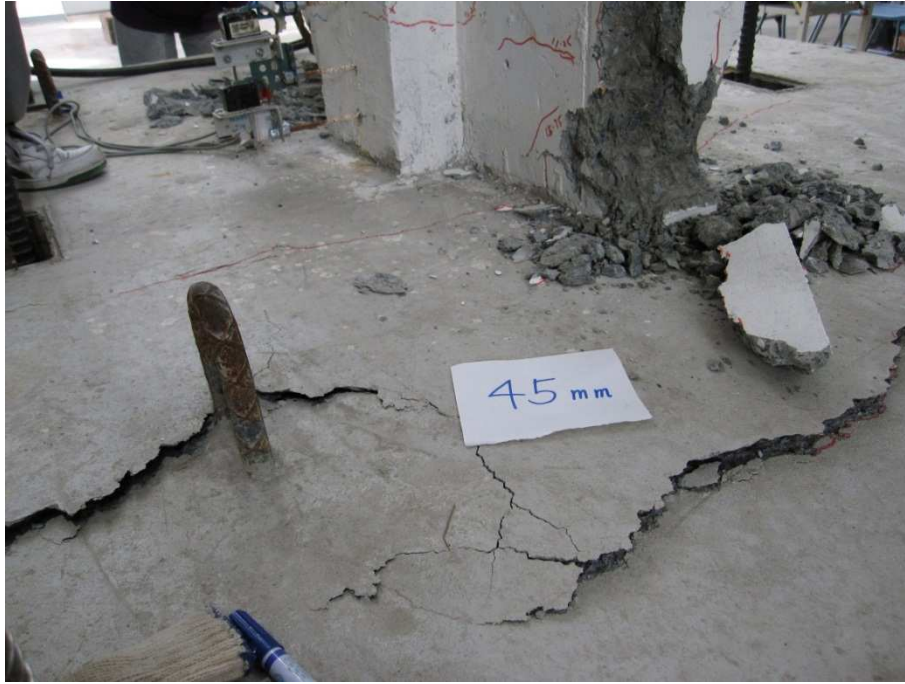
Fig. 10 Damage state of the footing of the specimen S4 when the drift ratio reaches to 2.5%

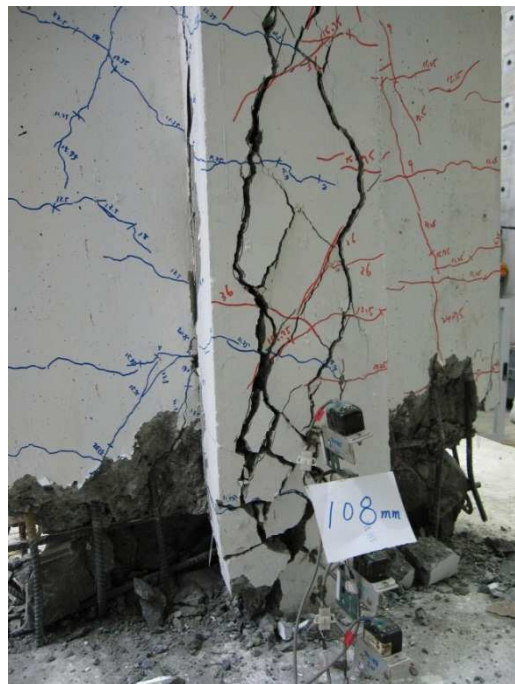
Fig. 11 Final failure state of the specimen S5 when the drift ratio reaches to 6%

Lateral displacement (mm)	Drift ratio (%)	Observation
20	1.125	Shear cracks were initially developed at the outmost corner of wing wall.
22.5	1.25	No cracks occurred on the surface of cover concrete in the footing.
36	2	Spalling of cover concrete and exposure of reinforcing bars were observed in the outmost edge of wing wall.
45	2.5	Severe damages were observed in the bottom of wing wall, but minor damage occurred in the cover concrete of the footing.
54	3	Rebar dowels in the bottom of wing wall buckled, and shear cracks at the bottom of column were developed very quickly.
72	4	Wing walls lost their shear resistance
108	6	Reinforcing bars of the original column buckled, and crush of core concrete at the bottom was observed as shown in Fig. 11.
