ASPECTS OF FIRE OCCURRENCES CAUSED BY TSUNAMI

Tokiyoshi YAMADA¹, U HIROI² and Noriaki SAKAMOTO³

Key Words: Great East Japan earthquake, tsunami fire, fire investigation, urban fire, fire safety, escapes facility

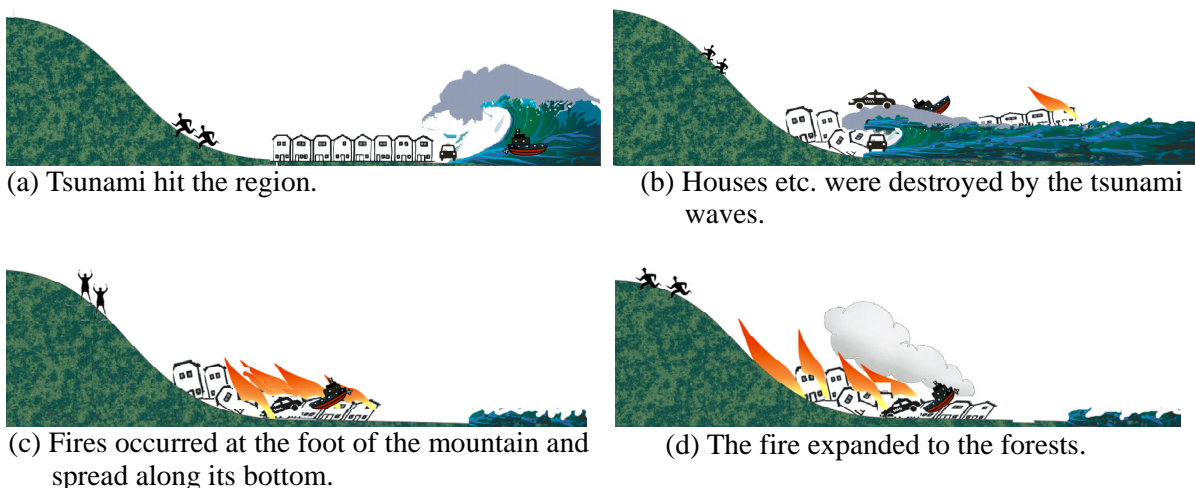
Fig. 1 Image of the general mechanism of the fires resulting from tsunami in the Sanriku coastal region

- 1) Houses, ships, vehicles, etc. are swept away by the tsunami waves from the seashore toward a hill (mountain). In particular, enormous quantities of wreckage pile up along a river, which is highly likely to spread fire. Few buildings collapsed due to the earthquake strength and none of fires that occurred before the tsunami arrived were reported. (Fig.1 (a))

- 2) A fire breaks out due to some shock when houses are destroyed or while they were drifting. Houses and fuels on fire start to drift toward the foot of the mountain. (Fig.1(b))

- 3) Enormous quantities of combustible materials, which were swept away toward the foot of hills (mountains) or fire-resistant buildings as rubble, catch fire and spread. (Fig.1(c))

- 4) The fire-fighting force is devastated by the tsunami attack, and moreover fire extinguishing activities are disturbed by the rubble and other obstacles, leaving the fires uncontrolled and spreading them to forests. Evacuees were forced to be evacuated to another place in some evacuation sites. (Fig.1(d))

As a result, fires that spread in many town areas of the Sanriku coastal region expanded along the foot of a mountain in a band shape, and people who had evacuated to evacuation facilities standing on hills, such as schools, were forced to be evacuated to another place in Otsuchi Town, Yamada Town (Funakoshi Tanohama district), and some other towns. The following introduces the details of the fires in Otsuchi Town and Taro Town in Miyako City as typical cases of fires that occurred in the Sanriku coastal region, and those in Kesenuma City as unusual cases of fires.

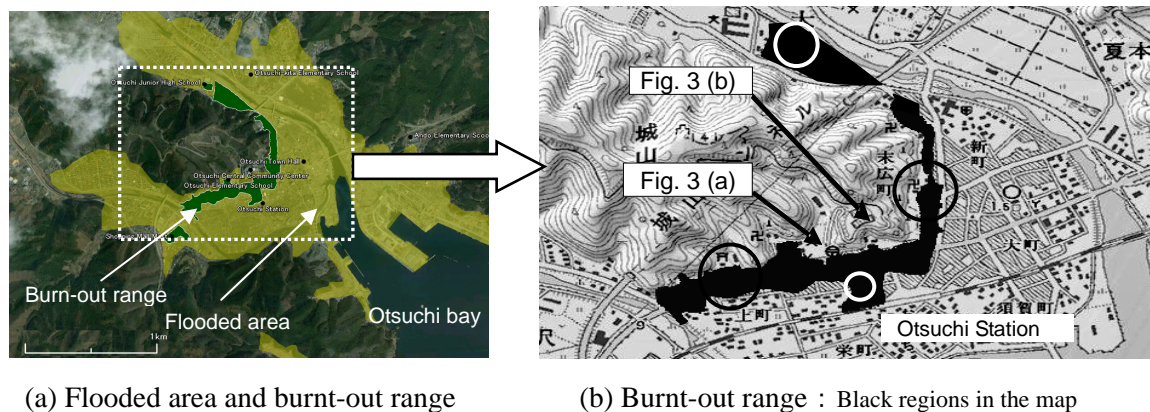
Fig. 2 Burnt-out range of the fire in the town area of Otsuchi Town

Fig. 2 shows the GPS tracks that the authors recorded by walking the fire sites along the outer edge of their fire spread area, and burnt-out ranges estimated by visual checks. According to videos posted on the Internet (Yomiuri Streaming 2011 and Jijicom 2011), a large number of fires occurred in this region of Otsuchi Town at around 3:38 pm on March 11, 2011. Then, fires occurred separately in the town area at least at three places along the mountain foot and at one place in front of Otsuchi Station (the areas circled in Fig. 2 (b)) at around 5:30 pm, which were nearly spreading to forests. At Otsuchi Elementary School (Fig. 3 (a)), which was an evacuation site, a fire from cars parked outside the school building spread into the building after the first floor was flooded.

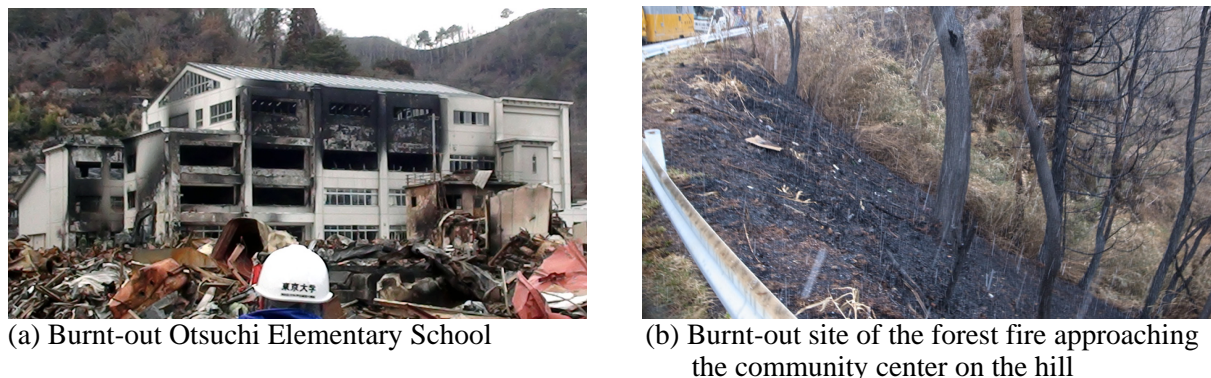
Fig. 3 Fire sites in Otsuchi Town: Photos taken on March 27, 2011

Another fire approached a community center, which was another evacuation center standing on a hill, exposing the center to danger of a forest fire (Fig. 3 (b)). According to interviews with the local volunteer fire fighters, the force of the flames increased along the mountain, spreading to the west edge. Therefore, they set up a line to prevent the fire from spreading at the west edge of the town area along a river, and successfully prevented the spread by using the river water. Meanwhile, the forest fire that spread to the mountain at the back of the school also expanded to the Kamaishi area, burning a far larger area than the fires in the town area. It is reported that a houses over the mountain was also burnt down.

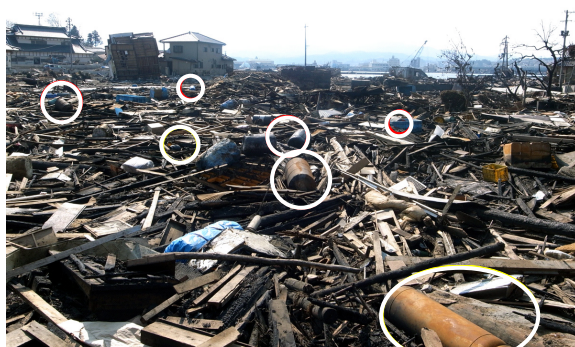
(a) Fire spread area in Kogoshio:
The circles show various objects swept away by the tsunami waves, such as oil drums, gas cylinders, and other fuel containers

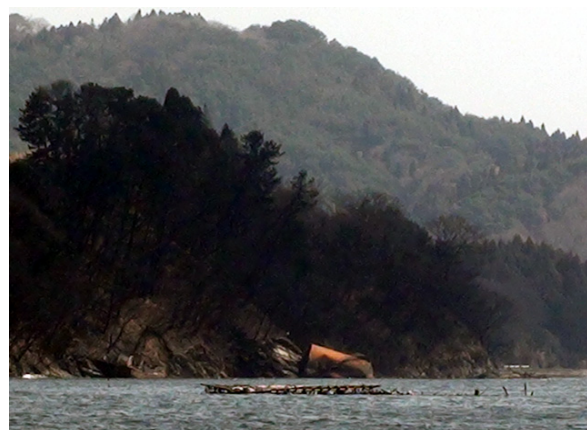
(b) East coast in which the fire spread from the sea surface to the forests

Fig. 7 Fire sites of the east coast of Kesennuma City: Photos taken on March 29, 2011

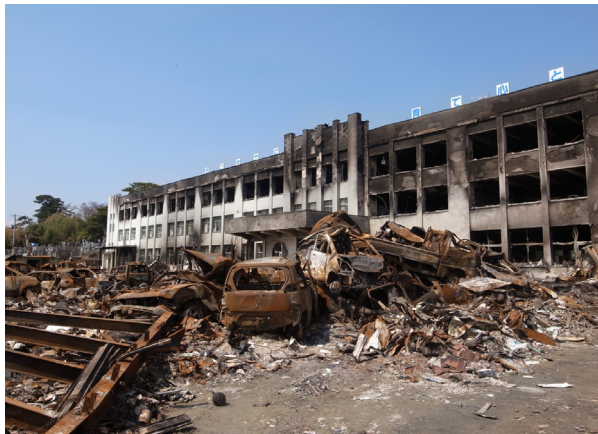
(a) Burnt-out site on the south side of Kadonowaki Elementary School

Fig. 9 Burnt-out site of Kadonowaki Elementary School in Ishinomaki City:
Photos taken on April 10, 2011

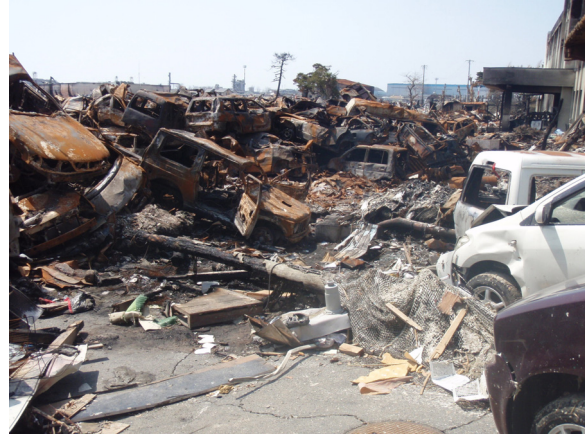
One of the characteristics of the fires in this region is that it resulted from a fire that broke out in cars parked at Kadonowaki Elementary School in Ishinomaki City. According to the interviews, a lot of cars used by evacuees were parked in the schoolyard before the fire occurred, however some of them were swept away by the tsunami waves, and they were crashed into the building and burst into flames, which spread and expanded to the school building. Though the first floor of Kadonowaki Elementary School escaped the fire because it was flooded by the tsunami waves, the external walls of the second and third floors still have the traces of severe heating applied externally by the fire of these cars. While the right (east) half of the building was burned from the first to the third floor, the fire did not spread to some part of the first and second floors of the left (west) half. Some of the estimated unburned reasons are that these floors had been flooded and that the windows and the doors had not been damaged severely, which prevented the fire spread.

(b) Cars reported to be a source of the fire spread

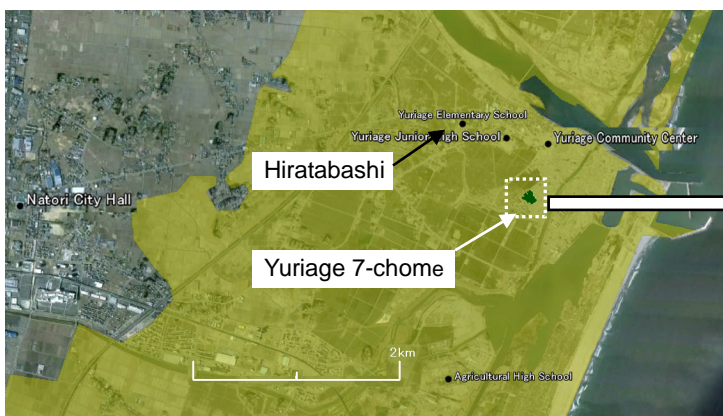
In the flooded areas in Natori City, fires occurred in two places: the Yuriage 7-chome district and the Hiratabashi area. The fire in Hiratabashi chiefly resulted from objects swept away to a river bank, and it spread over an area of 150 m, which is different from sort of a fire in the town area. In contrast, the Yuriage district that suffered from a fire in the town area is a new residential district constructed in a flatland located about 1 km inland from the coastline. As the aerial photographs in the newspaper etc.(Mainichi JP 2011) showed the fire immediately after it broke out, it is estimated that a fire occurred in the rubble piled up around the houses that had not been swept away by the tsunami waves, and it spread to the surrounding area after the water receded. Since paddy fields spread out along the boundary in the northeast area where the fire stopped to spread, and the rubble was scattered around over a broad area, the flames did not spread further.

(a) Flooded area and fire spread area

Fig. 10 Fires in the town area near the Yuriage district in Natori City

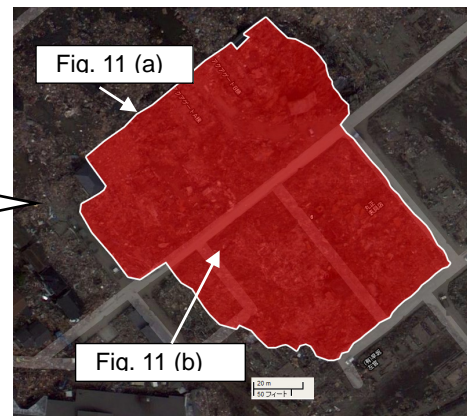
(b) Fire spread range in the Yuriage 7-chome district

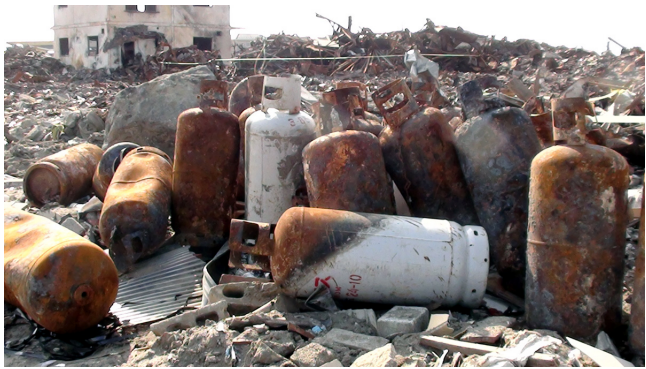
(b) Propane gas containers accumulated at the site

What was noticeable in this region is that a number of burnt or exploded propane gas containers were accumulated. We can see from various videos posted on the Internet (YouTube 2011) that propane gas containers installed at each house were swept away by the tsunami waves, and the gas blew out due to a breakage or the operation of the pressure relief valve at a crash into another object, catching fire from some sparks and bursting into flames. Though the propane gas cannot be identified as the source of the fires in this district, it could be concluded that energy sources including propane gas used for daily life can make a significant contribution to an outbreak or spread of fires in residential districts such as Yuriage.

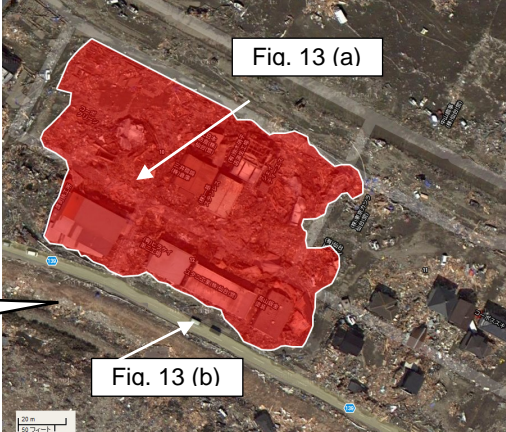
(b) Fire spread range in the Gamo 2-chome area

Out of these three fires, the largest one occurred in the Gamo 2-chome area (approx. 0.8 ha, about 20 buildings were burnt down). These buildings were located along a river bank, which is geographically apt to accumulate piles of rubble and vehicles. It is not known which of the leading waves or drawbacks of the tsunami brought these rubble and vehicles to this area, and the rubble accumulation conditions are also different between the north side of the building in the burnt-out area and the opposite river bank side (south side) as shown in Fig.13. The broken condition of shutters and crash situations of vehicles indicate that these piles of rubble flowed into the building from the north side in the same direction.

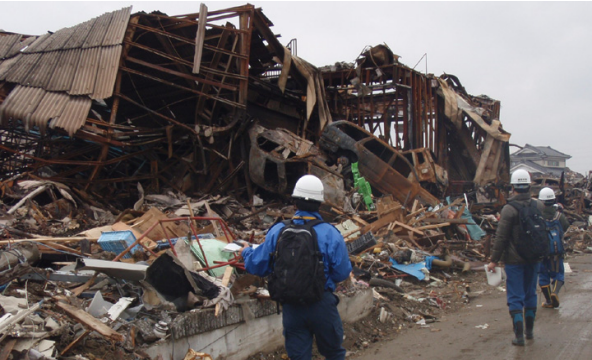
(a) Fire spread region in the north area where piles of rubble such as vehicles accumulated

Fig. 13 Fire site in the Gamo 2-chome area: Photos taken on April 9, 2011

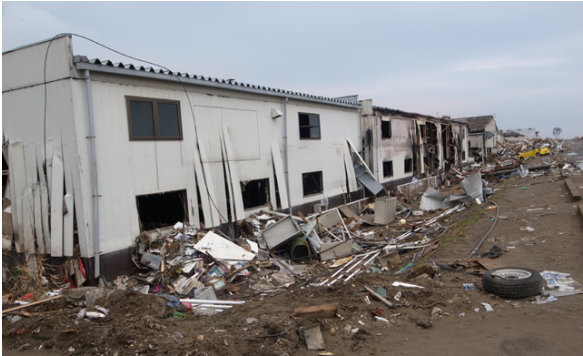
(b) Broken facilities on the river bank side (in the south area)

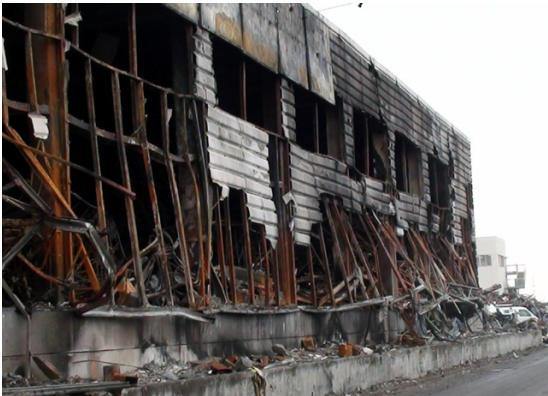
(a) The first floor was destroyed by the tsunami and fire

Fig. 14 Fires in the industrial facilities in the port region of the Miyagino ward in Sendai City: Photos taken on April 9, 2011

There are also other cases where a warehouse or a factory was burnt a few days after the earthquake. Most of these buildings had their first floor flooded and the external wall swept away by the tsunami waves as shown in Figure 14 (a). It is unlikely that the fires in these industrial facilities were caused by restored electricity few days later because the power was not supplied from outside. The further investigation into the causes of the fires in each individual facility and release the results are expected in order to prevent similar fires hereafter.

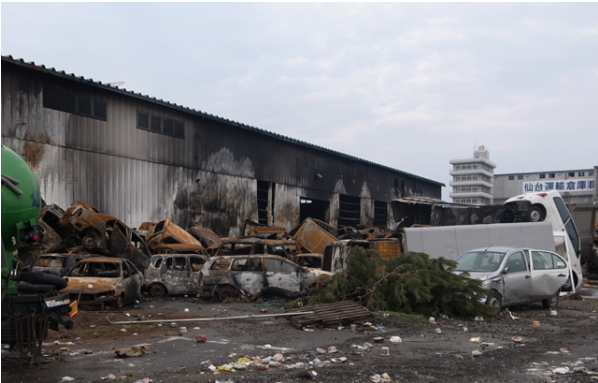
Another characteristic in the port district of the Miyagino ward is that numerous vehicles were burnt. Many vehicles were parked in this distribution center, and additionally it is reported that a number of cars were washed out from the integrated yard at the wharf by the tsunami waves, which are estimated to have contributed to the outbreak or spread of the fires in the buildings. Almost equal numbers of vehicle fires occurred immediately after the tsunami arrival and over the following days. Residents said that hundreds of vehicles were burnt after March 11 in Minato 4-chome. Though it is still unknown whether these subsequent vehicle fires were caused by a failure in the electrical systems

(b) Piles of rubble such as vehicles were swept away toward the building, causing a fire
