SIMULATION OF SLIDING FAILURE OCCURRED AT HIGHWAY EMBANKMENT IN 2011 GREAT EAST JAPAN EARTHQUAKE

Kouki MURAKAMI¹, Ken-ichi TOKIDA² and Aino TACHIBANA³

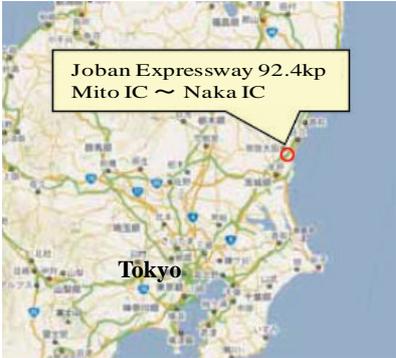
(a) Location of investigate site

Fig. 1 (a) shows the location of the embankment at Joban Expressway to investigate in this study which is about 100km far from Tokyo. Fig. 1 (b) shows the satellite photograph by Google (2011) where the damaged embankment is covered with blue sheets and about 1km away from Naka Interchange which locates in the right direction of the figure. It's necessary to note that the highway lanes from the right side to the left one in Fig.1(b) is named "Up Lane" to Tokyo where the embankment was slid and the reverse direction is named "Down Lane" from Tokyo in this paper.

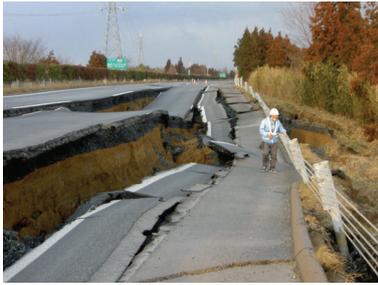
(a) Sliding failure around crest

Photo 1(a) reported by the East Nippon Expressway Co. Ltd. just after the earthquake shows the sliding failure at the embankment crest with the maximum displacement of 1.5m along the distance of about 150m together with a slight sliding occurred along the boundary of the two traffic lanes. Because the one lane of the Up Lane and two lanes of the Down Lane were not damaged, they could be used for the recovery works after the earthquake. So the damage level at this site can be indicated to be medium considering the performance-based design. Photo 1(b) shows the toe sliding failure of the embankment on March 13 because the side road and the base ground neighboring the embankment aren't deformed. Furthermore, the sand boils induced by soil liquefaction can't be observed at the base ground surface.

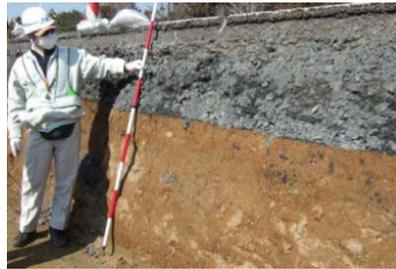
Photo 2 View of pavement and gravelly fine sand layer

The embankment body is modeled with four layers such as layer 4, layer 5, layer 6 and layer 7 shown in Fig.2 where layers 5, 6 and 7 are the pavements except for the asphalt and modeled as the sandy gravel in this study. The thickness of layer 7 of 0.6m is measured from Photo 2 and that of layers 5 and 6 is assumed to be half of the layer 7. The soil properties of the embankment body are assumed based on the results of the unconfined compression tests of the slid soils which conducted on March 13 by the East Nippon Expressway Co. Ltd. (2011).

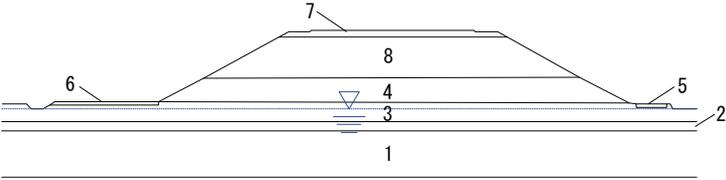
As for the soil layers of the embankment body considering the collapsed profile in detail, it can be clarified that the upper part of the embankment body whose thickness is 5.3m seems to be composed of the gravely fine sand and the lower part of that whose thickness is 3.3m seems to be composed of the loam. Then the embankment body is divided into two layers such as layer 4 and layer 8 shown in Fig. 5. Additionally, the ground water level which is 0.59m below the bottom of layer 4 or the surface of layer 6 is assumed as shown in Fig. 5. The unit weight of water is 10.0kN/m³.

Fig. 5 Modified model considering soil layers of embankment body and ground water

The trial and error to modify the soil properties of each layer in Fig. 5 to satisfy the two conditions such as the minimum safety factor in general condition and the toe sliding failure in both general condition and seismic one applied with seismic coefficients of $k = 0.1, 0.2$ and 0.3 . Table 2 show the final results by trial and error and Fig. 6(a) shows the example where the minimum safety factor of 1.085 is larger than 1.0 and the toe sliding failure form is performed in general condition. Furthermore, the sliding failure forms applied with the above seismic coefficients are also performed based on Table 2 as shown in Fig. 6(b) which is the example of $k = 0.2$. Compared Table 2 of the modified model with Table 1 of the fundamental model, generally speaking, the toe sliding failure can be assumed to occur when the strength of the base ground is relatively larger than that of the embankment body.

As shown in Fig. 5, the groundwater level is lower than the base ground surface. This means that the whole embankment body is located above the groundwater level and isn't saturated generally. However, estimated the body water conditions concentrated and/or stored as mentioned above, it can be assumed that the water contents above the groundwater level may be distributed irregularly and then the strength of body soils may be different at each position.

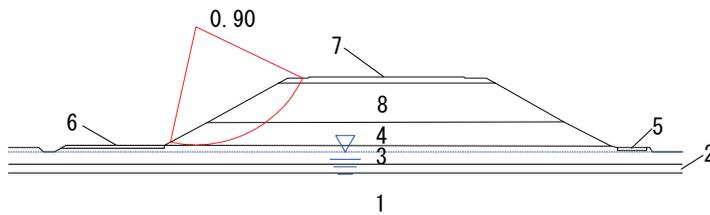
The example of results on the slope at the Down Lane in case of $k = 0.1$ can be shown in Fig. 7(a). As shown in Fig. 7(a), the sliding failure form takes on the toe sliding failure one. Furthermore the summaries of results in all cases of $k = 0.1, 0.2$ and 0.3 are shown in Table 7(b) and the sliding failure forms in all cases take on the toe sliding failure ones. As shown in Fig. 7(a), although the minimum safety factors at the slid slope at the Up Lane are a little larger than those at the non-slid slope, the differences between them seem to be very small from the engineering view point.

(a) Critical slip circle at down lane in case of $k = 0.1$

Fig.7 Stability at Down Lane and safety factors between Down Lane and Up Lane

As mentioned above, the reason why only one-side slope was slid at the same cross section can't be clarified in this study. The result is clear and expected because the both slopes at the almost symmetrical embankment with the same soil materials are estimated to be same as far as the circular sliding method is applied, in other words, it indicates the limitation to apply the circular sliding one.

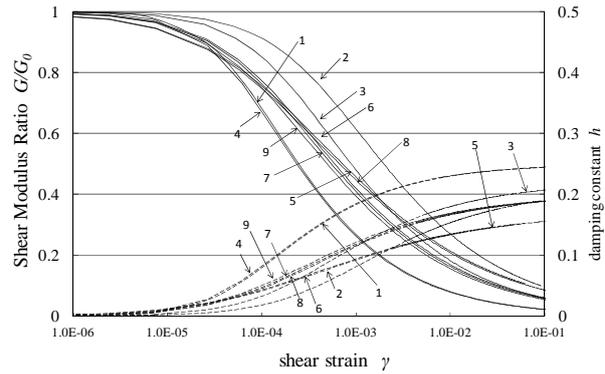
Fig. 8(a) shows the analytical FEM model of the objective embankment and base foundation. The left-side slope didn't slide and the right-side one slid in this earthquake. The static soil properties are same with Table 2 applied for the circular sliding method. The dynamic soil properties of both shear modulus ratio G/G_0 and damping content h according the shear strain γ shown in Fig. 8(b) which are estimated referring to Yasuda & Yamaguchi (1985) for the layer 1 to layer 4 of the base ground and Seismic Design Code of Railway Structure (1999) for the layer 5 to layer 9 of the embankment body, respectively are applied for the equivalent linear method. The layers 7, 8 and 9 are the pavements and modeled as the gravel, and the layer 10 is assumed to be the engineering base ground.

(b) Dynamic properties of each layer

Fig.8 FEM model and dynamic deformation properties

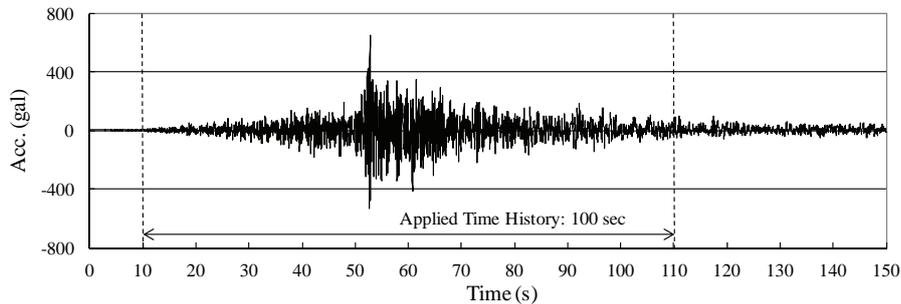
Two analytical cases shown in Table 3 are considered to investigate the effects by the input earthquake ground motion in this study. The earthquake ground motion inputted at the lower plane of the layer 10 of 10m deep in Fig.5 is estimated by Hata etc. (2011) from the earthquake ground motion recorded at Naka City Office which is about 4.5 km far away from the slid embankment. The time history of the acceleration estimated in the direction of the cross section of the slid embankment is shown in Fig. 9 where the applied time history is 100 seconds including the main large ground motion. It can be known that the maximum acceleration amplitude is +651gal and -533gal.

The plus (+) direction of the acceleration in Fig. 9 means to be the right side direction in Fig. 8(a) and then the seismic force induced by the plus acceleration tried to drive the body at right side slope to slide toward the right side in Fig. 8(a). So the direction of the inputted acceleration becomes important. In this study, two cases on the inputted direction of the base ground motion are considered, i.e. the direction of the plus acceleration is set to the right-side which is named “Real Direction” and the left-side which is named “Reversal Direction” to investigate the effects of the direction of the irregular ground motion on the dynamic behavior of the embankment.

Fig. 9 Inputted earthquake ground motion at engineering base ground of 10m deep

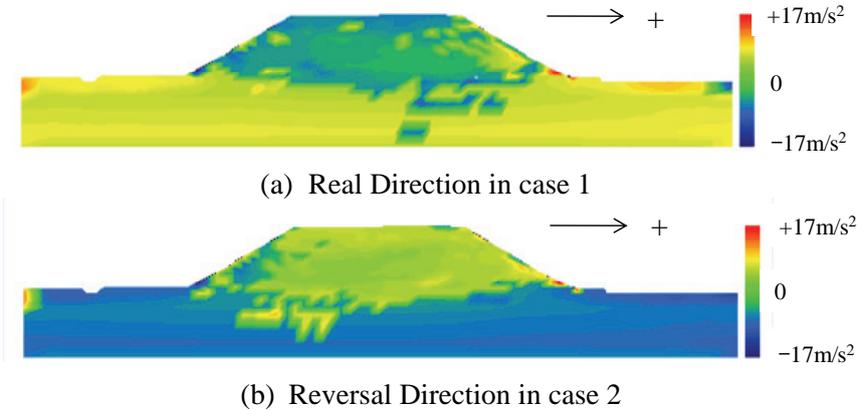
Fig.10 shows the distribution of the maximum acceleration at both embankment body and base ground for all duration time comparing the Real Direction with the Reversal one, and the maximum values only at the embankment body are picked up in Table 4. It can be known that both the distribution of

the maximum acceleration and the maximum values are almost same at the right-side body and the left-side one in the Real Direction and the Reversal Direction. Therefore, the difference induced by the direction of the inputted earthquake ground motion acting on the maximum acceleration at the embankment body can't be clarified from the view of the maximum acceleration occurred.

Fig. 10 Distribution of maximum acceleration

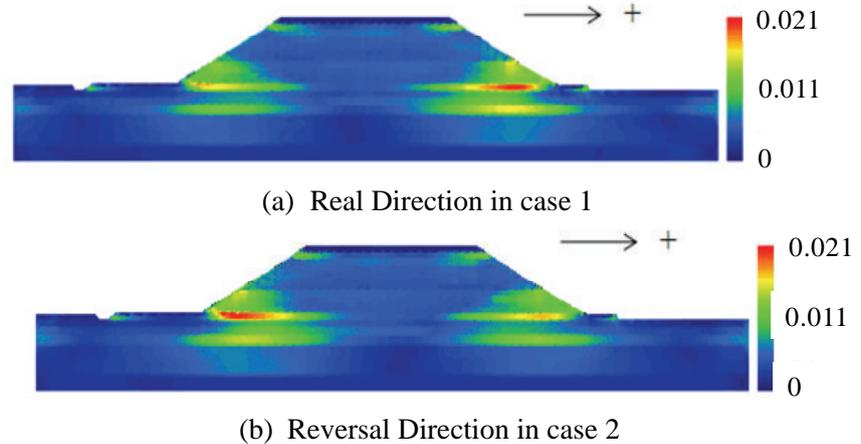
Fig. 11 shows the distribution of the maximum shear strain at both embankment body and base ground for all duration time comparing the Real Direction with the Reversal one, and the maximum values only at the embankment body are picked up in Table 4. It can be known that both the distribution of the maximum acceleration and the maximum values are almost same between the right-side body in the Real Direction and the left-side body in the Reversal Direction. This indicates that referring the maximum shear strain, the slope at the Down Lane has the possibility to be slid when the earthquake ground motion in Fig. 9 was inputted in the Reversal Direction.

Fig. 11 Distribution of maximum shear strain

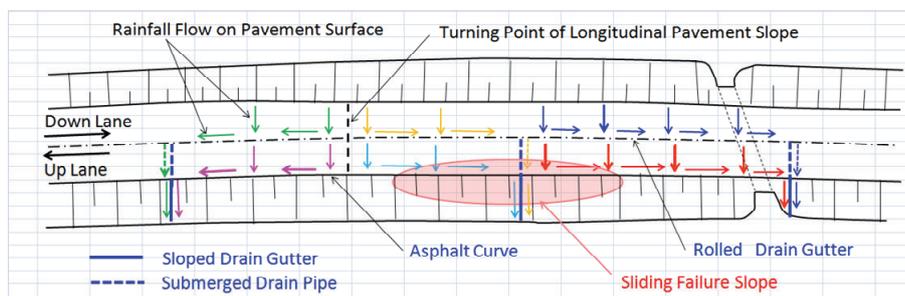
Although the slid embankment with the symmetry shape locates on the flat alluvium plane, the plane linearity of the highway route around the slid embankment can be known to be curved a little toward the lower direction in Fig. 1(b). Then, according to the layout of the drainage system around the slid embankment shown in Fig. 12 by the East Nippon Expressway Co. Ltd. (2012), it can be assumed that the rain fall and the water drained from the pavement are led to the lower direction in Fig. 12. Furthermore the detail field survey by the East Nippon Expressway Co. Ltd. (2012) has reported that the ground water level is observed to be high just after the rainfall inside of the right-side body at the Up Lane.

Based on the above conditions, the water oriented by the rainfall and/or drainage may be possible to concentrate and/or stored in the embankment body at the Up Lane in Fig. 1(b) where the sliding failure occurred in this earthquake. On the contrary, the embankment body at the Down Lane where the sliding failure didn't occur may be difficult to be concentrated and/or stored with the above water.

Fig. 12 Drainage system of rainfall on pavement surface

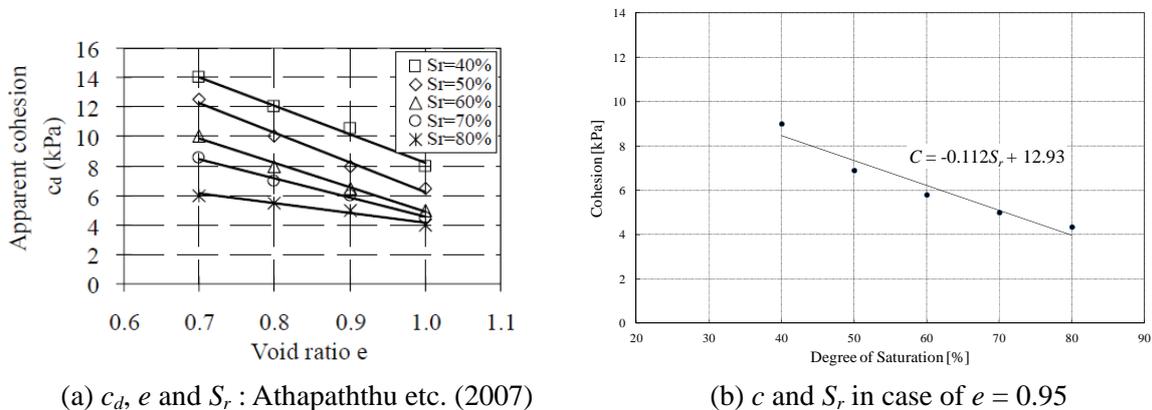
For investigating the above estimation, it is necessary to know the factors affected by the change of degree of saturation S_r which are considered to be the shear strength and the wet density in this study. As for the above shear strength, Athapaththu etc. (2007) indicate that the internal friction angle isn't related to the S_r and on the contrary, the apparent cohesion is related to that as shown in Fig. 13(a) through the consolidated drain tests. Based on Fig. 13(a), the cohesion of soils can be assumed to decrease according to the increase of the void ratio e of 0.7 to 1.0 depending on the S_r of 40% to 80%. Modifying Fig. 13(a), Fig. 13(b) can be obtained as the relation between the S_r and cohesion in case of the e of 0.95.

As shown in Table 2 which shows the soil properties on the layers 4 and 8 measured by the East Nippon Expressway Co. Ltd. (2011) just after the earthquake, the layer 4 is the loam with the void ratio e of 1.81 and then the cohesion is assumed not to be affected by the S_r in this study. On the other hand, because the layer 8 is the gravely fine sand with the e of 0.95, the change of the cohesion is assumed according to Eq. (1) shown in Fig. 13(b).

Fig. 13 Relation between cohesion c_d , degree of saturation S_r and void ratio e

Based on the Eq. (1), it can be known that the cohesion of 0.112kPa is decreased according to the increase of S_r of 1 %. Although the S_r of the layer 8 measured just after the earthquake is 44.2 %, the S_r of the layer 8 before the earthquake can't be known shown in Table 6. In order to investigate the difference of the slid slope and non-slid one, the layer 8 in the original cross section of Fig. 14(a) is divided into two layers: the half layer at the right side where the sliding failure occurred and the that at the left one where the sliding one didn't occur shown in Fig. 14(b). Then, the degree of saturation of the layer 9 in Fig. 14(b) is estimated to be S_{r0} before the earthquake and the sliding safety factor is calculated applying the increase of S_r from 10% to 30% with the step of 10% from the S_{r0} .

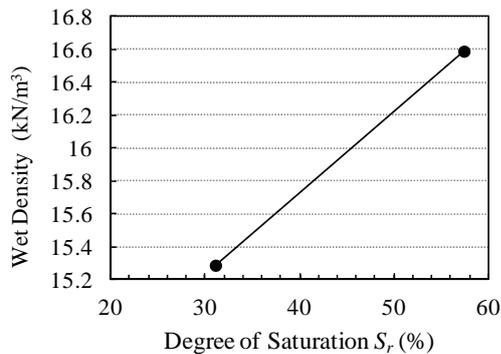
(a) Relation S_r and wet density

Fig. 15 Relation between cohesion and wet density considering S_r

On the other hand, the relation between the wet density and S_r is estimated based on that estimated by two soil samples shown in Fig. 15(a), and then the wet density of 0.0494kN/m³ is assumed to be increased according to the increase of S_r of 1% in this study. The analytical conditions of 3 cases where the decrease of cohesion is considered in Case-1, the increase of wet density is considered in Case-2 and both cohesion and wet density are considered in Case-3 according to the increase of S_r are summarized in Fig. 15(b).
