STRONG MOTION DATA RECORDED IN BUILDINGS DAMAGED BY THE 2011 GREAT EAST JAPAN EARTHQUAKE

ABSTRACT: Building Research Institute (BRI) has initiated construction and operation of the strong motion network aimed at building structures in 1957, as one of its research activities. Fifty-nine stations in the BRI strong motion network were triggered by the 2011 Great East Japan Earthquake. The paper reported notable cases recorded during the East Japan Earthquake and its aftershocks in the BRI strong motion network.

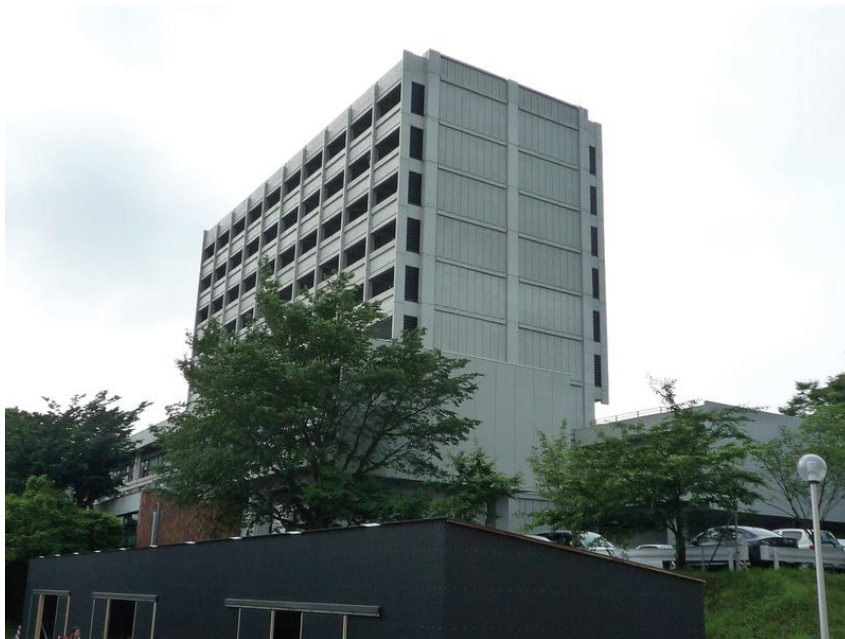
At the station THU, a nine-story steel-framed reinforced concrete building in the Aobayama Campus of Tohoku University, Sendai city, is the target of instrumentation. This building has a long history of strong motion observation. Among them, strong motion records on the ninth floor of the building that were obtained in the 1978 Miyagi-ken-oki (Off Miyagi prefecture) earthquake are well known to have represented a maximum acceleration of more than $1,000 \text{ cm/s}^2$. The instrument has two acceleration sensors on the first floor (01F) and the ninth floor (09F).

Photo 1 THU building

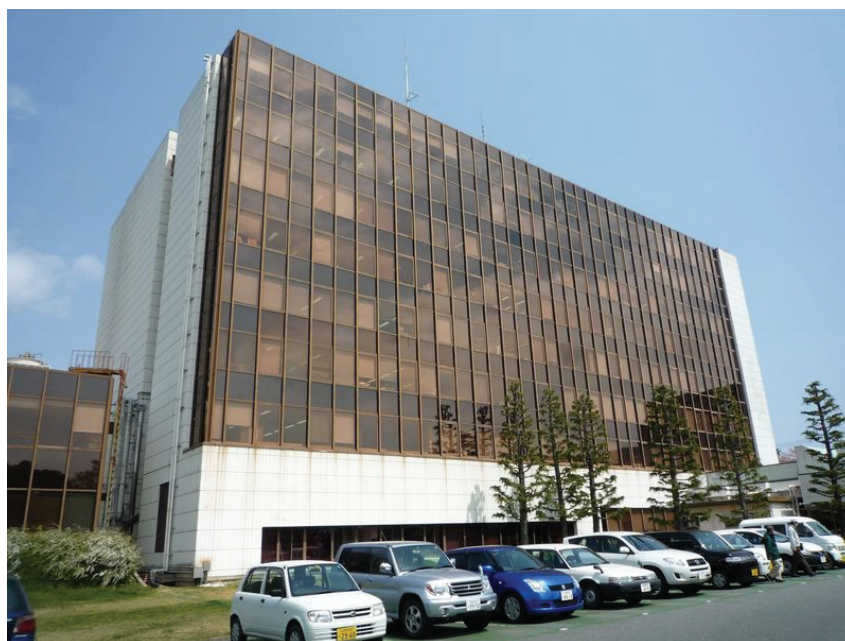
The Iwaki City Hall that is an eight-story steel-framed reinforced concrete building is instrumented in the station IWK. Two acceleration sensors are placed on the first basement floor (B1F) and the penthouse floor (09F). The appearance of the building is shown in Photo 2. The epicentral distance of the IWK station was 210 km.

Photo 1 IWK building

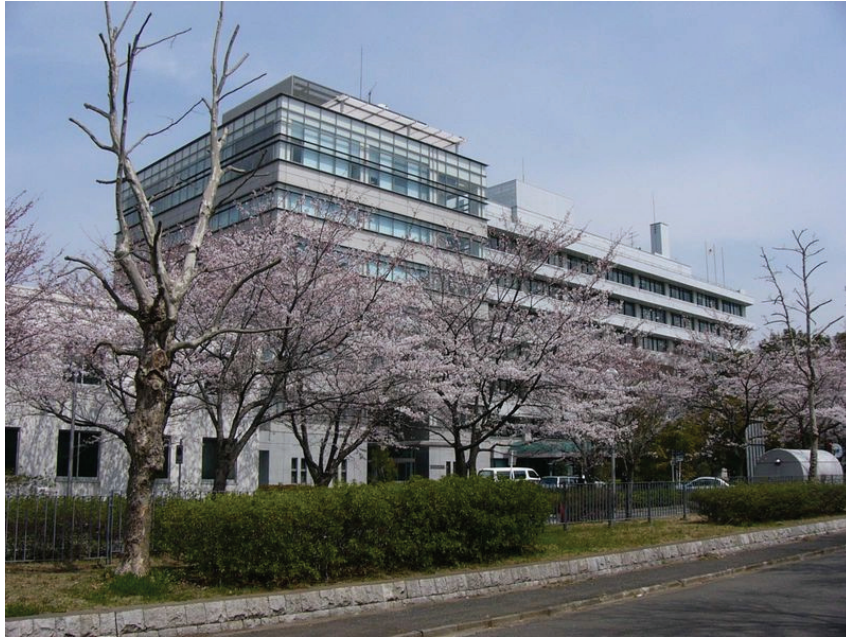
The station ANX has a densely instrumented system targeted on two buildings and the surrounding ground in the Building Research Institute (BRI) in Tsukuba City, Ibaraki Prefecture. The target is equipped with eleven acceleration sensors in the annex building, seven sensors in the surrounding ground, and four sensors in the main building. The annex building is an eight-story steel-framed reinforced concrete building with one basement floor, and the main building is a seven-story steel-framed reinforced concrete building with one basement floor. Two buildings are connected by the passage way with the expansion joint. Photo 3 shows the annex building and main building of BRI and Fig. 8 indicates the sensor configuration.

Photo 3 Instrumented buildings of ANX station

The East Japan earthquake violently shook and damaged both of the buildings. Especially in the passage way between the two buildings, the expansion joints were broken and ceiling boards fell off. Figures 9 and 10 indicate acceleration waveforms recorded in the annex and main building, respectively. Maximum accelerations on the basement floors (BFE and MBC) are about 200 cm/s^2 in the both of the buildings. Accelerations on the eighth floors (8FE and M8C) are 2.5 to 3.0 times larger than that on the basement floors.

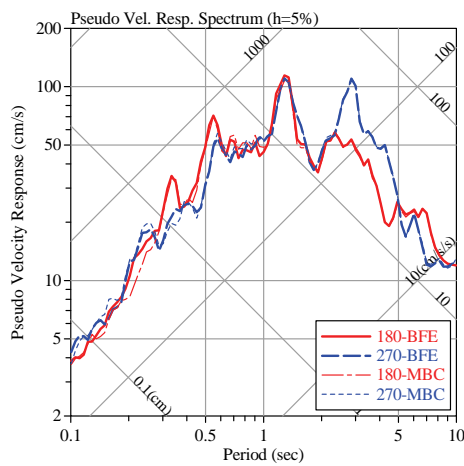
Pseudo velocity response spectra of the strong motion data recorded on the basement floors of the both buildings are plotted in Fig. 11. Several peaks appear on the spectra in the both horizontal directions, and the pseudo velocity response at the period of 1.3 seconds exceeds 100 cm/s .

Fig. 11 Pseudo velocity response spectra of the strong motion records at BFF and MBC ($h=5\%$)
