第4回リモートセンシング技術を用いた災害軽減に関する研究委員会

話題提供資料

Fragility Analysis of Road Structures subjected to a Tsunami Wave Load in the 2004 Giant Earthquake and Tsunami in the Indian Ocean

Damage Detection due to the 2007 Pisco Peru Earthquake Using PALSAR and ASTER Imagery

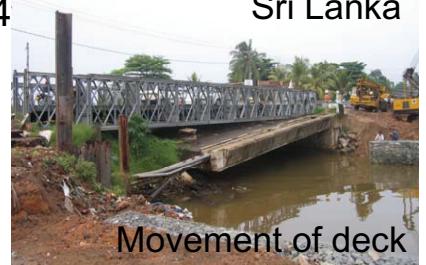
Sri Lanka

Movement of deck

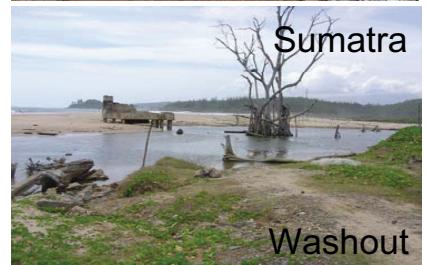
Sumatra

Washout

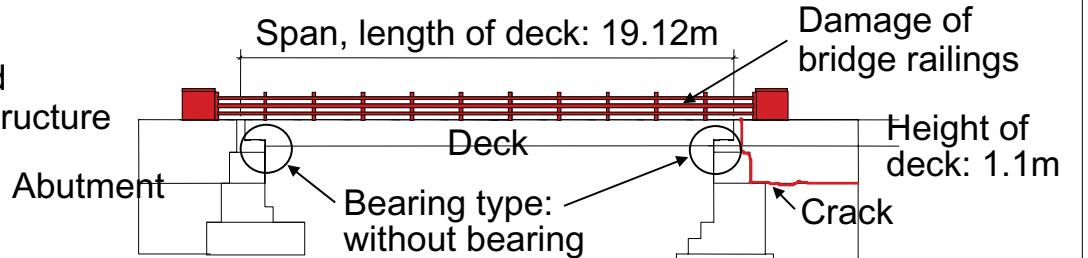
- e.g. Magalle bridge at Galle, Sri Lanka

Structural type:
1span reinforced
concrete (RC) structure

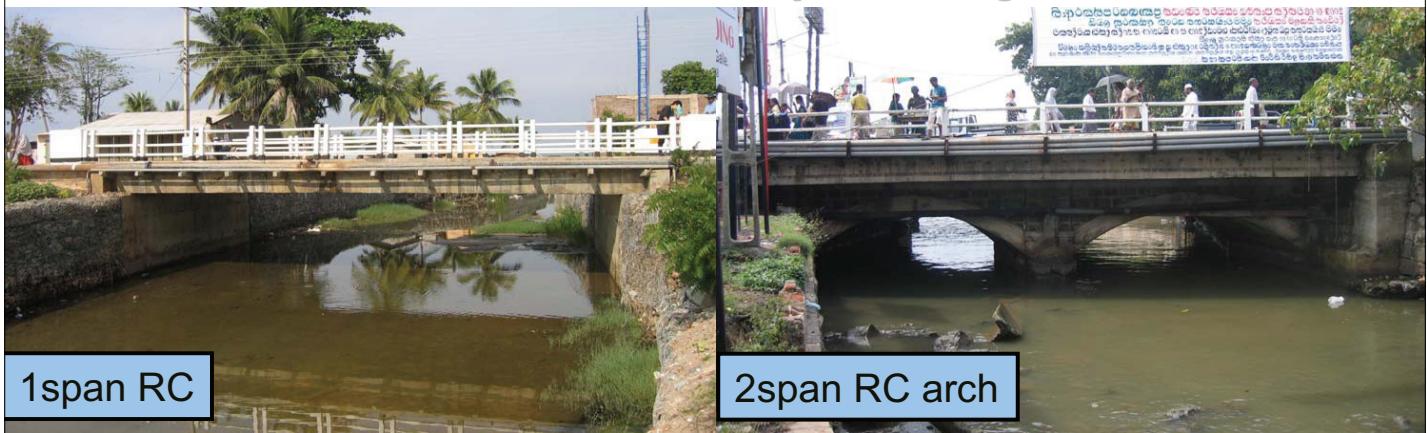
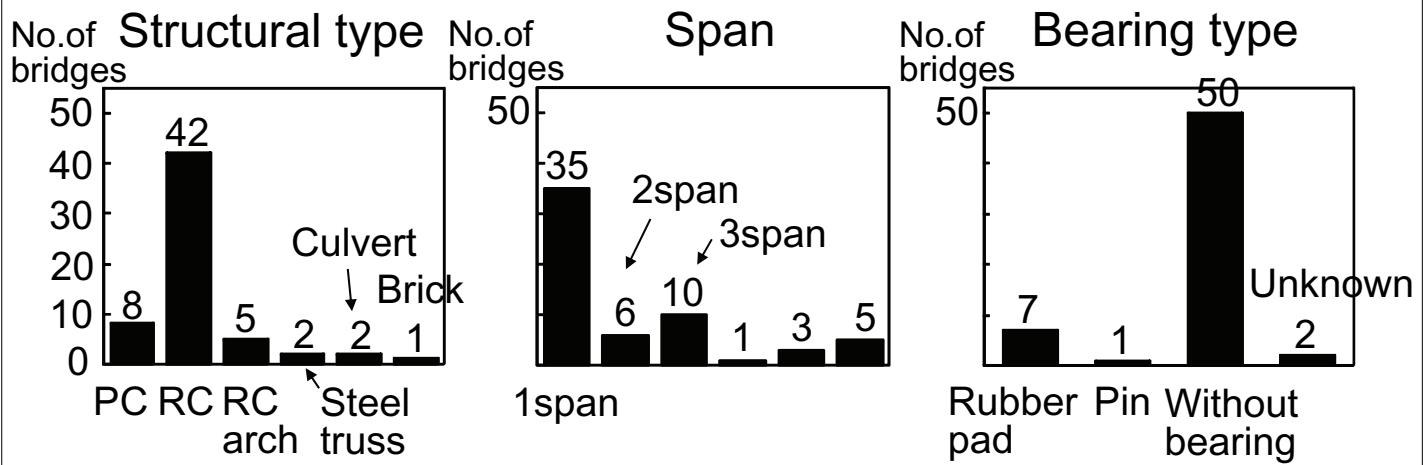
Structural characteristics of subject bridges on Sri Lanka

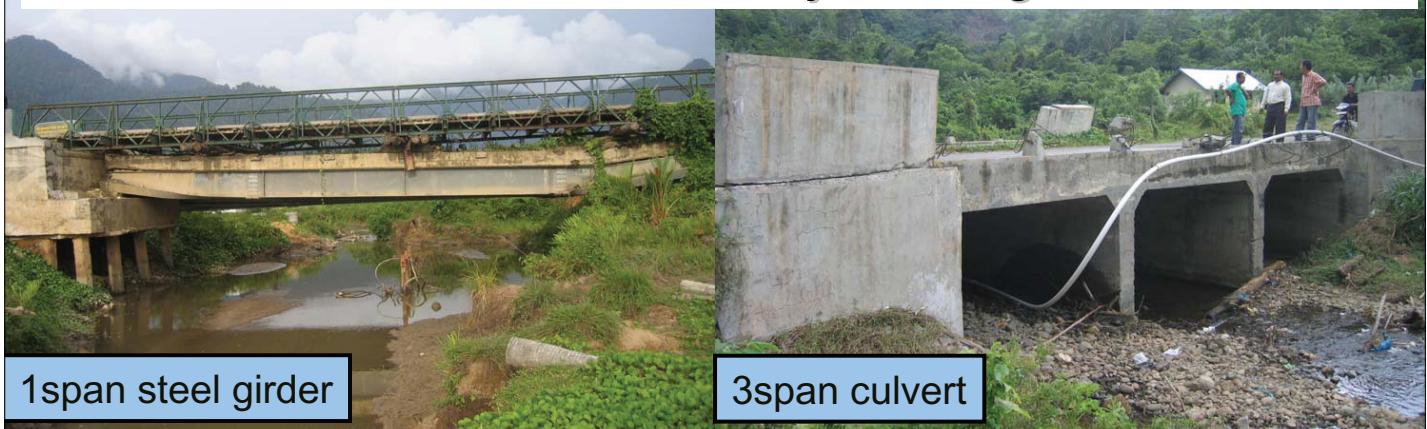
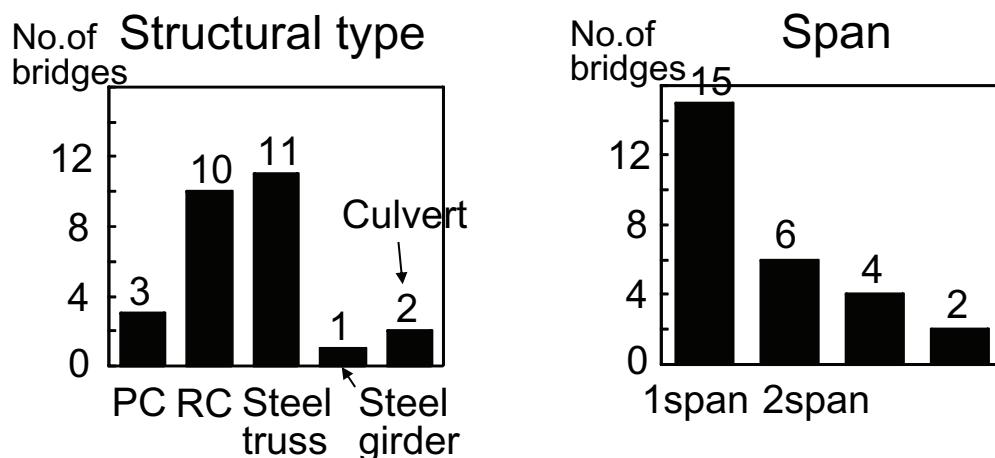
Structural characteristics of subject bridges on Sumatra

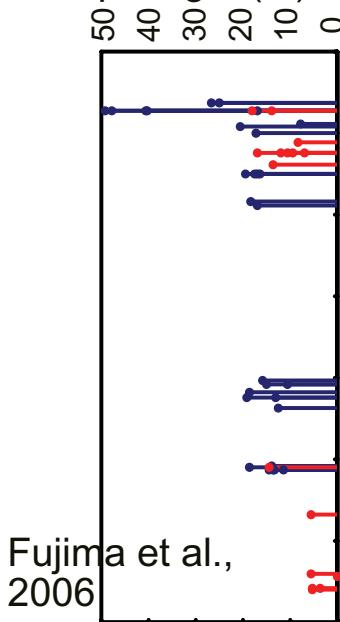
Inundation height and tsunami runup height near the sites of subject bridges in Sumatra

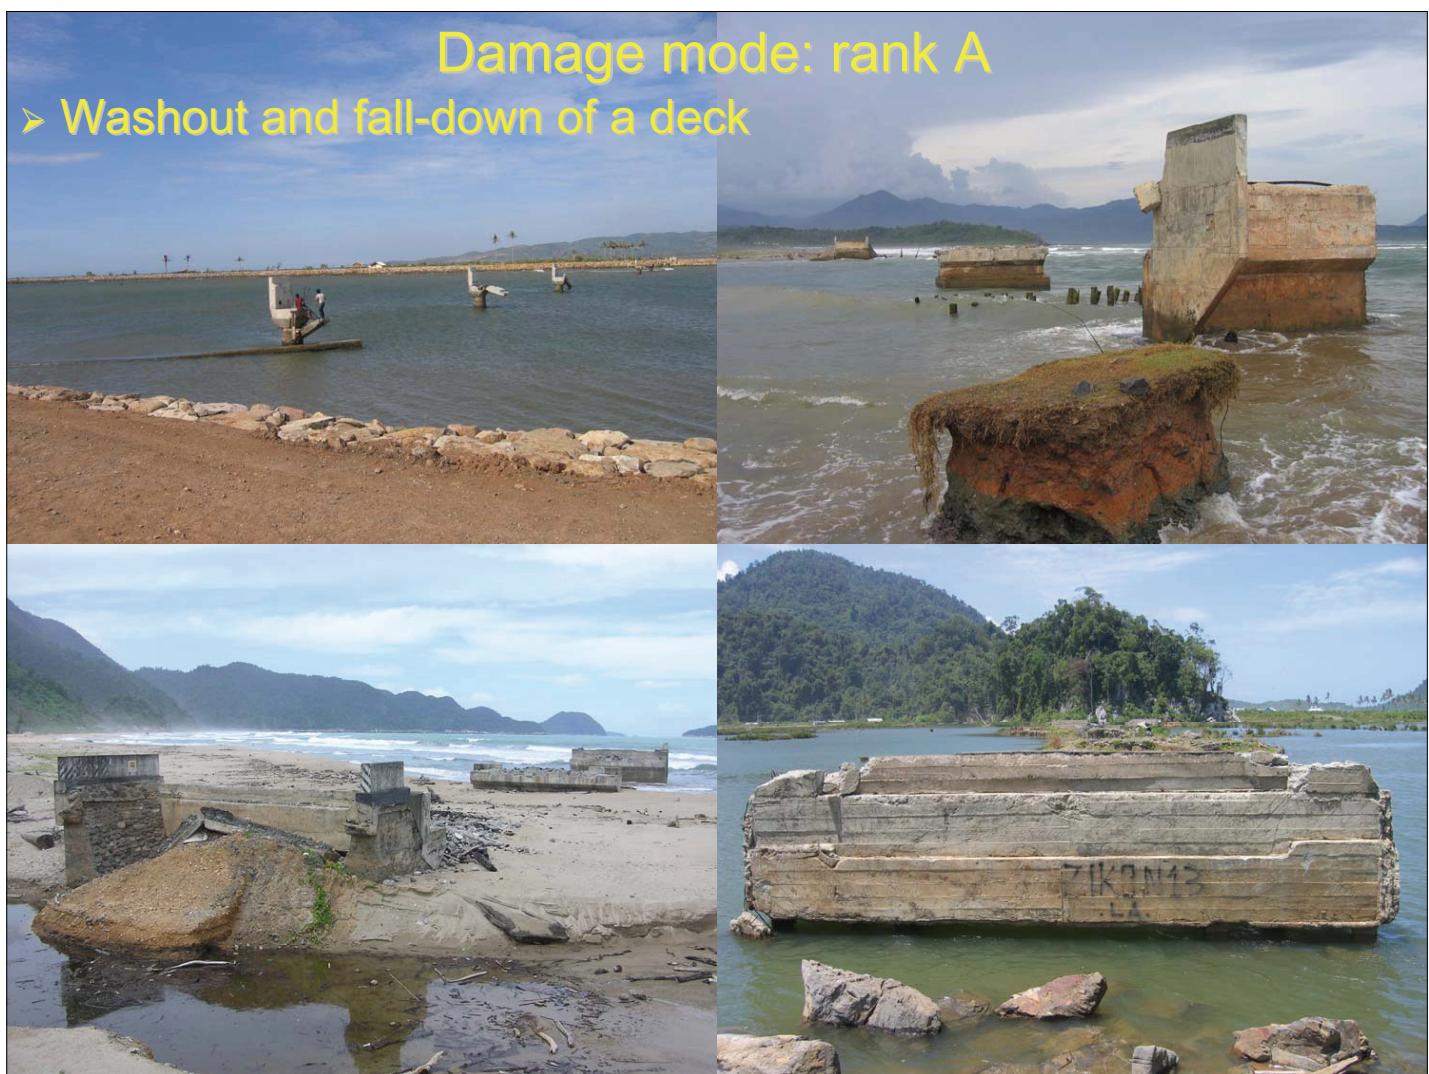
Damage mode: rank A

➤ Washout and fall-down of a deck

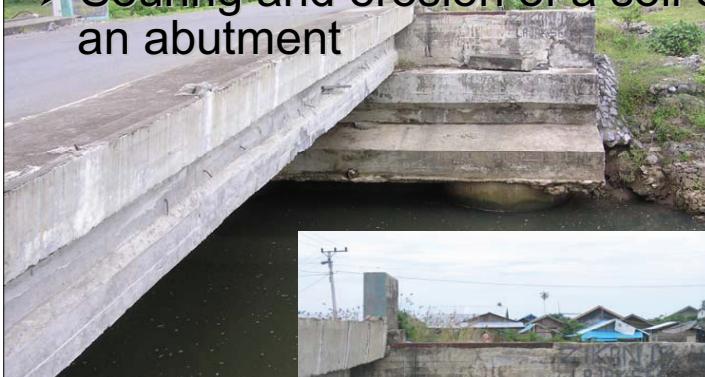
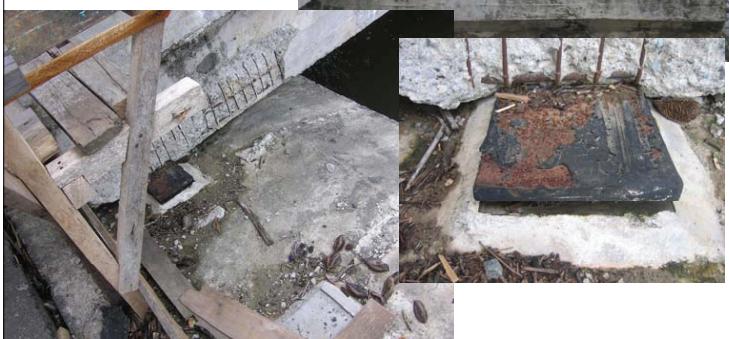
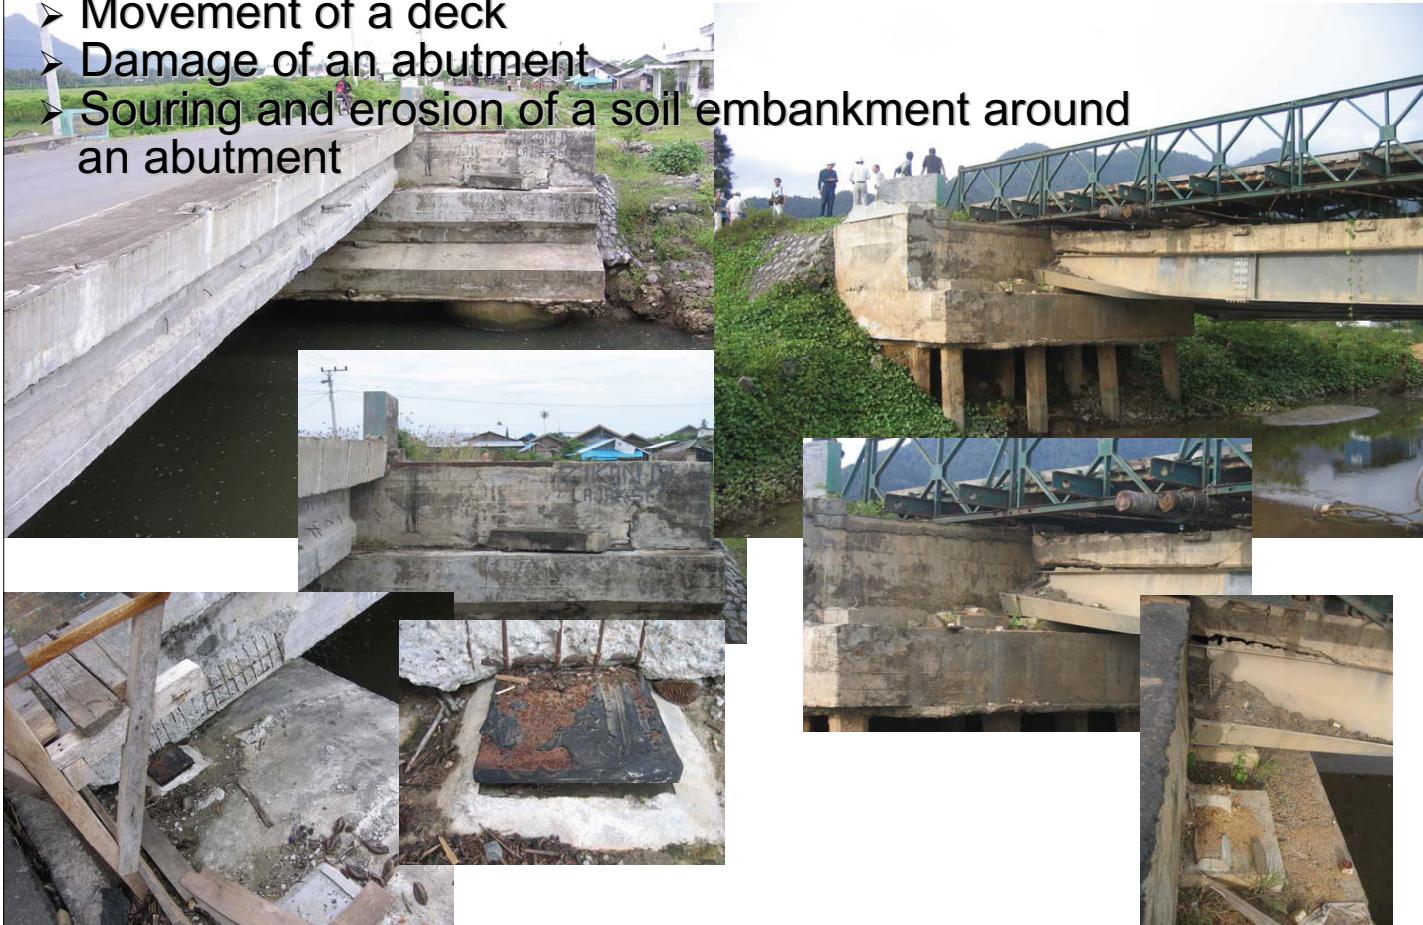
Damage mode: rank B

- Movement of a deck
- Damage of an abutment
- Souring and erosion of a soil embankment around an abutment

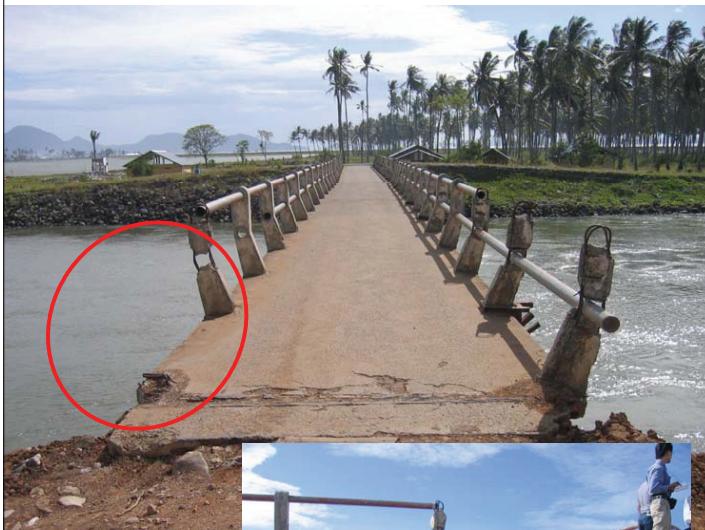
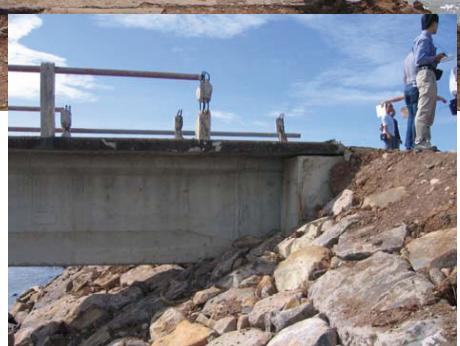
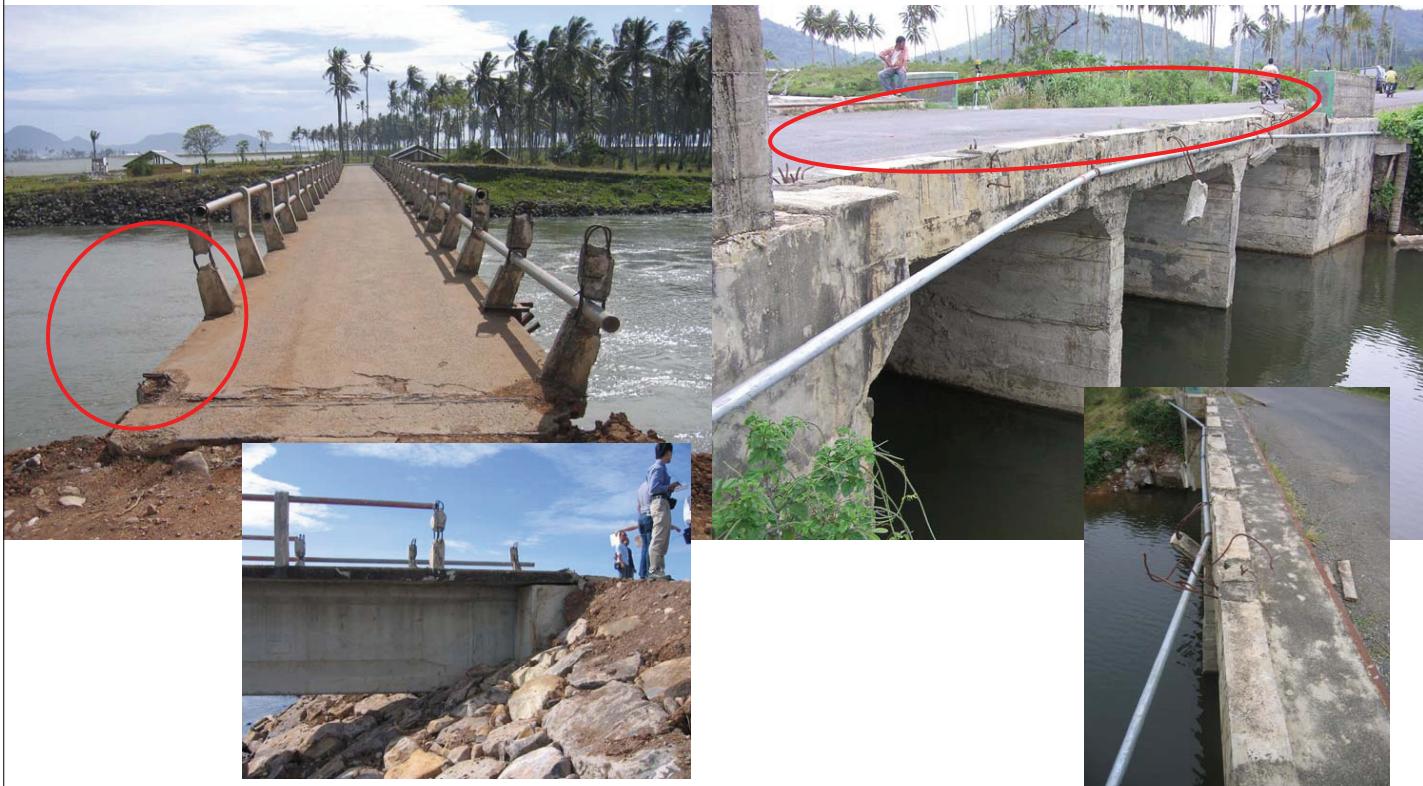
Damage mode: rank C

- Damage to a deck attachment such as bridge railings

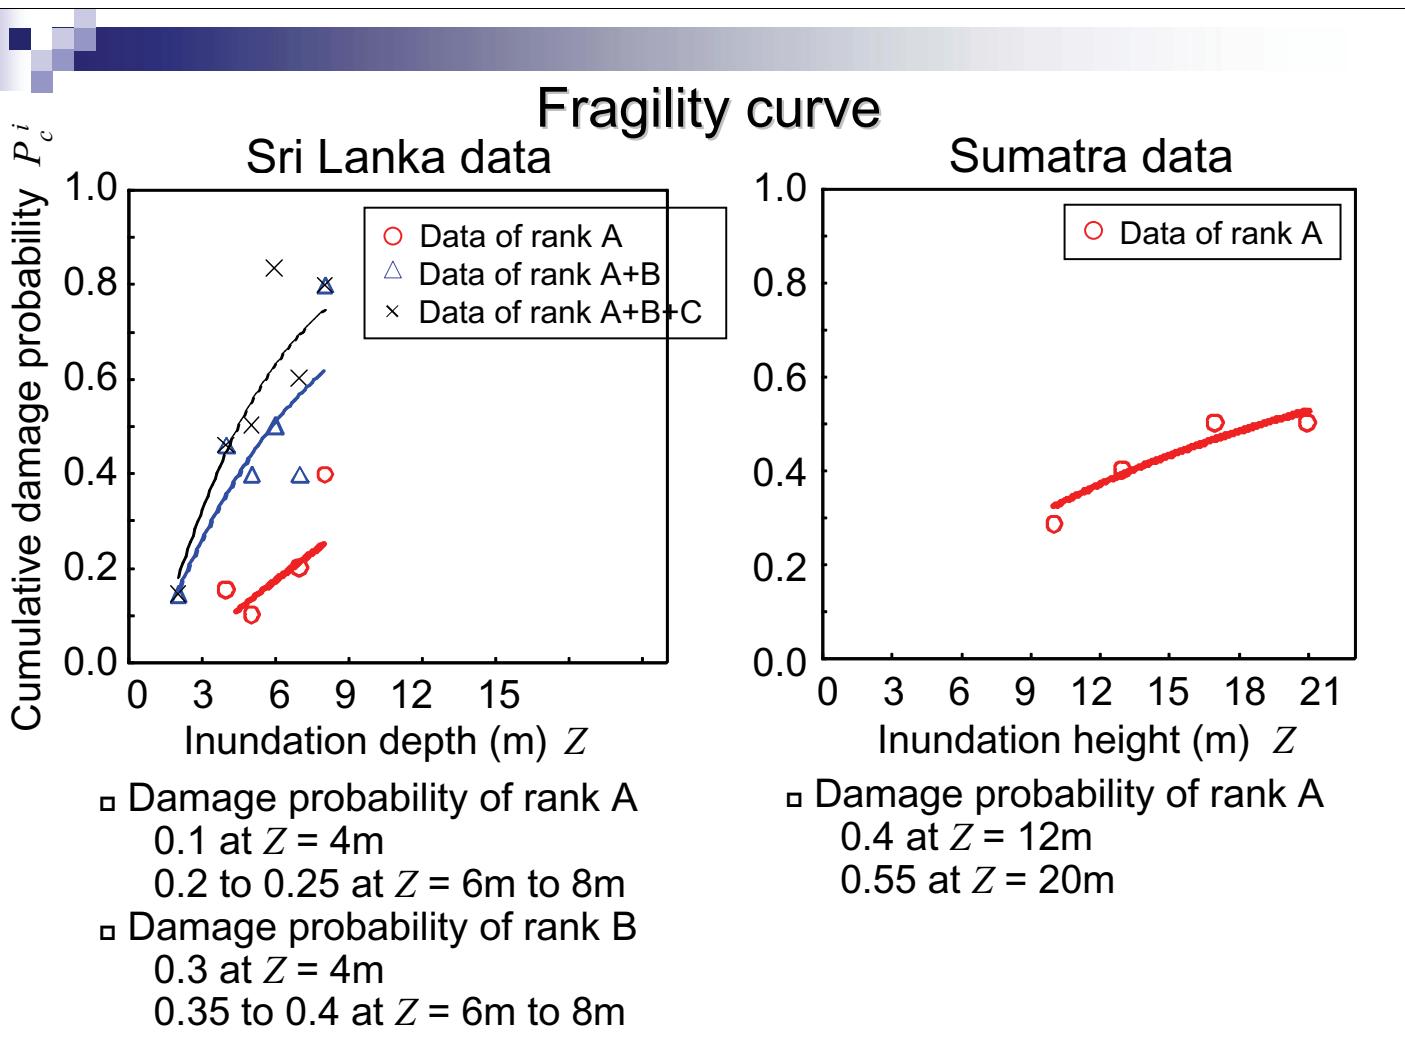
➤ Damage probability versus tsunami wave load

$$P_C^i = \int_0^z \frac{1}{\sqrt{2\pi} \cdot \sigma_Y \cdot z} \exp \left\{ -\frac{1}{2} \left(\frac{\ln z - \mu_Y}{\sigma_Y} \right)^2 \right\} dz \leftarrow \text{Logarithmic normal distribution}$$

P_C^i : cumulative damage probability
 i : damage mode
rank A
~ rank D, no damage

Z : tsunami wave load
inundation depth, assessing Sri Lanka data
inundation height, assessing Sumatra data
 $Y = \ln Z$
 μ_Y : mean-value of Y
 σ_Y : standard deviation of Y

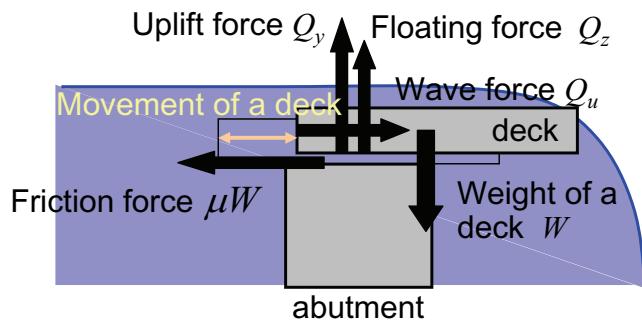
'Major' damage mechanism based on fragility analysis of Sri Lanka data
@5-m to 10-m inundation depth level

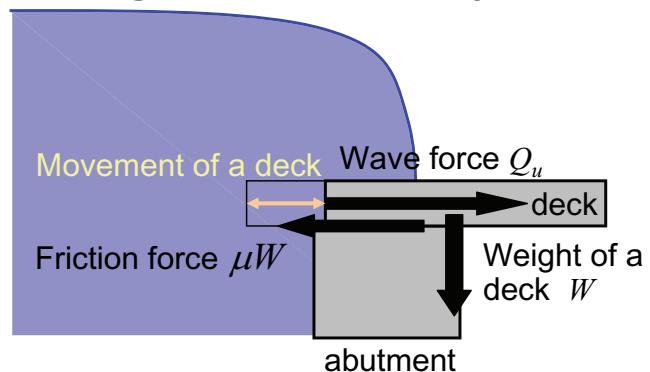
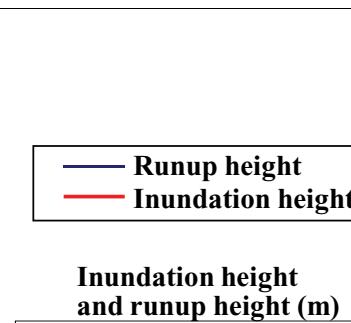
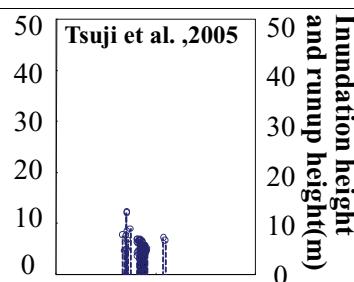
'Severe' damage mechanism based on fragility analysis of Sumatra data
@20-m inundation height level

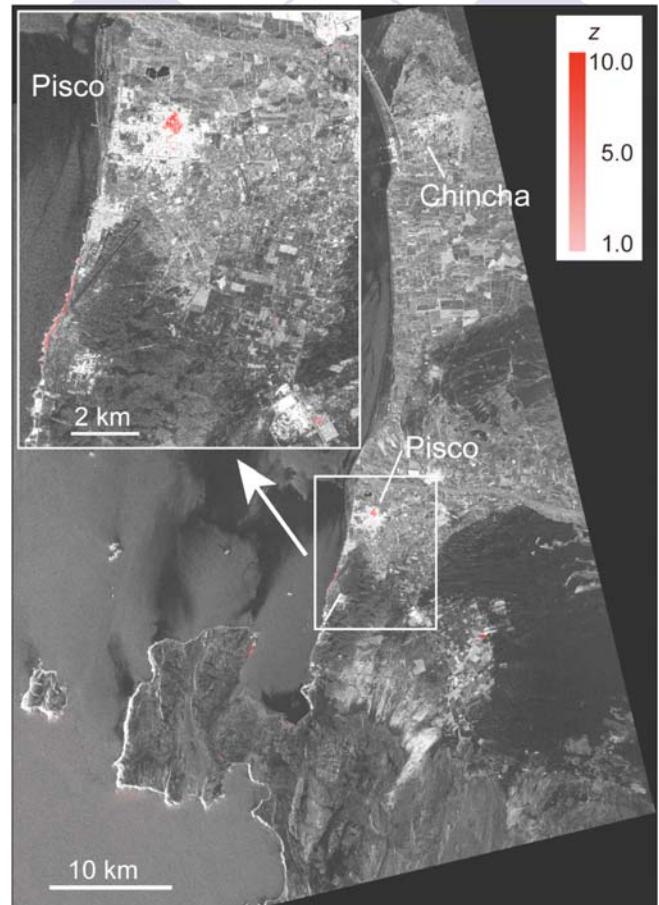
z-Value Distribution

Damage map estimated from PALSAR

- Calculating the compound variable, z , that used the difference value and correlation coefficient of the backscattering coefficient within a corresponding window as explanatory variables using the pre- and post-event speckle-reduction filtered SAR images (Matsuoka and Yamazaki, 2004).
- Vegetated areas are masked by NDVI threshold value derived from ASTER base map for damage detection target selection.
