第7回リモートセンシング技術を用いた災害軽減に関する研究委員会

話題提供資料

Multi-Scale Approach to Assess the Impact of Major Tsunami Disaster

中国四川省地震による岩石流

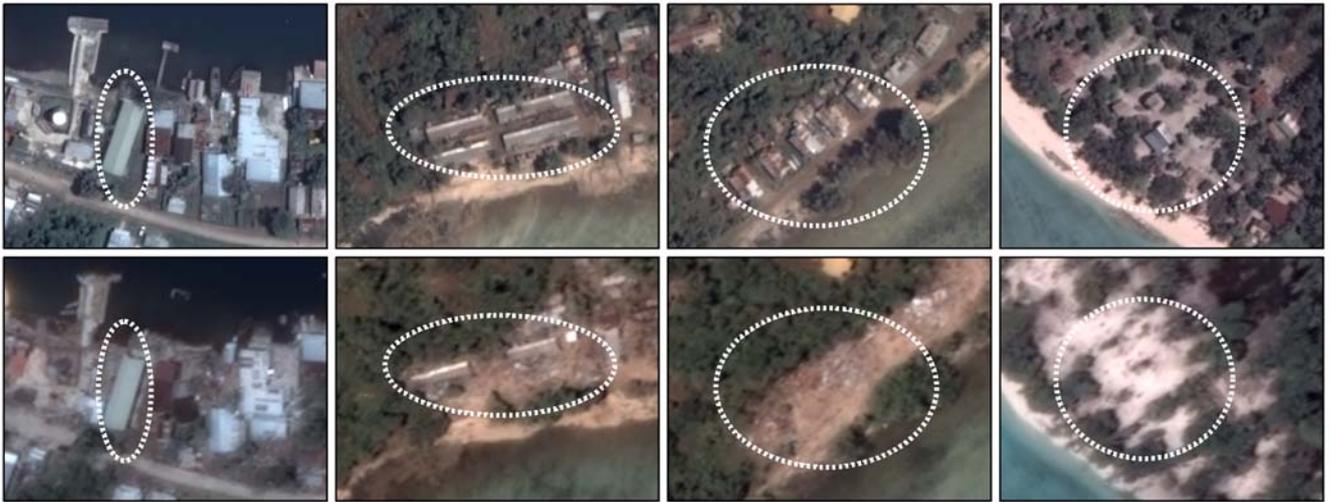
Visual Damage Detection Damage Classification

a) No /very slight damage

b) Slight

c) Major

d) Washed Away

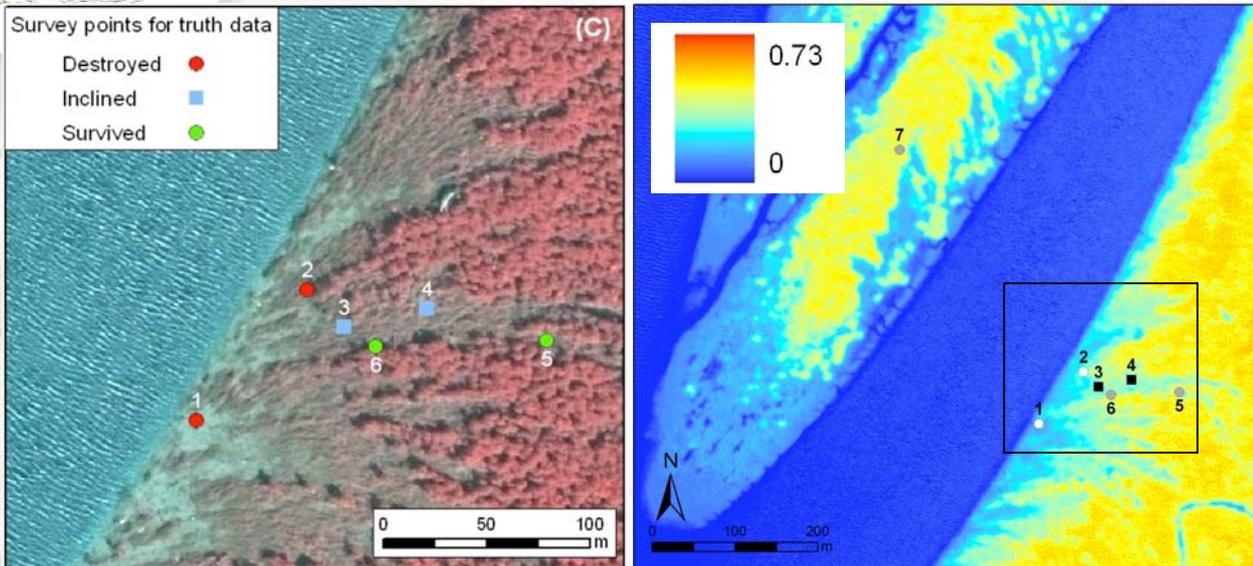
Normalized Difference Vegetation Index (NDVI) at NamKem, Thailand (QuickBird Imagery)

$$NDVI = \frac{IR - R}{IR + R}$$

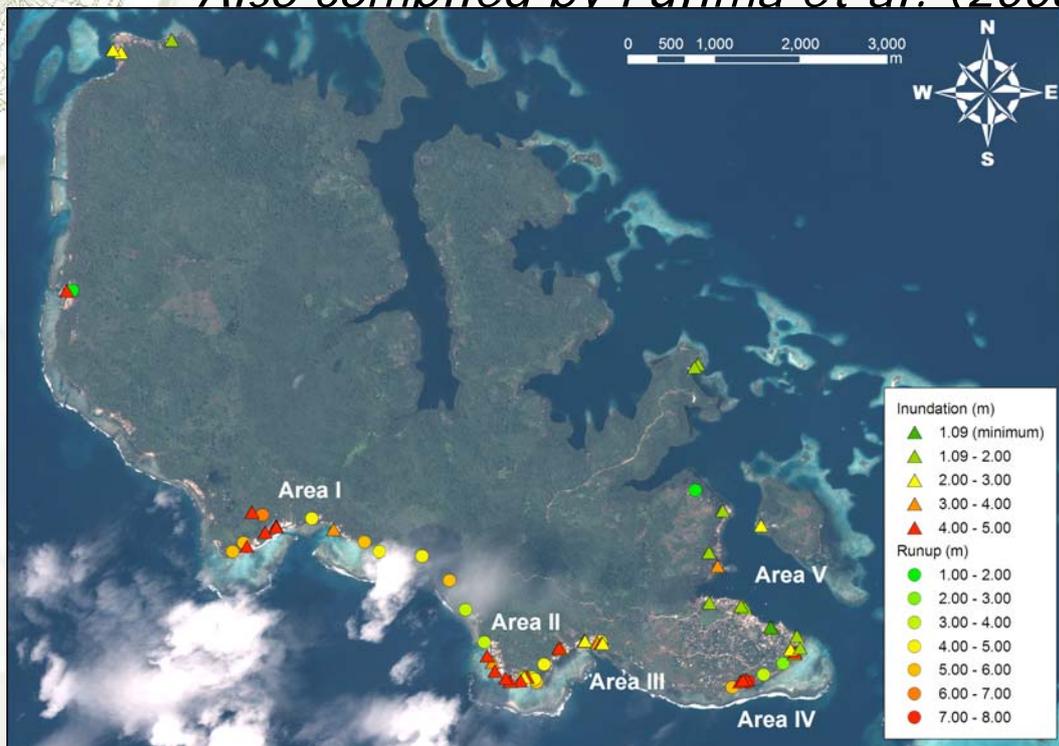
Structural Damage Classification within the Inundation Zone

Area	Measured Tsunami Height (m)	Destroyed	Major	Slight	Almost No Damage	Not Classified
I	4.35	49	7	6	12	1
II	4.71	75	8	10	5	0
III	4.94	26	8	5	0	0
IV	4.53	12	32	16	36	0
V	1.98	0	2	3	158	0

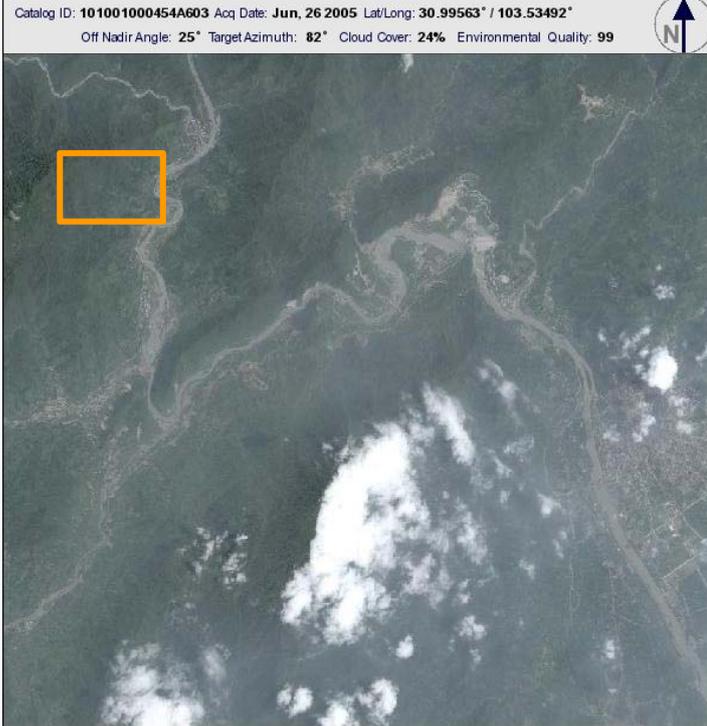
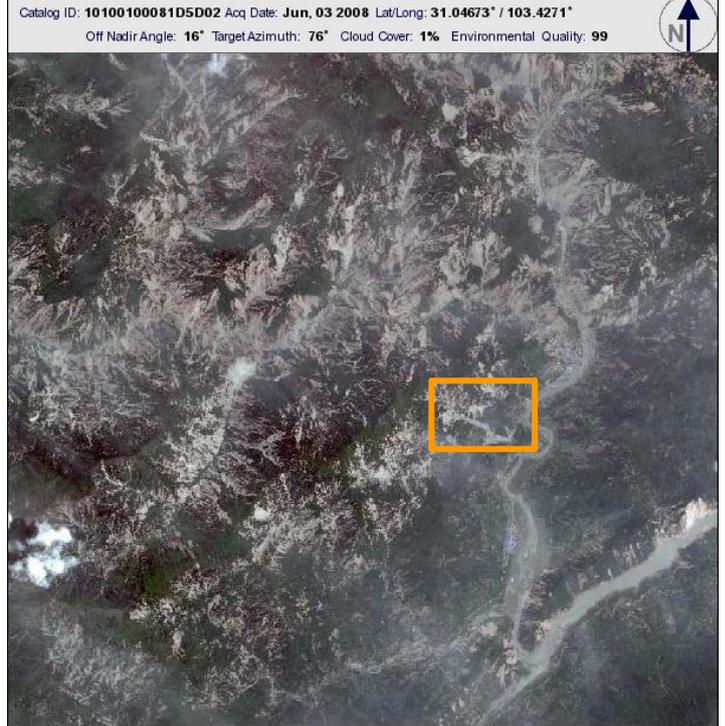
QuikBird Image

2005/ 6/ 26

2008/ 6/ 3

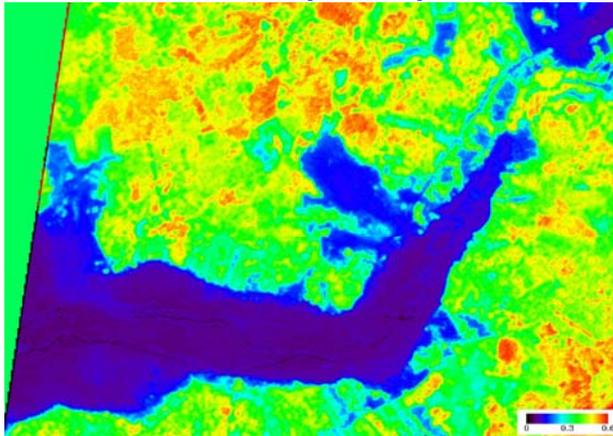
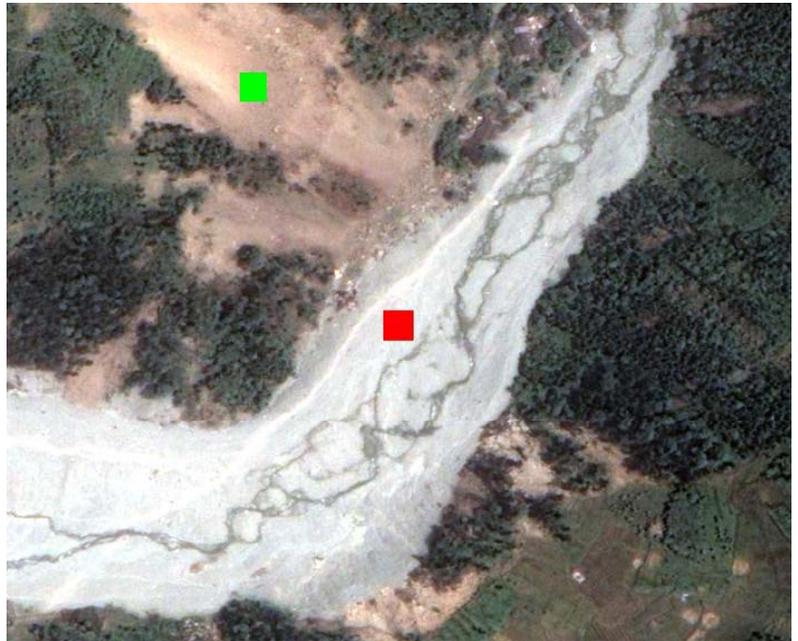
Histogram

NDVI(0~0.6)

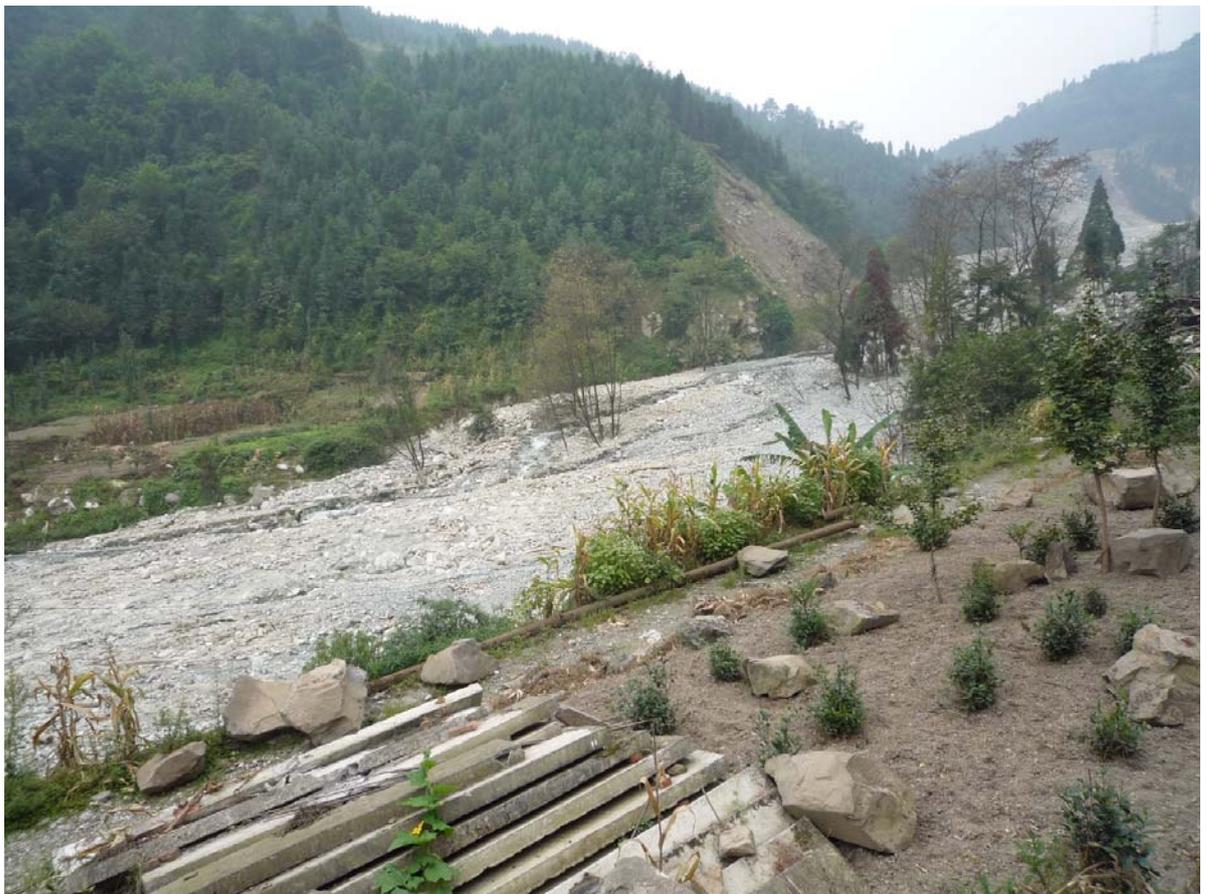
牛圈溝の最下流

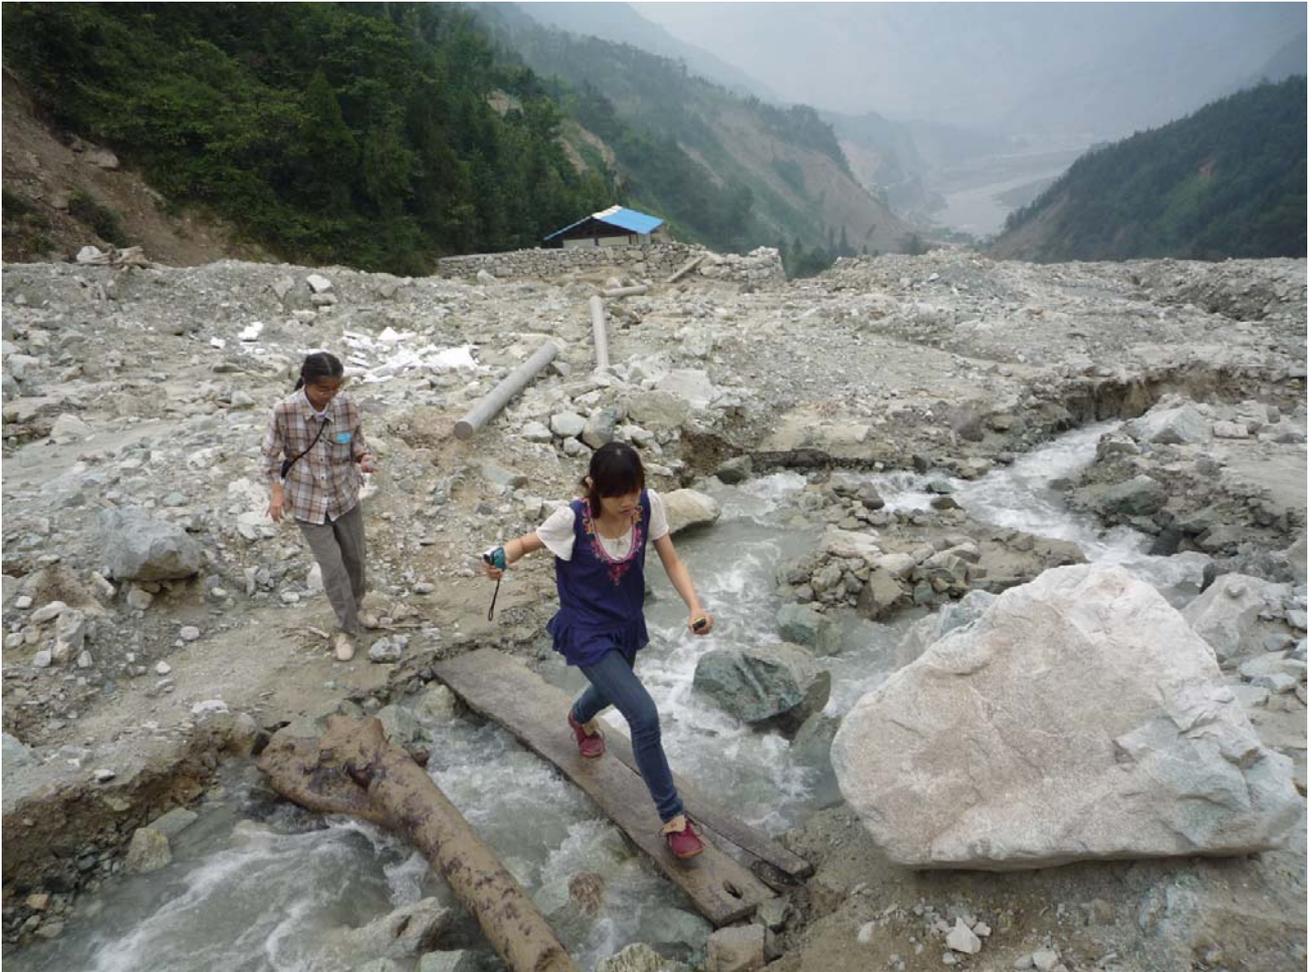
牛圈溝の中央部

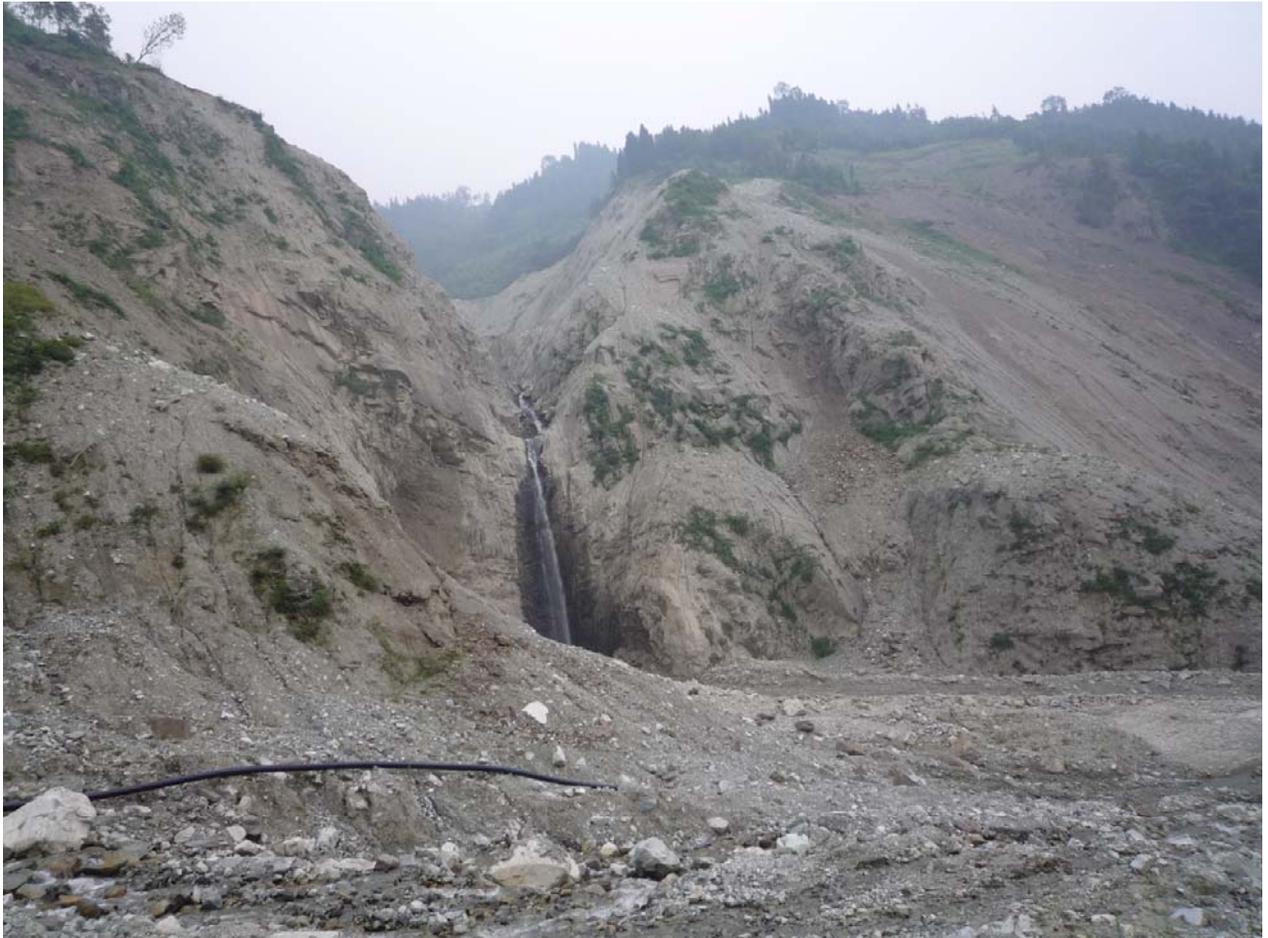
連花芯溝から牛圈溝へ流入する滝

- 地震発生とともに連花芯溝の奥の山肌が大規模に崩落した。崩落した岩石は急な斜面を落下して、急な谷を転がり落ち、連花芯溝の出口の滝のところで跳躍した。
- このようにして、かなりの岩石が、連花芯溝から乾いた状態で牛圏溝に落ちた。また、連花芯溝の溪流は崩落した岩石で埋まった。
- この状態で夕方雨が降り、連花芯溝に堆積した岩石は、土石流となって連花芯溝を高速で流れ下り、滝のところで跳躍して、両側の斜面に衝突しながら流下し、大量の土石が牛圏溝を埋め尽くした。

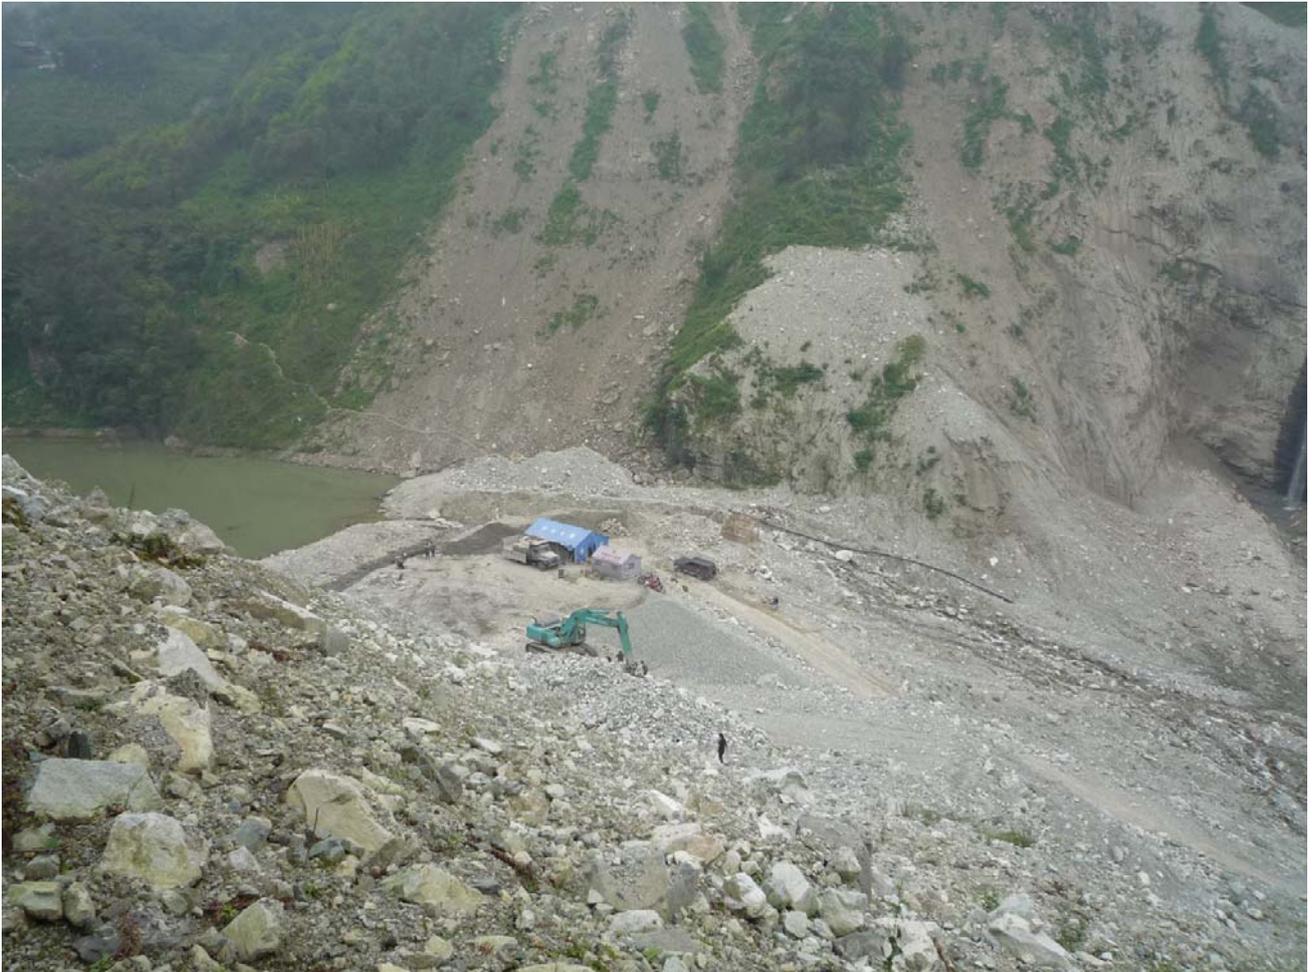
牛圈溝上流の堰止湖（滝の横）

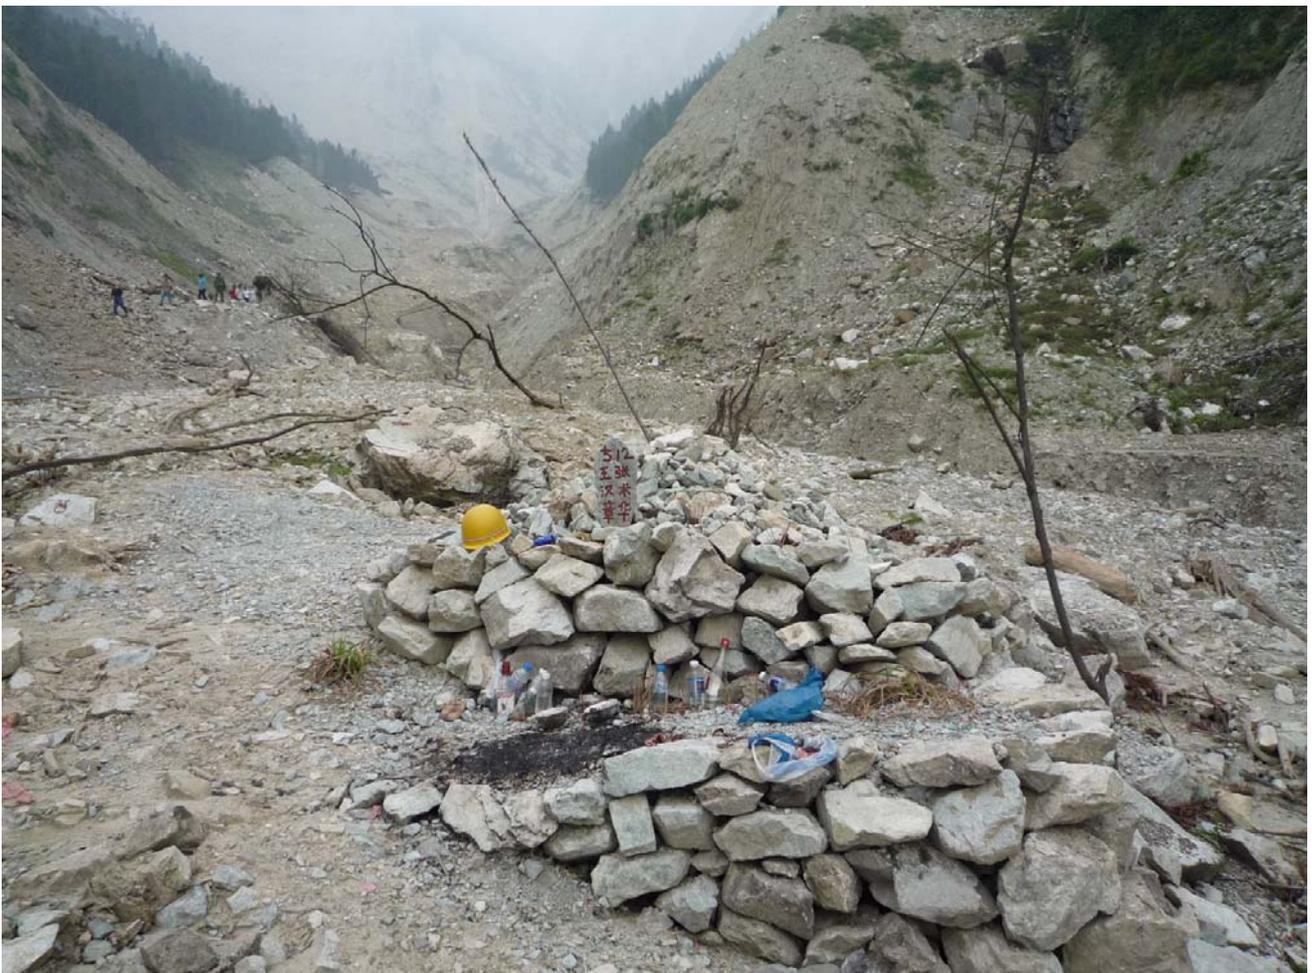
土石流に巻き込まれた家：連花芯溝
