## SEISMIC PERFORMANCE ASSESSMENT OF EXPANSION JOINTS FOR WATER LIFELINES

**ABSTRACT:** In the 2011 Great East Japan Earthquake, the largest water leakage flows occurred at failed expansion joints in 2400mm and 1200mm diameter water pipelines in Miyagi Prefecture. The damage mechanism of buried expansion joints was investigated by site damage inspections and seismic response analyses, which suggested that the expansion joints had absorbed certain settlement before the earthquake, and as a result, the seismic shaking triggered expansion joint failure. This study proposes a new seismic design method for expansion joints, especially those used in arc-welded steel pipelines.

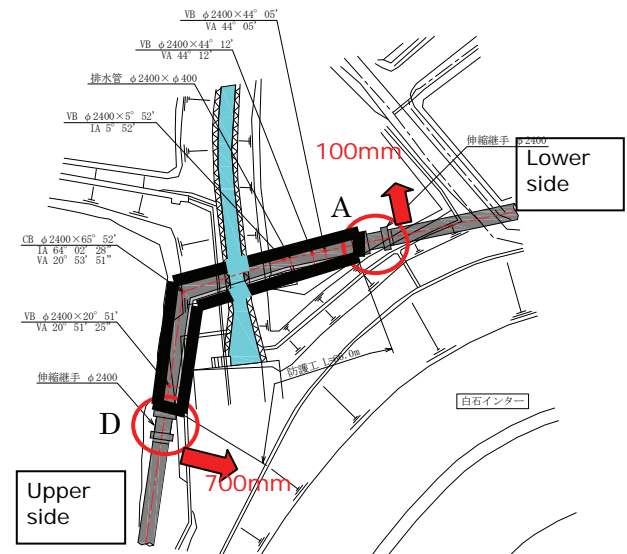
Fig. 4 Location map of expansion joints under-crossing stream line.

Photo 1 shows the large-scale water leakage from the expansion joint in the 2400mm diameter water pipeline immediately after the main shock. The accident occurred at both sides of the concrete encased pipeline under-crossing a water stream, as shown in Figure 4. It must be noted that this leakage occurred at the same time from both expansion joints. The concrete encased structure moved 700mm in the anticlockwise direction at site A and 100mm at site B.

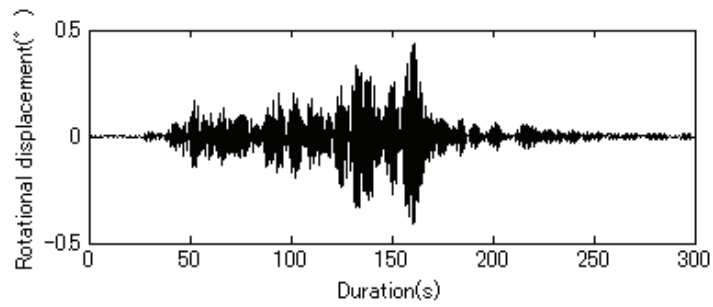
Fig. 8 Rotational angle of under-crossing concrete encased structure.

In the numerical analysis, the spring modulus was randomly modified from the original value to smaller ones in order to obtain the largest responses that can exceed the limit boundary of the expansion joint. Figure 7 shows the excessive displacements between the ground responses and the structural responses in the axial and transverse directions at points A and D in Figure 6.  $\delta_{1A}$  and  $\delta_{1D}$  are the responses in the axial direction, and  $\delta_{2A}$  and  $\delta_{2D}$  are the responses in the transverse direction, respectively. These figures show that the maximum response appears in the transverse direction of point D, as shown by  $\delta_{2D}$ . This result does not conflict with the observation that the largest movement at the encased concrete structure occurred at point D in the transverse direction. The second largest response is given by  $\delta_{2A}$ , which might support the observation that both expansion joints were simultaneously destroyed by the main shock. Figure 8 is the rotational response of the concrete encased structure. These structural responses as shown by the triangular and square marks in the multiple limit state diagram for the expansion joint failure modes in Figure 9. In this figure, three different performance limit curves are shown as boundary conditions of the joint failure. Here, two modified performance curves were prepared for reduced allowance conditions which correspond to existing settlement before the earthquake. The numerical results suggest that the expansion joints at the site might have produced an existing settlement equivalent to 1/3 to 2/3 of maximum performance before the earthquake.

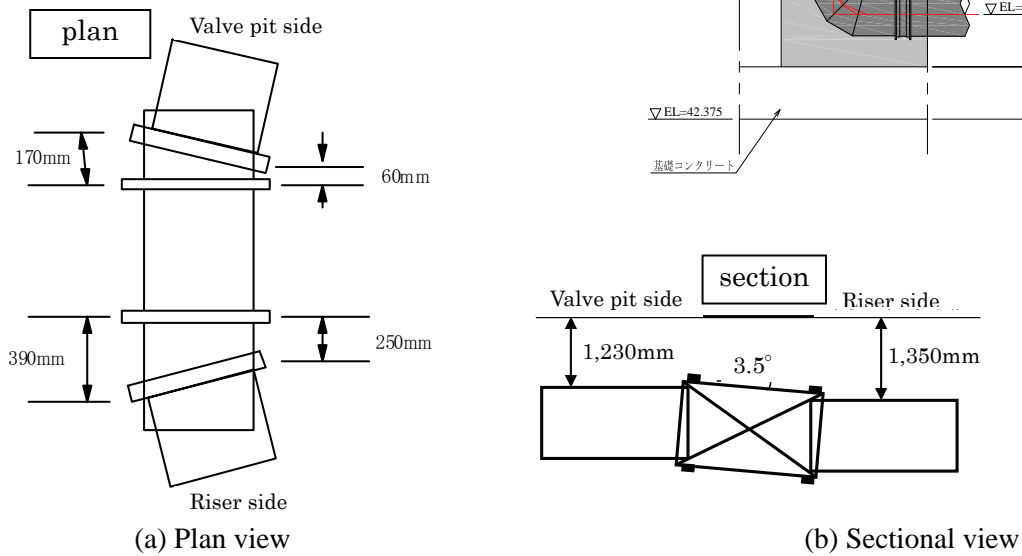
Fig. 11 Site allocation of expansion joint after leakage.

The expansion joint, which is located between the valve pit and the riser structure as shown in Figure 10, had a potential risk of uneven settlement, so that the expansion joint was forced to absorb vertical displacement. As a result of this settlement, the residual allowance for the seismic effect was limited. Based on the site investigation on April 7<sup>th</sup>, 2011, different vertical settlements were measured at the two ends of the expansion joint, as shown in Figure 11. This suggests that the joint had rotated to an angle of 3.5 degree before the earthquake. Using the site soil conditions shown in Figure 12, the seismic response of the concrete riser was analyzed with a single-degree-of-freedom system as follows.

vicinity of the valve pit. Therefore, it should be noted that the expansion joint must not be connected to a pipe which may be subjected to additionally forced settlement.

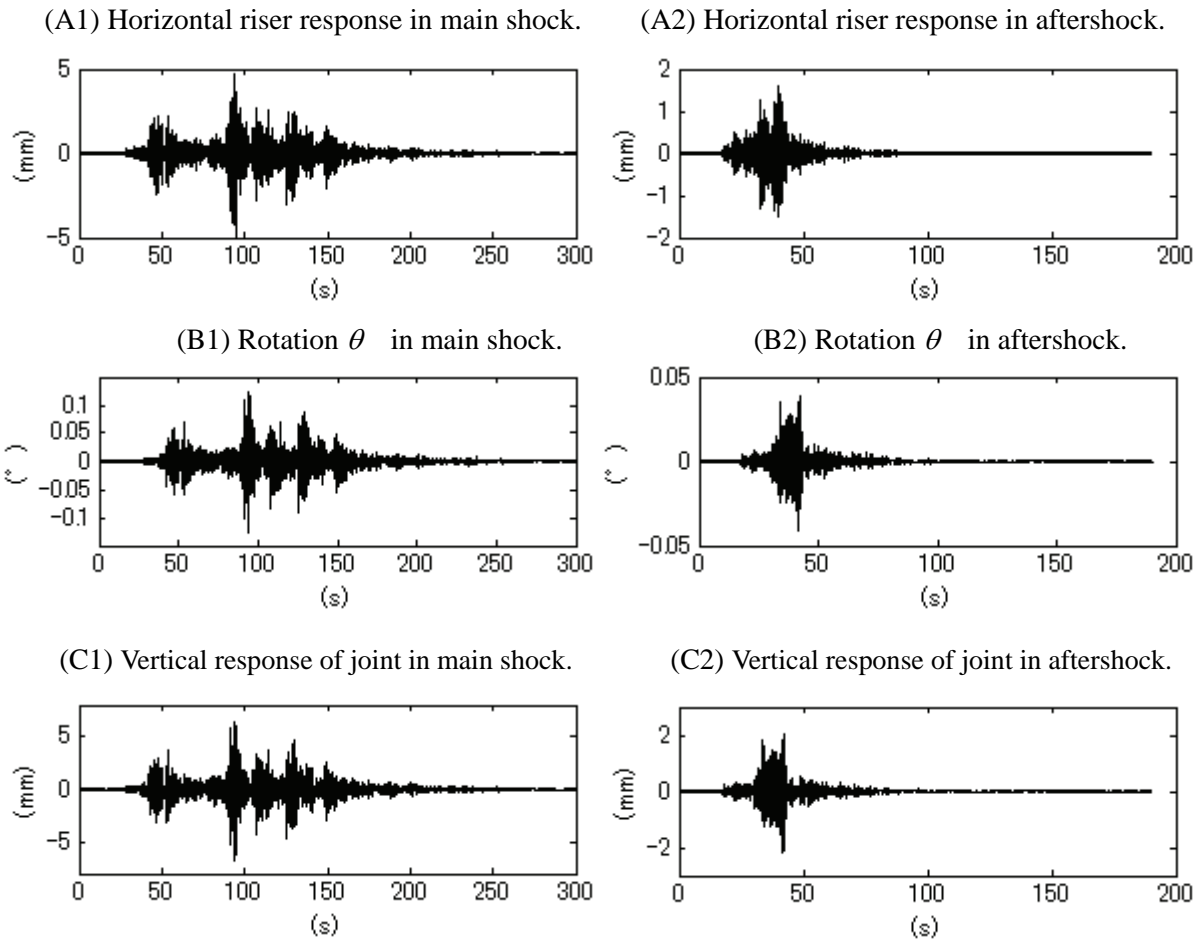
Fig. 14 Seismic responses of riser and expansion joint in main shock and aftershock.

in which  $x_Q, x_G, x_{si}$  and  $\theta$  are base-rock ground motion, structural and surface ground responses, and rotation angle, as shown in Figure 13, and,  $k_i$  and  $l_i$  are the spring constant and the length at the  $i$ -th point from the gravity point.  $I_G$  and  $k_R$  are the rotational rigidity of the riser and its rotational stiffness for the surrounding soil and structural interaction. Figure 14 shows the seismic responses of the riser and the expansion joint in the main shock and the aftershock. In the main shock, the maximum rotation is less than 1 degree, which is not sufficient to destroy the expansion joint. This response led to a small leak from the joint since the pre-existing settlement had already produced rotation of 3.5 degree in the expansion joint. According to the fabricator’s specification shown in Figure 15, the allowable maximum angle is 6 degree, so the main shock could not cause large-scale leakage immediately after the main shock. However, one month after the first small leakage, the hydro-blasting effect had worked on the sealing ring, reducing the thickness of the bolt diameter and the ring itself. As a result, when the second shock occurred in the aftershock of April 7<sup>th</sup>, the sealing ring had already been worn out, and could easily be broken by a small impact. This is a reason the expansion joint suffered a leakage failure in the aftershock.

In the second example, the pre-existing settlement played an important role in initiating small leakage from the sealing ring, which caused hydro-blasting that reduced the metal portion of the sealing elements. This result suggests that the allowable displacement of the expansion joint should be designed not only for vertical settlement under ordinary construction conditions but also for excessive displacement by future earthquakes.
