DAMAGE AND EFFECTS CAUSED BY TSUNAMI FIRES: FIRE SPREAD, FIRE FIGHTING AND EVACUATION

ABSTRACT: The Great East Japan Earthquake triggered fire outbreaks in many structures and buildings including hazardous-material facilities. The tsunami induced by the Earthquake also produced a huge impact under which various tank and gas-cylinder facilities, automobiles, etc. were damaged and caused to leak hazardous materials, such as gas and gasoline. In addition, the tsunami swept away numerous objects, causing collisions between objects and sparks from broken electric cables. Under such situations, fires broke out at various points in the affected region, some escalating to large-scale urban fires or forest fires. Many of the people that had been evacuated from the tsunami-affected zone had to be evacuated a second time to escape from the spreading and escalating fires.

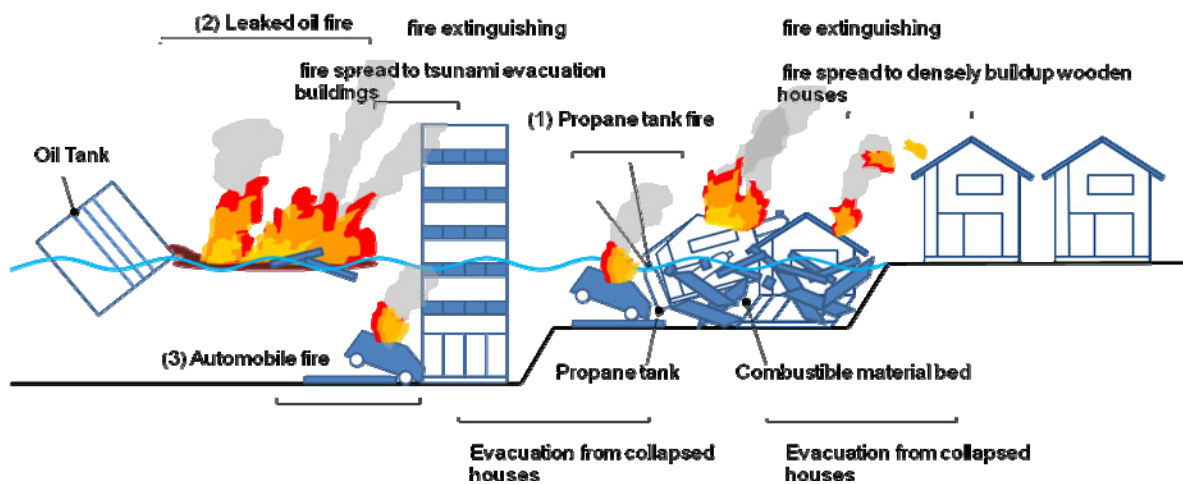
Fig. 40 Mechanism of tsunami fire and responses

Hazardous materials are main factor to occurrence of tsunami fires. Combustible materials from broken houses hit by tsunami determine the possibility of fire spread. Drifting materials, houses and boats contribute to fire spread.

It is difficult to evacuate from tsunami evacuation buildings and collapsed houses in case of fire, it is necessary to consider secondary evacuation routes, safe zone in buildings, fire extinguishing equipments or other strategies.
