DAMAGE ANALYSIS OF BRIDGES AFFECTED BY TSUNAMI DUE TO GREAT EAST JAPAN EARTHQUAKE

Kenji KOSA¹

ABSTRACT: The Great East Japan Earthquake and the resulting tsunami hit the coastal areas of Japan. It is found that the outflow of steel and steel truss bridges is more serious than concrete bridges. By the use of videos, the tsunami velocities in 5 severely affected areas were estimated and the overall average is about 6.0m/s. In Rikuzentakata, 30% RC buildings suffered structural damage and 40% bridges flowed out. Besides, it is found that the outflow of superstructure is able to be judged by the level of ratio β between superstructure resistance and wave horizontal force primarily.

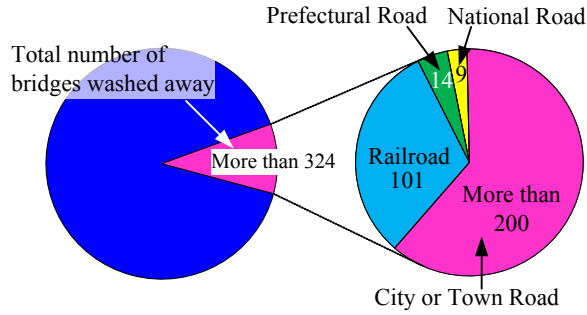
Fig. 1 Amount of bridges washed away

During the Great East Earthquake, the outflow of superstructure and excessive scour occurred to more than 300 bridges in East Japan. Fig. 1 illustrate the bridges which suffered damage Rank A (bridge seriously damaged and could not be used). Among the 300 bridges, 9 national way bridges, 14 prefectural road bridges and 101 railway bridges, suffered serious losses. Despite a lack of official data about the damage to city and village roads, by the use of Google Earth, it is noted that at least 200 bridges suffered serious losses.

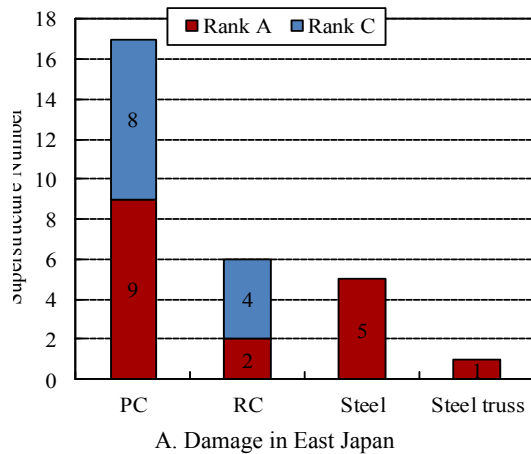
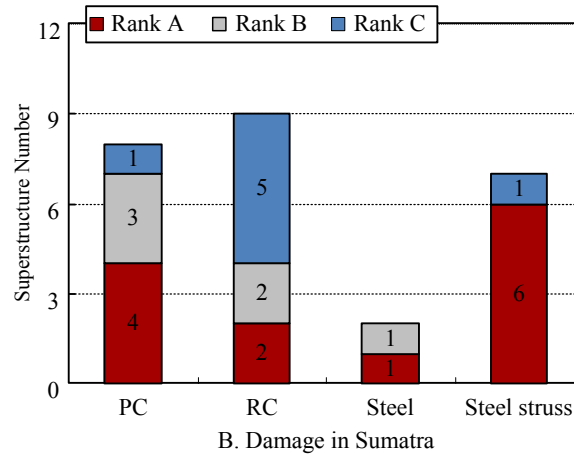
Fig. 2 Comparison of tsunami damage

Furthermore, the damage extent of bridges in East Japan is compared with the damage to bridges caused by Sumatra Earthquake. Before comparison, we define the damage level in Table 1, focusing on the outflow condition of bridge superstructure. The damage level of 29 different bridge superstructures affected by tsunami in Great East Japan Earthquake is plotted in Fig. 2-A and the damage level of 26 bridge superstructures affected by tsunami in Sumatra Earthquake is illustrated in Fig. 2-B. From the 2 figures, it is found that the bridges constructed by steel or steel truss suffered more serious damage than concrete bridges. All the 6 survey steel and steel truss bridges flowed out by tsunami. For the concrete bridges, during the 2 tsunami disaster, about half PC superstructures belong to Rank A while about 2/3 RC superstructures belong to Rank A.

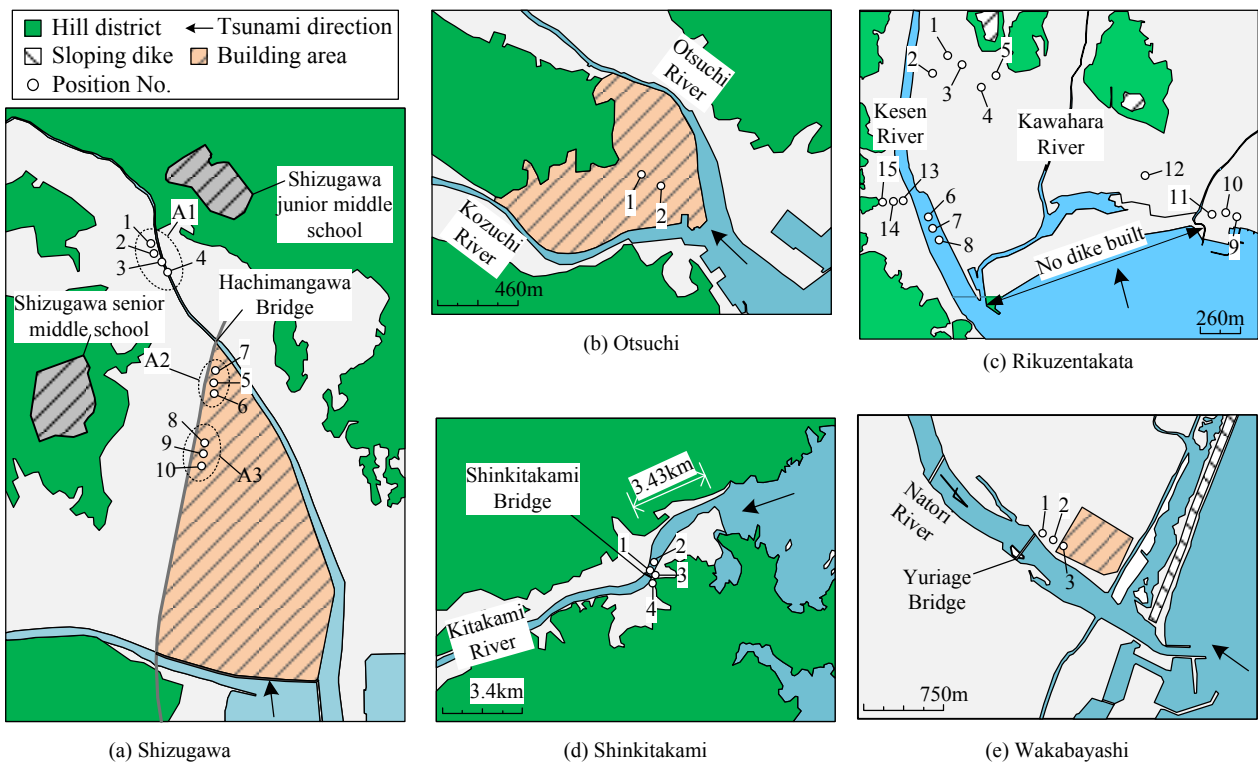
Fig. 4 Velocity result

In Shizugawa, 2 videos made at junior and senior schools are able to be used for the estimation of tsunami velocity. By using the method in last section, the velocity is measured by 10 times at different positions, which are plotted in Fig. 4-(a). Among the 10 positions, No.1~4, No.5~7 and No.8~10 locate at A1, A2 and A3 areas respectively. Table 2 plots the debris types and velocity result in Shizugawa. The average velocity in Shizugawa is 5.8m/s.

By the same process, the tsunami velocities in Otsuchi, Rikuzentakata, Shinkitakami and Wakabayashi have been estimated and the measure positions are illustrated in Fig. 4-(b) to (e). The velocities of each measure position and the maximum, minimum and average velocities in each area

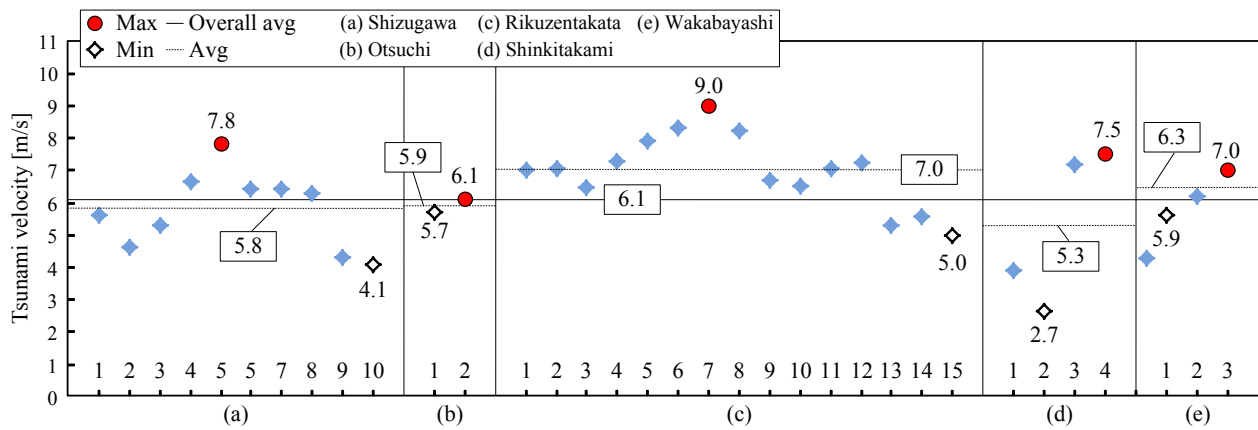
Fig. 5 Maximum, minimum and average velocities

are given in Fig. 5. The overall average is 6.1m/s. It is obvious that the average velocities in Shizugawa, Otsuchi and Wakabayashi have the same level (about 6.0m/s) and are close to the overall average. In addition, the average velocities in Rikuzentakata is greater while in Shinkitakami is smaller than the overall average.

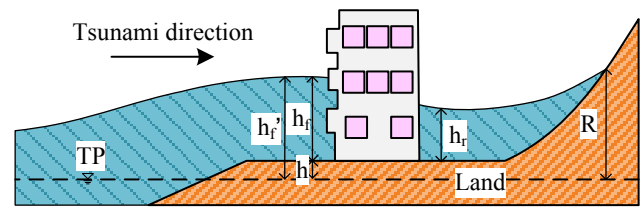
Fig. 12 Factors for equation

in which, u is the tsunami velocity; h_f and h_r are the inundation depth in front and behind of the building, respectively; R is the tsunami run-up height; C_v is the velocity coefficient; F_r is the Froude number; g is the gravity acceleration (9.8m/s^2). Some of the parameters are illustrated in Fig. 12.

As illustrated in Fig. 12, h_f' is the inundation elevation (front of building, from TP level). h is ground height (ground settlement by earthquake included, from TP level). Values of these two parameters can be obtained based on reference (The 2011 Tohoku Earthquake Tsunami Joint Survey Group 2011). Thus, based on the inundation depth h_f (difference of h_f' and h), velocities near four buildings (positions shown in Fig. 13) can be calculated from Eq. 6. Table 6 shows calculation parameters and results. From Fig. 13, evaluated tsunami velocities from equation can roughly coincide with those in neighboring areas from videos. (A B with (d), C D with (c), Fig. 13)

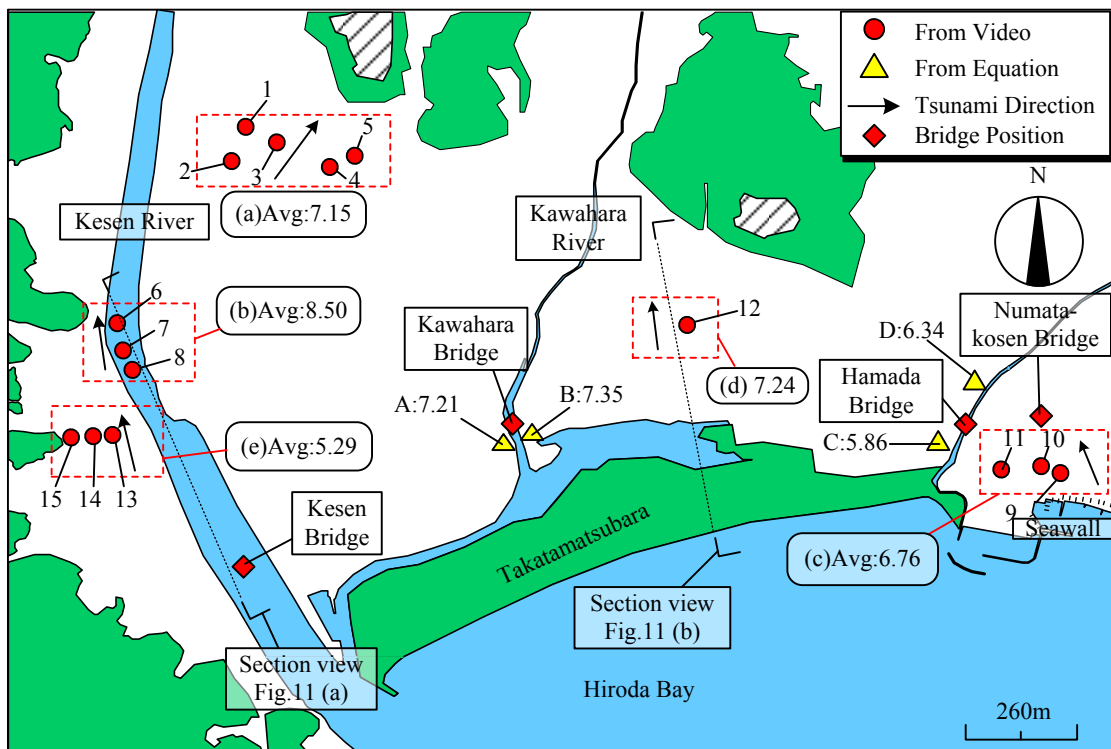
Fig. 13 Distribution of tsunami velocity

Thus, focus on evaluated results from videos as illustrated in Table 5 and Fig. 13, the average tsunami velocity for Rikuzentakata is about 7.0m/s, being greater than 6.0m/s of entire Tohoku area.

Based on the distribution of measured tsunami velocities as shown in Fig. 13, the detailed velocity near each bridge is used for recalculation. For Kesen Bridge, the average velocity 8.50m/s in (b) river area is applied; for Kawahara Bridge, the average velocity 7.28m/s of A and B points is applied; for Hamada Bridge, the average velocity 6.10m/s of C and D points is used; and for Numatakosen Bridge, the average velocity 6.76m/s in the (c) area is used.

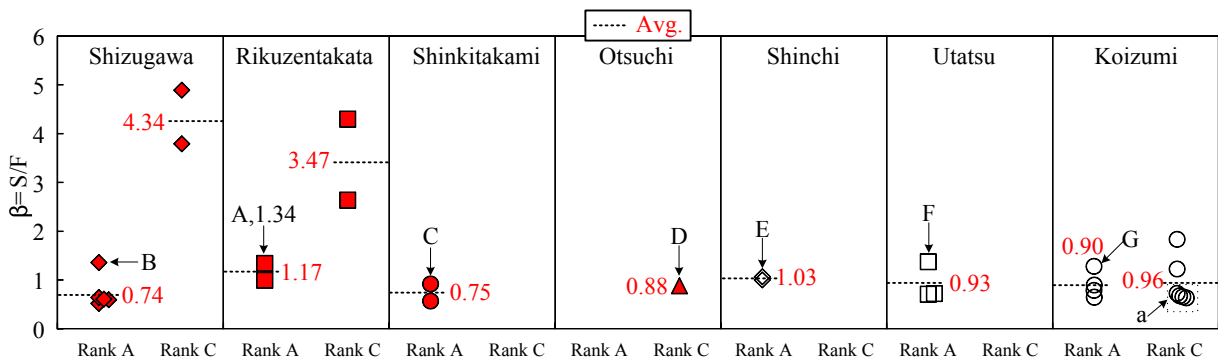
Fig. 16 Former β ratios for entire area

Compared with the summary results of former β ratios (velocity assumed as 6.0m/s) in different areas (Fig. 16), we get to know the following phenomenon. For Rikuzentakata area, as the increasing of velocity (6.0m/s vary to be 7.0m/s), the β ratios have reduced entirely. The β ratio of girders for Numatakosen Bridge (Rank A, Mark A of Fig. 15) reduced to be smaller than 1.0, reflecting outflow
