DAMAGES OF MACHINES AND STRUCTURES IN GREAT EAST JAPAN EARTHQUAKE AND LESSONS FROM THE DISASTER

Masaki SHIRATORI

Professor, Center for Risk Management and Safety Science, Yokohama National University
Chairman of the JSME Investigation Committee on the Great East Japan Earthquake
masaki@ynu.ac.jp

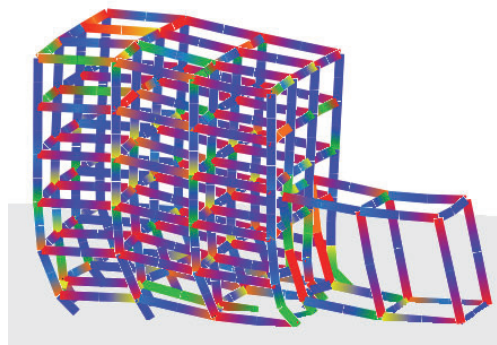
Figure 2b A snapshot of ASI-Gauss-based simulation of building attacked
by debris carried by tsunami (Lynn, K. M. and Isobe, D. (2007). “Finite Element Code for Impact
Collapse Problems of Framed Structures”, *International Journal for Numerical Methods in Engineering*,
Vol. 69, No. 12, 2538-2563.)
